CSC Operations

Run & DPG Coordination
Workshop, Turin
25.01.2017

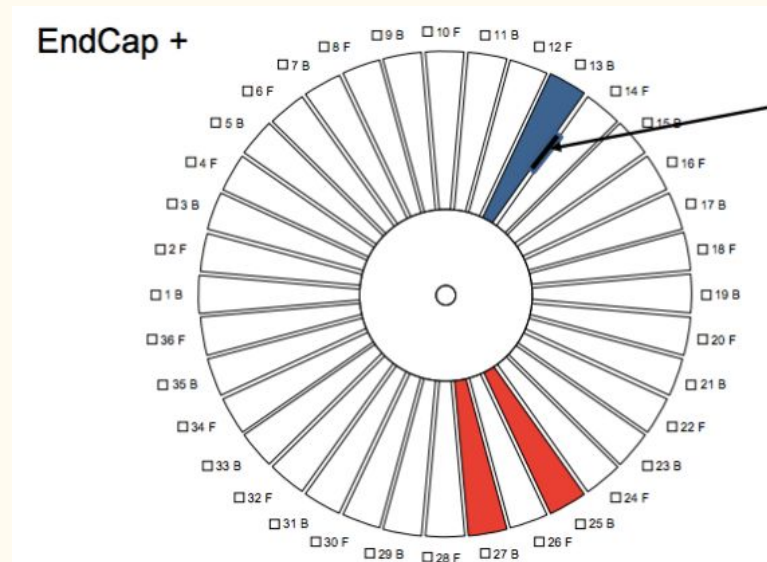
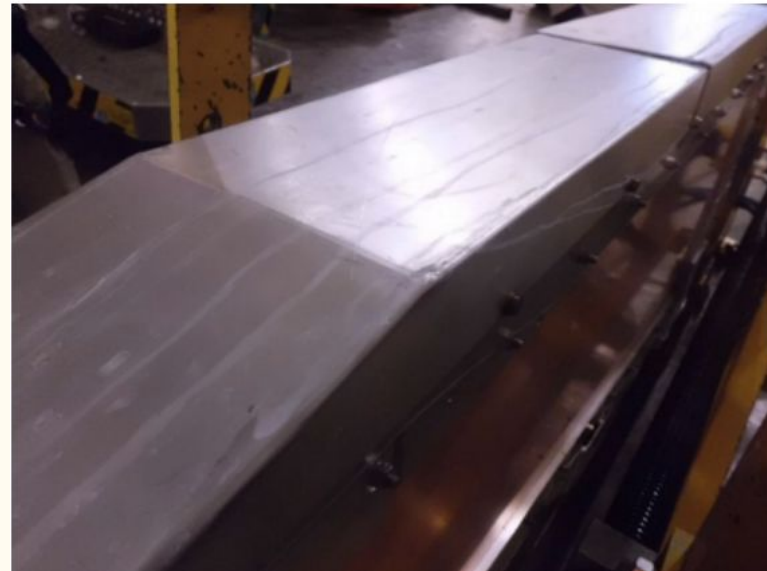
ME1/1 water leak in late 2015

- **Water leak detected during Heavy Ion run of 2015**

- Leak traced to ME+1/1/13
- 3 chambers extracted, brought to the surface, cleaned and repaired

- **Precautionary measures**

- Enable water valve control of individual ME1/1 circuits when CMS is closed
- Humidity sensors installed in vacuum tank
- Water collectors installed to channel any water away from instrumented regions

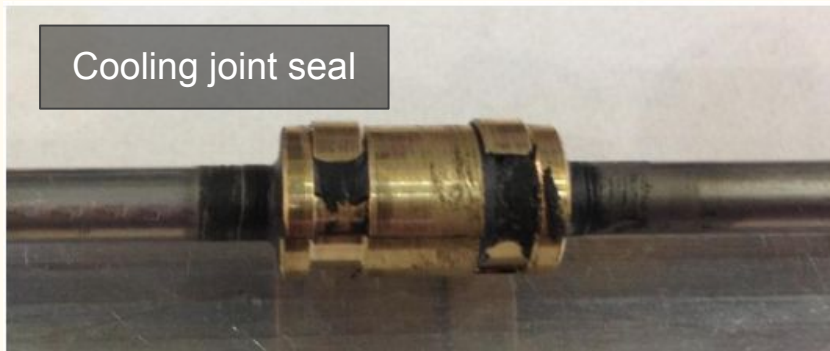
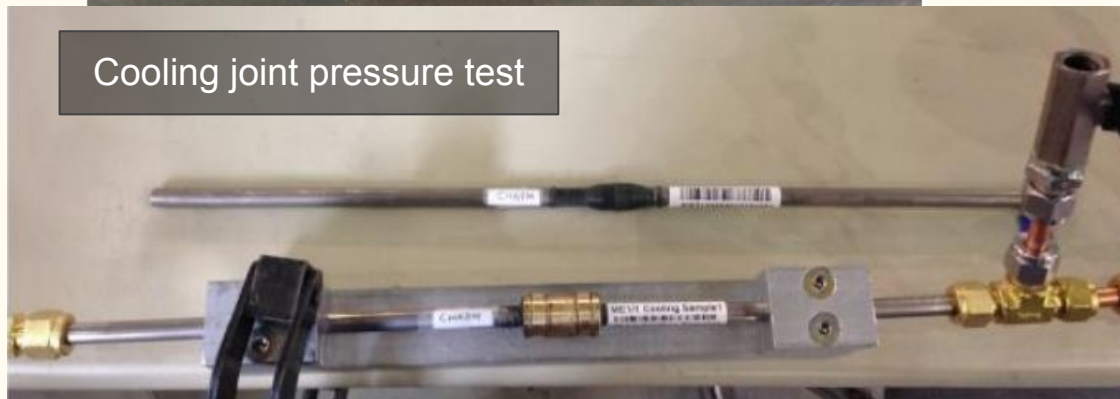
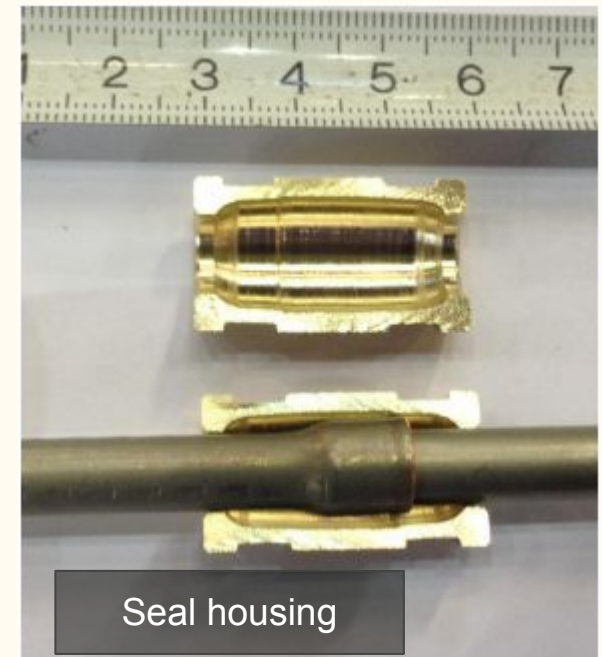
ME1/1 cooling circuit repair

- The leak was caused by a faulty on-chamber cooling pipe joint
- Reinforcing all ME1/1 cooling joints during this YETS
 - High-performance rad-hard epoxy compound (Germetal)
 - Was shown to reliably seal the pipe joints even without any welding
 - Radiation tests at CHARM and CASTOR table showed no signs of degradation

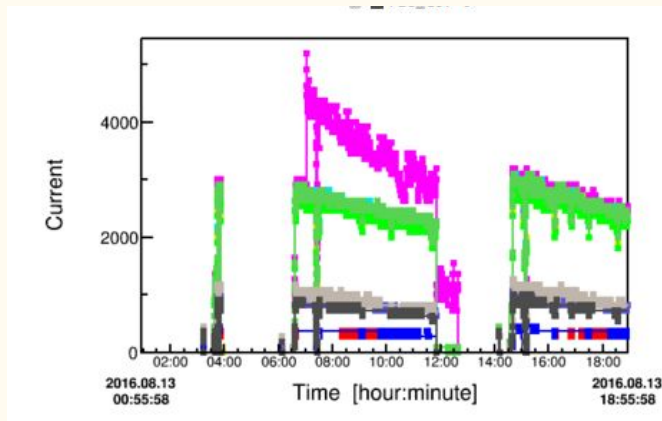
Malter effect in me+2/1/07

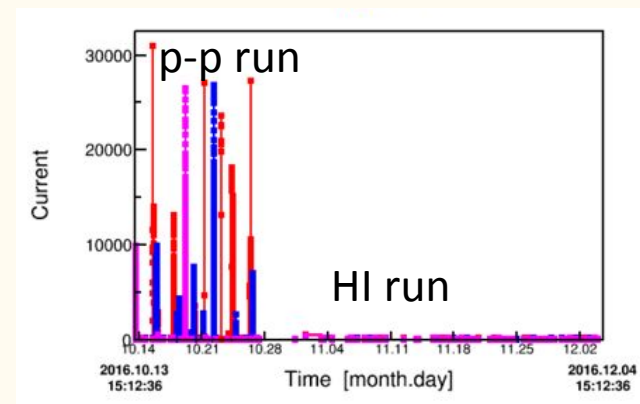
Spikes in HV currents of me-1/3/20

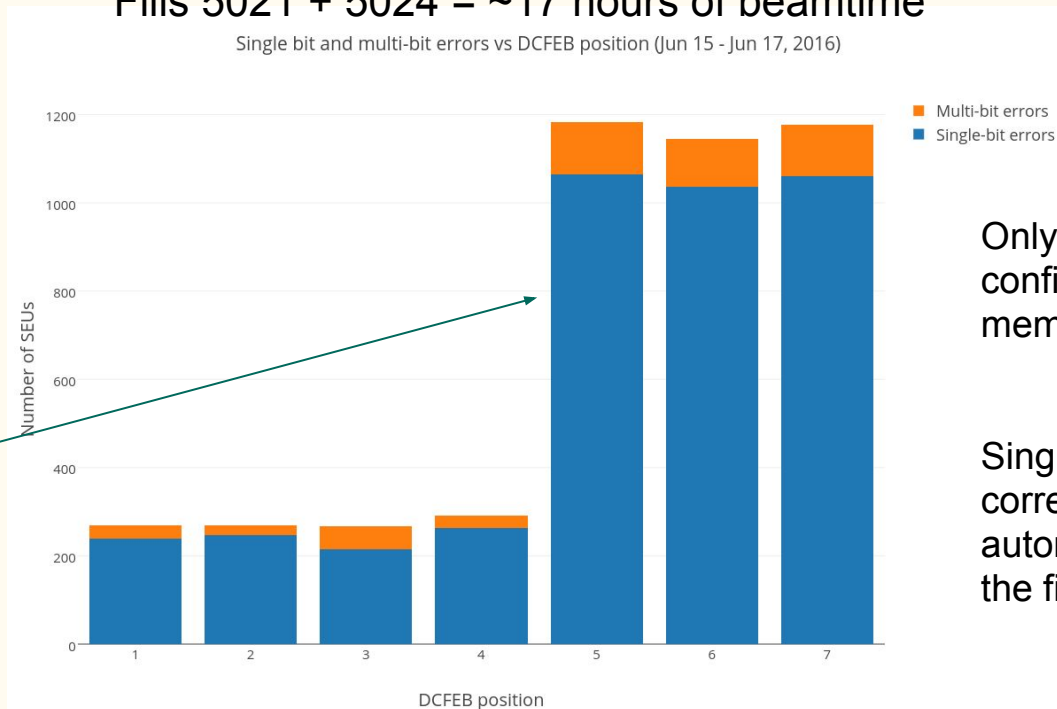
Total SEU count vs DCFEB position
Fills 5021 + 5024 = ~17 hours of beamtime

Only shows configuration memory SEUs

Single bit errors corrected automatically by the firmware
