Pixel, tracking e b-tagging 2017

A. ROSSI

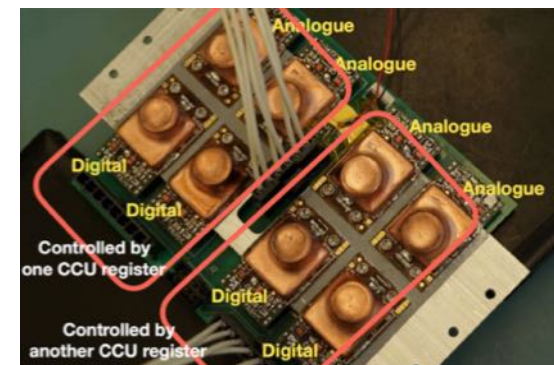
- DCDC stop working without (apparently) no reason
- First event on October 5th
- Almost all of them after a dis/en-able cycle or a power cycle
 - Only one hours after the last power cycle and one during stable beams
- Both digital (3.3/3.5V) and analog (2.4V) DCDC converters are affected
- Both Bpix and Fpix
- Power cycle or dis/en-able many of them in any case
 - to recover modules affected by the “unrecoverable” SEUs in the TBM
 - To investigate the problem
 - Because of global power cycles of the detector
 - LHC and beam conditions
- Failures almost continuously up to now
 - Rate slightly decrease in the last 2 weeks

- Task Force in place
 - <https://twiki.cern.ch/twiki/bin/view/CMS/PixelPowerProblems>
- Daily Pixel Operation meeting :
<https://indico.cern.ch/category/1732/>
- Technical Incident Panel
 - <https://indico.cern.ch/event/677774/>
- Explanation and solution not yet found

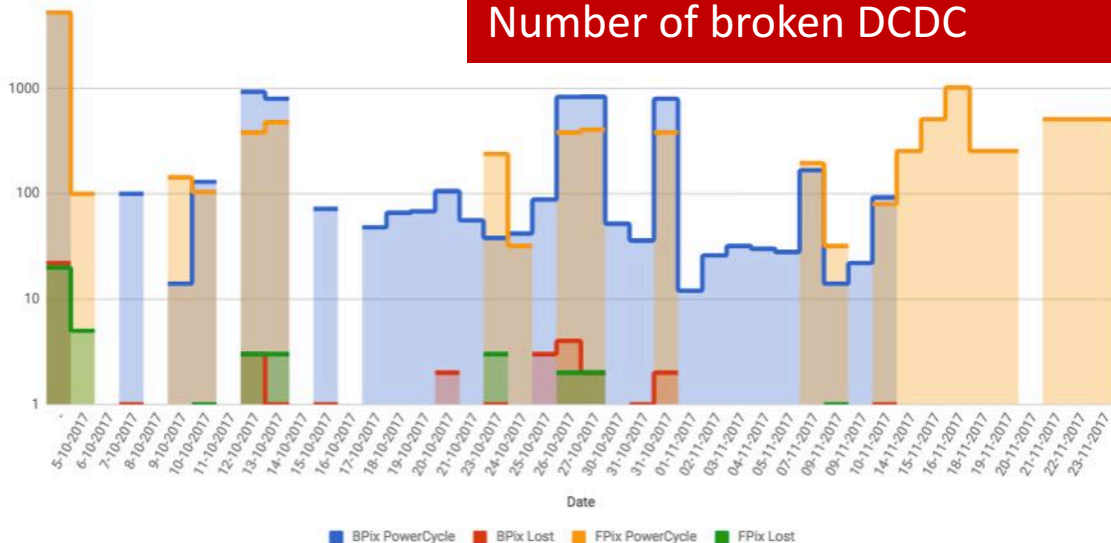
BPix PC, BPix Lost, FPix PC e FPix Lost

Number of DCDC powercycled
Number of broken DCDC

- All DCDC power cycle from October 5th
 - Manual dis/en-abling to recover "stuck TBM"
 - Full detector power cycle (5)
 - Fpix D1+D3 massive power cycles (10)
 - Automatic PC
 - Re-enable for few hours

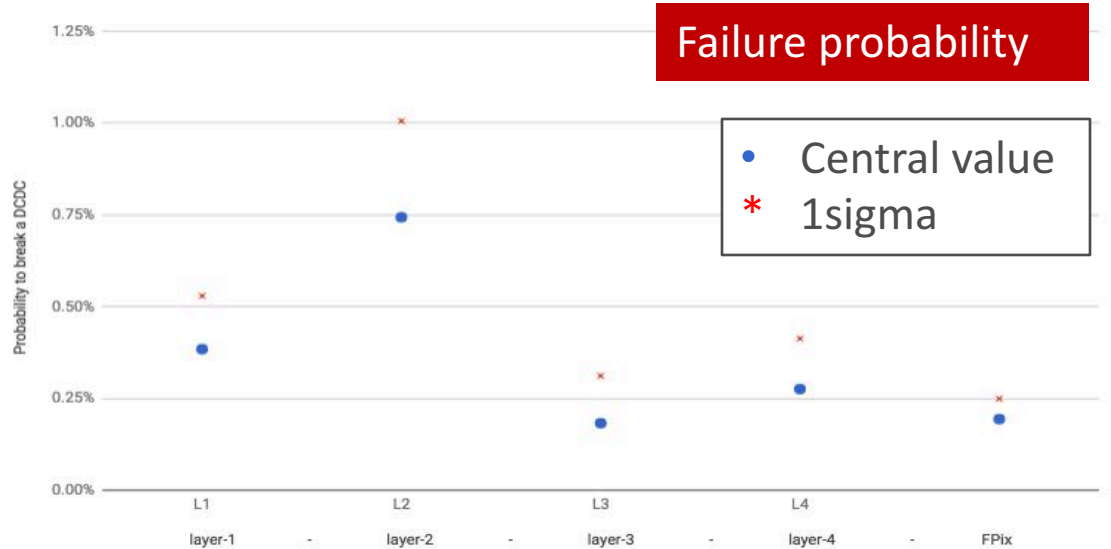
Failure probability

- 55 DCDC converter failures
 - **Few of them restart to work (spontaneously)**
 - 5 Analog, 4 Digital
 - 3 unstable
 - 2 provide limited analog current

- Inactive channels build up because of “stuck TBM” and no automatic power cycle
- Interfill power cycles recover them but can break DCDC converters
 - DCDC failure proportional to luminosity

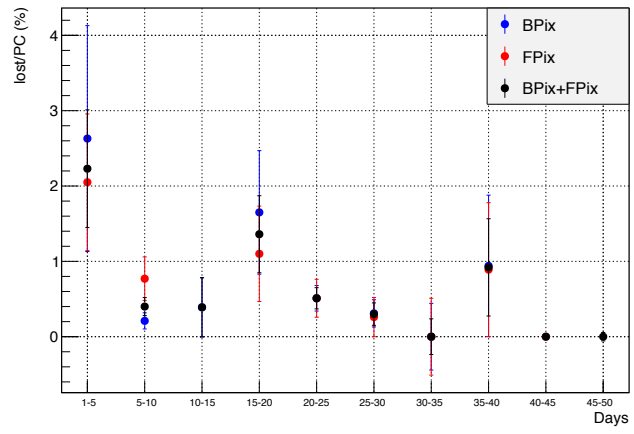
Probability to lose a DCDC (in bins of 5 days)

- During the last two week the rate decrease

- Clearly visible the moment when automatic Software Recovery was disabled

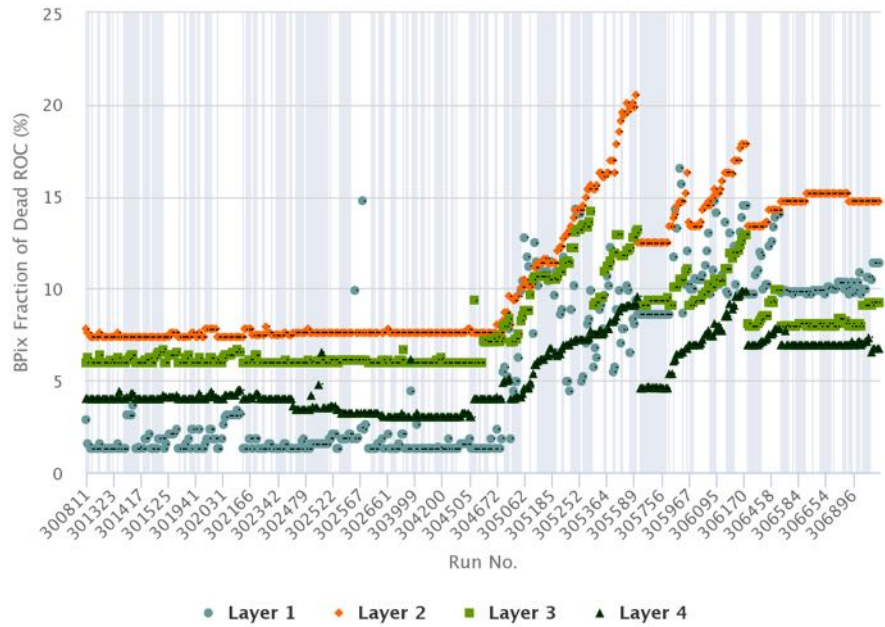
BPix Fraction of Dead ROC (%)

- Total fraction of inactive ROC now $\sim 11\%$

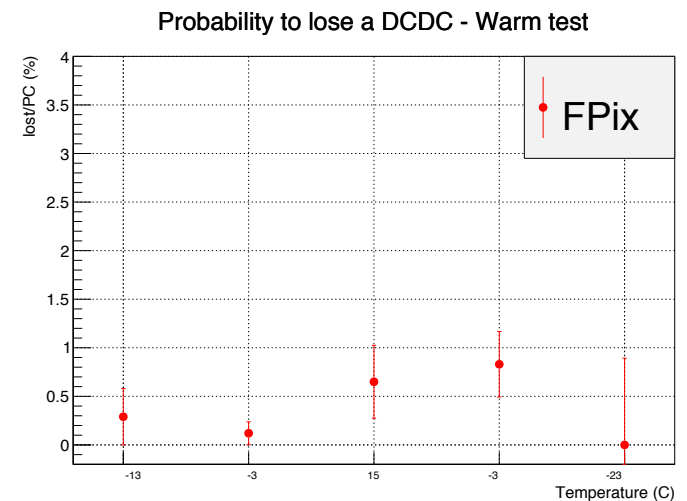
- Reduced input voltage (11V→9V) in 50% analog converters
 - No failure of ANY analog converters since then...
- Some DCDC on Bpix are unused, stress test on those

- ~500 dis/en-able cycles: no failure
- Stress test of four DCDC converter sets (8 converters) in FPIX
 - One failure after ~250 power cycles (for each converter), digital converter

- after ~3300 power cycles no other failure show up
- Failure rate measured at different temperatures
 - Failure rate per power cycle close to the one observed in standard conditions **in the first 30 days**

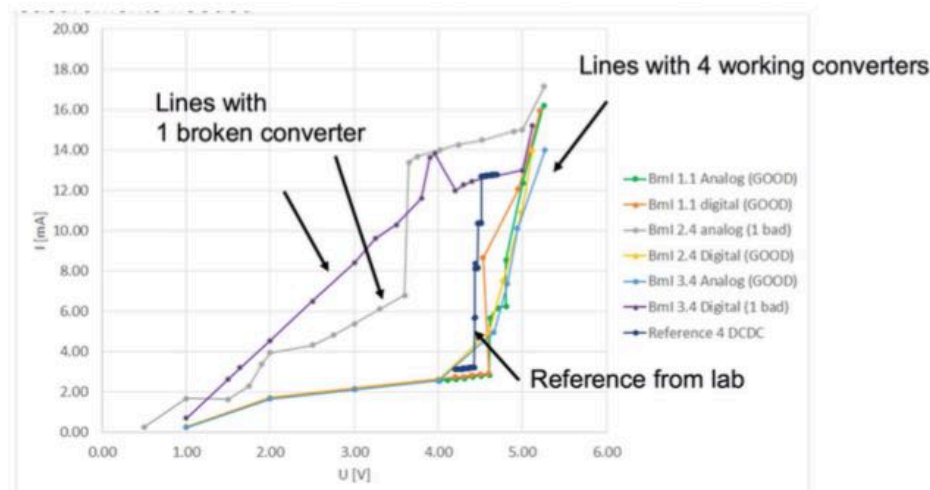
- FEAST2 designers suggested to measure the IV curve to see the DCDC linear regulator switch on
 - Voltage on DCDC from 0 to 4.7V (output not enable)
 - Every linear regulator should drain 3mA

- When all DCDC converter are good the behavior is as expected
- When there are broken DCDC an ohmic behavior show up
 - Similar behavior of lab DCDC broken with over voltage
