Performance and Operation of the CMS Phase 1 Pixel Detector

Lea Caminada on behalf of the CMS Collaboration

The CMS Phase 1 Pixel Detector

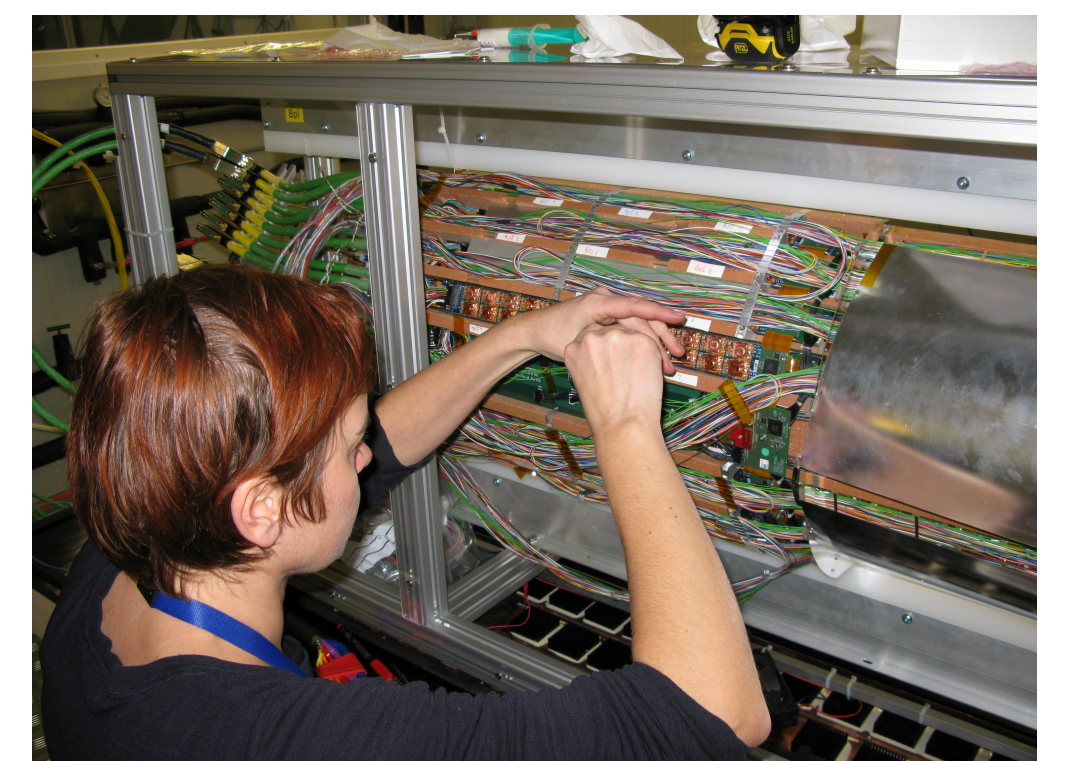
- Issues with individual power and readout groups (4%) resolved by improving connections or component replacement

Other repairs

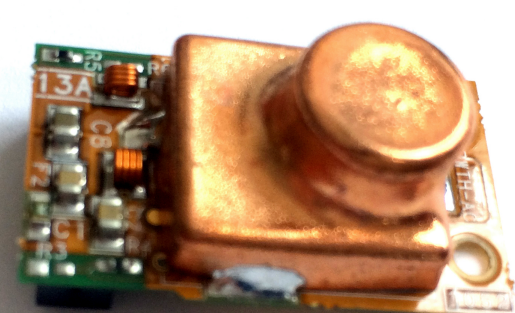
DCDC converter issue

- 1184 DCDC converters used for powering
- Components started failing during last two months of operation (67 converters)
- Detector extracted for repair at the end of 2017
- Failure traced to FEAST2 chip, cause still under investigation

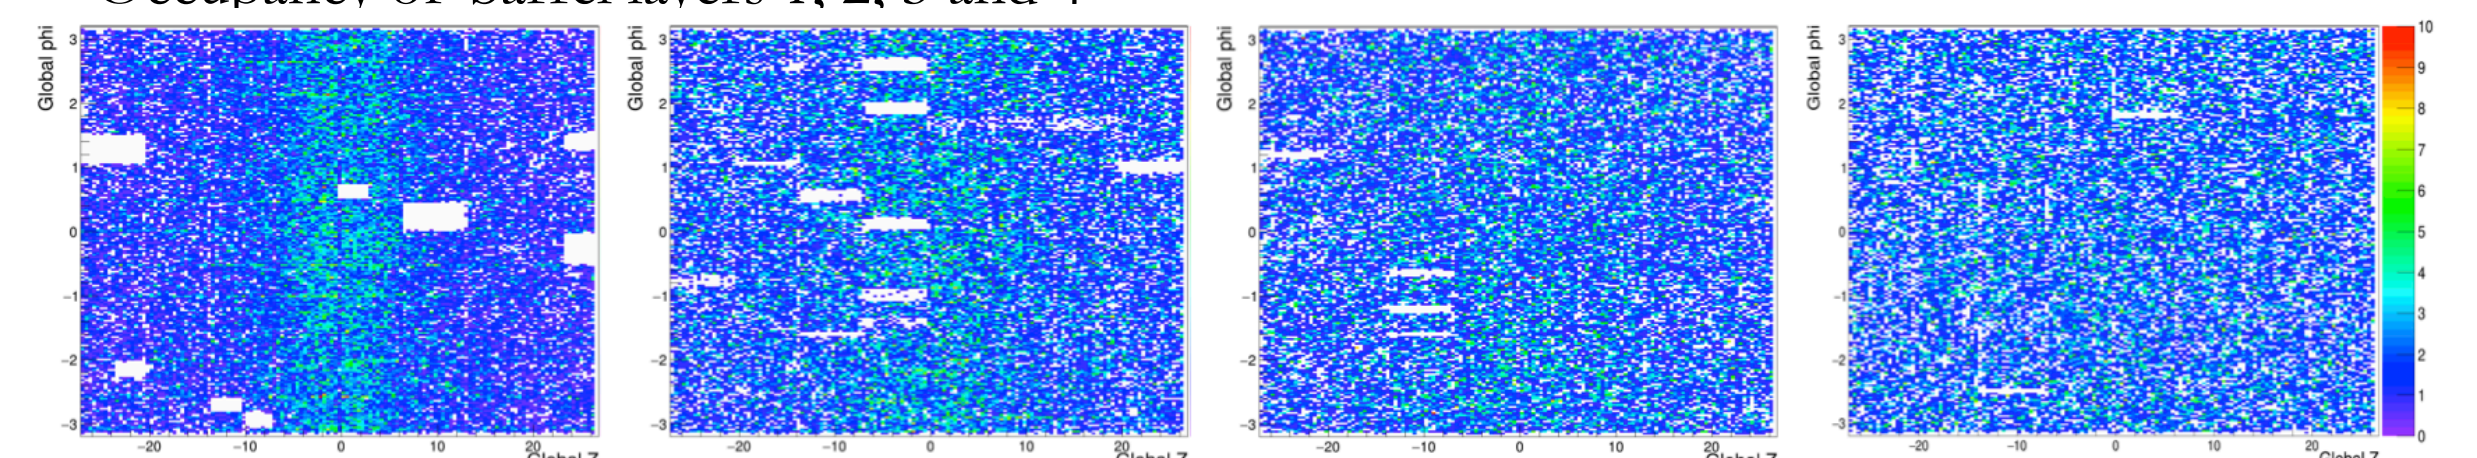
Occupancy of barrel layers 1, 2, 3 and 4

- Detector successfully re-installed in February 2018
- Ready to record first collisions of 2018 with working fraction of 97.8%
- Performance of DCDC converters closely monitored and preventive measures put in place to mitigate potential losses
