IPHC Detector Lab activity and scanning table upgrade

IPHC detector Lab activity

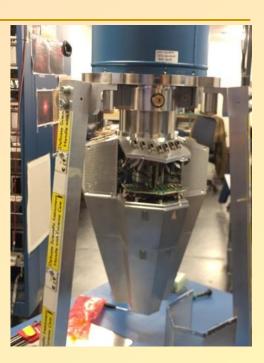
Encountered problems while working on ATC14

- Missing segments
- Very weak signals
- Oscillations
- Noisy segments
- Offsets increasing with HV

Due to: - Soldering defaults on a 6FETs-card or on the ½ moon-card

- Broken HV resistor on a Core card
- Bad preamp card
- Leakage current on B010 (had to be replaced)

Some problems are detected at room temperature, but most of it in cold conditions, so it took several cooling /warming cycles to fix everything

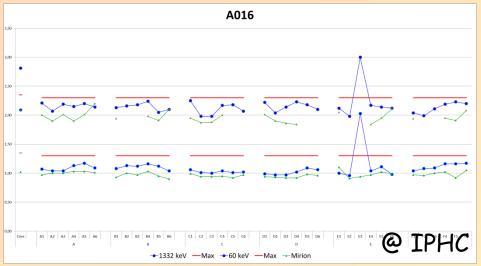
A016 Acceptance Test

→ Leakage current on E3

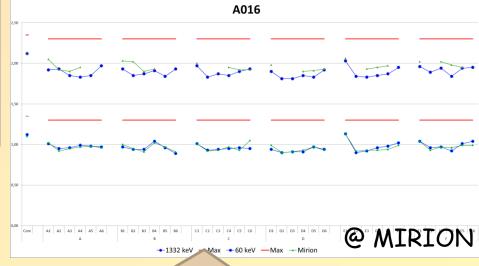
→ very good resolutions

Repaired @ MIRION

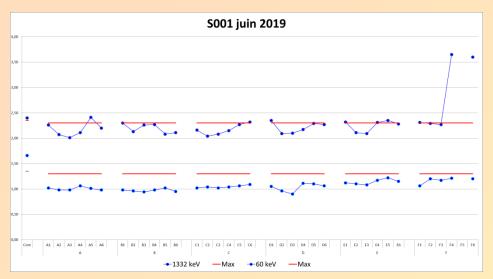
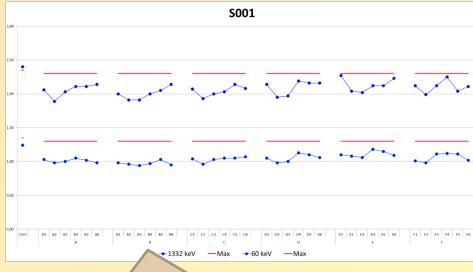
5001 Performance test before scanning

→ Very high count rate on F5

Feedback wire problem inside our test cryostat

→ Good performance but slightly too high Core resolution
