# Beam Monitor update

FOOT performance meeting  
05/02/20

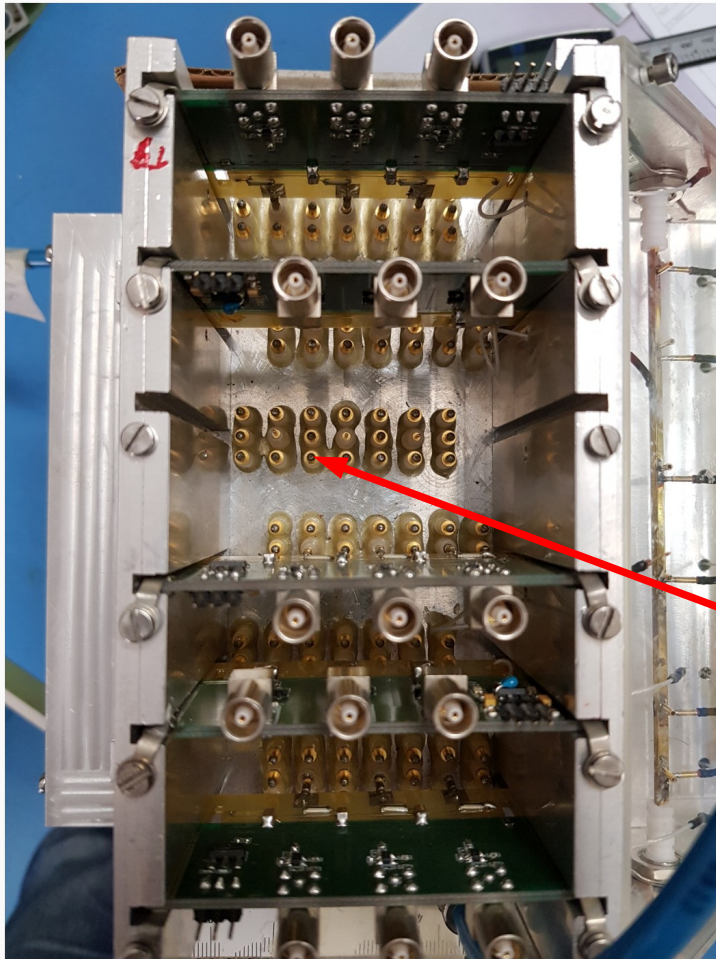
- In 12/2019 we tried to test the BM stand alone acquisition chain.
- The pins of the low voltage has been plugged in the wrong way (we naively believed what was written on the board).
- This caused the damage of the capacitors of the LW board used in the voltage stabilizer circuit.
- In the substitution of the capacitors, one sense wire of a cell has been broken.

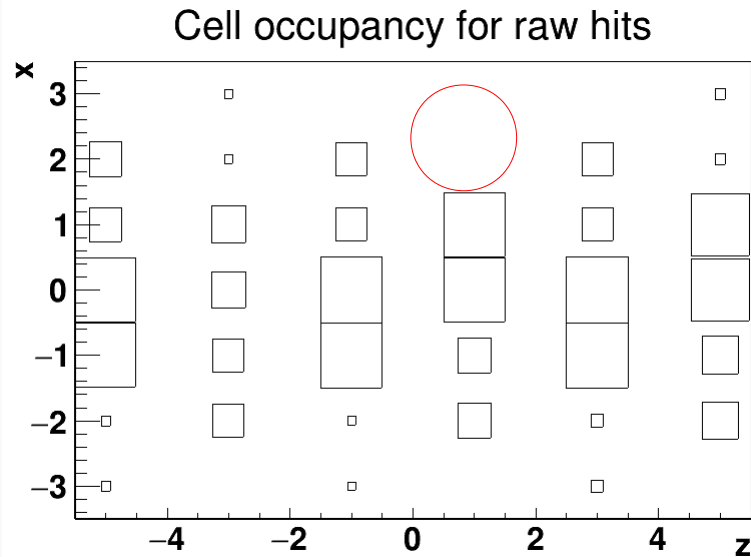
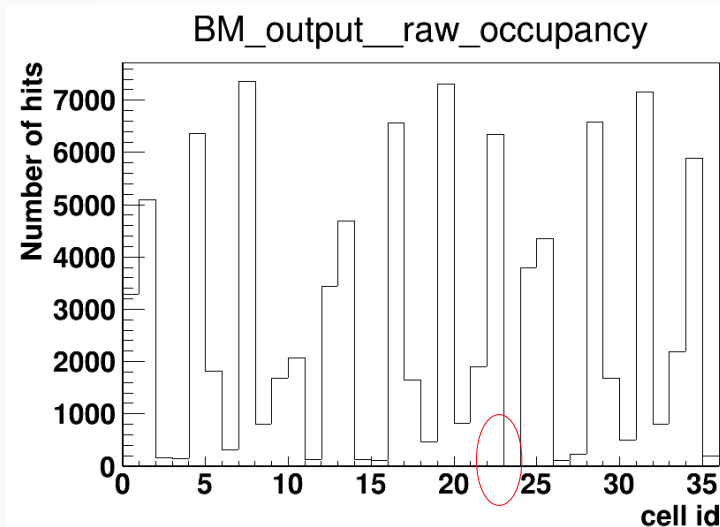
- The channel lost is a side cell with the wire parallel to the y direction (gives the x meas.)
- The broken sense wire has been extracted and after different tests, apparently no wire residuals seems to be present in the chamber.
- All the other channels are not damaged and the capacitors have been substituted without difficulties.
- We tested the BM @ Trento with Proton beam to check its performances.
- Comparing with the old tests, we do not see great differences.

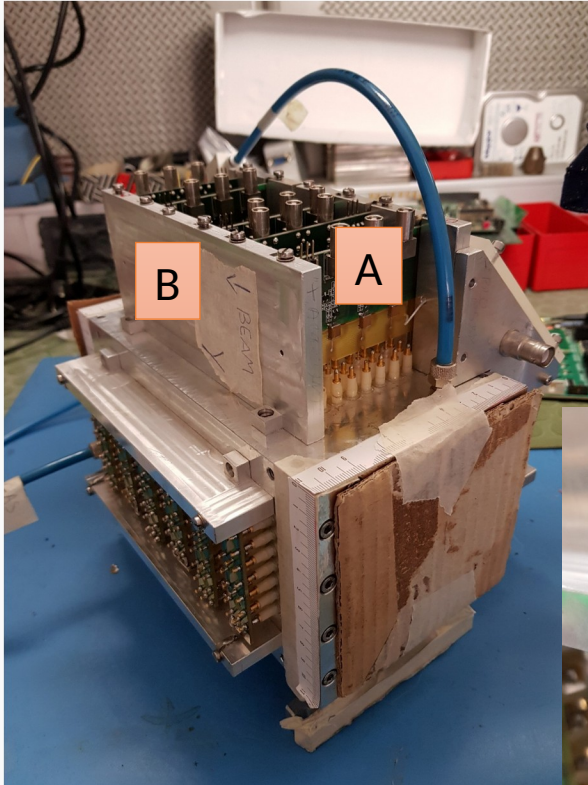
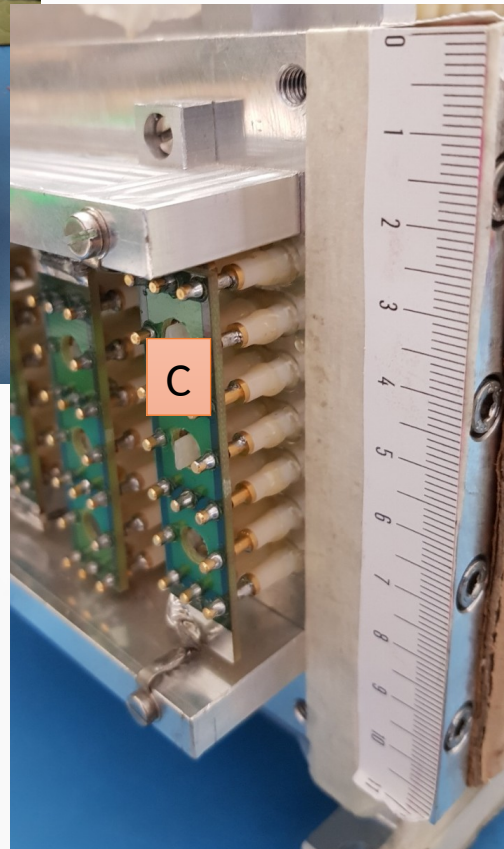
At the moment there no evidence for the need to fix the dead channel. However if it is needed, the work to do should be the following:

- Remove all the reading boards (A)
- Remove the lateral panel B
- Remove the board (C)→ very critical
- Add a wire inside → very critical
- Glue the wire on on side and pinch it on the other side
- More difficulties due to the fact that who built the BM is retired.
