Visual investigation of possible degradation in GEM foil under test

S. Chatterjee*, A. Sen, S. Das, S. K. Ghosh, S. Biswas

Department of Physics, Bose Institute, Kolkata, India

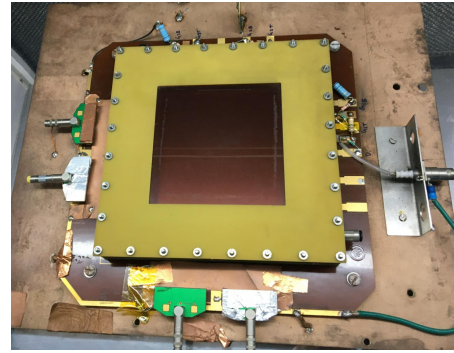
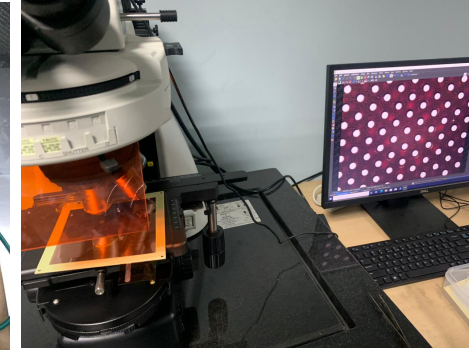
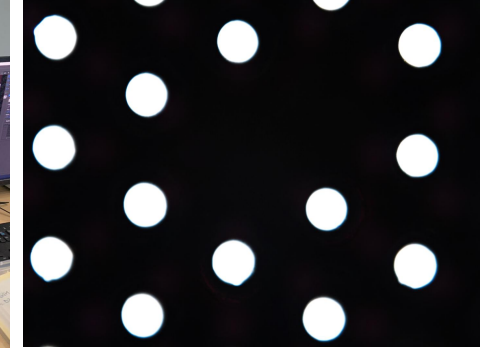
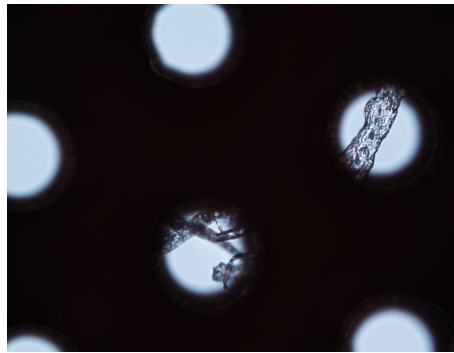
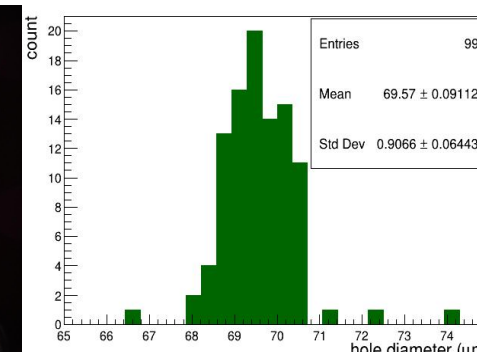
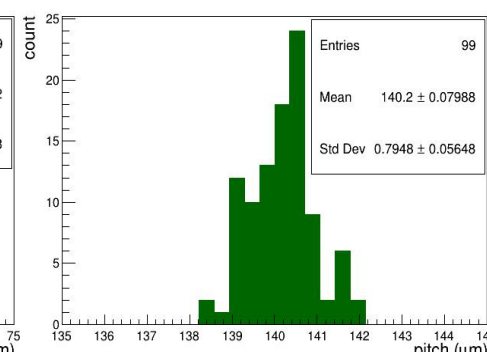
- During the long-term study of a Single Mask triple GEM chamber, the 3rd GEM foil of the chamber is found to be damaged
- The measured resistance is found to be $\sim 40 \text{ k}\Omega$
- Optical inspection of the GEM foil reveal imperfections in the GEM foil
- The short paths in the GEM foil are removed by using an ultrasonic ($\sim 20 \text{ kHz}$) bath with millipore water
 - The foil is kept in the ultrasonic bath for ~ 5 minutes
 - The foil is dried for ~ 30 minutes under continuous heat flow and after that the resistance of the foil was found to be high
- The leakage current of the GEM foil is measured and found to be reasonable (at $\Delta V \sim 300 \text{ V}$, RH $\sim 50\%$; $\sim 0.3 \text{ nA}$)
