# EPDT-RPC3 status

G. Rigoletti, D. Magatti, B. Mandelli

EP-DT  
Detector Technologies

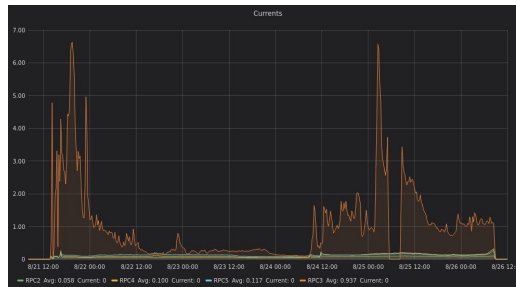
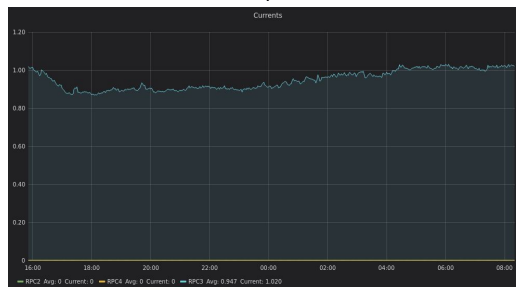
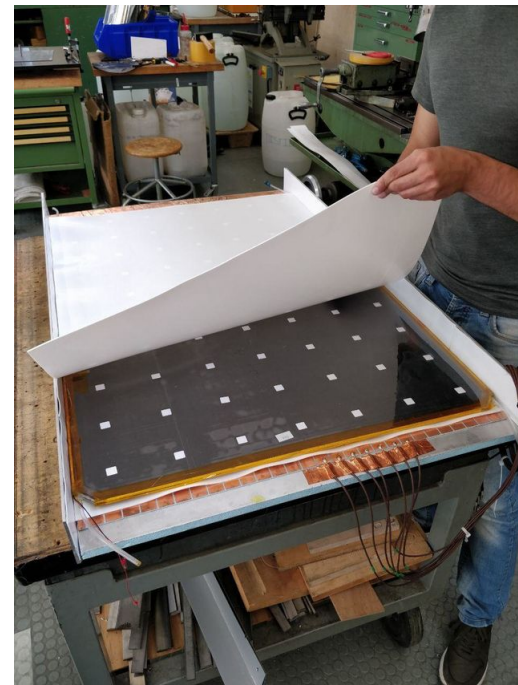
- Stability **OK** with std. mixture
- Stability **OK** with ECO1 mixture (50% CO<sub>2</sub>)
- Stability **Not OK** with ECO2 mixture (60% CO<sub>2</sub>)

- HV connector fixed
- New more robust frame
- Added layer of teflon + mylar around the gap

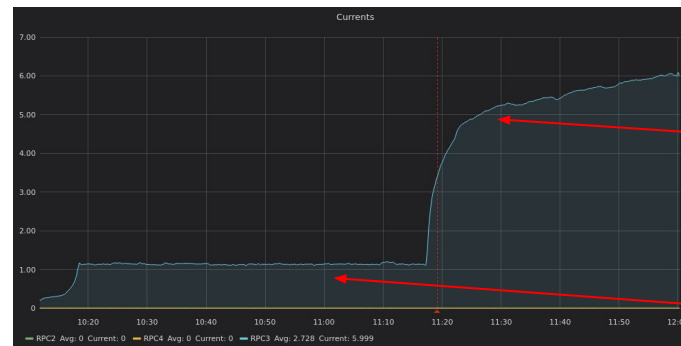
Issue with stability of the currents at ~ working point

Currents start drifting systematically

Drift starts here

Currents stable ~ 1 uA

- Understand the drift
- Mount the chamber back on the trolley

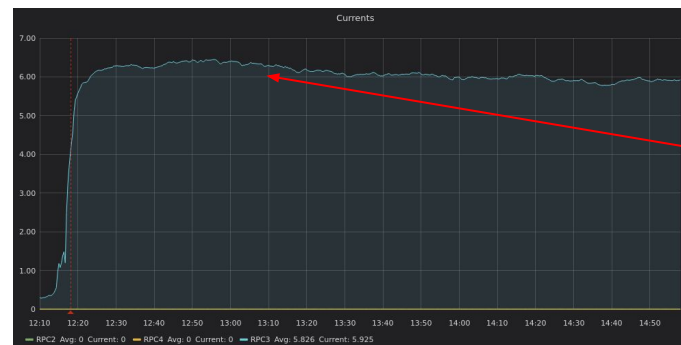
Stabilizing after ~1 hour at 6 uA
