L3 Tests

Ilaria and Riccardo
on behalf of the working group

BESIII Italia
Marzo 2021

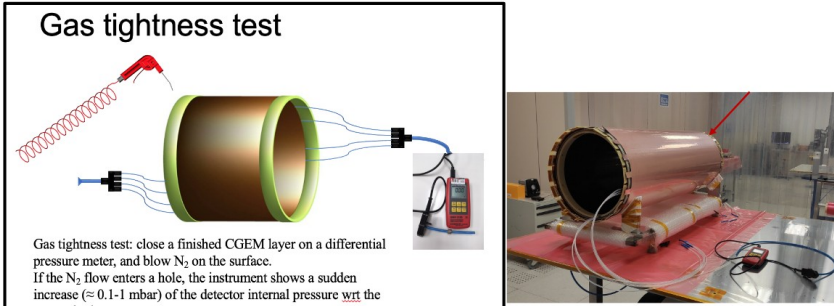
Gas tightness test: close a finished CGEM layer on a differential pressure meter, and blow N₂ on the surface. If the N₂ flow enters a hole, the instrument shows a sudden increase ($\approx 0.1-1$ mbar) of the detector internal pressure wrt the atmospheric one.

The first test showed a leakage

- Durante i test di validazione si inizia ad evidenziare una **notevole perdita di gas** (non presente all'uscita della camera pulita) di circa **30%**

- perdite nei fori di spina (1,2)
 - man mano che si chiudono fori se ne trovano altri più piccoli non evidenziabili prima, nel contorno degli anelli (3), [essendo più stretti di L2 e L1, fanno meno tenuta gas nella zona in cui gli elettrodi sono incollati sugli anelli]

- il gas filtra attraverso i fori di spina e trova strada all'interno dell'anello esterno dell'anodo
- si controlla ogni volta la perdita totale flussando con N₂, flussimetri massivi in ingresso e misuratore di flusso in uscita

- glue sealing
- Following test showed no leakage

- I primi di dicembre si fa upgrade del sistema di gas: flussimetri massivi in ingresso e misuratore di flusso in uscita (prestato da G.Bencivenni)
- si riporta in camera pulita assieme a sistema di gas e si cominciano ricerche di fughe (con metodo sovrappressione) e **sigillature a più riprese**:

- si arriva ad un **perdita finale dell'8%** ritenuta tollerabile

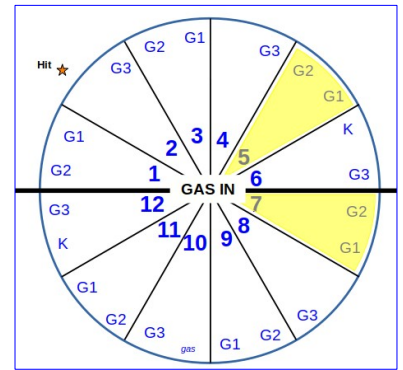
All electrodes singularly tested

T2 and T1 showing issues
→ T2 @580V, T1 @470V
→ → Identified 5G1 and 7G2 as problematic

All electrodes on at 100V to look for miscabling

Everything alright

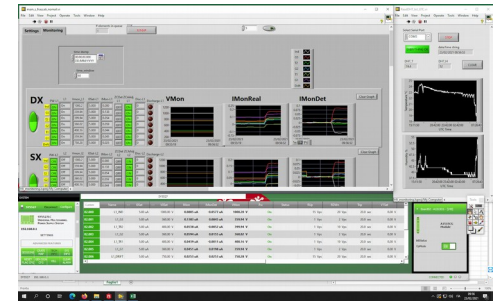
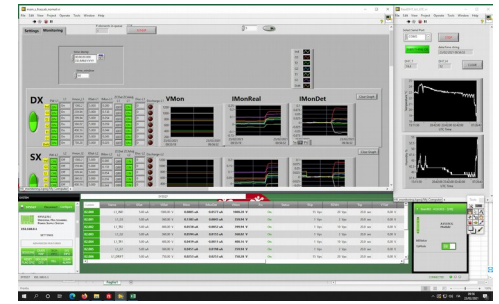
- Induced difference in current:
G3 IDet ~ 80nA
- Few discharges during operations
- IND, GEMs, DRIFT at nominal values:
1000V, 360V, 750V
- T~ 19°C, H ~ 50% (stable during this test)

No differences, the source was not close to the problematic sectors

~20% difference, pro L3 all

L3 cut gains performance with higher HV

Source from inside is better, to be considered for future tests
