# Shift report

01-07/04

Liliana Congedo and Alessandra Pastore

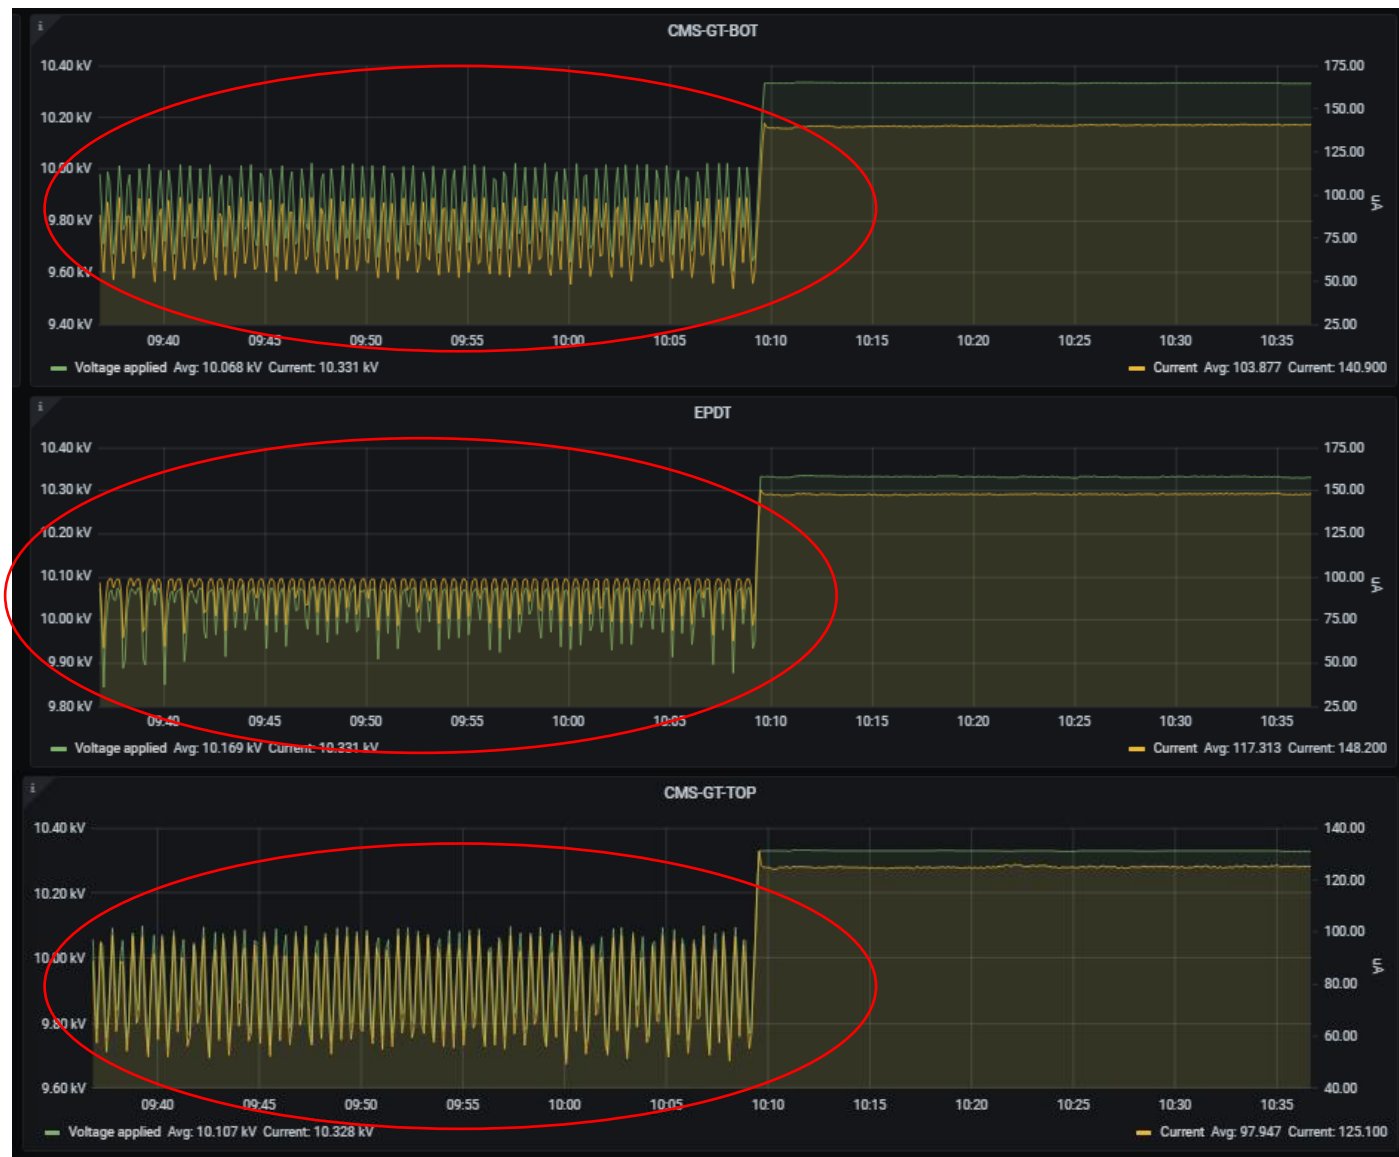
CAEN data

HV values were set to the standard values but the current limits were too low. Thus, the chambers were rumping up and then tripping continuously.

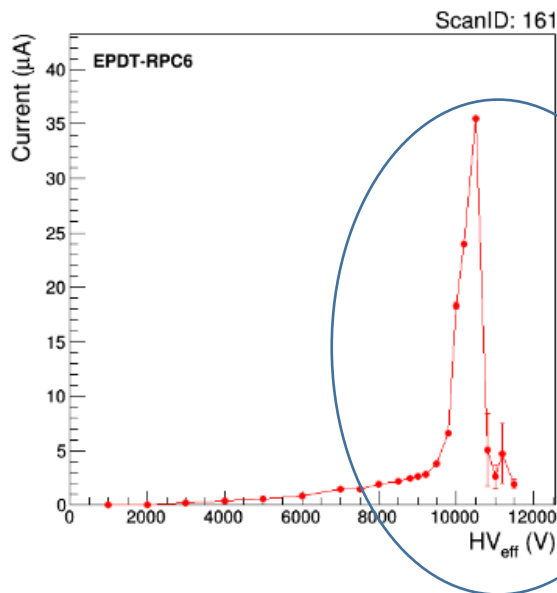
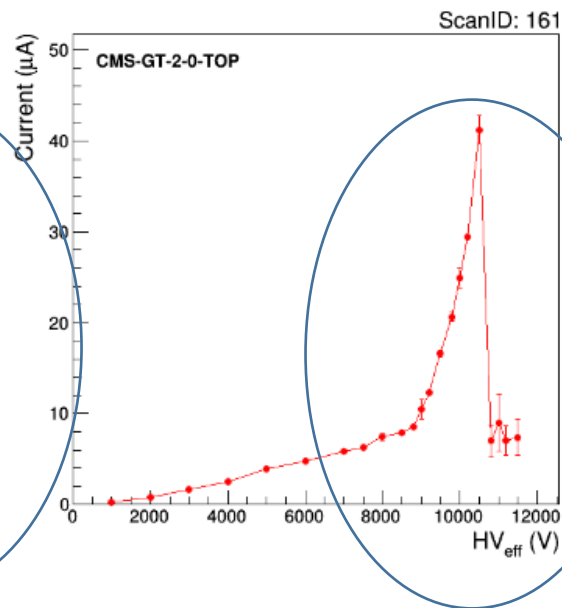
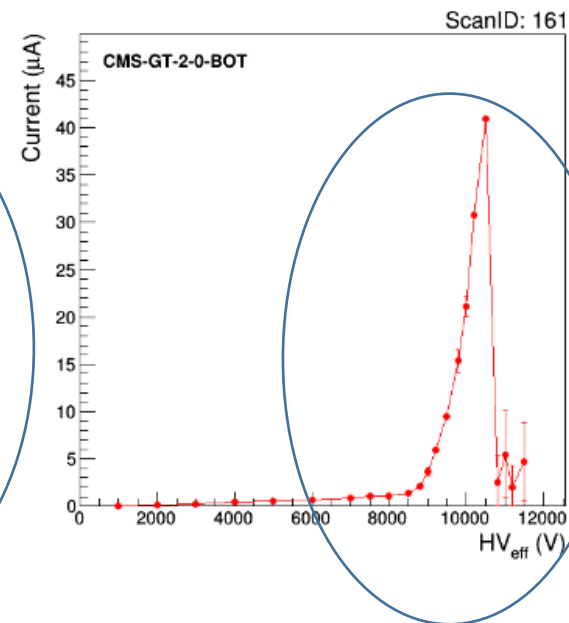
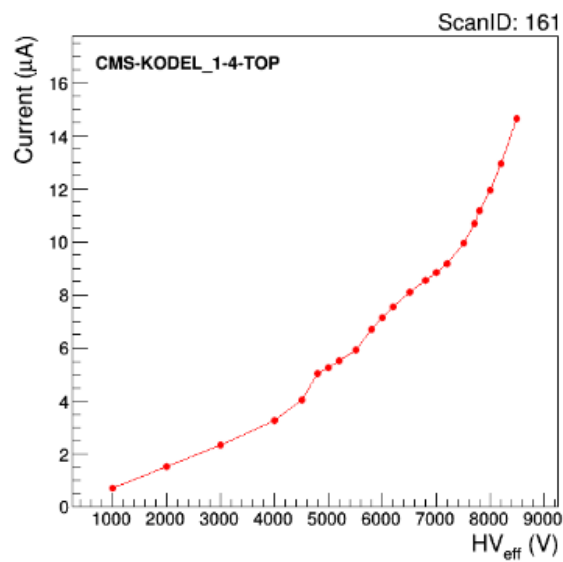
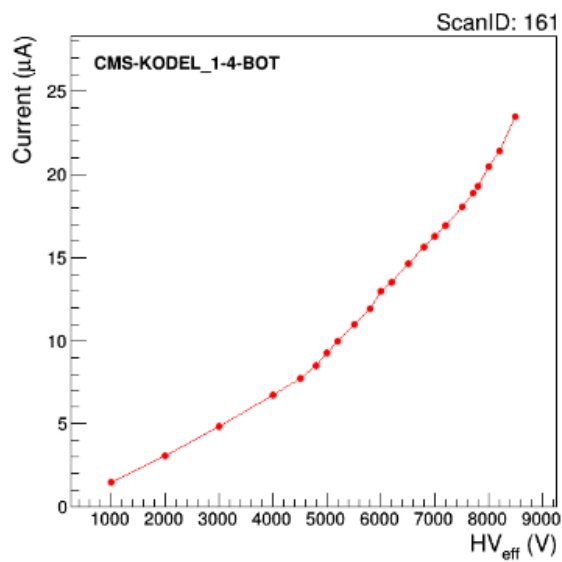
# HV scan 31/03/2021

Currents above i0 values  
with the old config!

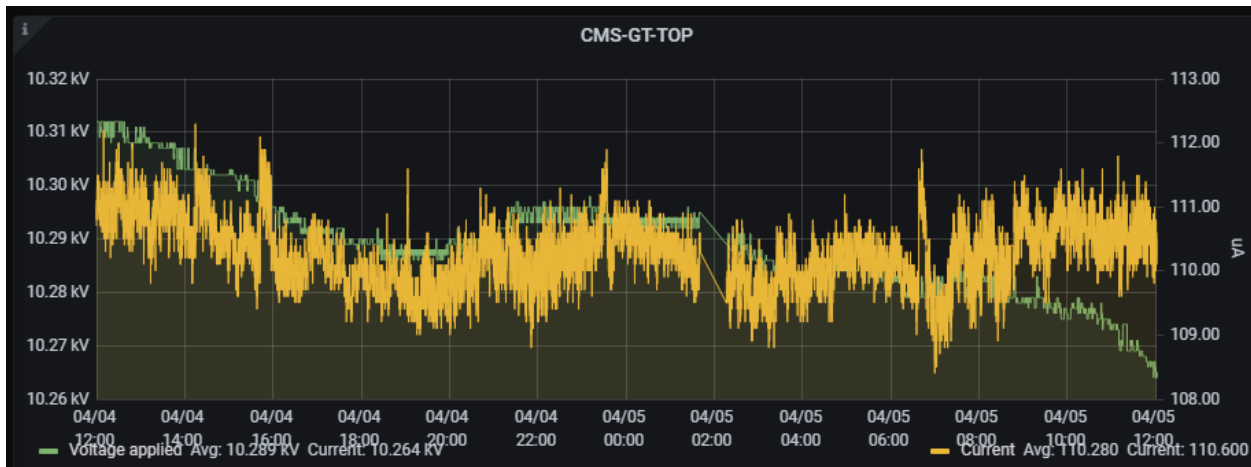
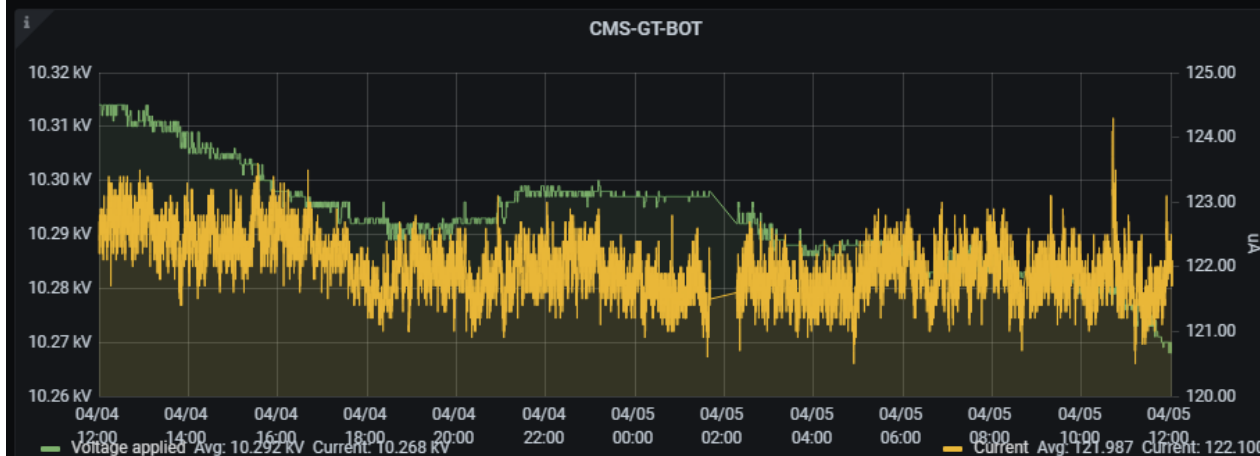
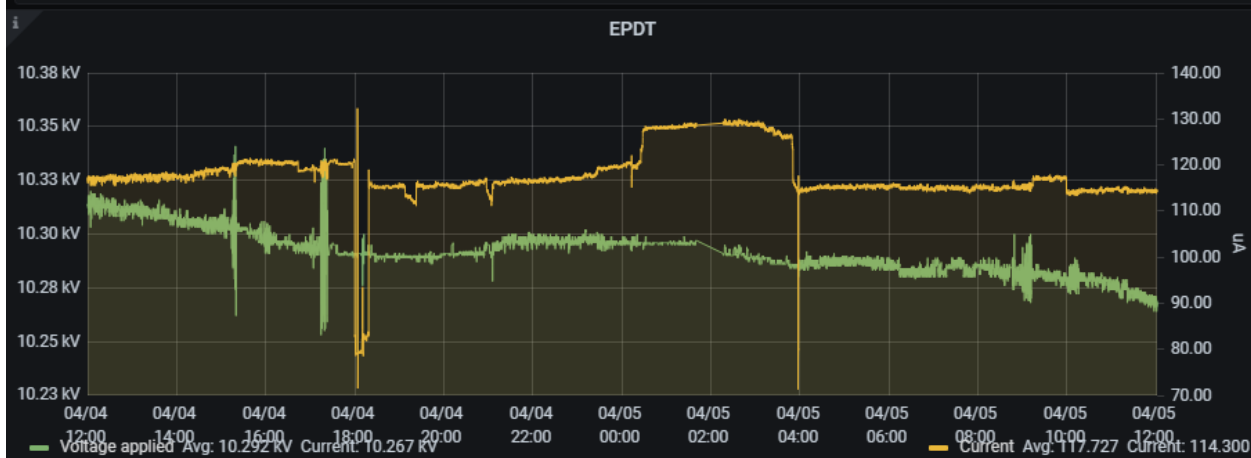
Weekly stability run:  
currents 04/04

Some current spikes (up to about 50 microA) happened for EPDT. HV was correspondingly fluctuating of about 100 V. The source and attenuation factor were stable. The CMS chambers current fluctuations were about 2uA.
