CERN
CH1211 Geneva 23
Switzerland

EDMS NO.
2802473

Microscopic examination of triple-GEM detector after installation and operation on LHCb with CF₄-based gas mixture

Previous studies in 2004 showed that after operation with CF₄-based gas mixture, the copper surface of a triple-GEM detector was etched due to bad gas flow rate conditions [1]. The aim of the current study is to inspect by microscopic means different layers of a triple-GEM detector after its operation in LHCb also with CF₄-based gas mixture.

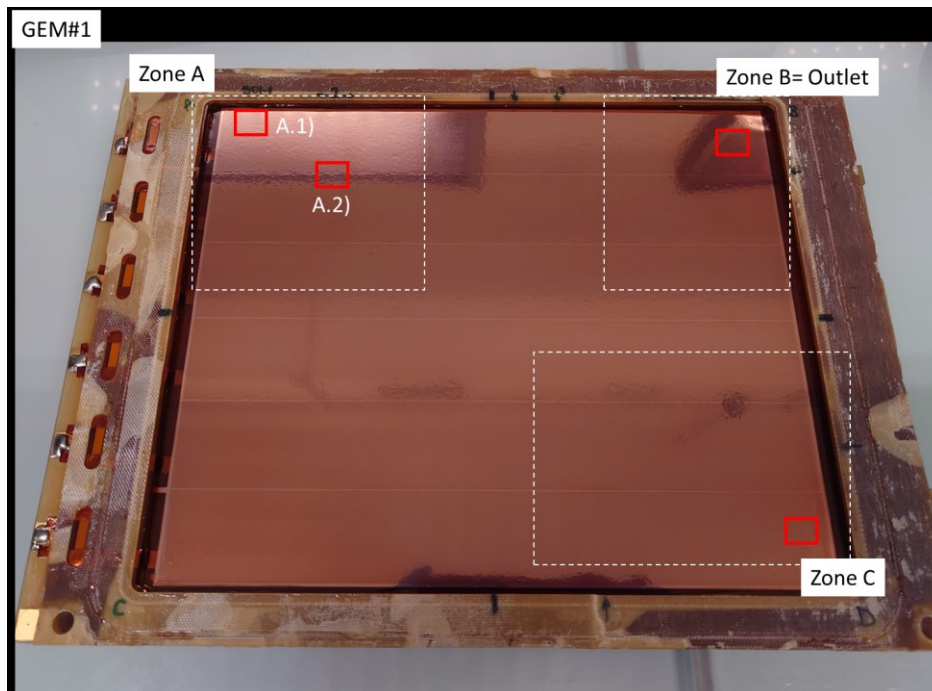
Figure 1 - General aspect and areas under study on GEM#1

The general aspect of the GEM#1 is homogenous. Nevertheless, when observed on the microscope some features and colour contrast on the copper (Cu) surface were visible. Three zones were identified as shown in Figure 1 and imaged by optical and electron microscopy. The red squares correspond to areas inspected at higher magnification (zones A.1, A.2, B and C).

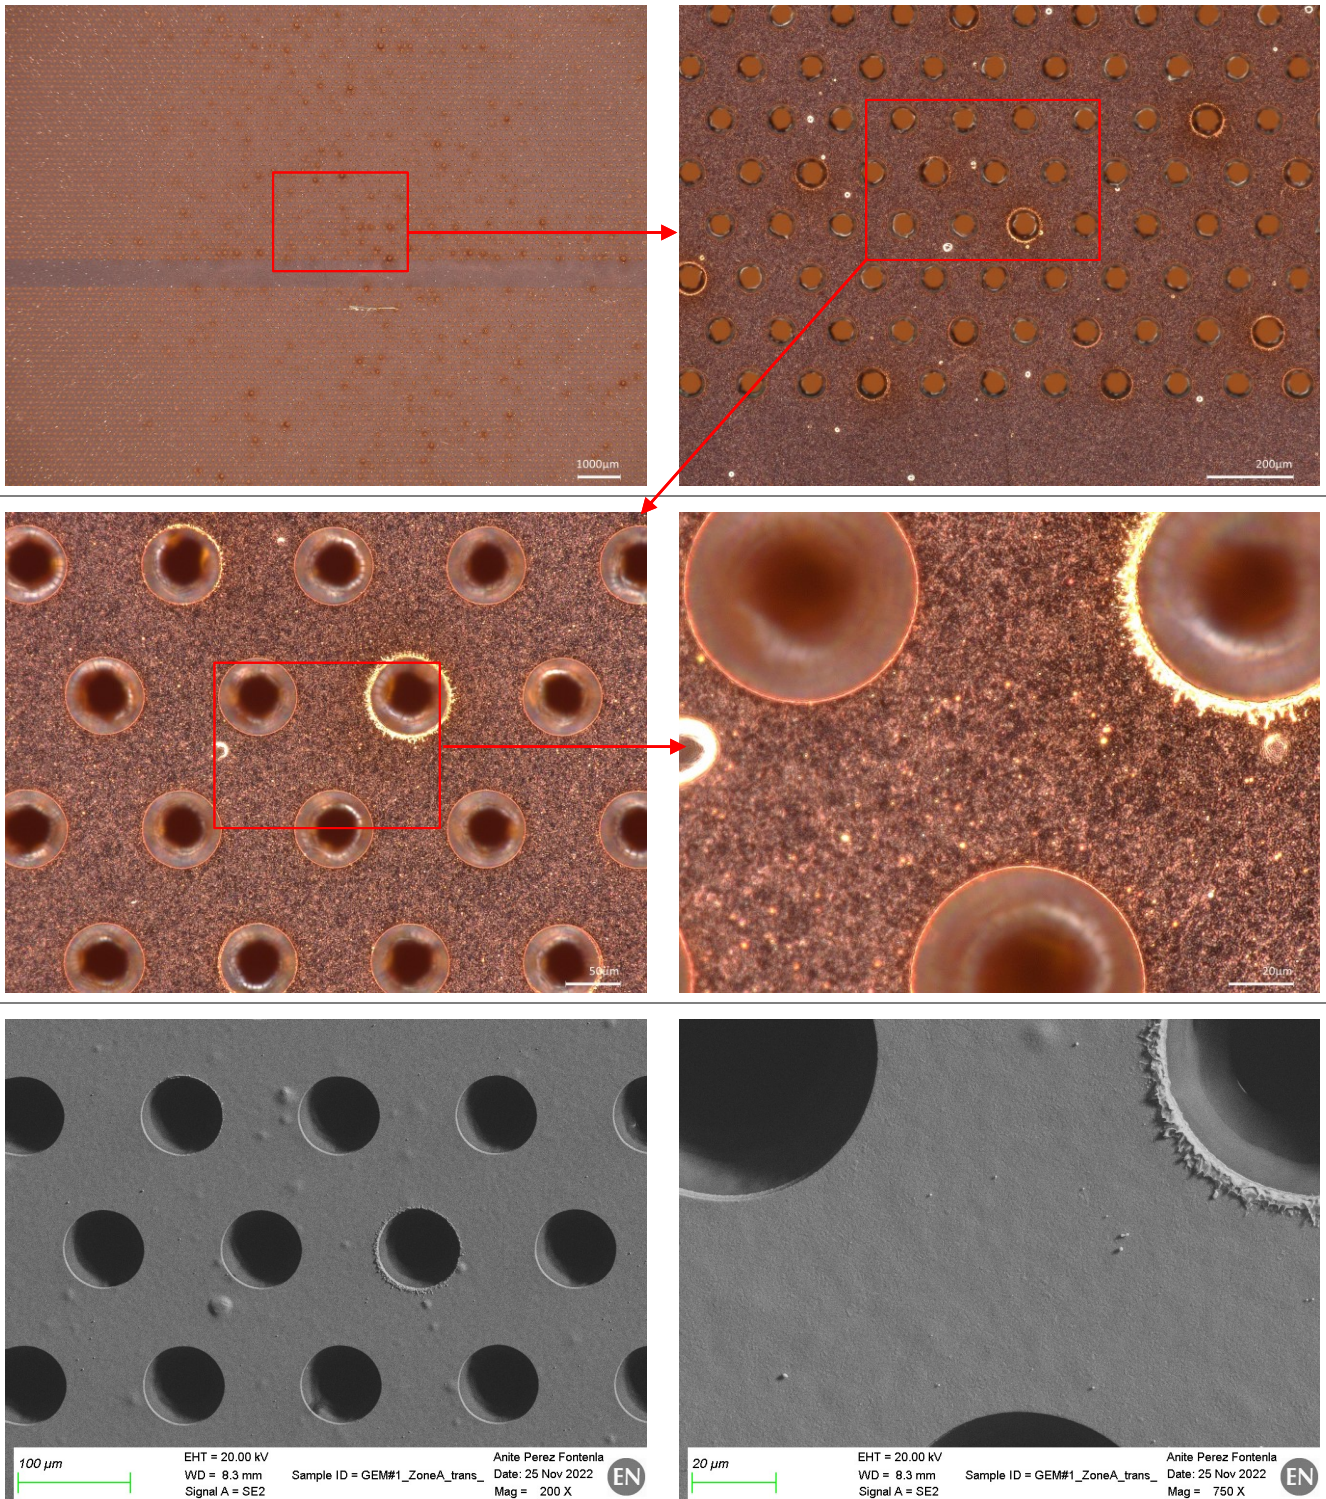
Figure 3 - OM and SEM images of the GEM#1 aspect on zone A.2

It was noticed that the Cu surface surrounding numerous holes present an oxidized aspect. The SEM observation showed that they correspond to holes where the Cu edges were damaged during operation (molten aspect) as shown in Figure 3.

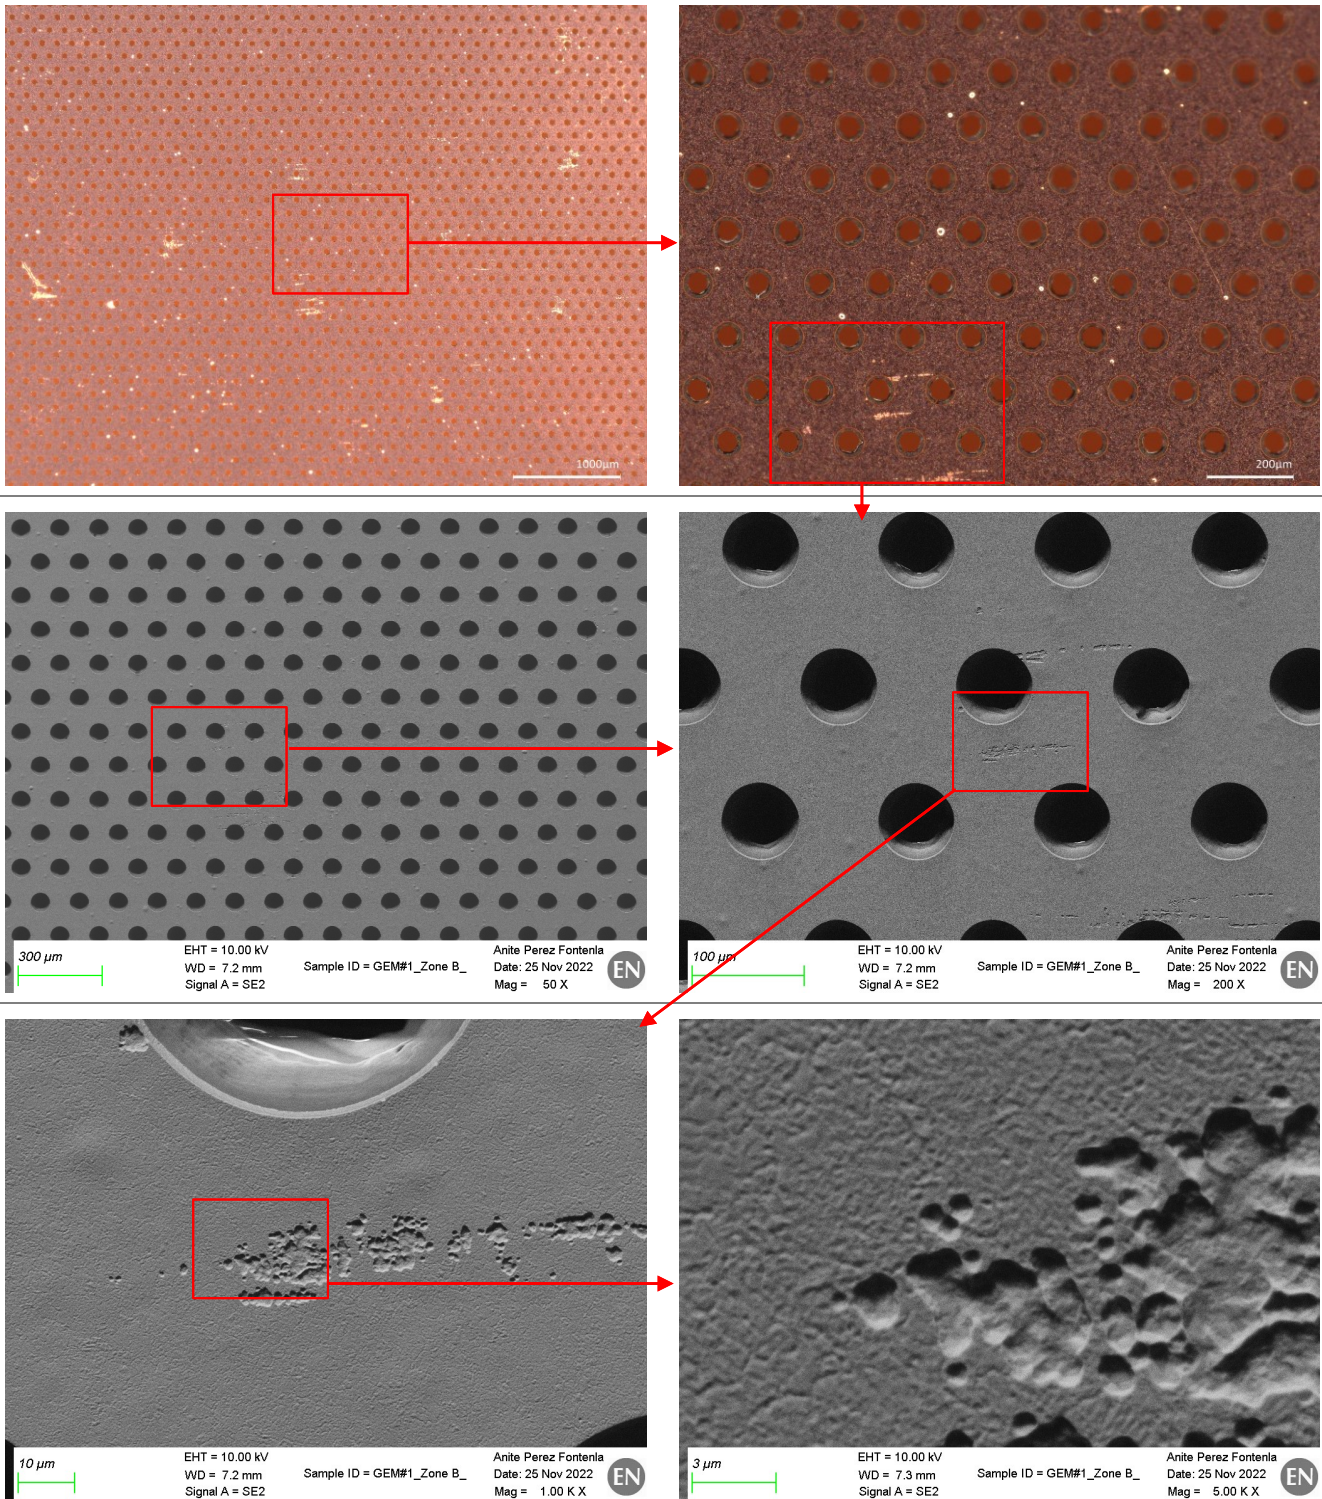
Also remarkable all over the Cu surface on GEM#1 is the presence of micrometric marks. When observed by SEM they correspond to sites where the Cu was attacked or removed up to a depth of ~ 1 micron (see Figure 4 and Figure 5). EDS does not show major compositional differences between the marks and non-affected Cu (Figure 6).

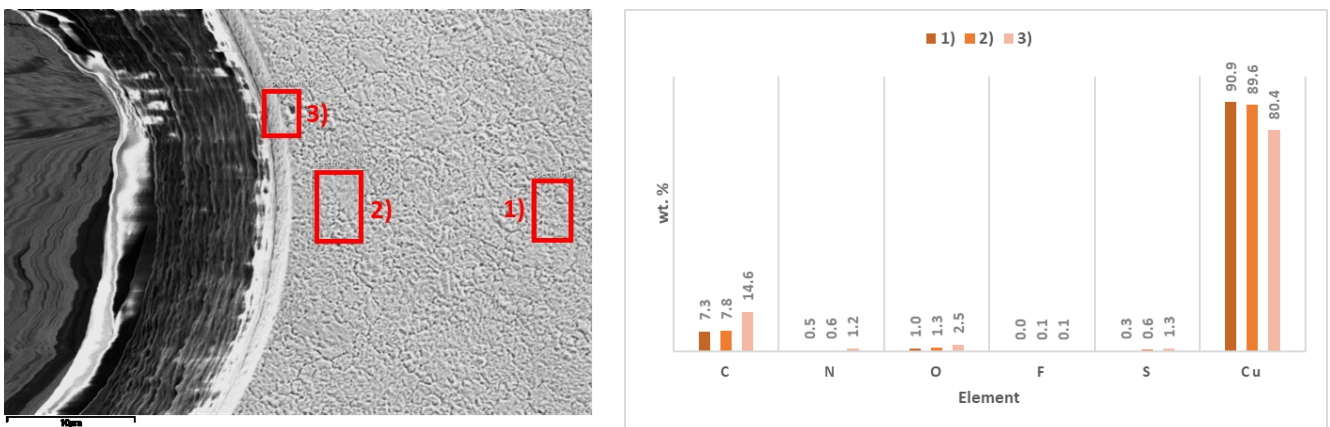
Figure 8 – Elemental composition analysis by EDS on the hole surrounding area on zone B (GEM#1). The results are presented in wt. % and normalized

Chemical analysis by EDS was also performed on the hole's surrounding area and it was observed that the content of sulphur (S), nitrogen (N) and oxygen (O) slightly increase when approaching the hole edge. Also the carbon (C) increases due most probably to the Kapton presence and fluorine (F) remain constant and in all cases below 0.1 wt. % as presented in Figure 8.

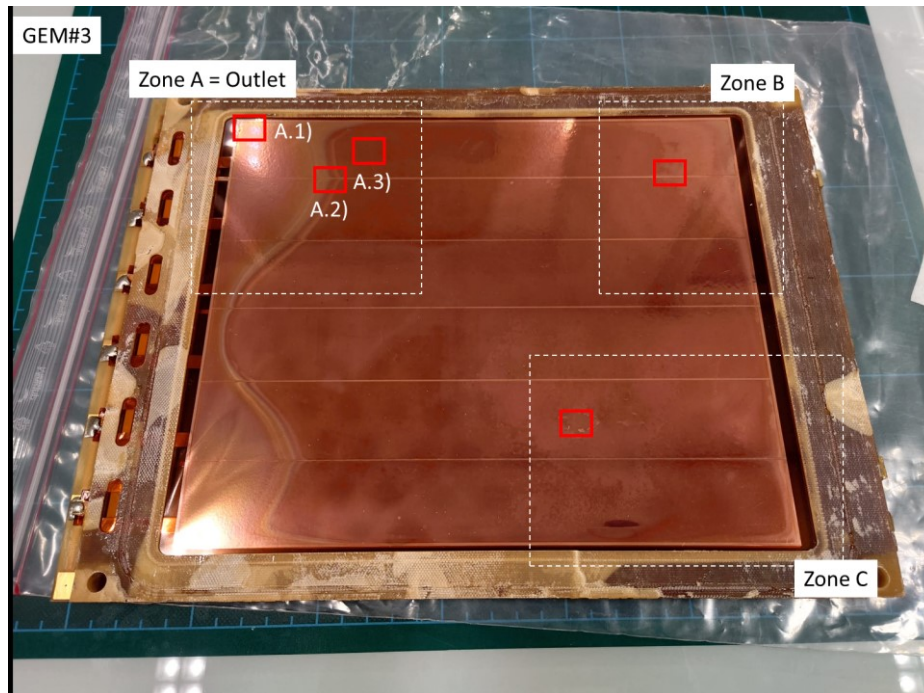
Figure 9 – General aspect and areas under study on GEM#3. The red squares correspond to areas inspected at higher magnification

Digital microscope inspection was performed on the different areas that presented colour contrast. The location of the studied areas is shown in Figure 9 (zones A.1, A.2, A.3, B and C).

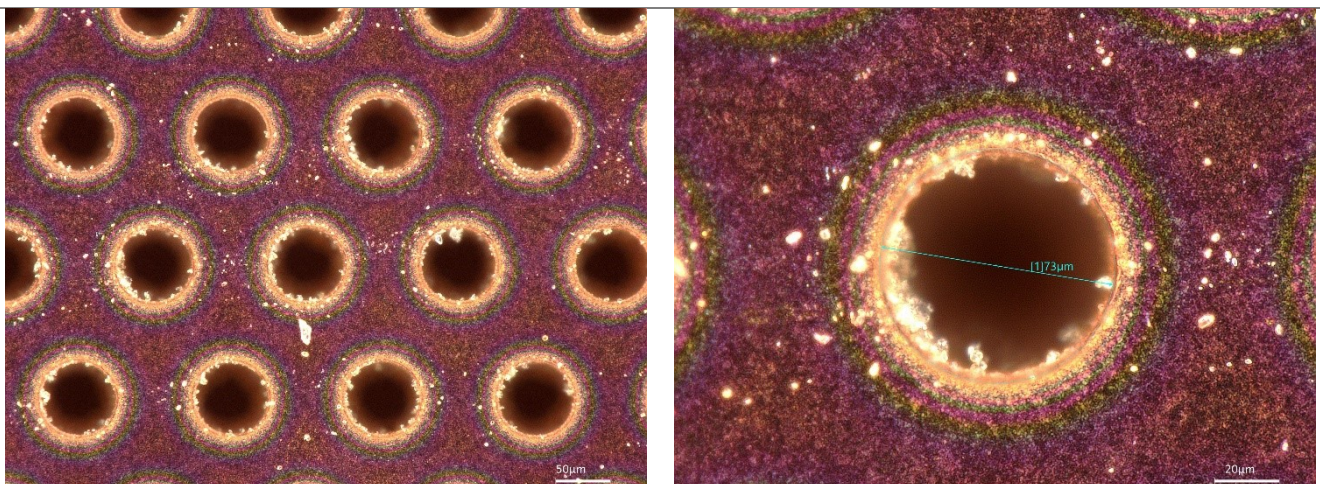
Figure 10 – OM images of the GEM#3 aspect on location A.1

In location A.1, the Cu surface colour around the holes changes concentrically. In addition, micrometric particles are visible surrounding the holes (see Figure 10). SEM inspection performed in location A.1 and A.2 confirmed the presence of the micrometric particles. The hole's edges appear rougher as well as the Kapton into the holes (see Figure 11).

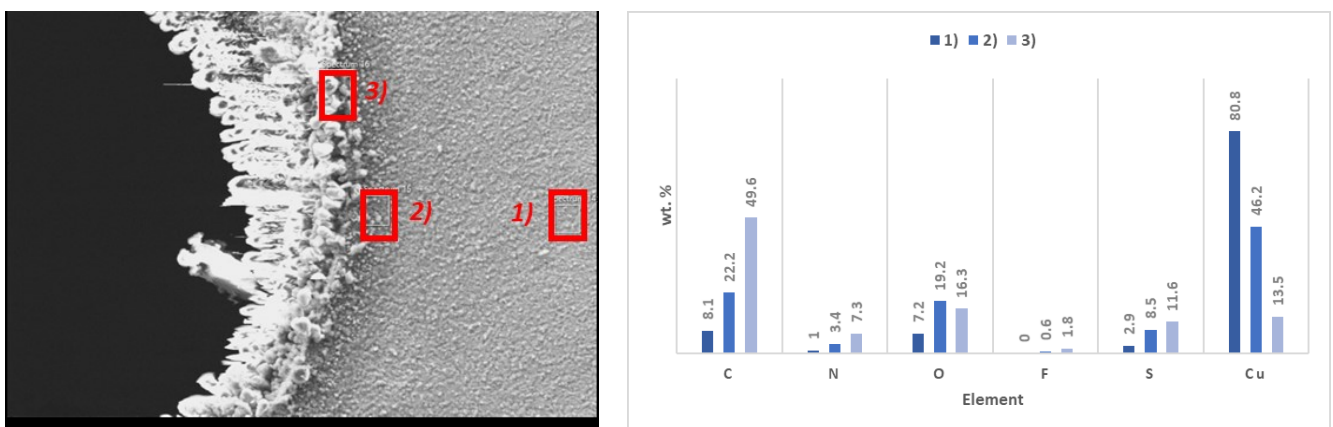
Figure 12 – Elemental composition analysis by EDS on the hole surrounding area on zone A (GEM#3). The results are presented in wt. % and normalized

Chemical analysis by EDS on the hole's surrounding areas pointed out an increasing content of C, S, N and F when approaching the hole's edge as shown in Figure 12.

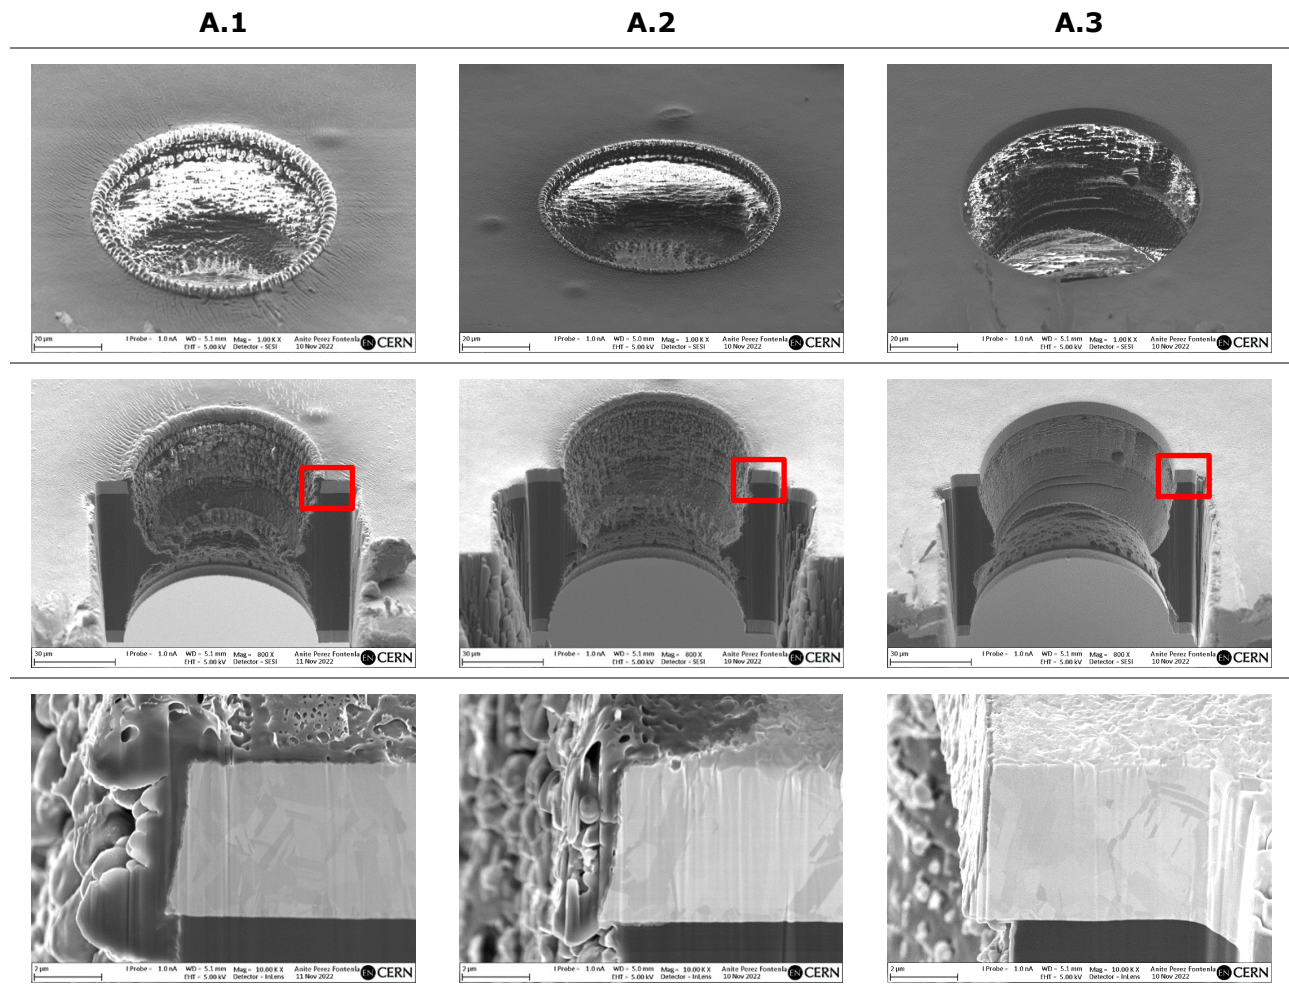
Figure 13 – Representative SEM images of holes in locations A.1), A.2) and A.3) before and after FIB cross sectioning and detail of the deposit on the copper edge

FIB-SEM inspection confirmed that the residue observed on the hole's edges is also deposited into the hole internal surface covering the Kapton and modifying the hole's geometry. The layer is thicker on location A.1 ($\sim 2 \mu\text{m}$), is also present but thinner in location A. 2 ($\sim 1 \mu\text{m}$) and is just noticeable in location A.3 (nanometric).

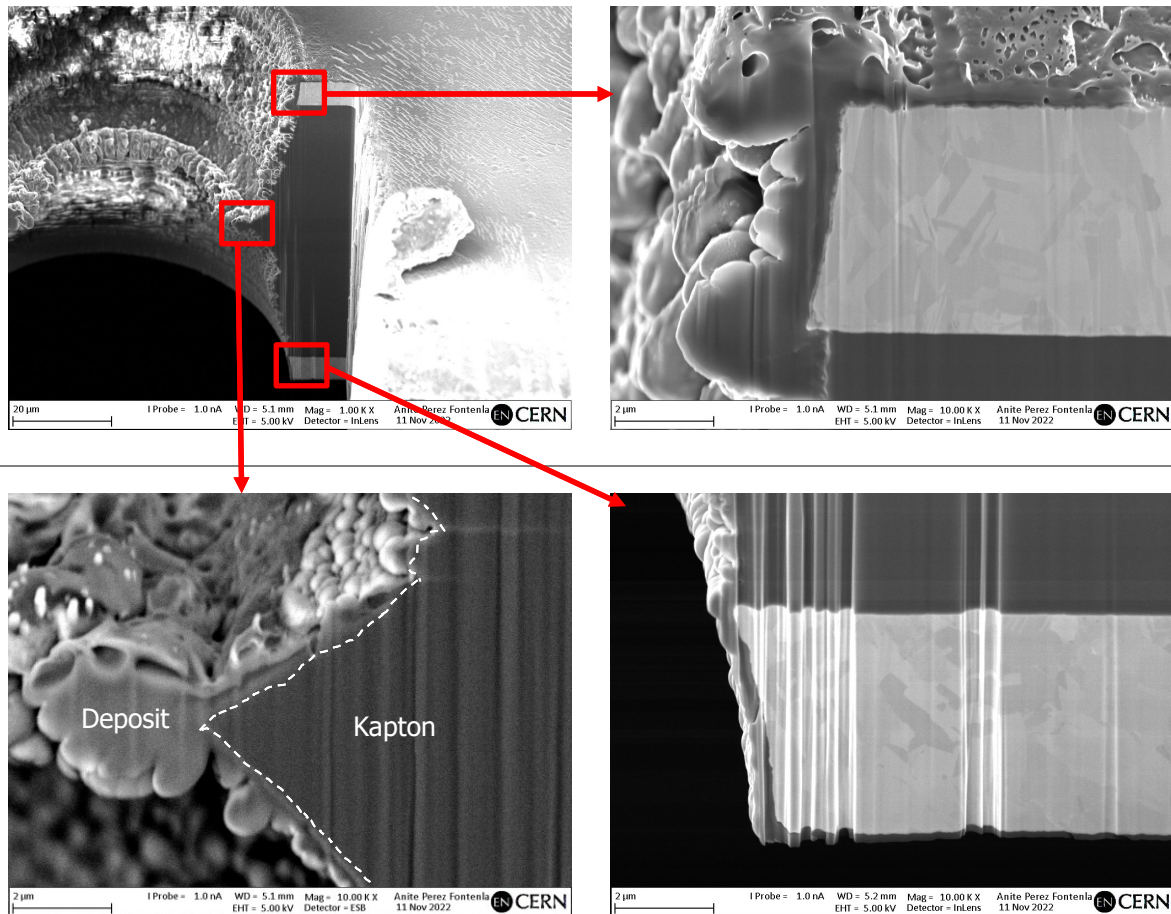
Figure 14 – SEM images of the hole cross section on GEM#3 location A.1 and comparison of the EDS spectra on the deposit and the Kapton

A more detailed observation on the hole cross section on site A.1 and a comparison of the EDS spectrum on the deposit and the Kapton are included in Figure 14. The deposit presents a significant amount of S and F when compared with the Kapton.

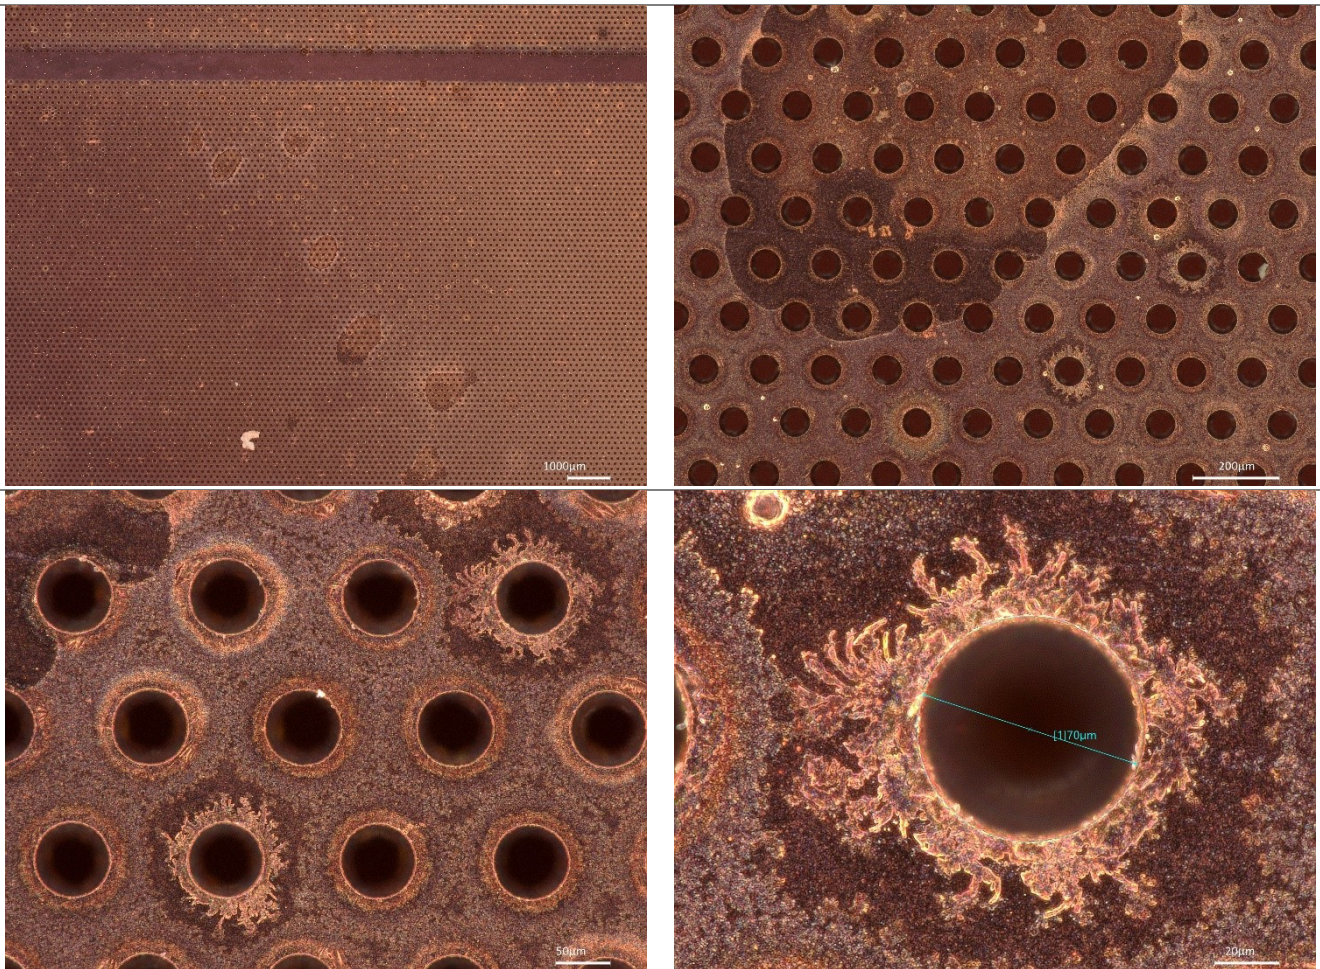
Figure 15 – OM images of the GEM#3 aspect on zone B

Microscopic observation on zone B and C confirmed the presence of a residue visible on the Cu surface. Representative images are included in Figure 15 and Figure 16 respectively. The chemical analysis of the deposit confirmed the same composition as observed in zone A with

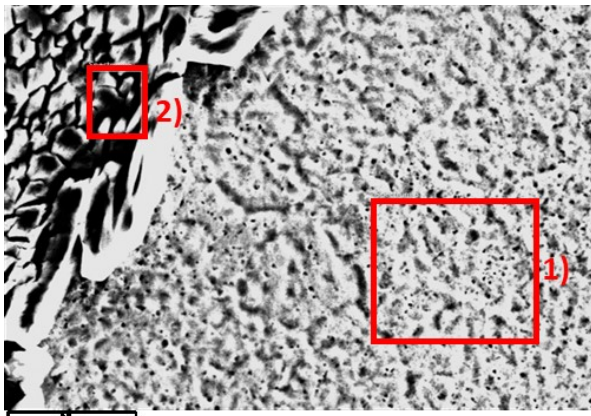
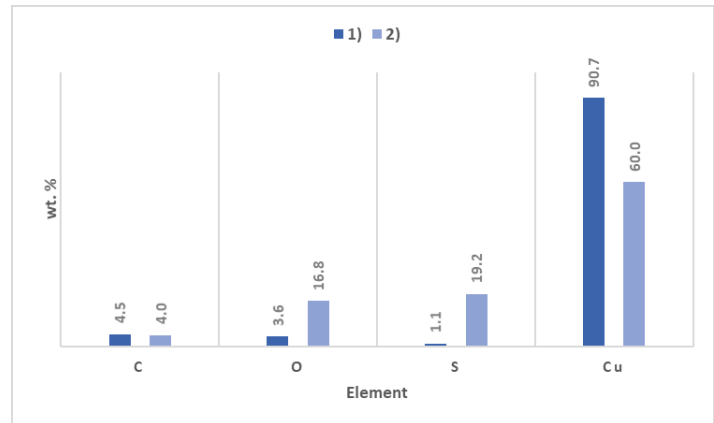
Figure 17 – Elemental composition analysis by EDS on the residue on zone C (GEM#3). The results are presented in wt. % and normalized

presence of C, O and S. In some cases, traces of F were also detected. Comparison of EDS results on the residue and cleaner sites is included in Figure 17.
