Gamma irradiation of ATLAS18 ITk strip sensors affected by static charge

Sensors affected by static charge in real experiment

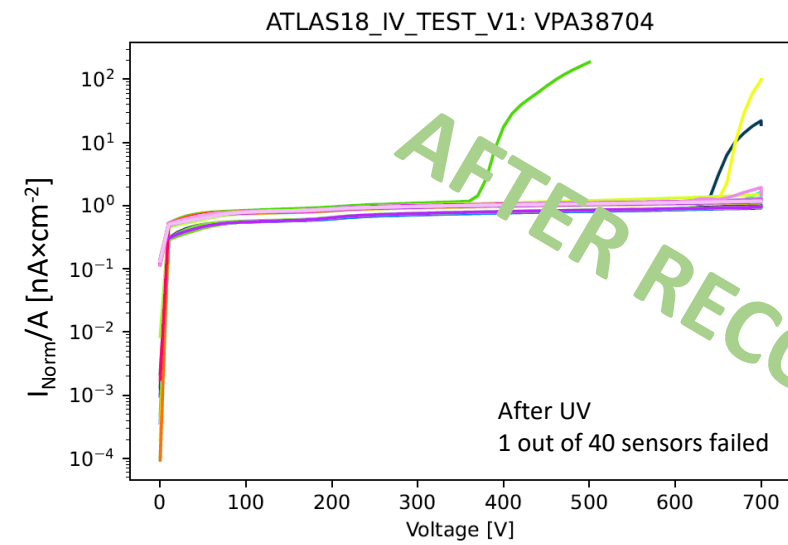
static charge measurement

- Strong correlation between observed electrical failures and high electrostatic charge (up to ~ 100's V)
- Electrostatic charge accumulated on the surface of the sensor
 - in the strip area can lead to the loss of interstrip isolation
 - close to the edge and bias ring can cause instability of current or low breakdown voltage

- Introduced sensor recovery techniques:
 - irradiation of the sensor surface with **UV-A** and **UV-C** light
 - application of the intensive flow of ionized gas
 - subject the sensors to high-temperature exposure
 - dry storage over days / weeks

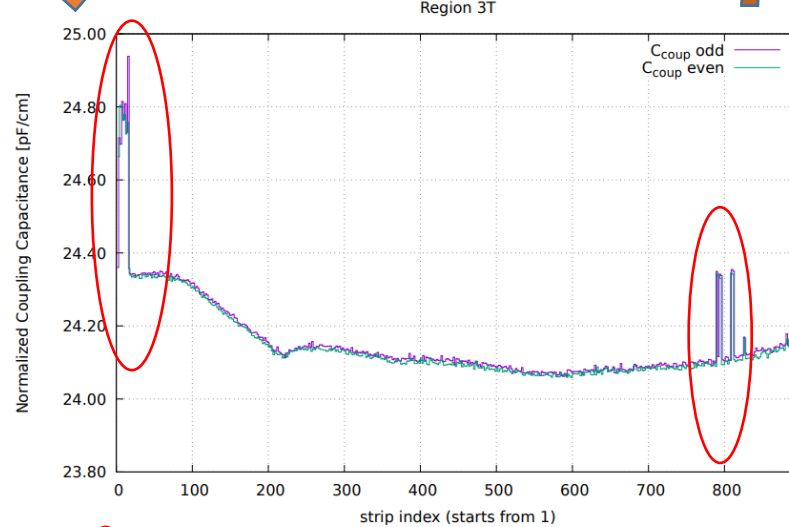
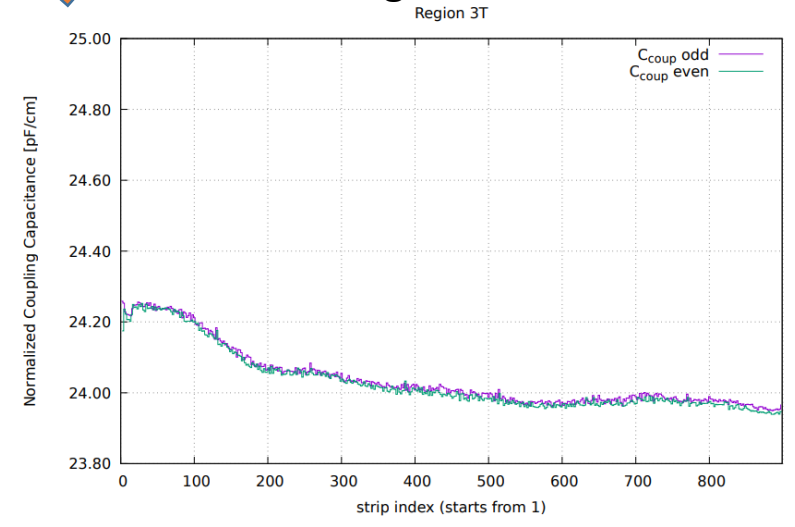
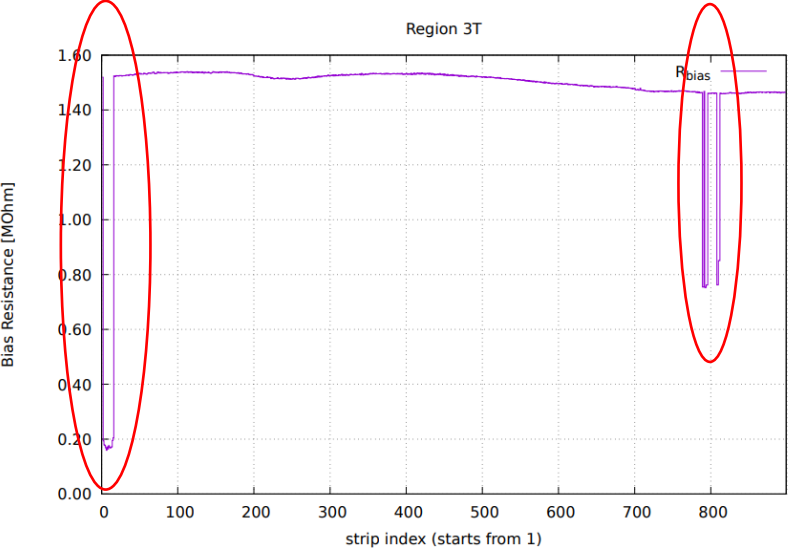
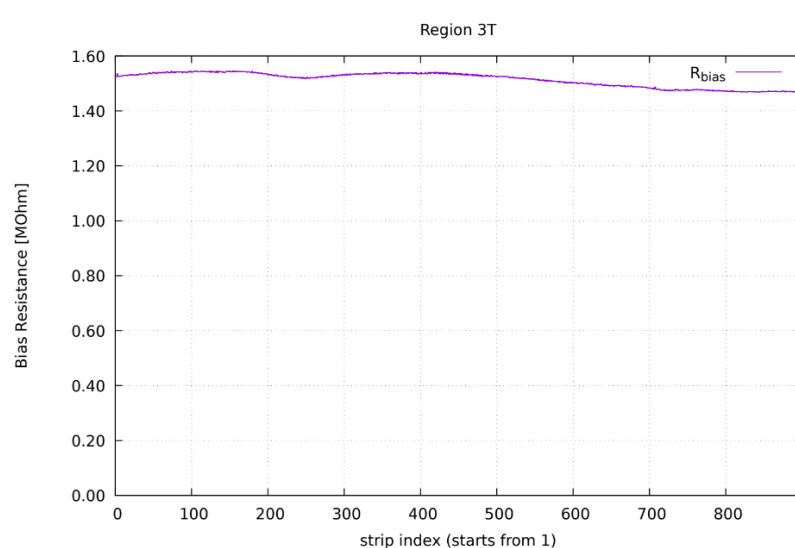
R3-W1014: Full Strip Tests

Full strip test before irradiation: # of bad strips	Full strip test after irradiation: # of bad strips
R1-W635	40	0
R1-W620	18	18
R3-W1014	24	0

- Gamma irradiated sensors **cured**: BDV increased and low interstrip isolation areas disappeared
- Reference sensor (transported and handled alongside the other sensors, not subjected to irradiation) **not recovered**.
- Gamma irradiation resolved issues successfully during initial planned step of irradiation with 11 krad (~1 week in the real experiment) => further irradiations to higher TIDs were not needed
- Instead, the reference samples were irradiated to an even lower TID of 1.5 krad (~1 day in the real experiment).
