# Report on hardware interventions on the LHCb/SHiP chamber

*A. Pastore*  
*on behalf of the SHiP/LHCb Bari group*

## ***Check SHiP chamber at 904 – April 2023***

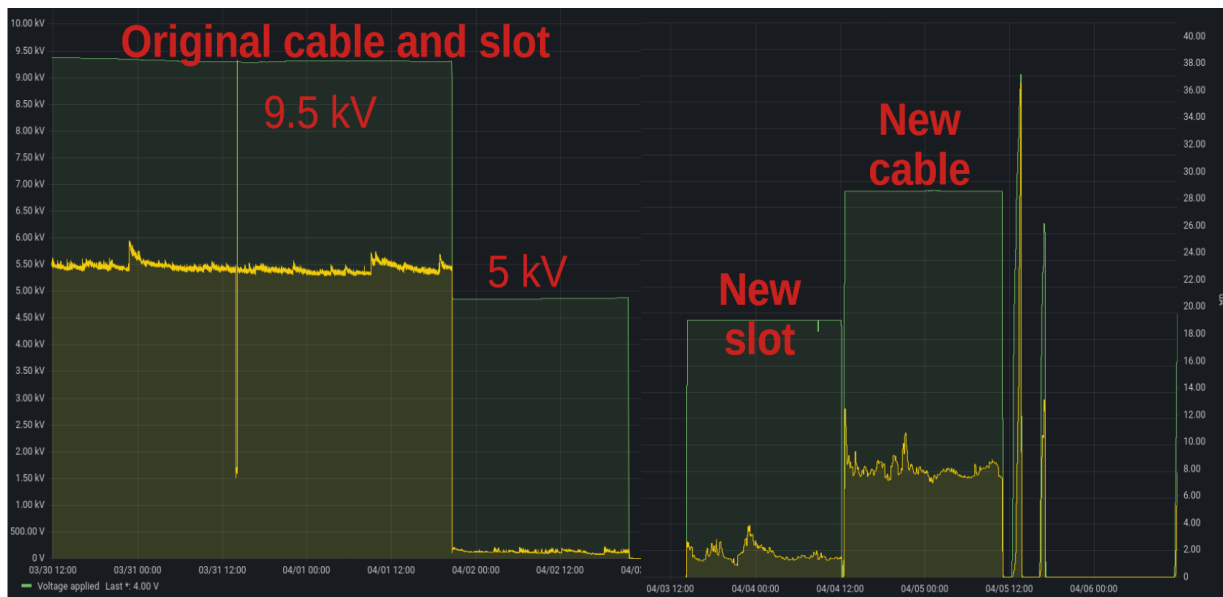
- During the stability scan a few “bumps” where current increased and then went down were observed
  - Not correlated with source change or other parameters
  - Occurrence frequency was monitored and it was decided to lower the HV to 5 kV to observe if those bumps still appeared
  - Change of HV slot and cable to see if they were correlated with the cable

- Bumps are still there, now source off HV scan has been performed with the old cable but in the new slot
- On Grafana, “ShiP-temp” panel to monitor the behavior of SHiP chamber

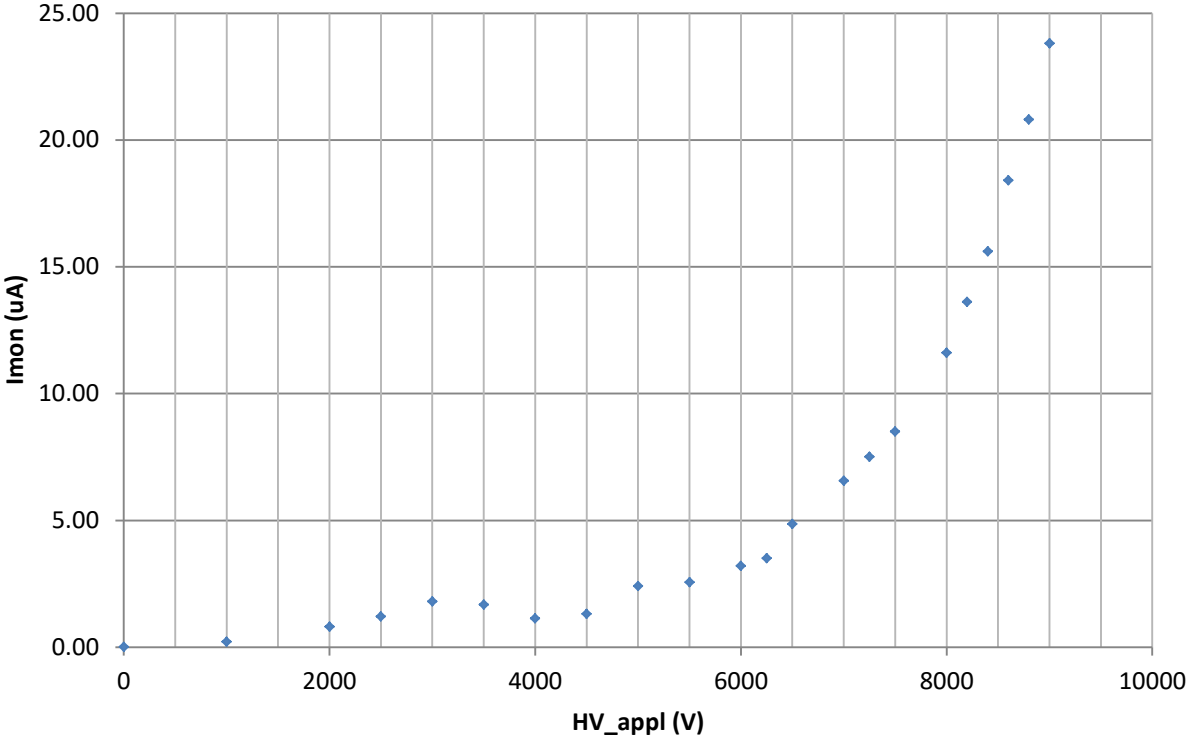
**Reference scan (cosmics) @904, STD mix, 15/4/23**

WP std mix ~ 8.2 kV (Hveff!)

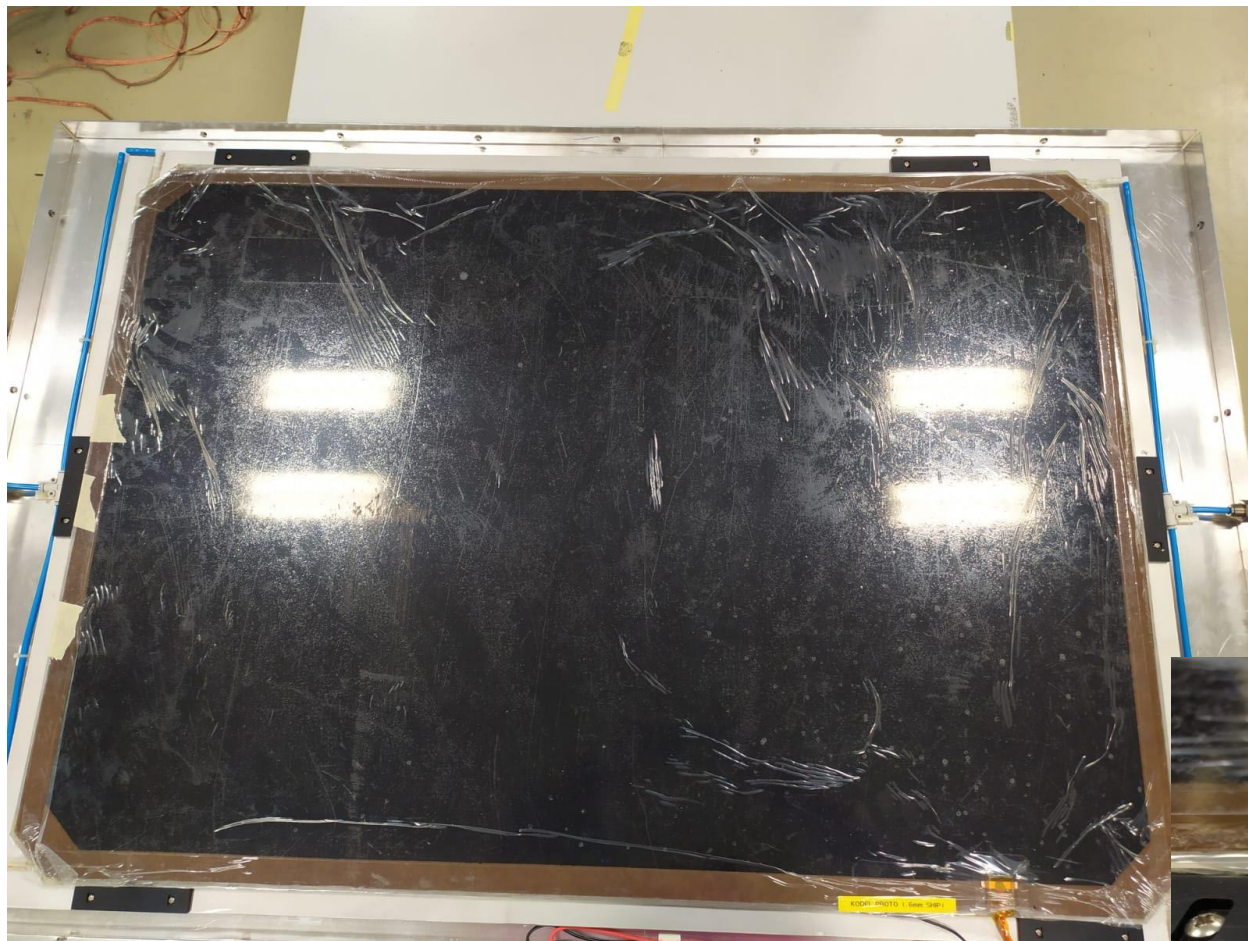
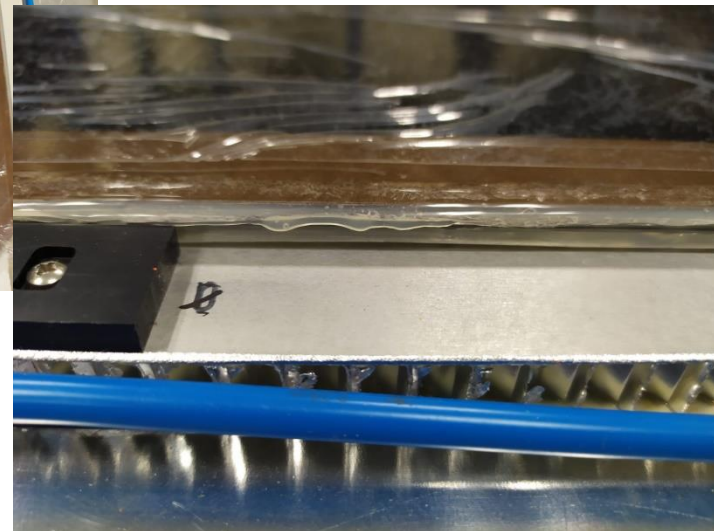
**16/4/23 – box opened**

- Plastic film removed from the HV side (not present on the other gap face)
- In and out tygon pipes replaced (in-bot side & out-top side were a little bit oiled inside)
- Gas leaks check -> no leak found
- HV connector check → OK, working well
- Visual inspection lateral holes/breaks → none found
- Inspection looking for lateral holes/breaks with “electrical” probe → none found

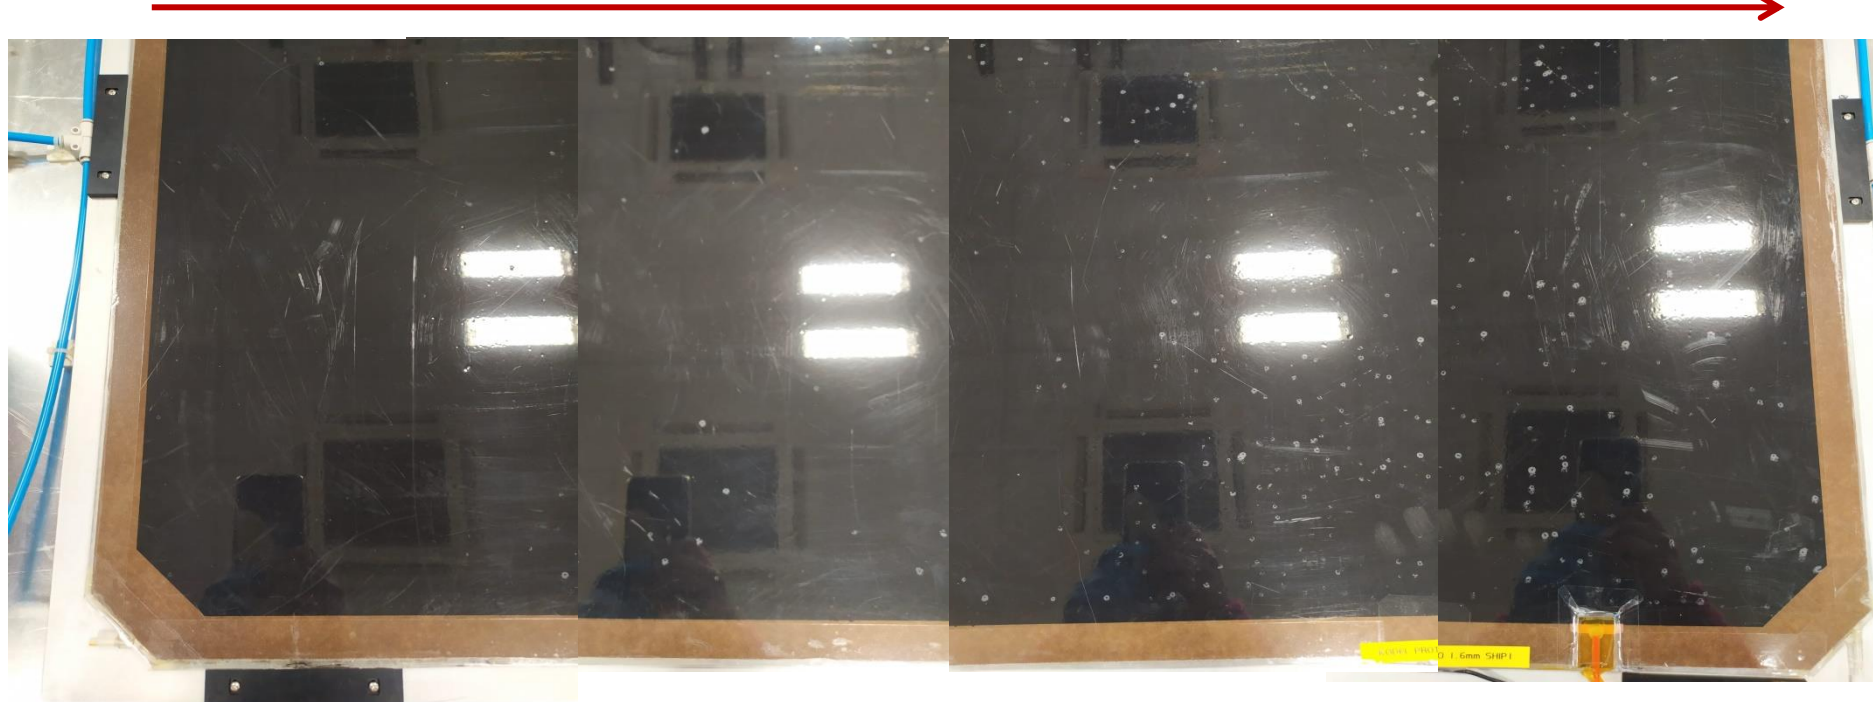
**16/4/23 – surface spots**

spot density

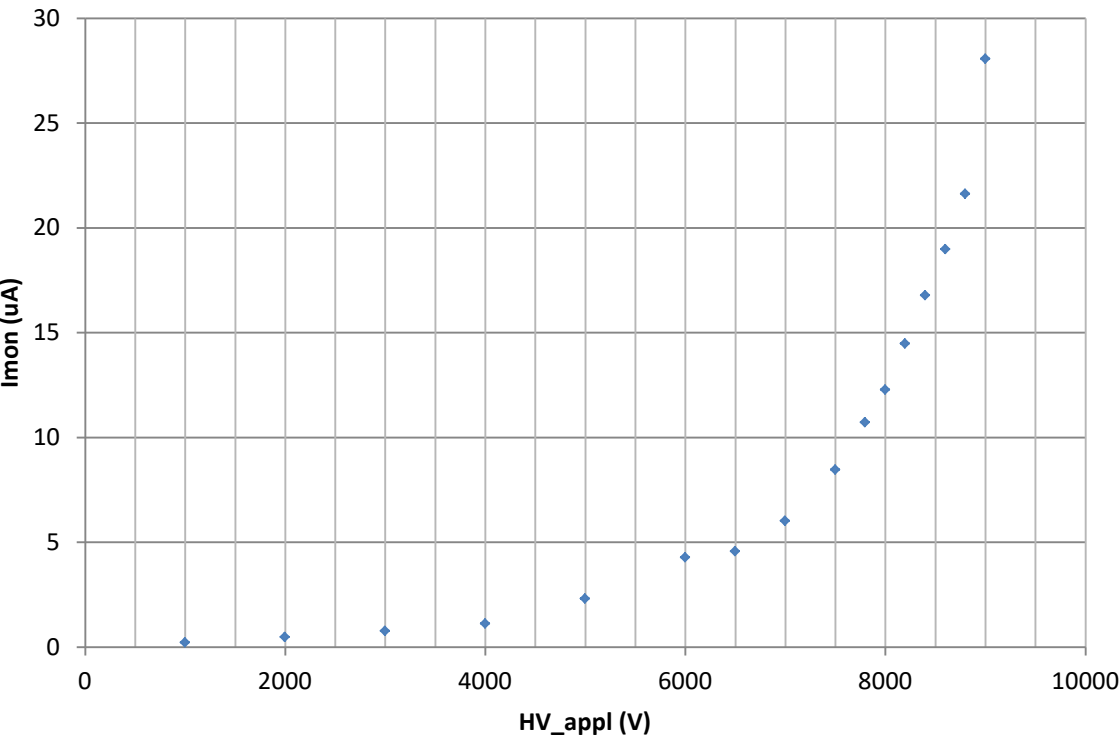
***HV-I scan (cosmics) @904, STD mix and box opened (no top side), 16/4/23***

WP std mix ~ 8.2 kV (Hveff!)

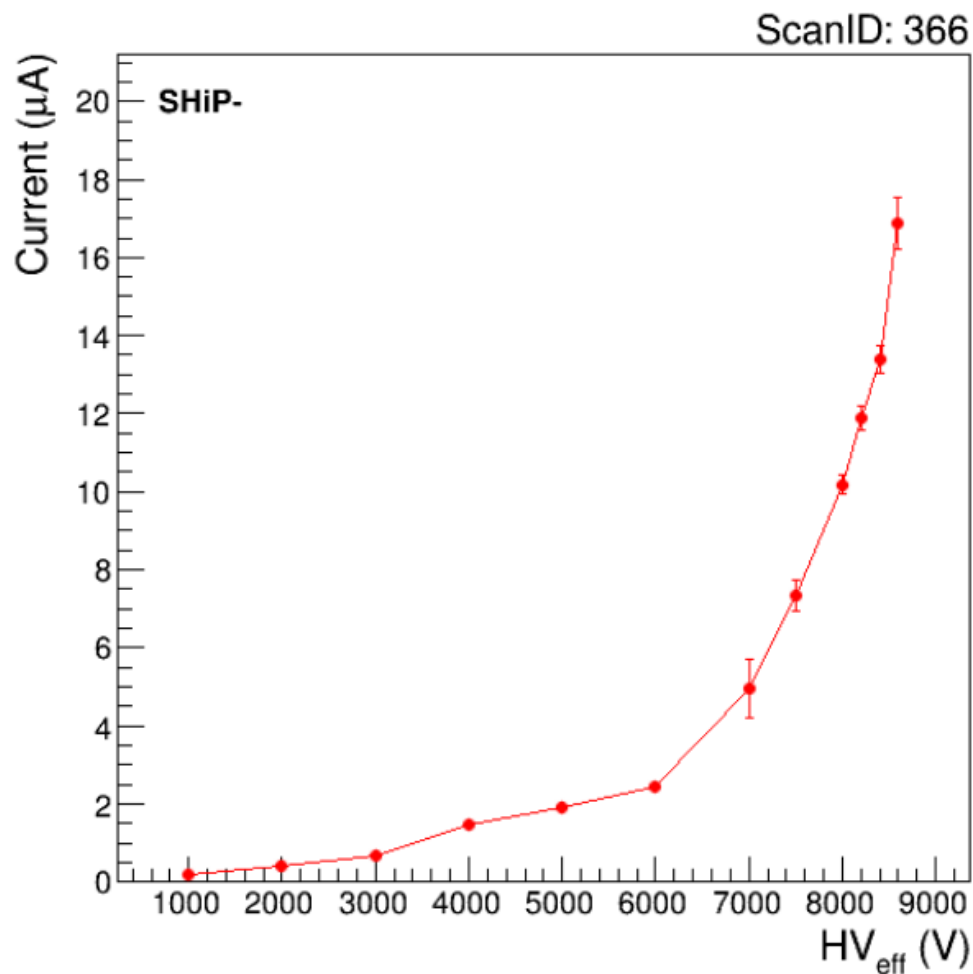
## WebDCS guided HV scan 17/4/23 – std mix

- Gas leakage check → none found
- Box closed
