The Infrastructure Team

AGATA@LNL

Identified issues and adopted solutions

AGATA Week, October 19, 2023

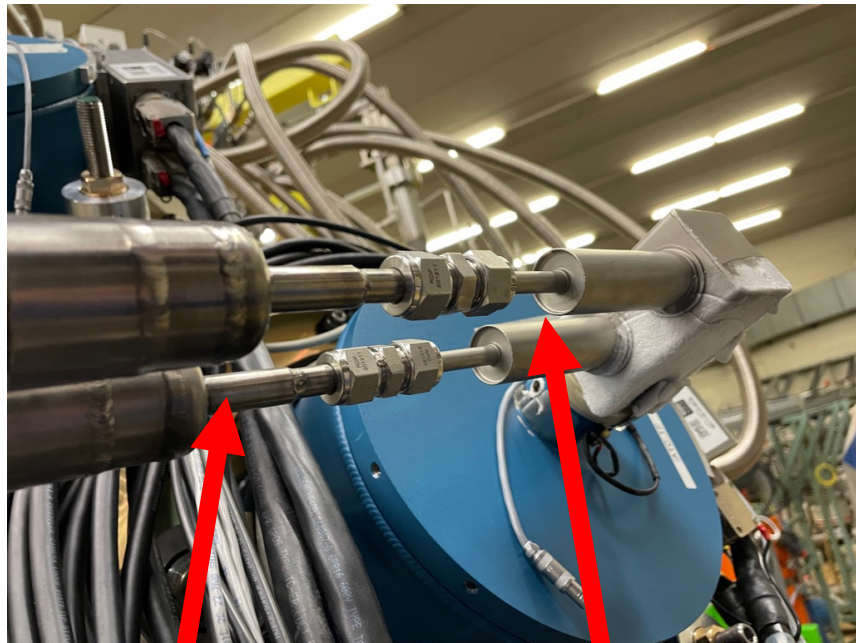
Detector bayonet

Limited flexibility

Mechanical fragility

Precise alignment and reduced strain on cryostat collar

New insert to improve mechanical stability

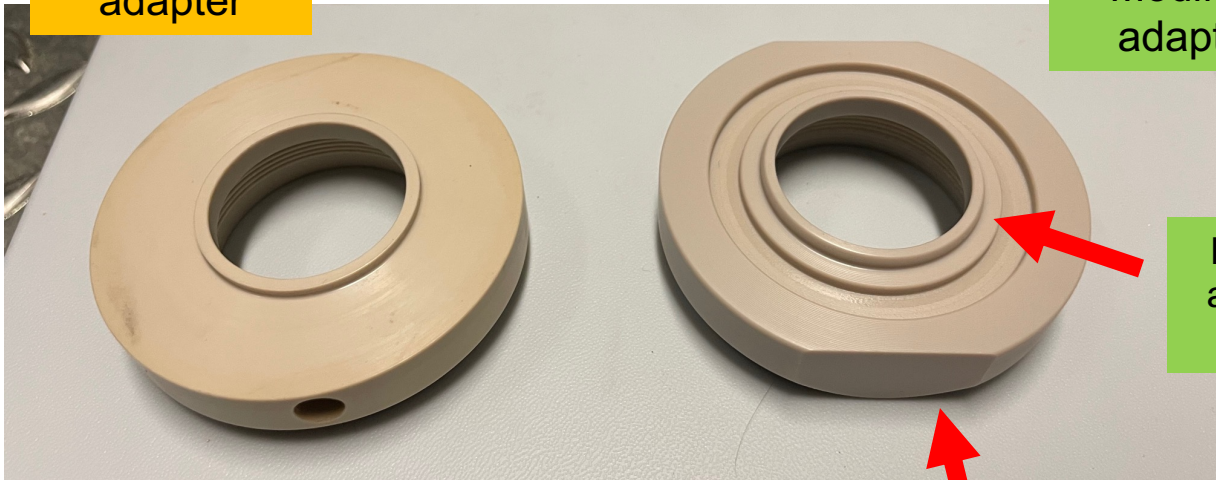
Original adapter

- Very thin bayonet O-ring

Modified adapter

Improved alignment ring

Standard fixing key

Additional O-ring

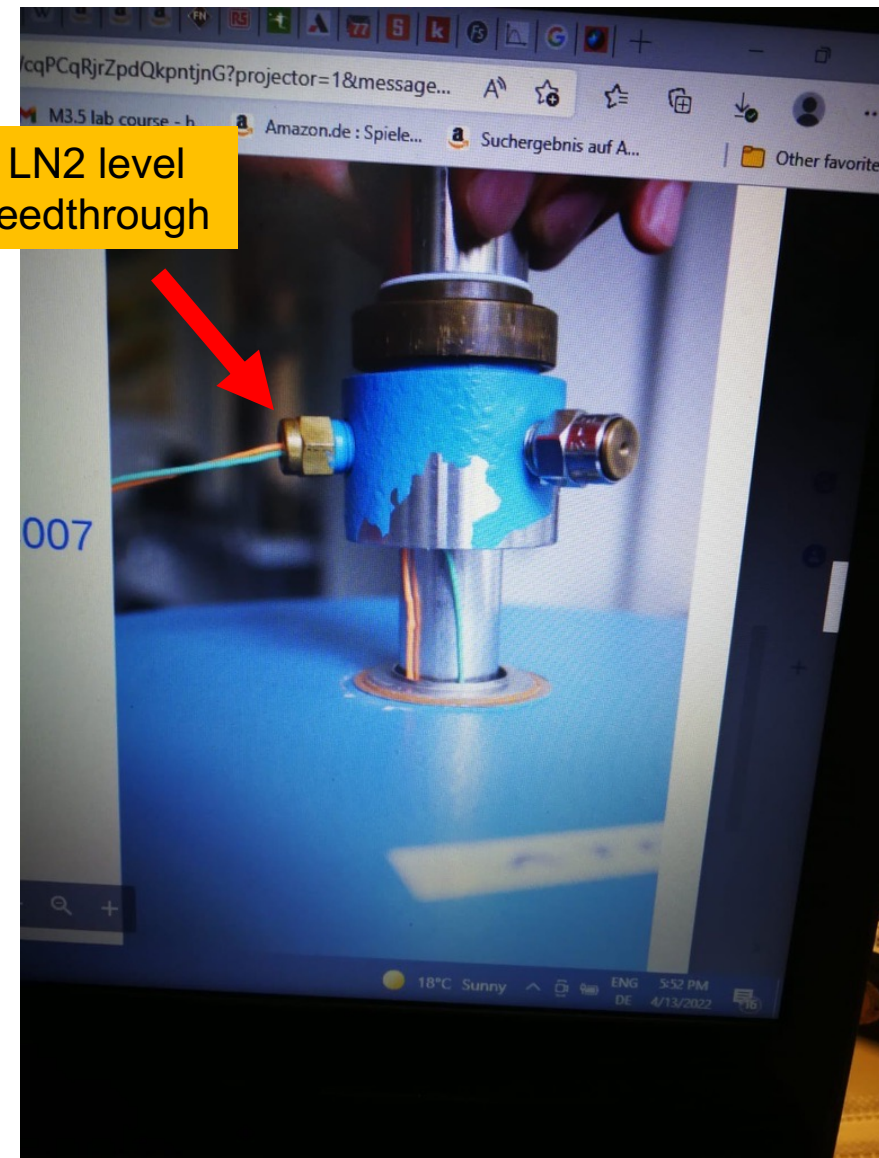
LN2 level feedthrough

- Fragile sealing of level capacitor feedthroughs

Not resolved yet

How to fix the problem of leaking feedthrough sealant ?

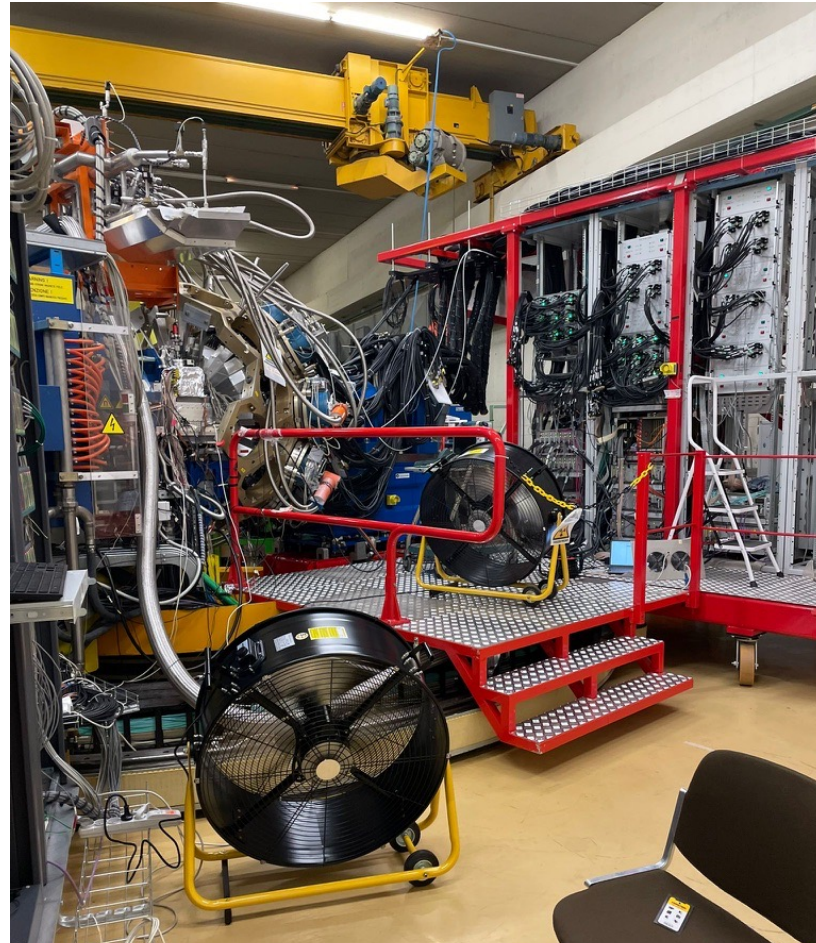
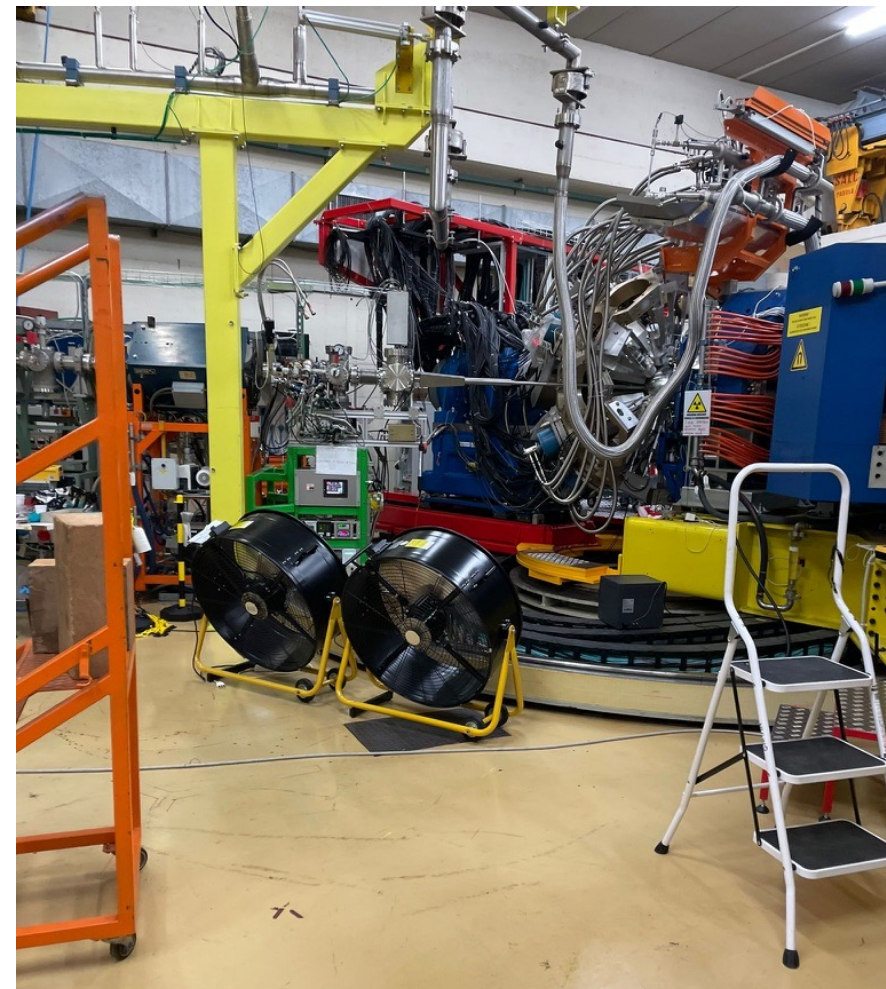
Air circulation

- Humidity

Installed several fans to improve air circulation: reduced condensation of humid air on cold detector surfaces and lower electronics working temperature

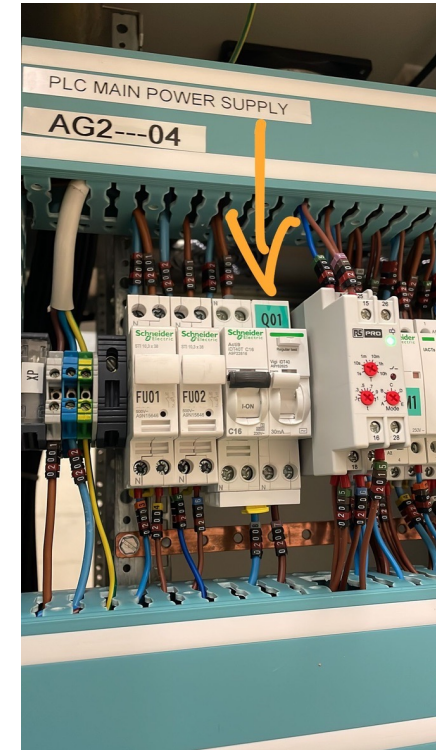
Circuit breaker Q01

- 9.02 @ 23:35 general power down following circuit breaker activation. Reason unknown

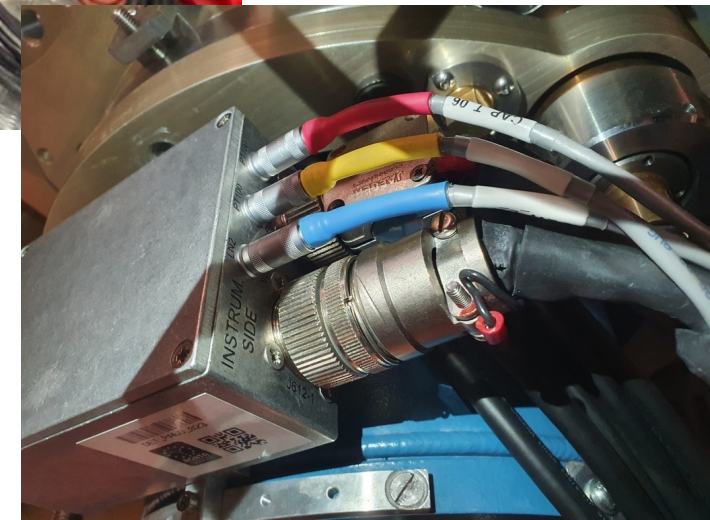
LV cable

- Few damaged LV cables. Spares available

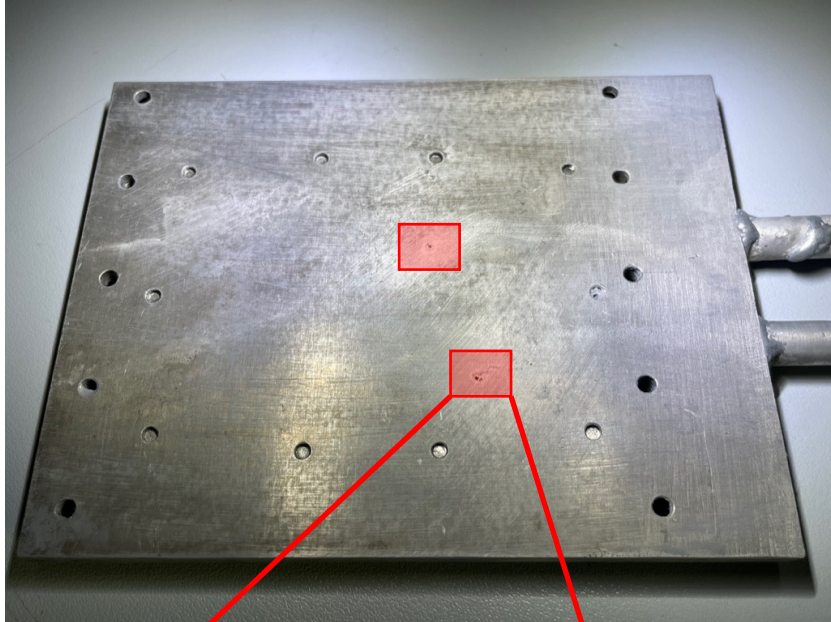
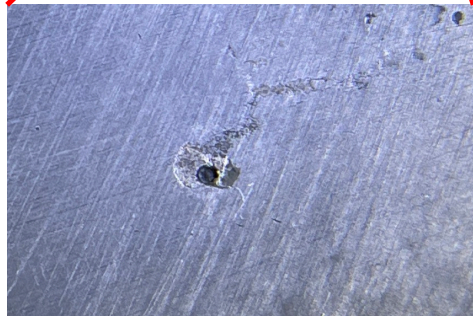
Holes observed in several V1 digitizer's cooling plates and pipes

Work in progress: *modify the cooling system to add a chiller/heat exchanger using “non corrosive” cooling fluid*

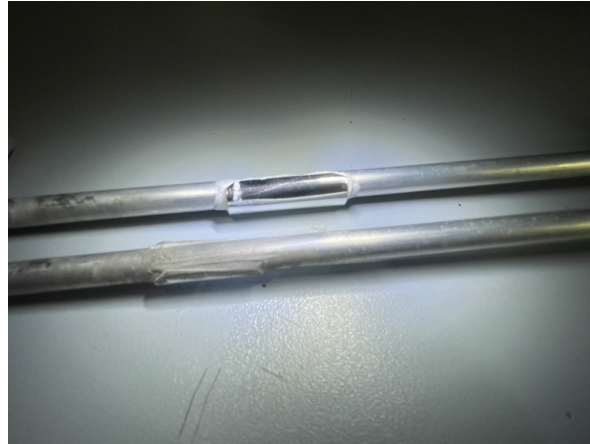
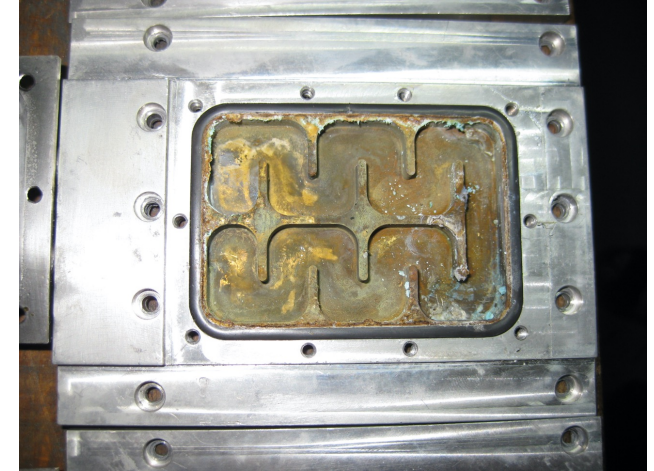
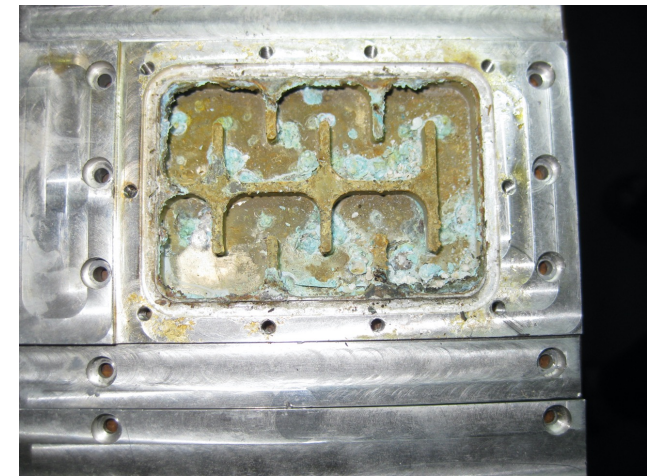
Corrosion (intermediate to severe) along the water path

Deadly effects on the electronics

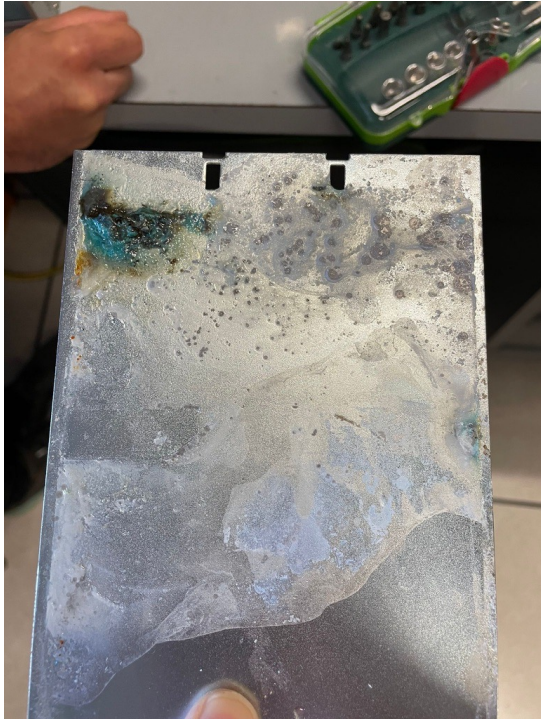
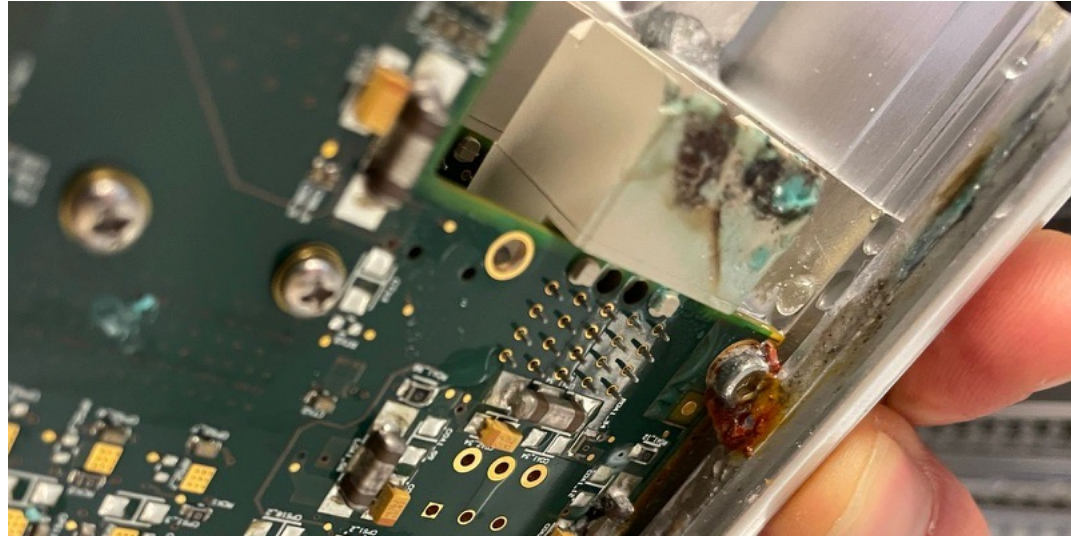
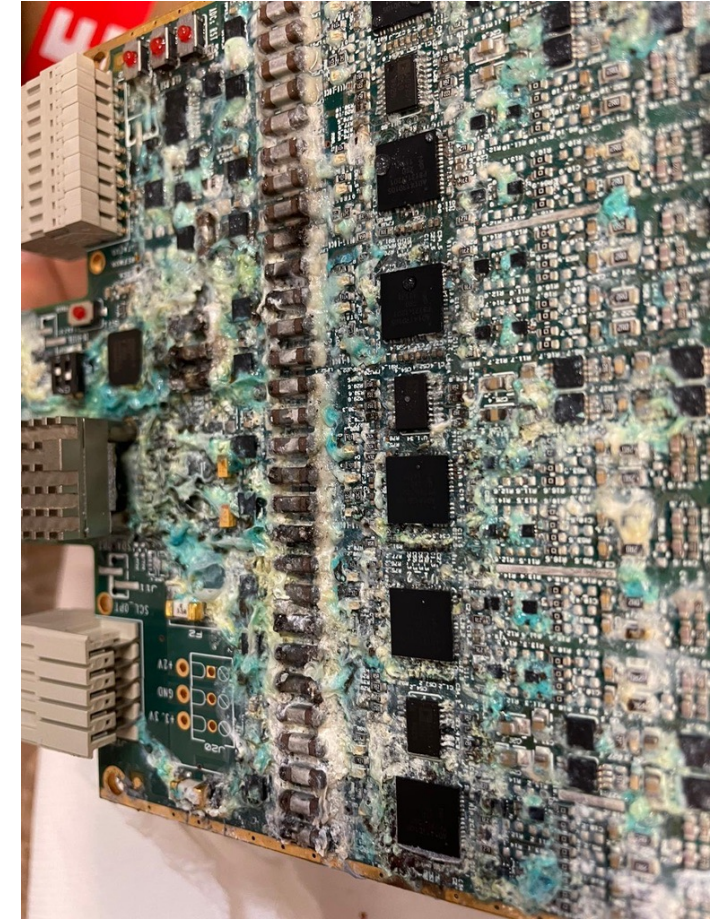
Damaged digitizers from corrosion of Al plates and pipes
