Istituto Nazionale di Fisica Nucleare
Sezione di Bologna

Status rivelatore TOF, richieste 2024 e programma manutenzione straordinaria

A. Alici, P. Antonioli

Riunione con INFN referee - Roma, 20-21 Luglio 2023

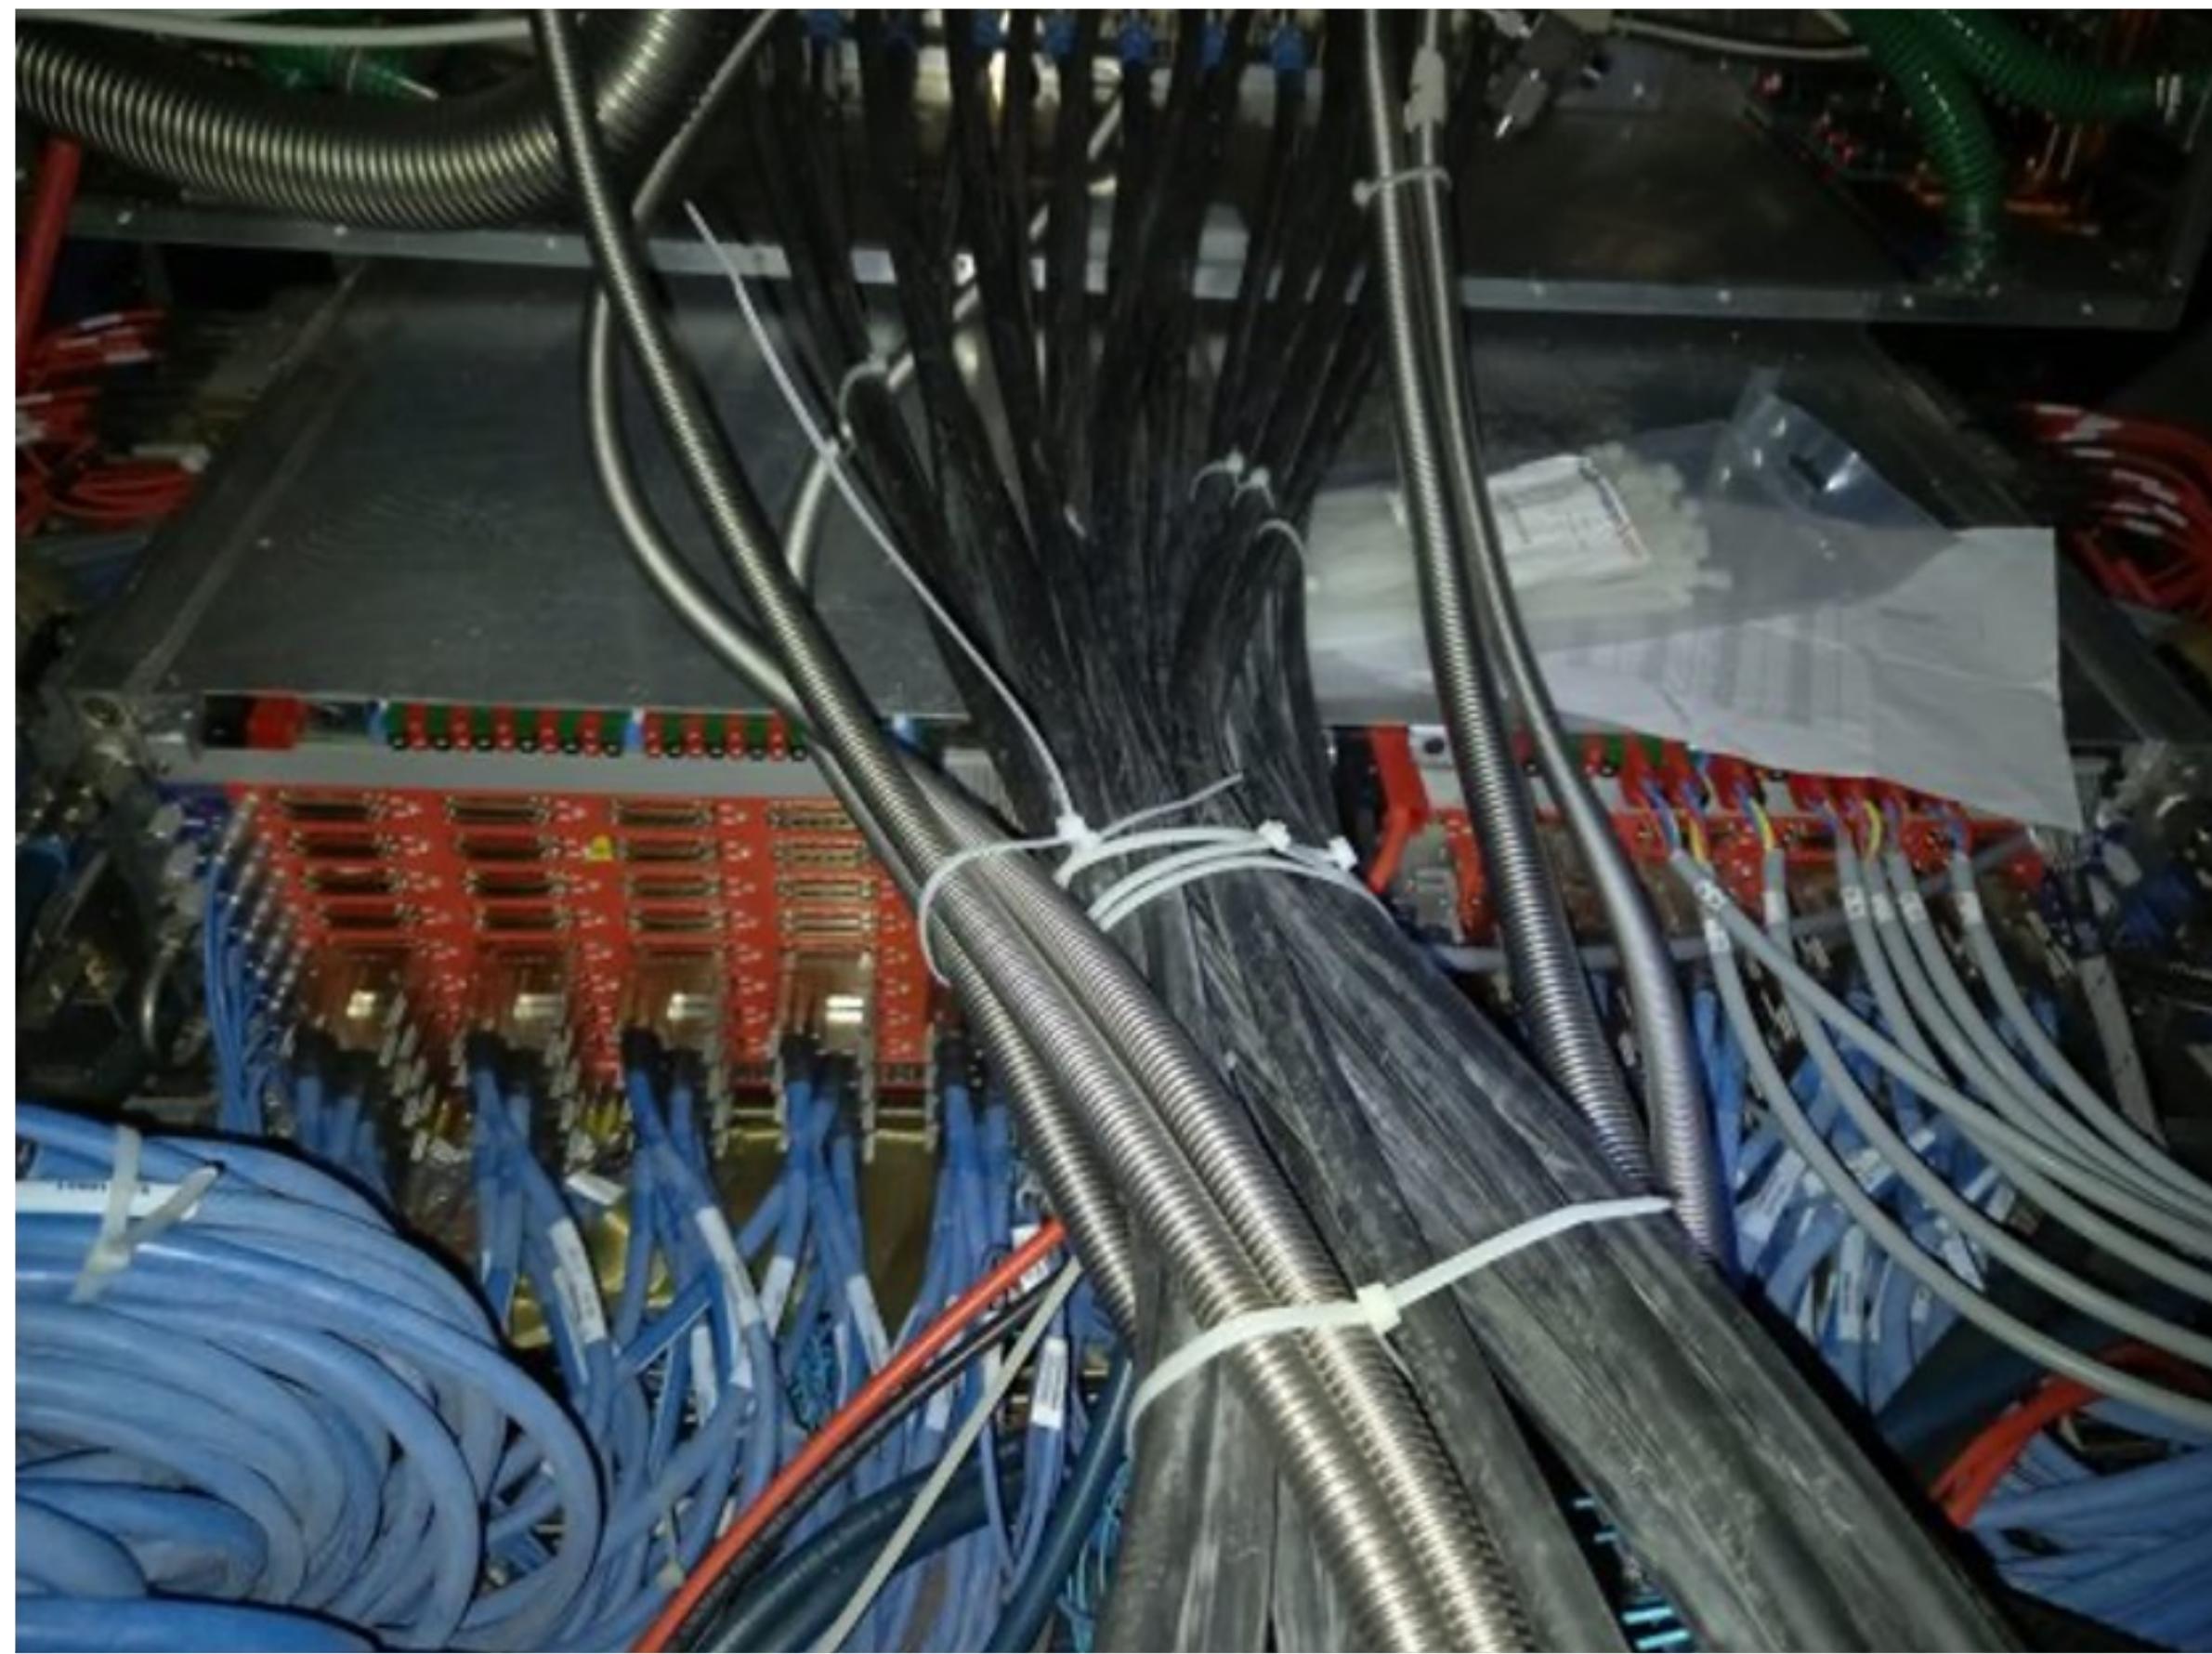
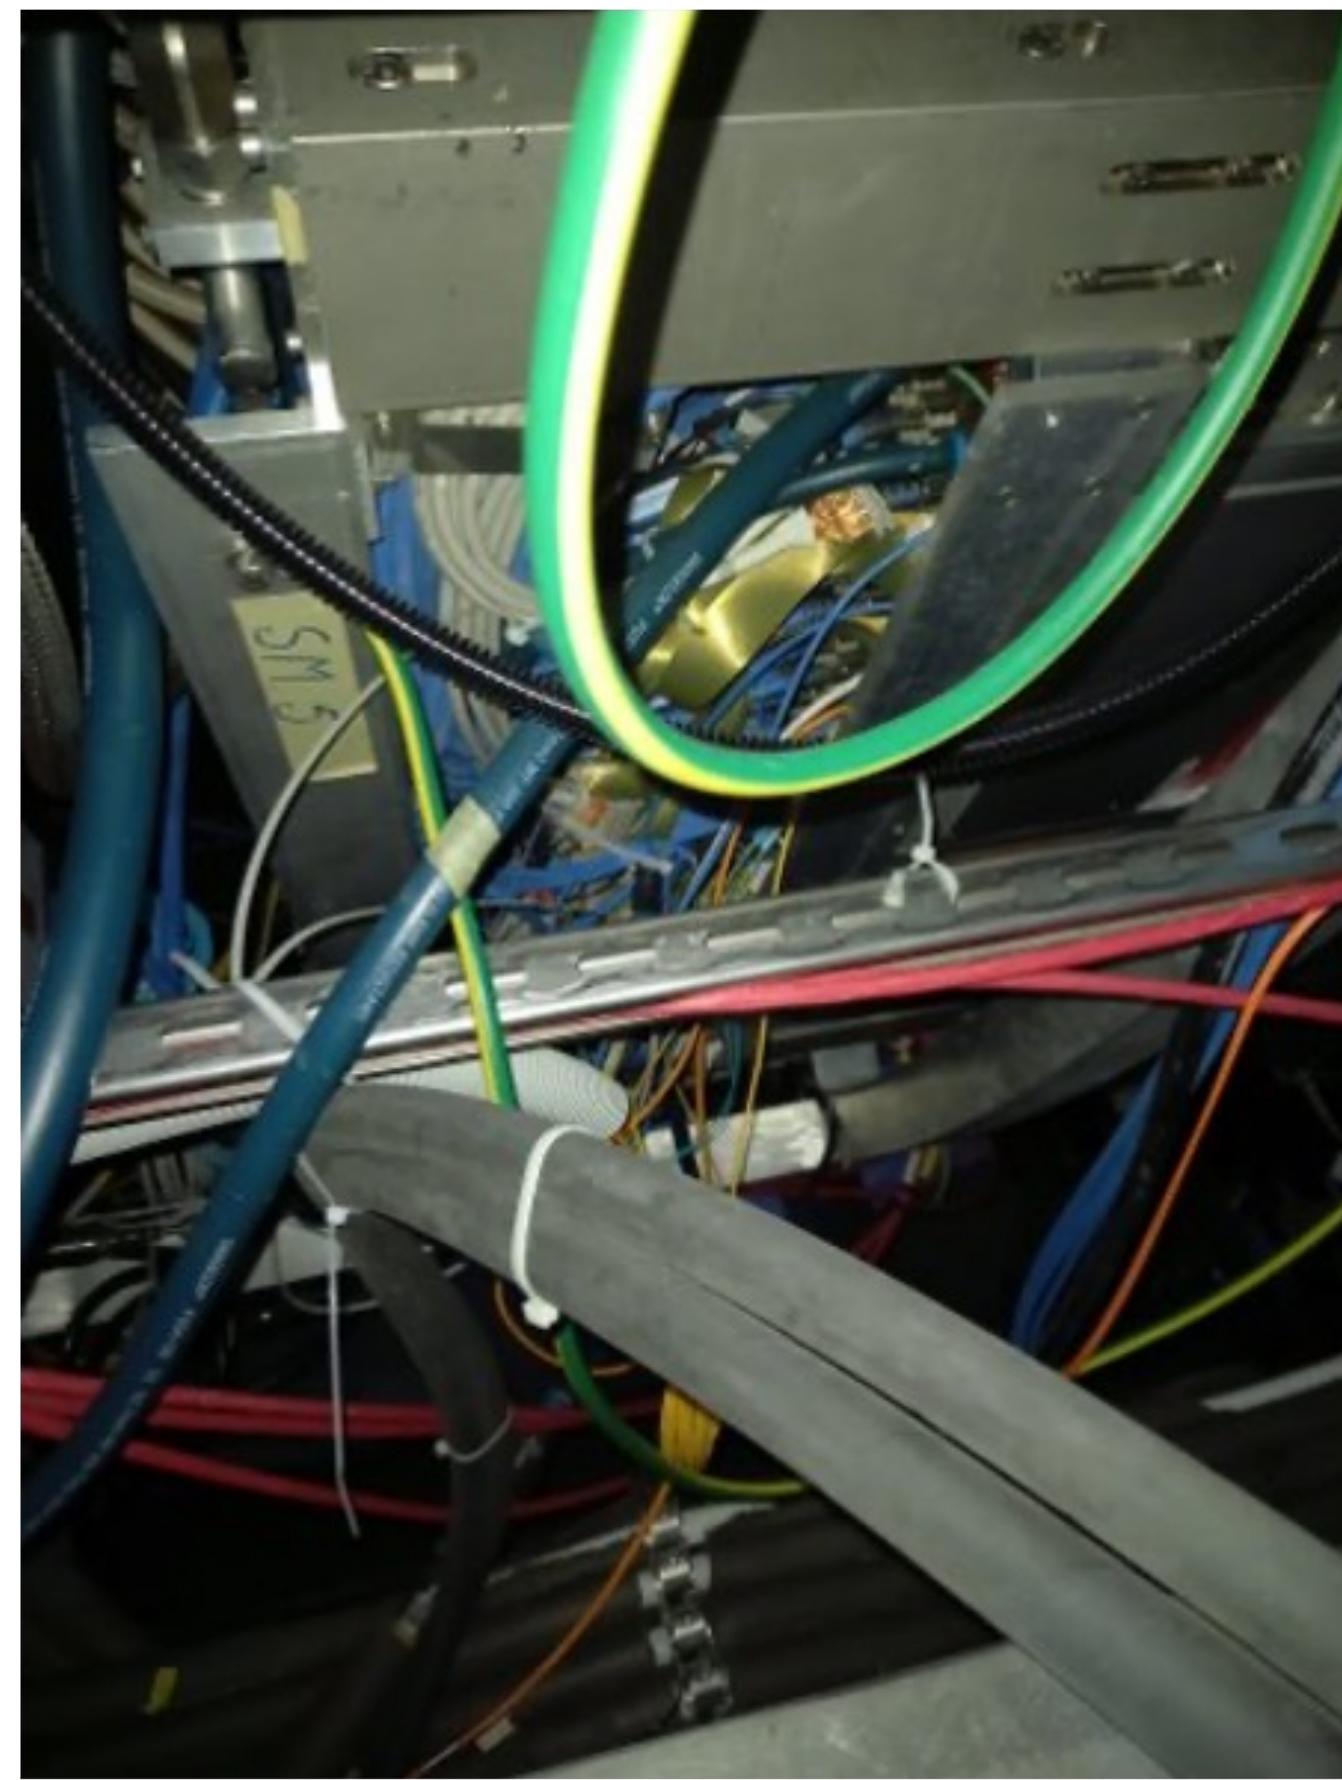
TRM replacing campaign

Replacing even a single TRM sometimes requires uncabling multiple boards... Most of the times in extremely narrow spaces

- 34 TRMs reincluded in acquisition during YETS
→ **19 TRMs replaced by spares**

As of 12/06/2023 with **684** TRMs to serve TOF

- **651** are working
- **33** TRMs disabled (50% of them presumably not repairable)
- **Only 25 spares available now**

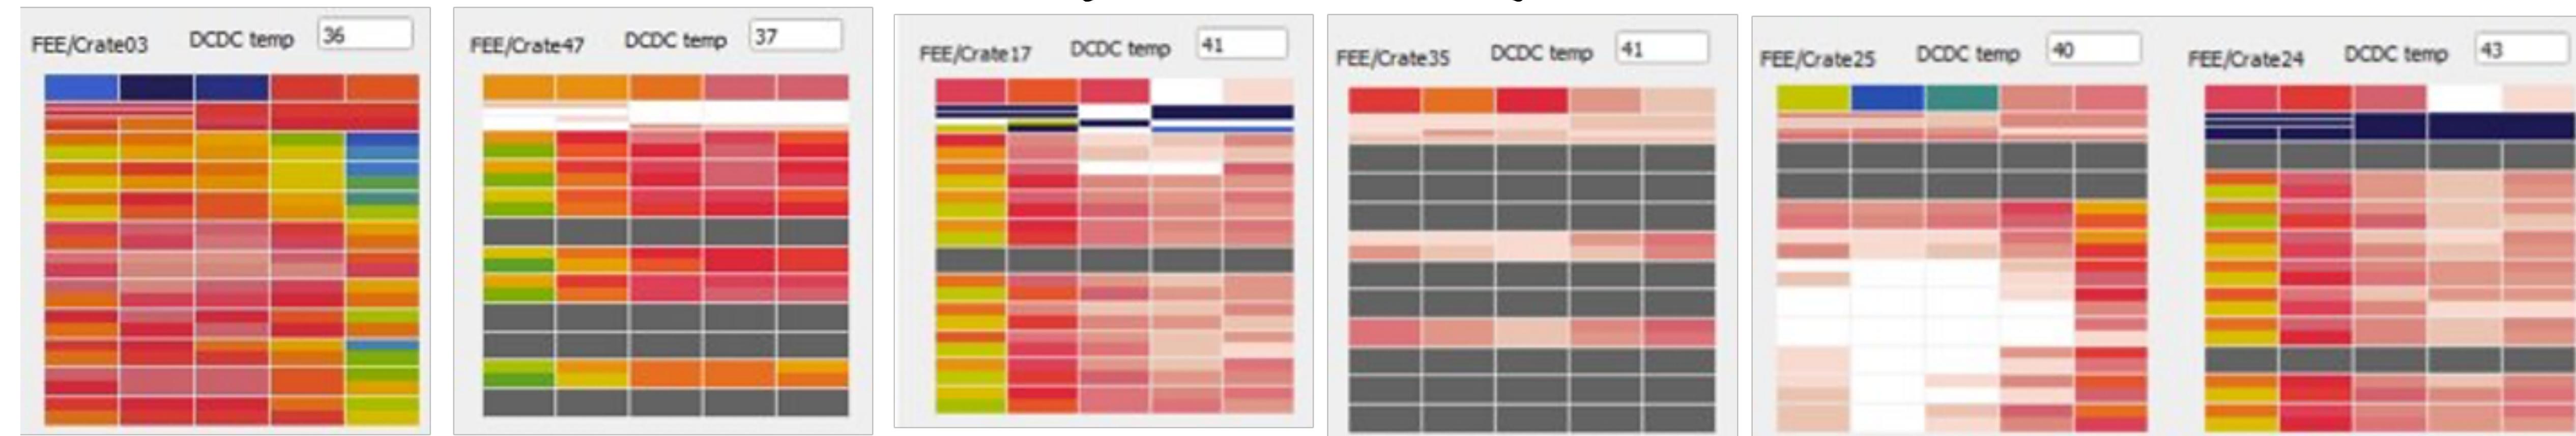
End of 2022 situation

Before YETS few crates were experiencing high temperatures → multiple trials using acids and a pressure pump did not lead to significant results. New procedure performed during YETS → 6 crates unclogged successfully

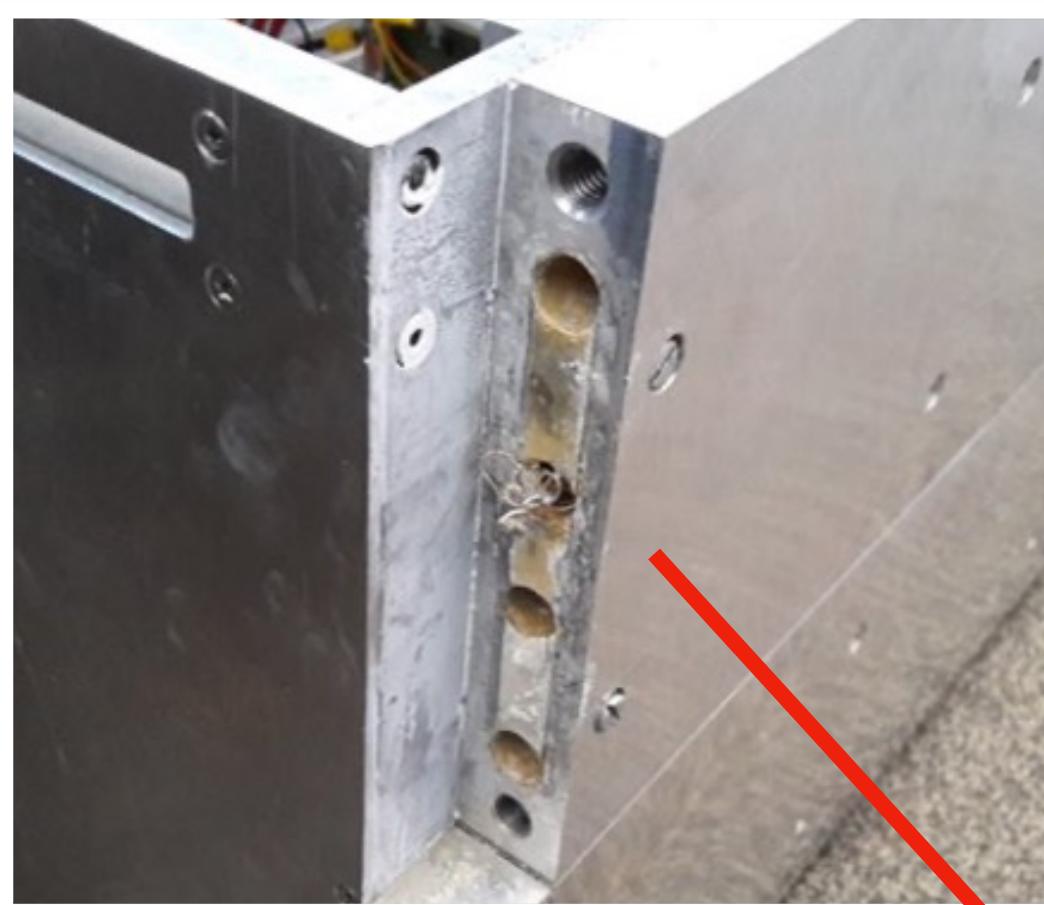
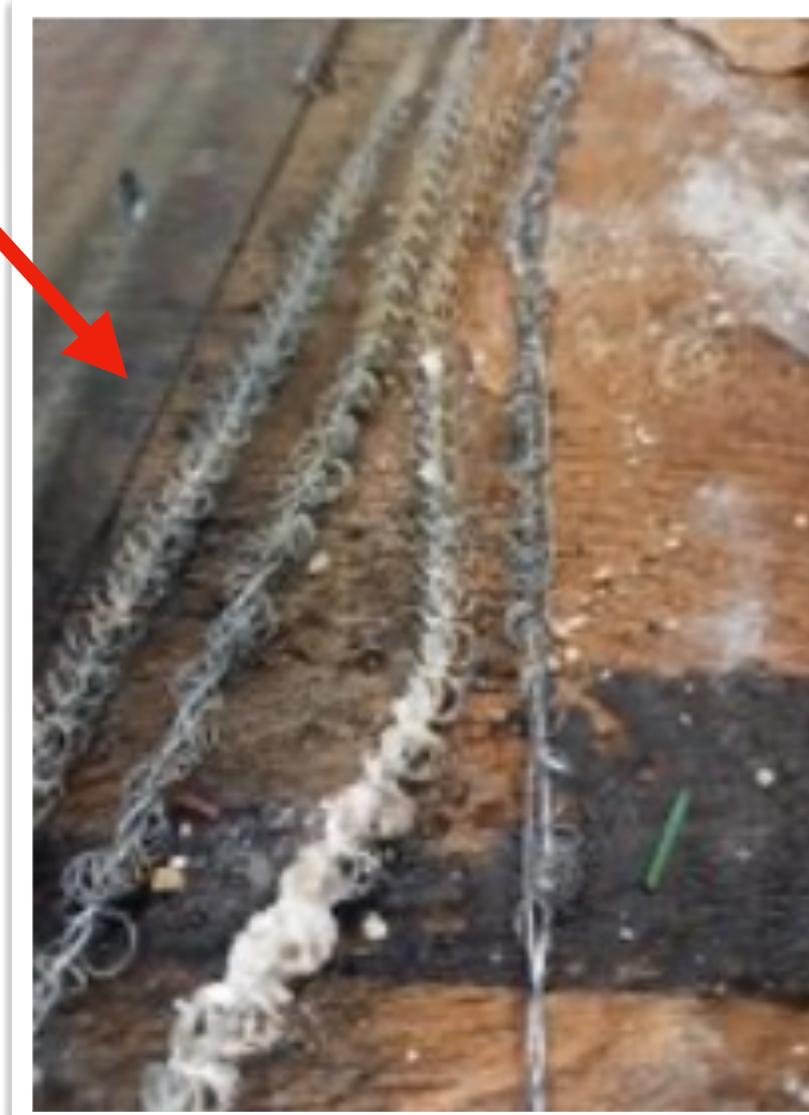
Cooling intervention during 2022 YETS

Before YETS few crates were experiencing high temperatures → multiple trials using acids and a pressure pump did not lead to significant results. New procedure performed during YETS → 6 crates unclogged successfully

- Deposit on crates pipes and turbolators dissolved using phosphoric acid (5-10% conc.) **left to act for 1 or 2 days**
- Pressure wash needed to break down the hardest deposits left after the acid bath → in some occasions they were able to block also valves used for the job
- All crates involved showing a nominal flow >2 l/min after the treatment
- **Crates temperature stable even after cooling plant restart**, but corrosion inhibitor still NOT included...

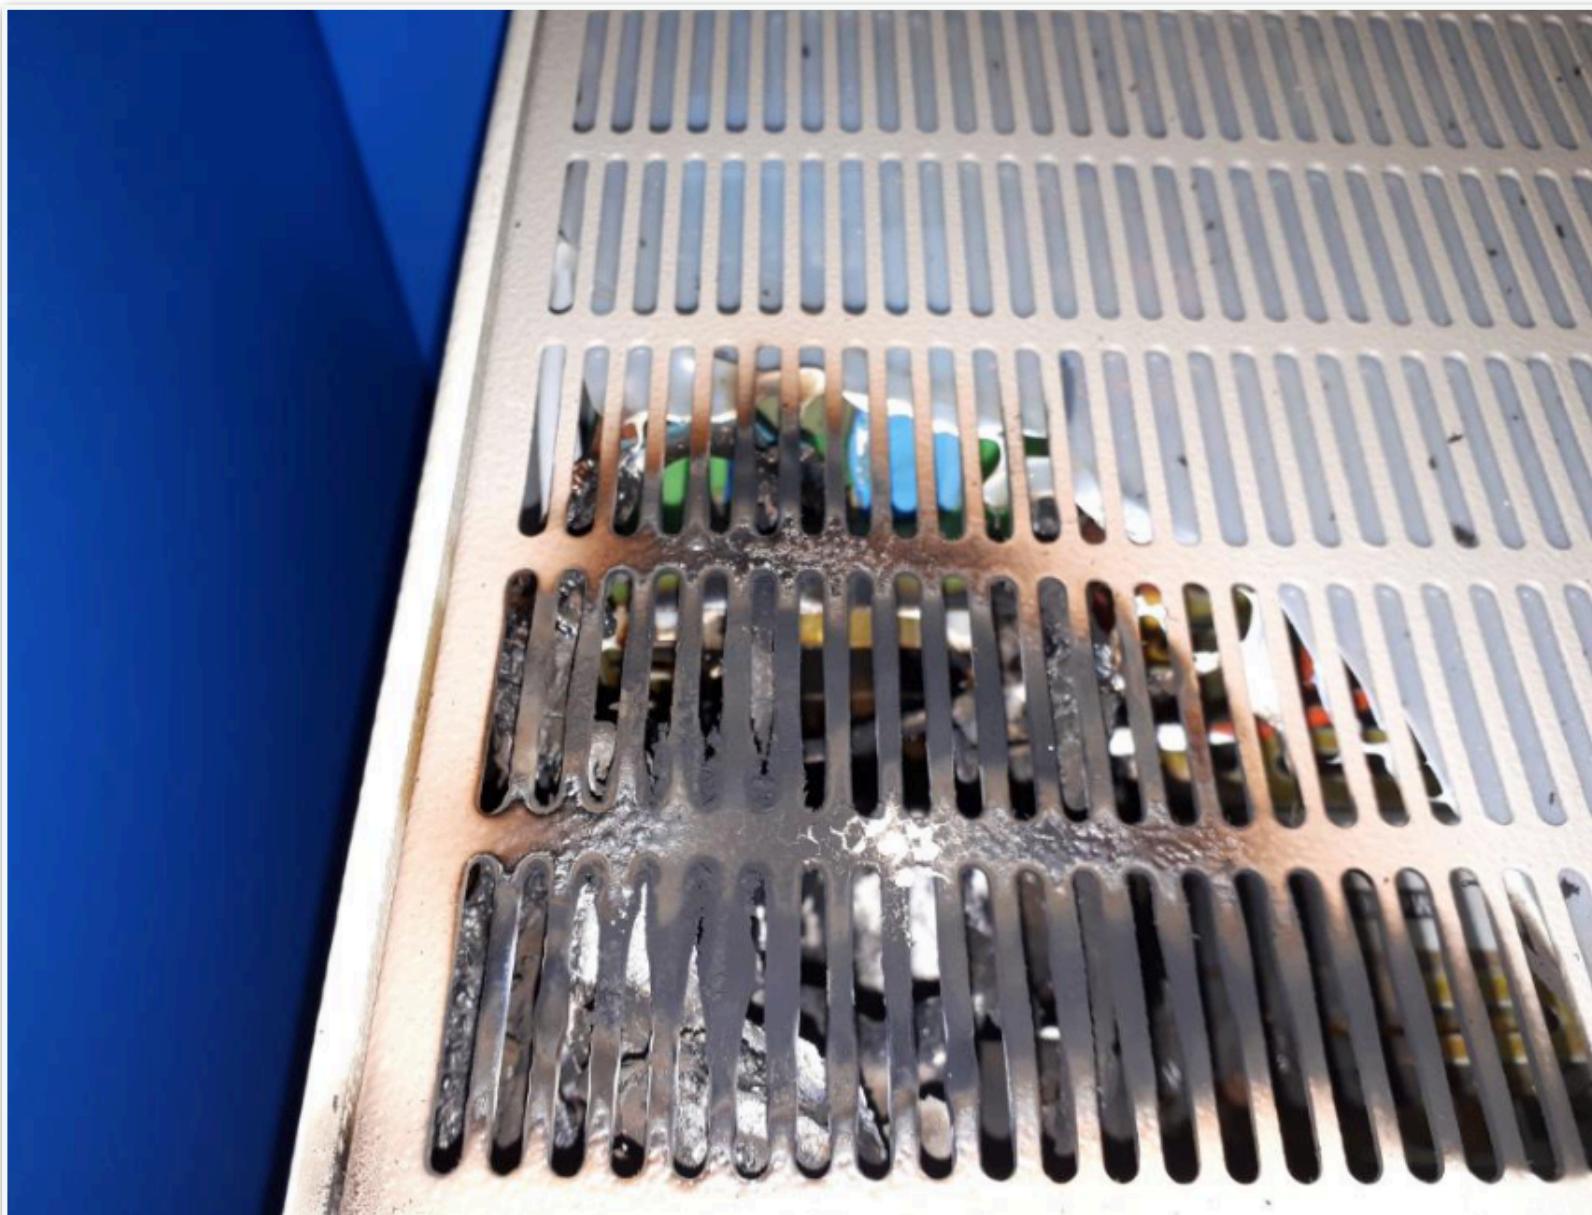
15/03/2019

A3000NF burned capacitor

A3000NF 3-phase notch filter for a A3486 (in order to be CE compliant on harmonic current emissions).

- 24 installed in 12 racks in the ALICE cavern (+ 2 spares) —> 26 filters in total
- (a) two typology of capacitors installed are reaching their end life, for a total number of 12 capacitor for each A3000NF. Few problematic modules in ATLAS investigated by CAEN, problem originated from a capacitance that overheated and then burned out (20% higher load in ATLAS wrt ALICE)
- (b) considering that the replacement of the capacitors will require the disassembling of the whole module, it's worth probably evaluate the replacement of the fan units too, that could face age-related issues
- (c) finally, it is possible to add a protection that disables the device in case of overheating of the capacities subject to this type of event

- (c) finally, it is possible to add a protection that disables the device in case of overheating of the capacities subject to this type of event
-
- a. 750/1000 € (Capacitance replacement + test at CERN) x 26 units = **19.5/26 k€**

- b. 250/300 € (Fans replacement, optional) x 26 units = **6.5/7.8 k€**
 - c. 200 € (Capacitance overheating protection, optional) x 26 units = **5.2 k€**

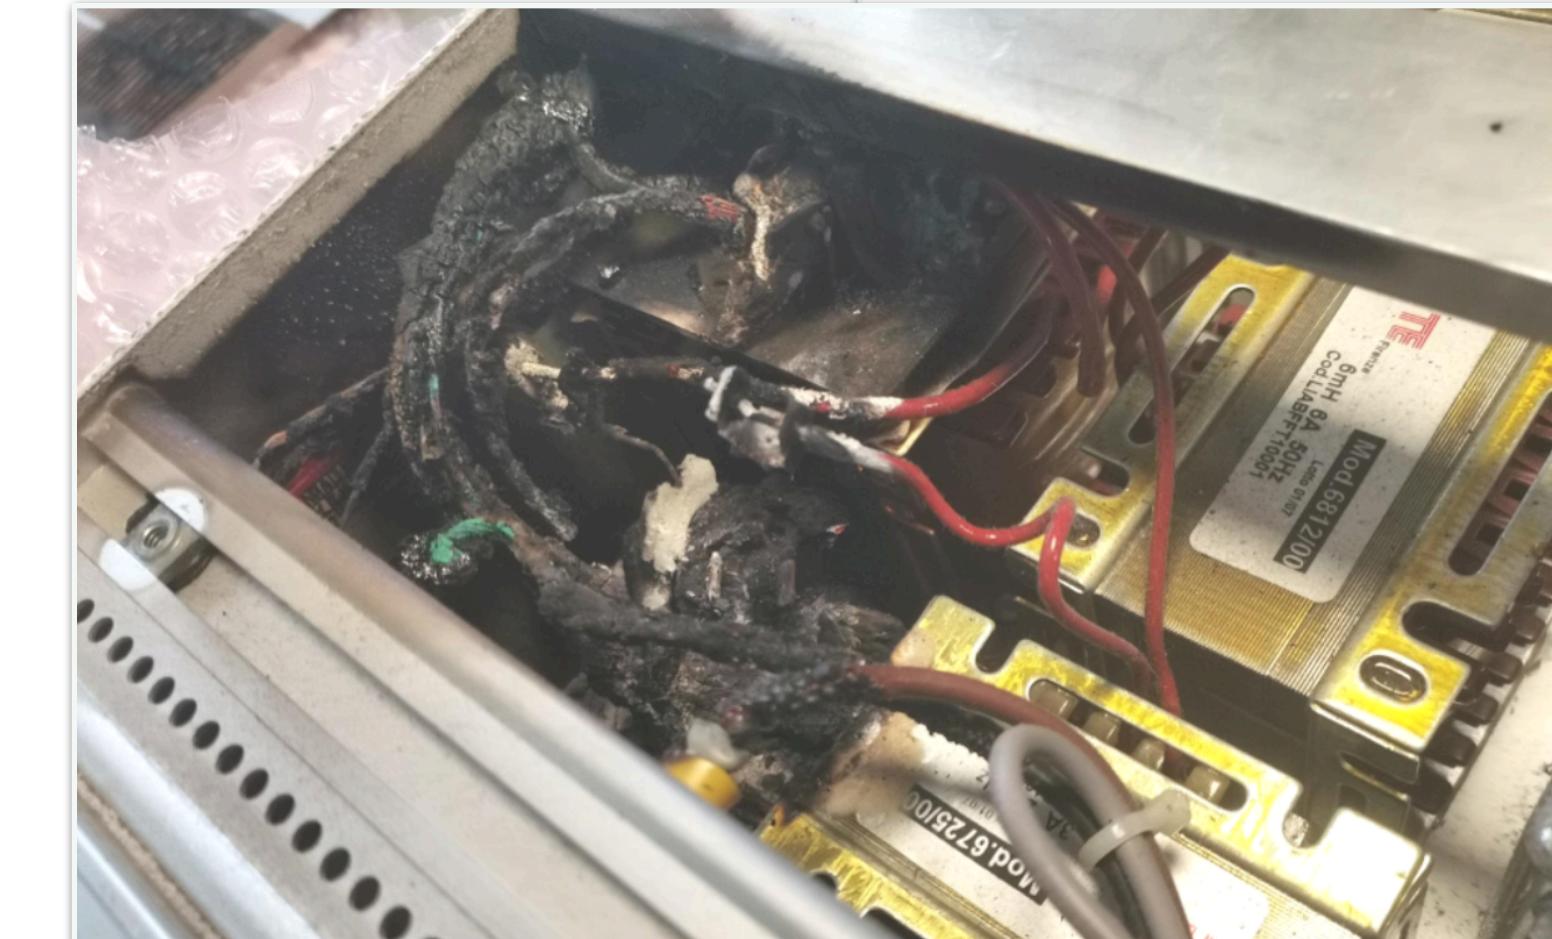
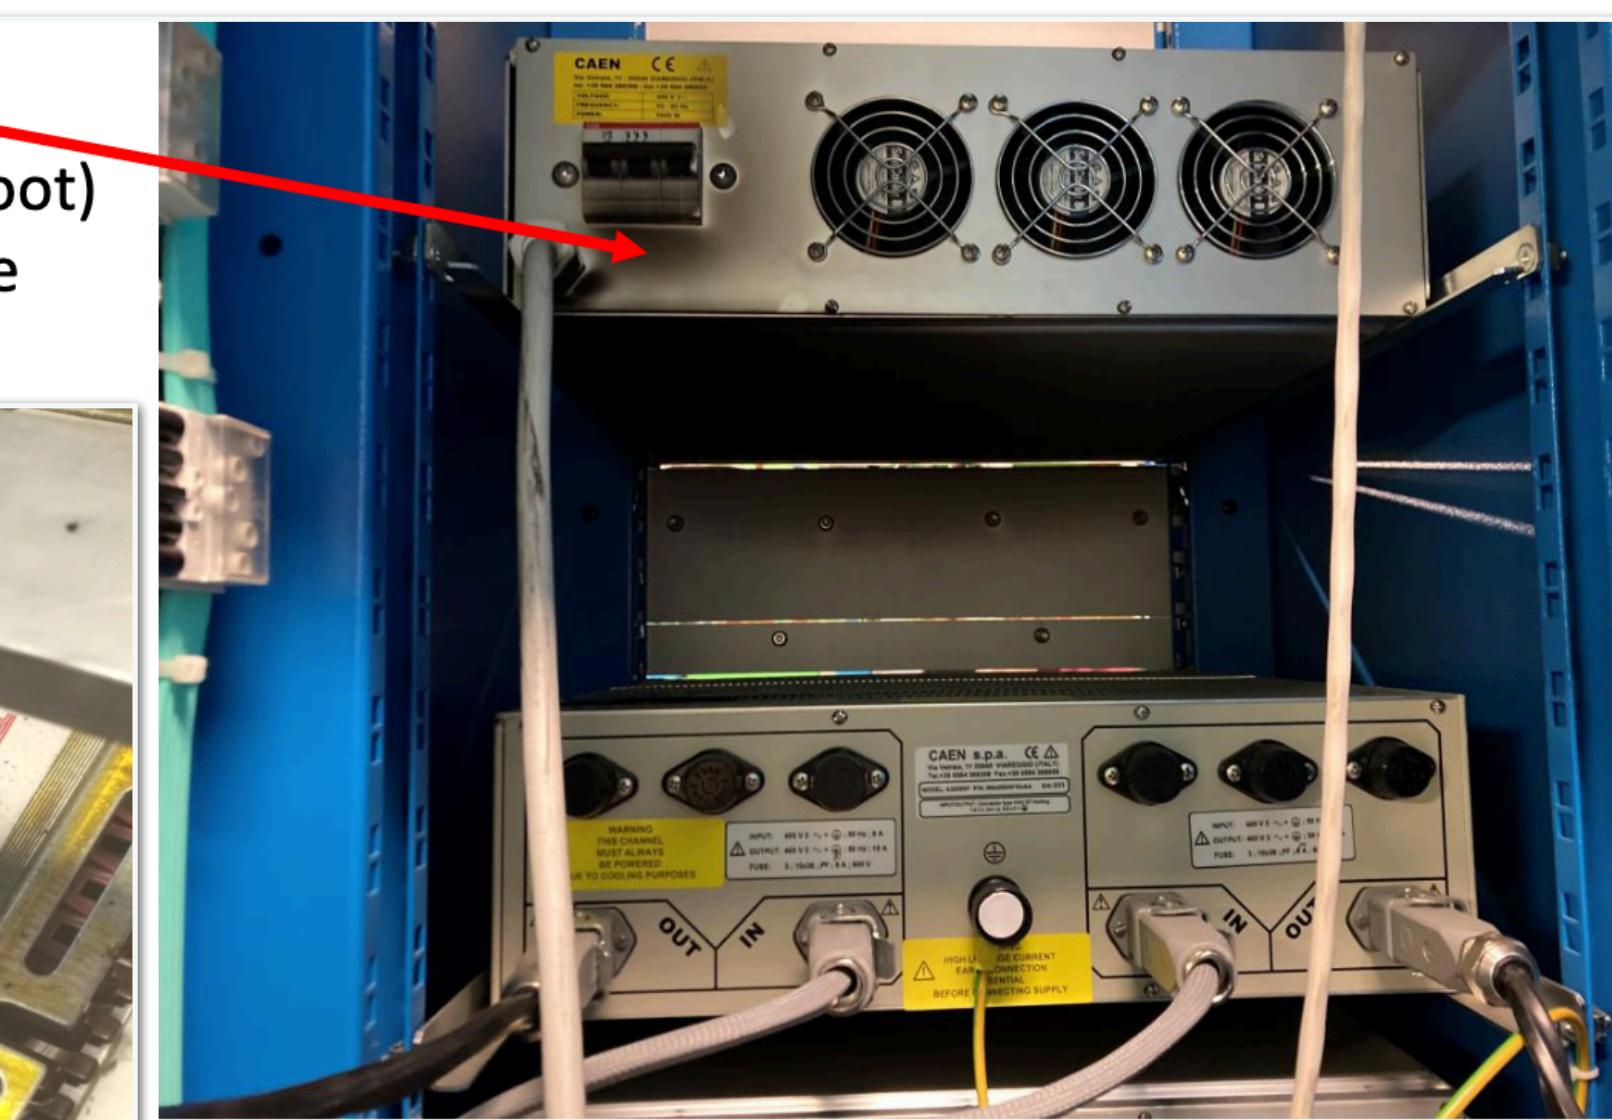
12/04/2023

Traces of the smoke/fire/flash (soot) on the device above the failing filter

- 24 installed in 12 racks in the ALICE cavern (+ 2 spares) —> 26 filters in total
 - (a) two typology of capacitors installed are reaching their end life, for a total number of 12 capacitor for each A3000NF. Few problematic modules in ATLAS investigated by CAEN, problem originated from a capacitance that overheated and then burned out (20% higher load in ATLAS wrt ALICE)

- (b) considering that the replacement of the capacitors will require the disassembling of the whole module, it's worth probably evaluate the replacement of the fan units too, that could face age-related issues

Intervento sostituzione capacito 2.5 k€ costo capacitori + 750 € per modulo, sostituzione ventole 300 € per modulo, sistema di protezione 200 € per modulo —> 35 k€ (ANTICIPABILI)

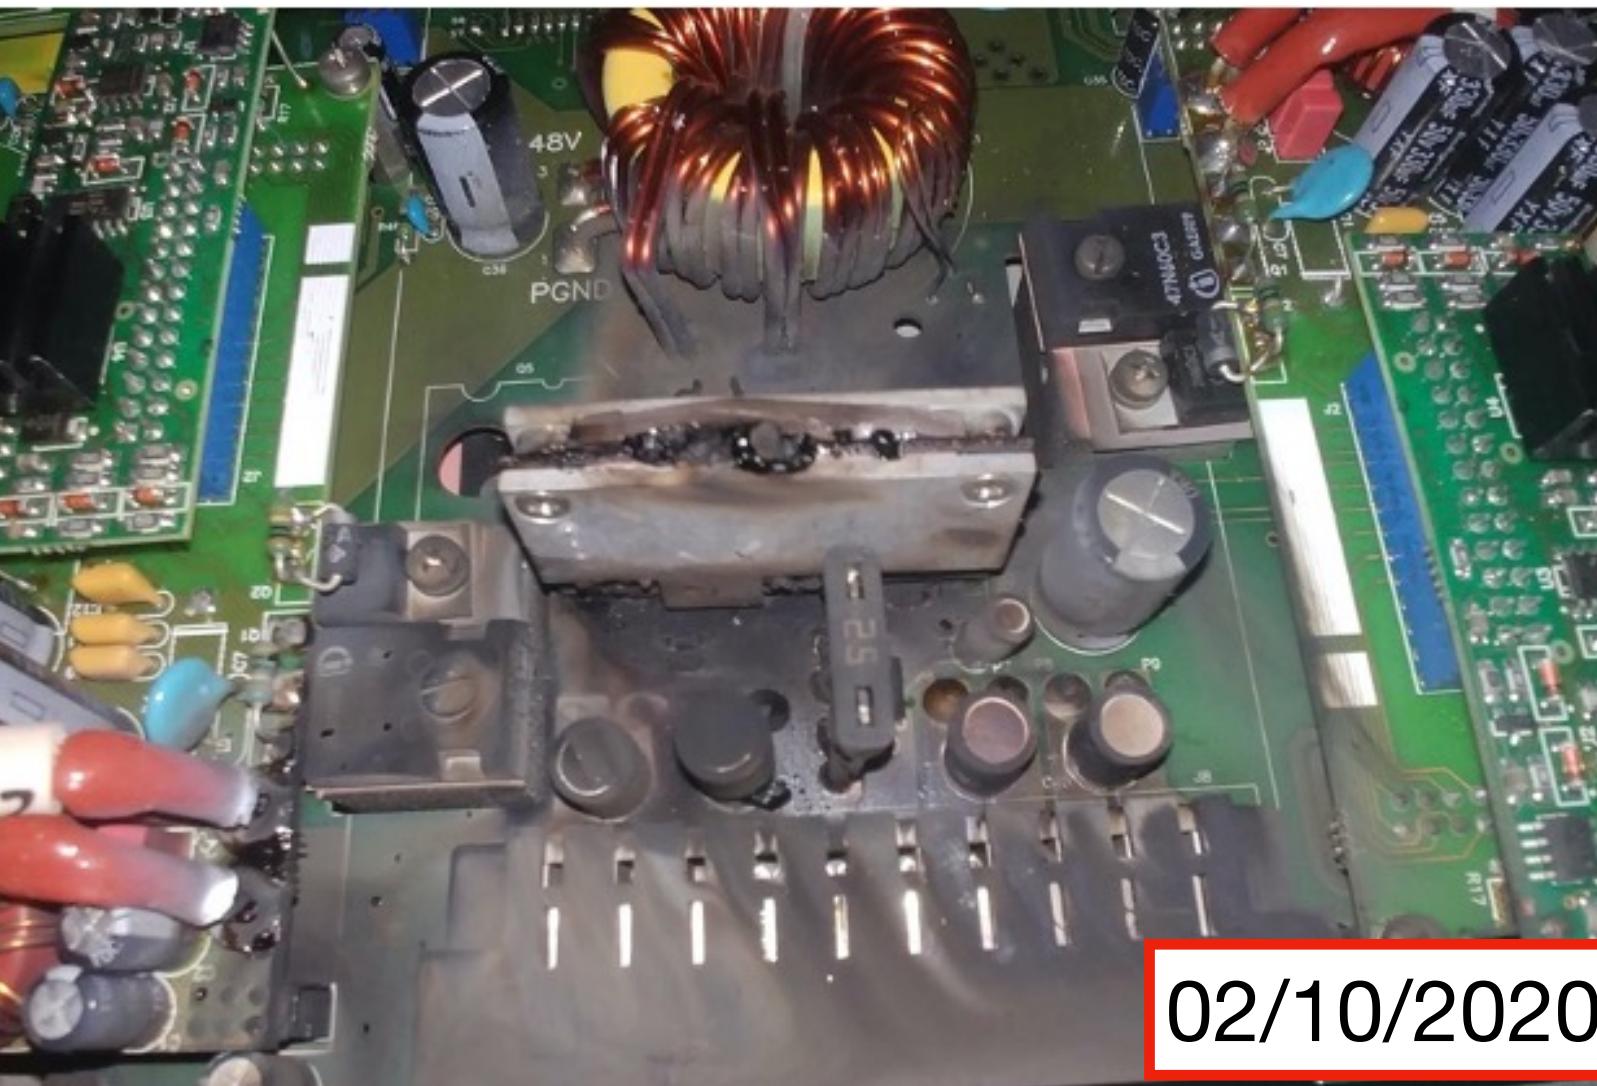
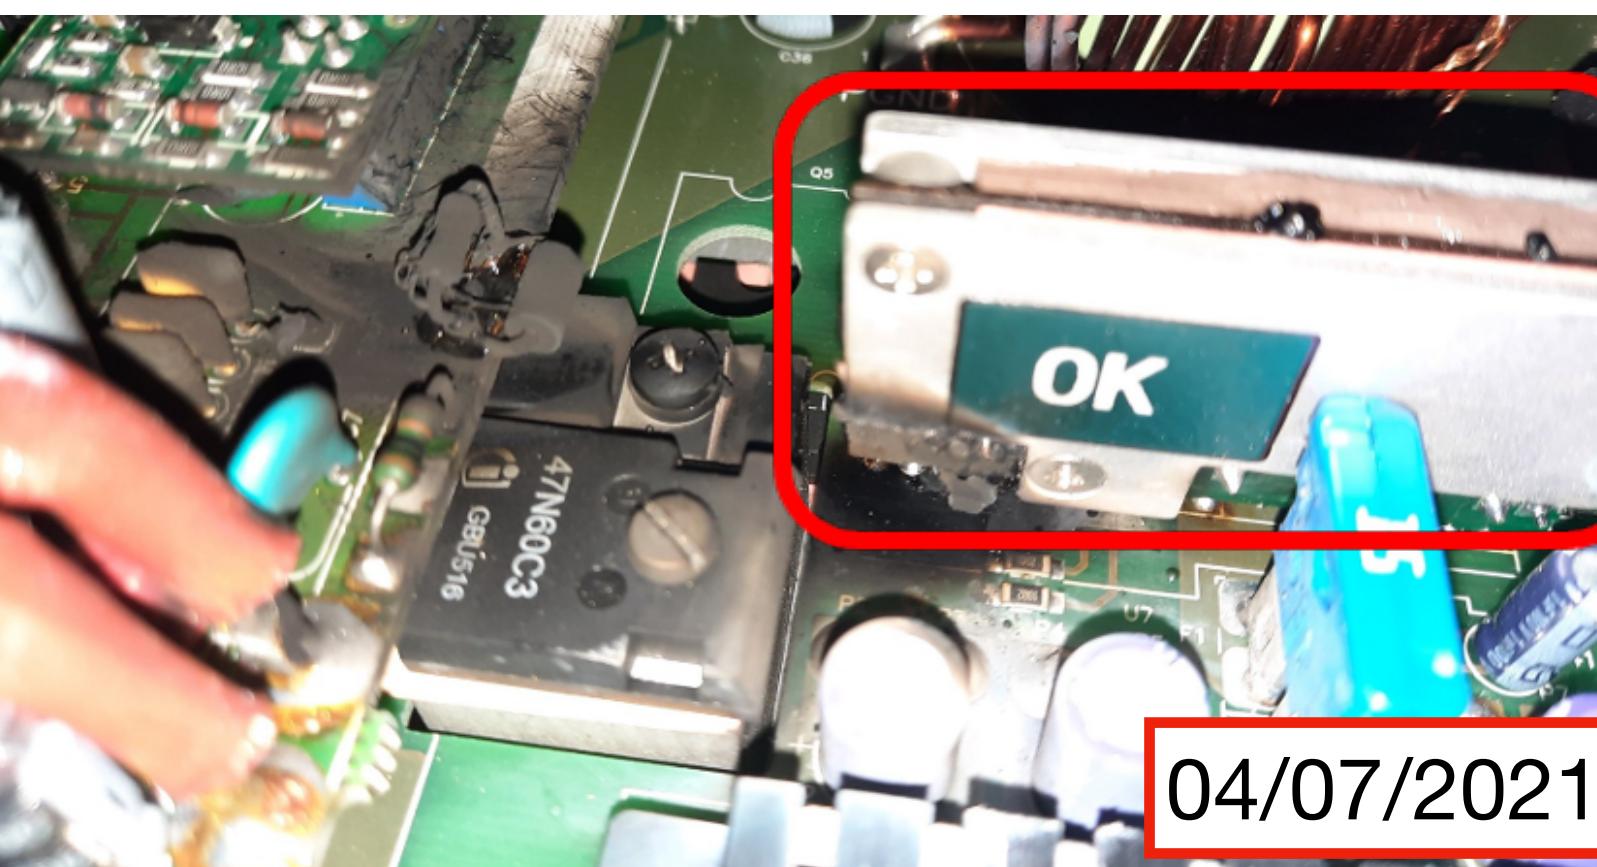
Where we left off... DC/DC accident (1)

Two critical hardware failures in 2020/2021: burning of the internal Mosfet on the **Solid State Fuse** (which controls the power ON/OFF of the DC/DC channels with 48V input) installed on all TOF DC/DC converters during the refurbishment campaign 2018-2020.

First failure difficult to interpret because it occurred on a crate in which the DCDC temperature interlock was mistakenly disabled (it stayed at a temperature higher than 53°C for about 5 hours). The second event triggered a severe warning...

At power-up the circuitry is very quick (1 ms) and capacitive load of the line is high (4 mF) —> high transient current! It was found CAEN validated the scheme with a 48V Power Supply power limited (600W). This unrealistic test setup "protected" the circuitry. But ALICE-TOF Power Supply have 4kW power.....

Short-term mitigation approach: shutdown of 64/72 TOF crates, 8 crates operated half-power

Tested solution: removal of the component (control with 2 ext. Mosfet) + 47 uA capacitor to reduce peak and slow ramp-up.

Rework completed between end of 2021 and beginning of 2022.
