Istituto Nazionale di Fisica Nucleare
Sezione di Bologna

Status rivelatore TOF, richieste 2024 e programma manutenzione straordinaria

A. Alici, P. Antonioli

Riunione con INFN referee - Roma, 20-21 Luglio 2023

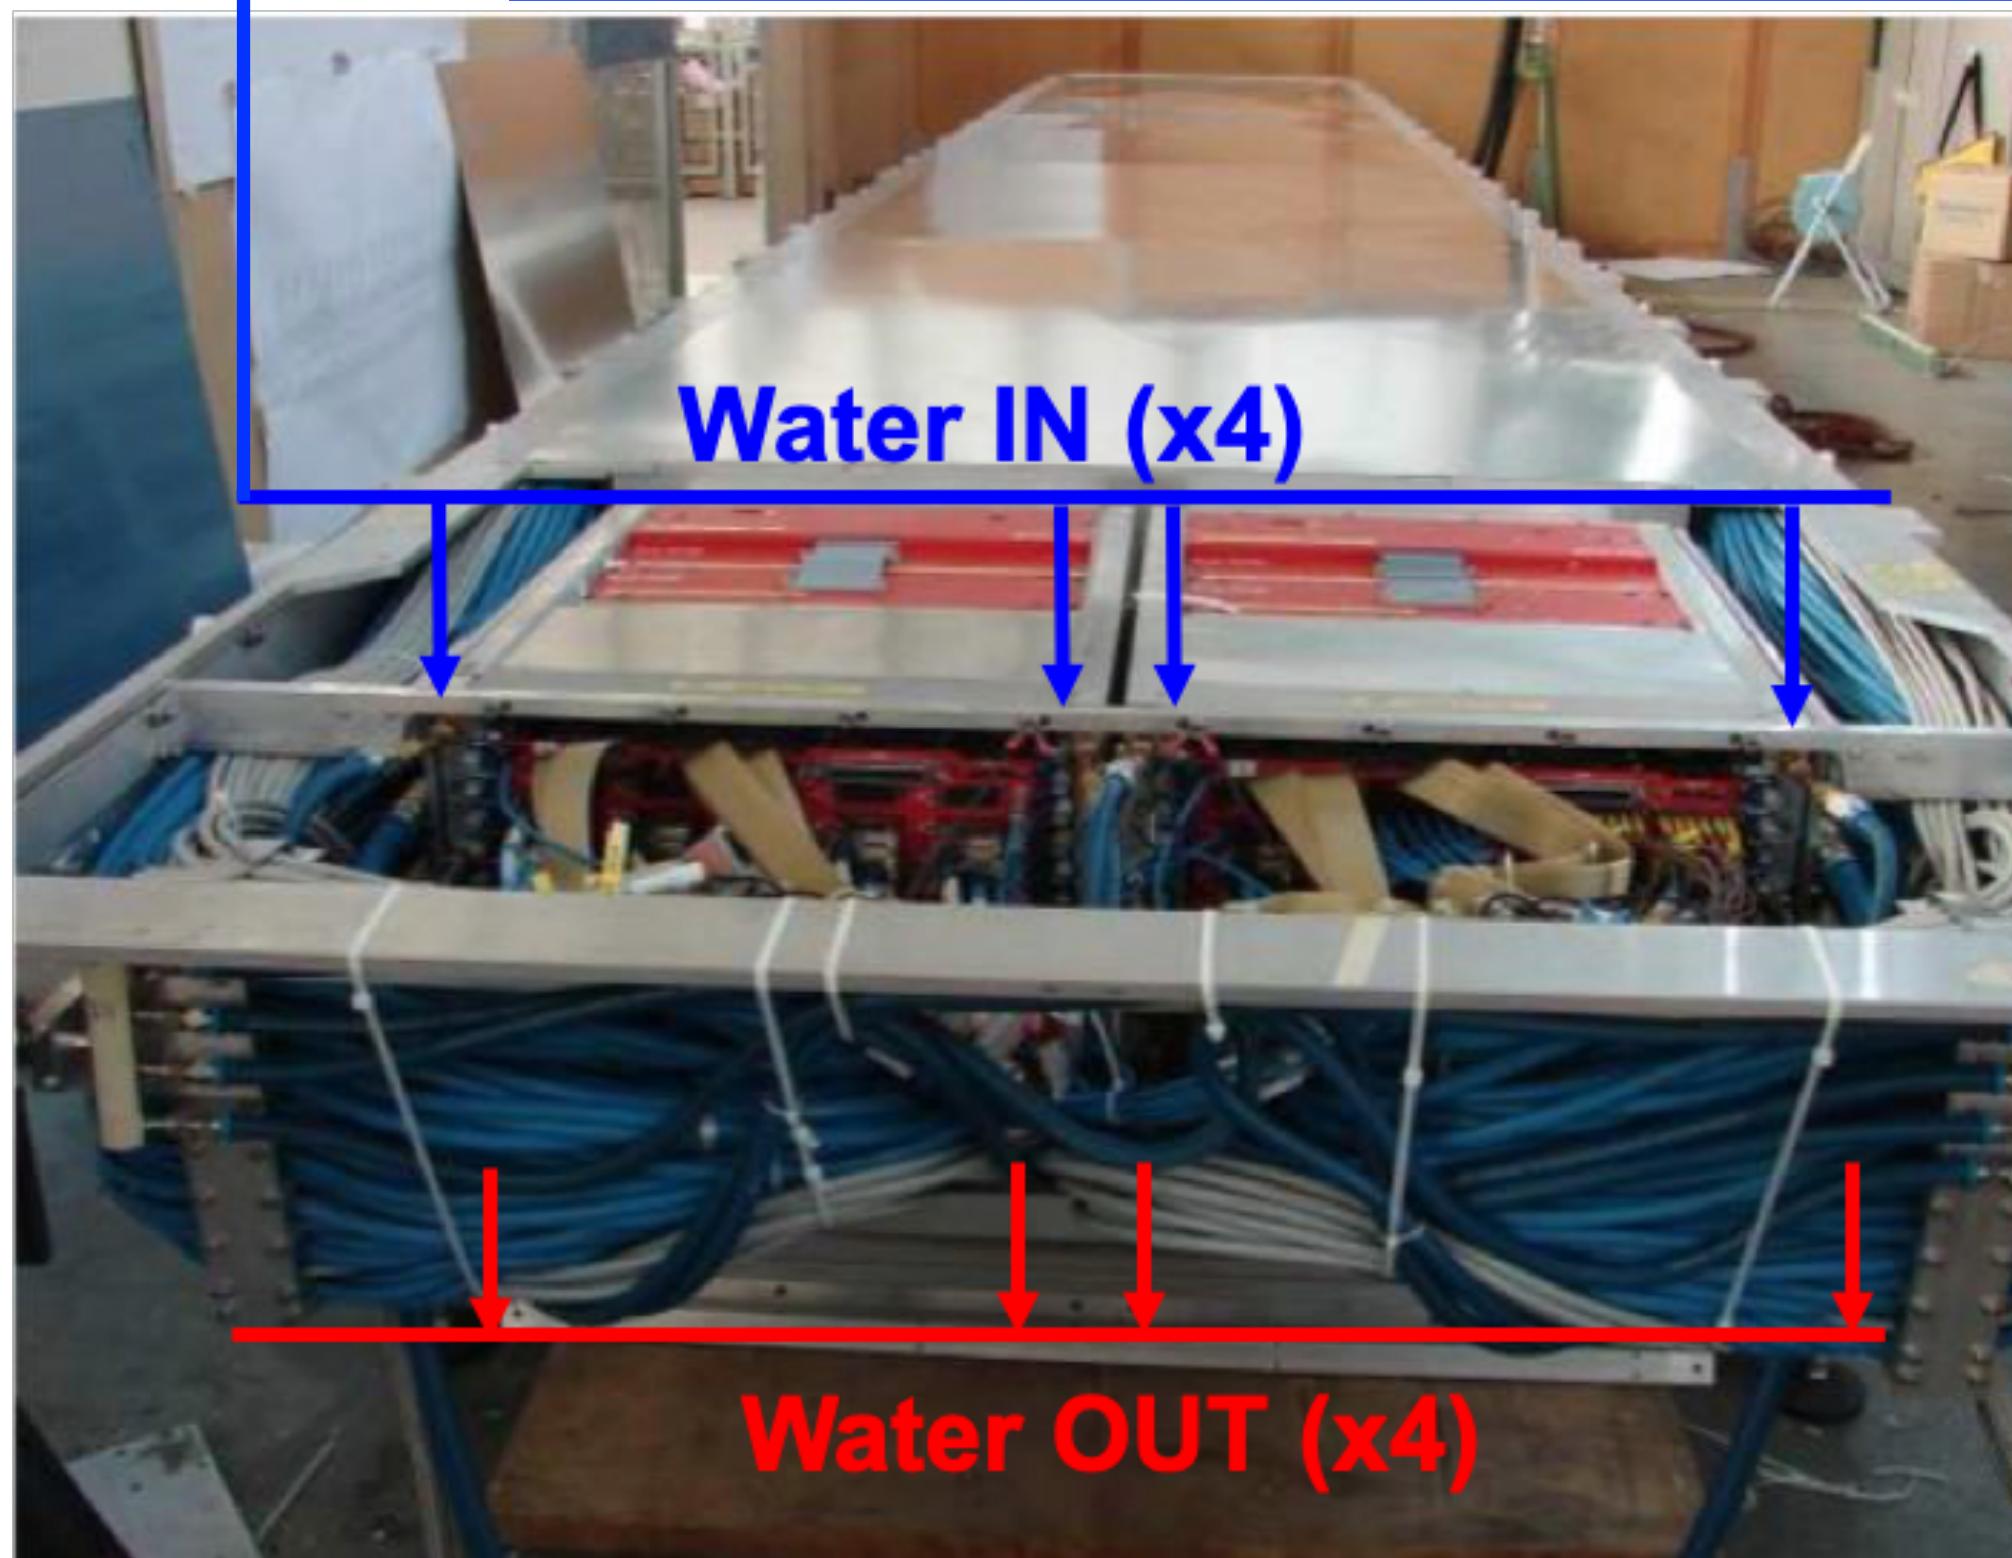
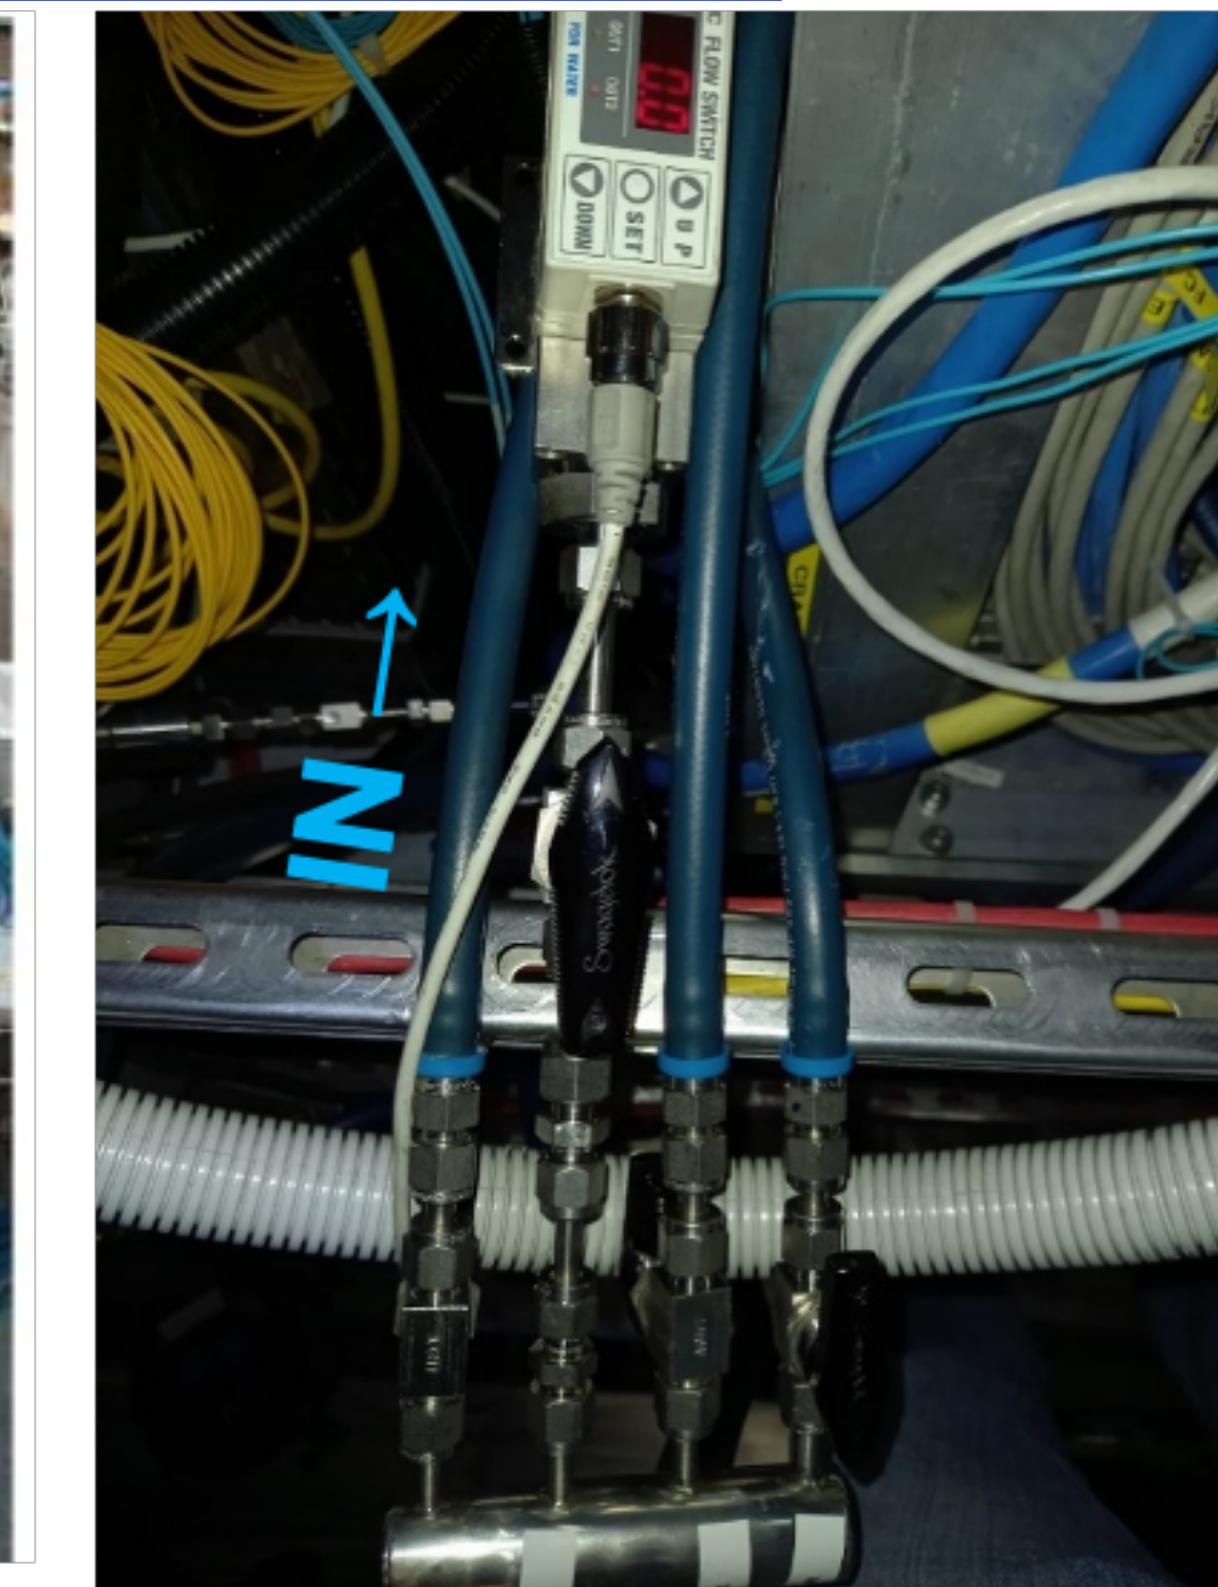
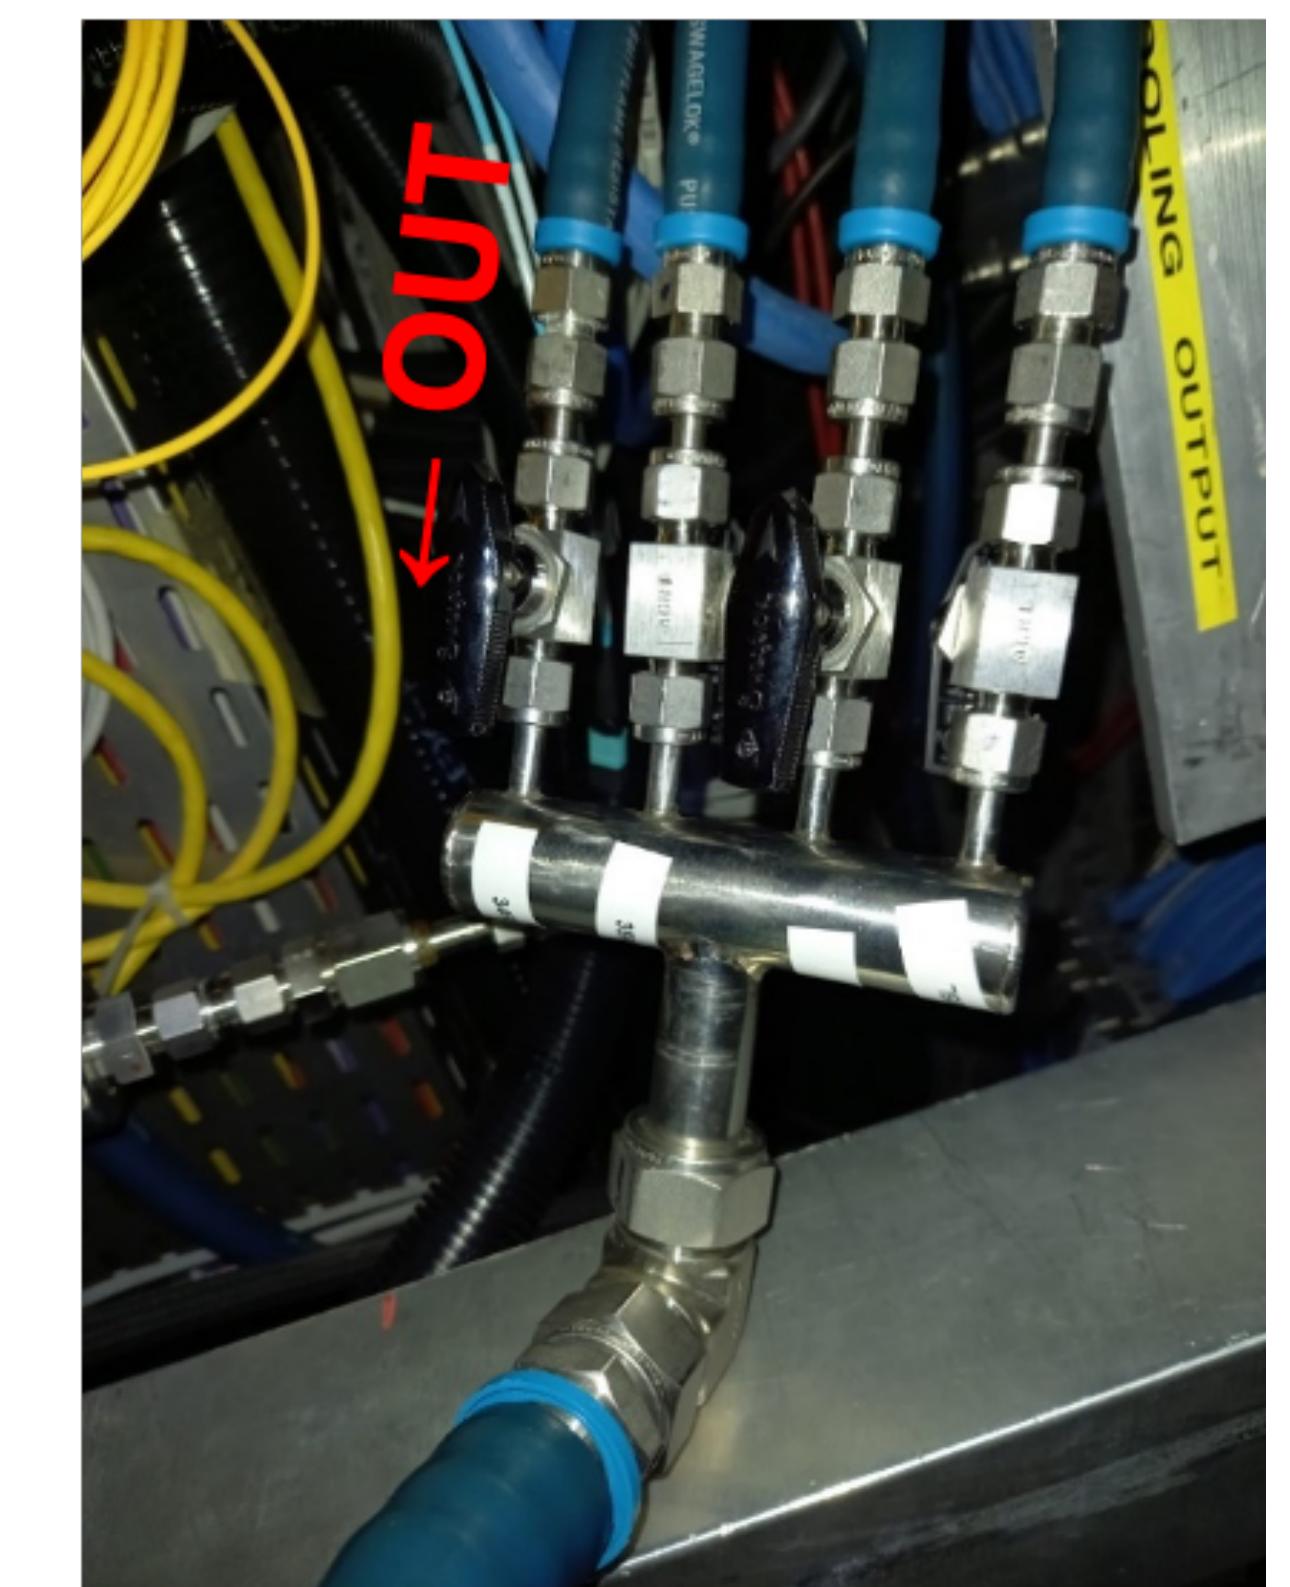
TOF VME crate cooling issue (3)

- Several attempts to fix the problem in the past (included industrial acid usage) didn't solve the problem
- New attempt in January with the installation of **valves + flowmeter** to (try to) balance the water pressure on the 4 parallel lines (forcing the water circulation in the clogged line)

- ogni linea in ingresso in un settore (SM) viene divisa in **4 linee parallele** (due scambiatori di calore per crate VME)
- ogni settore in parallelo con **altri 5 settori**

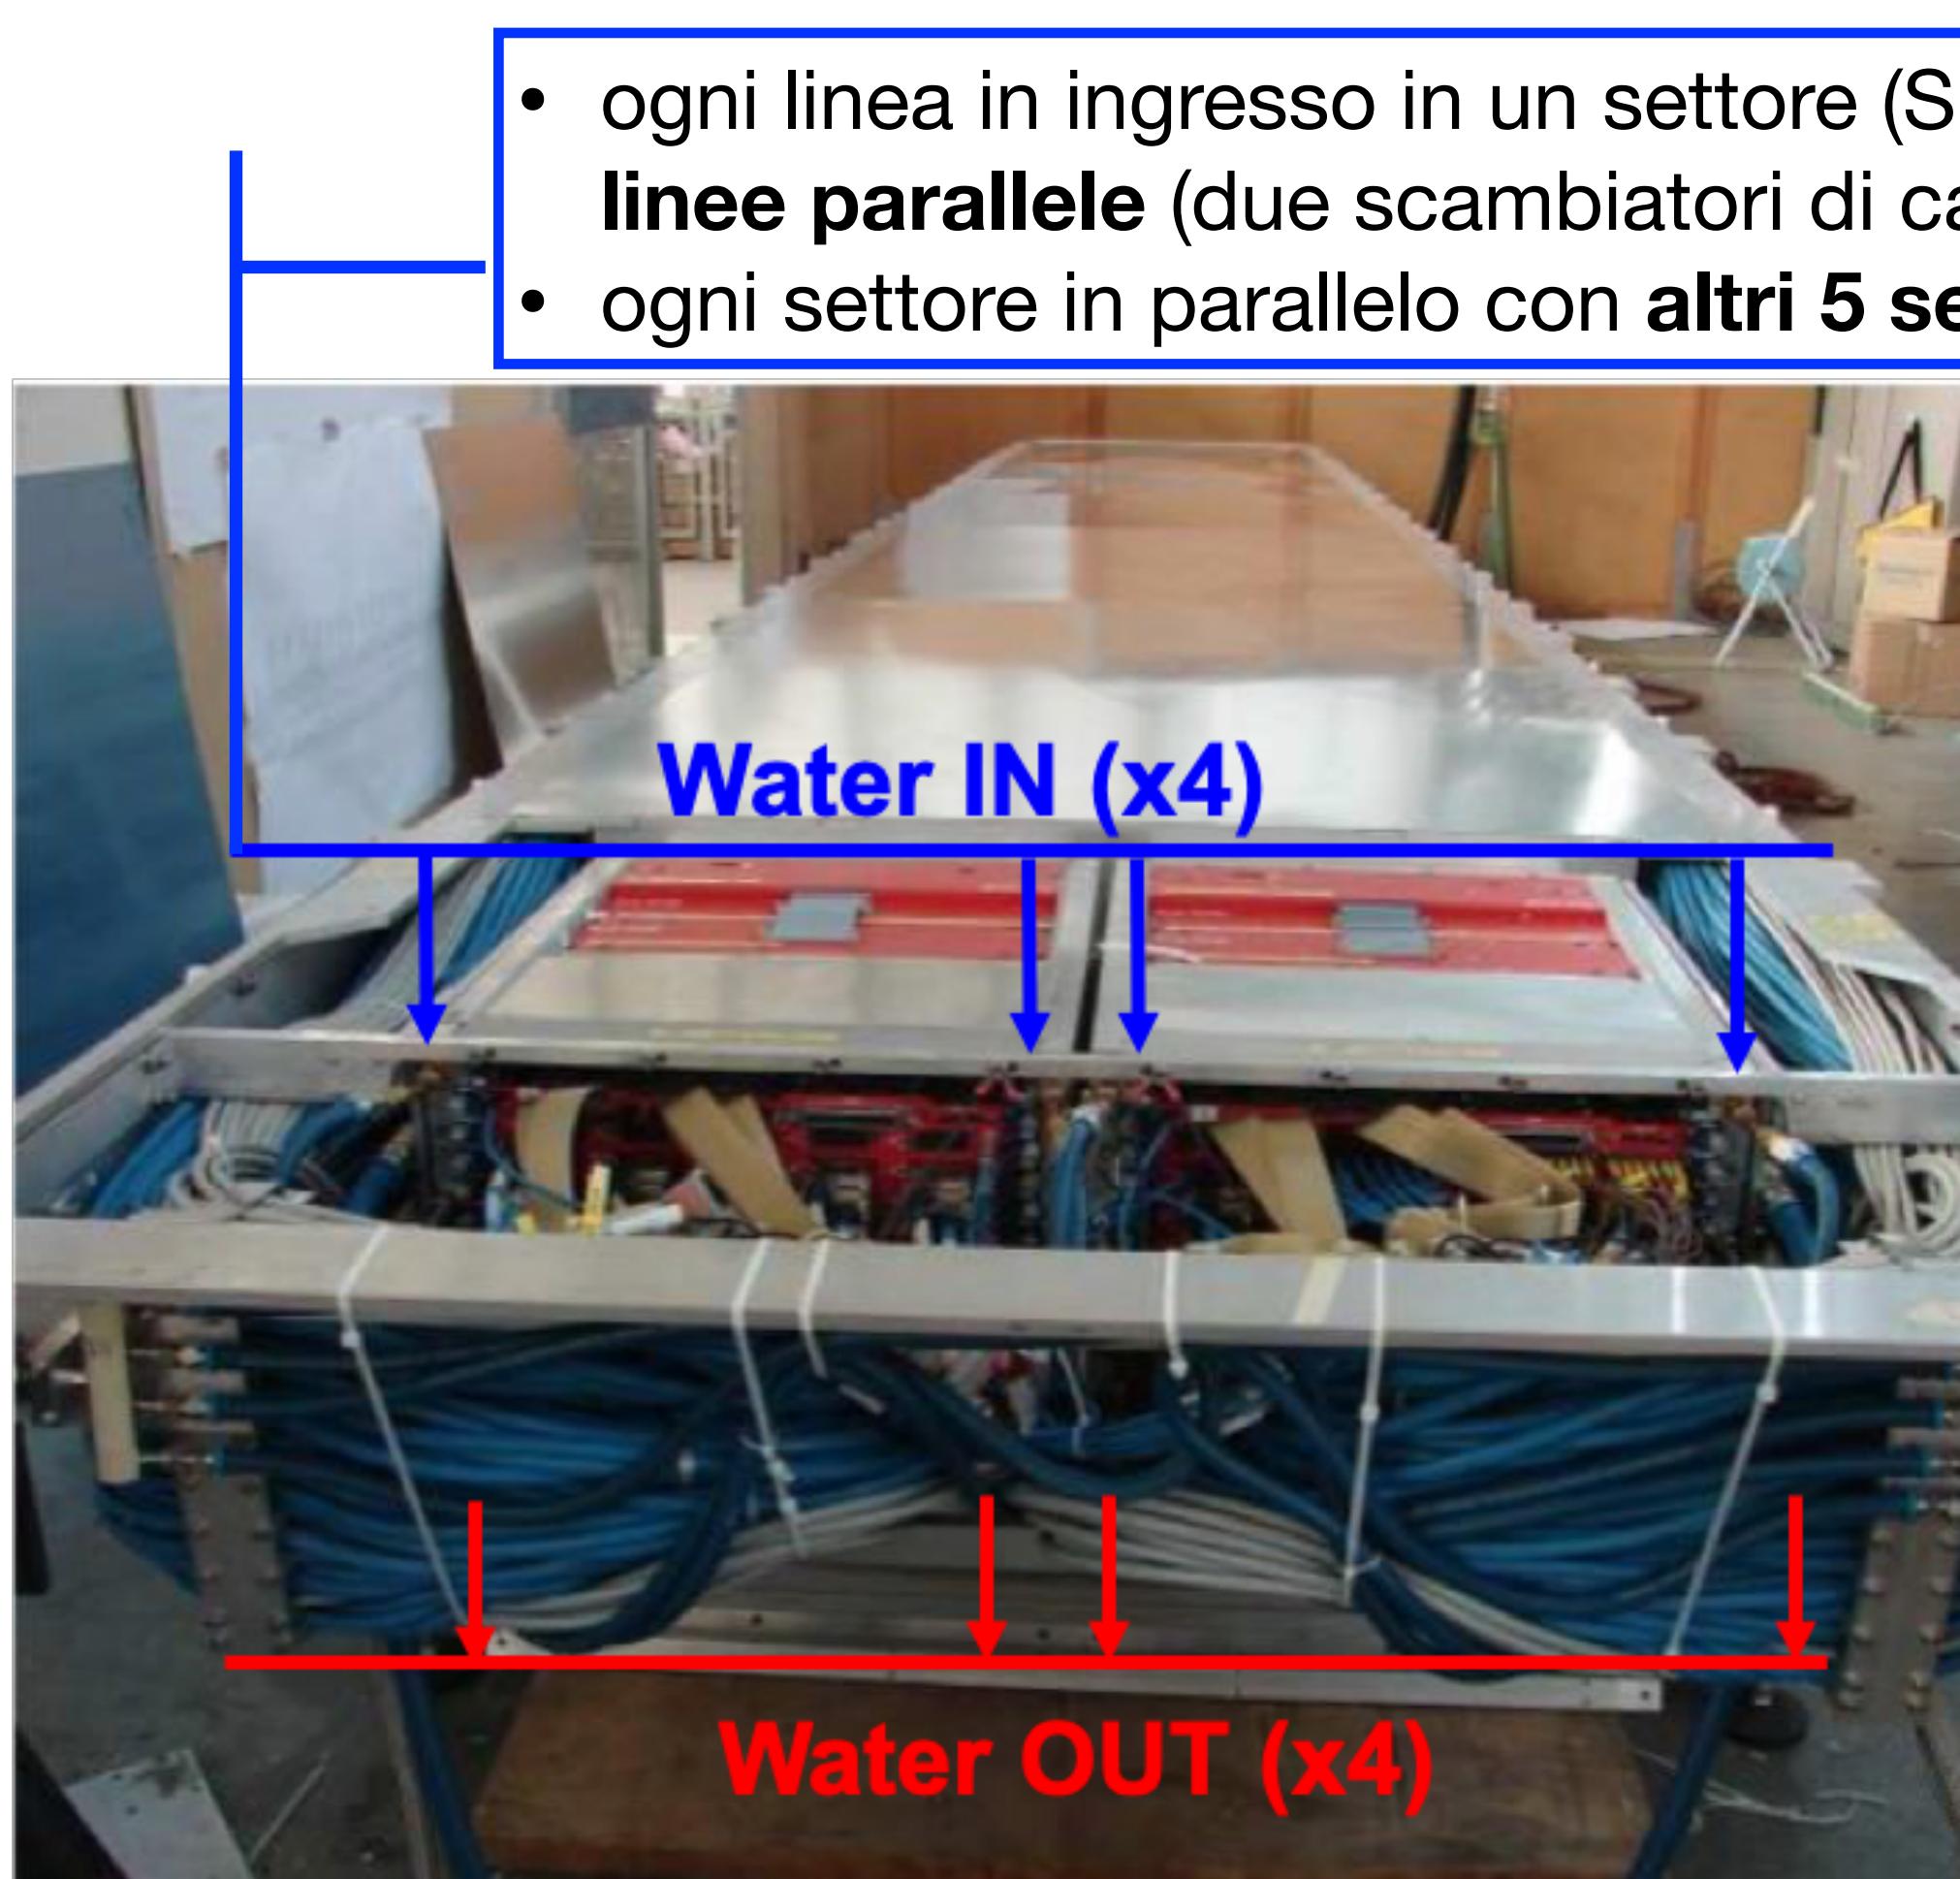
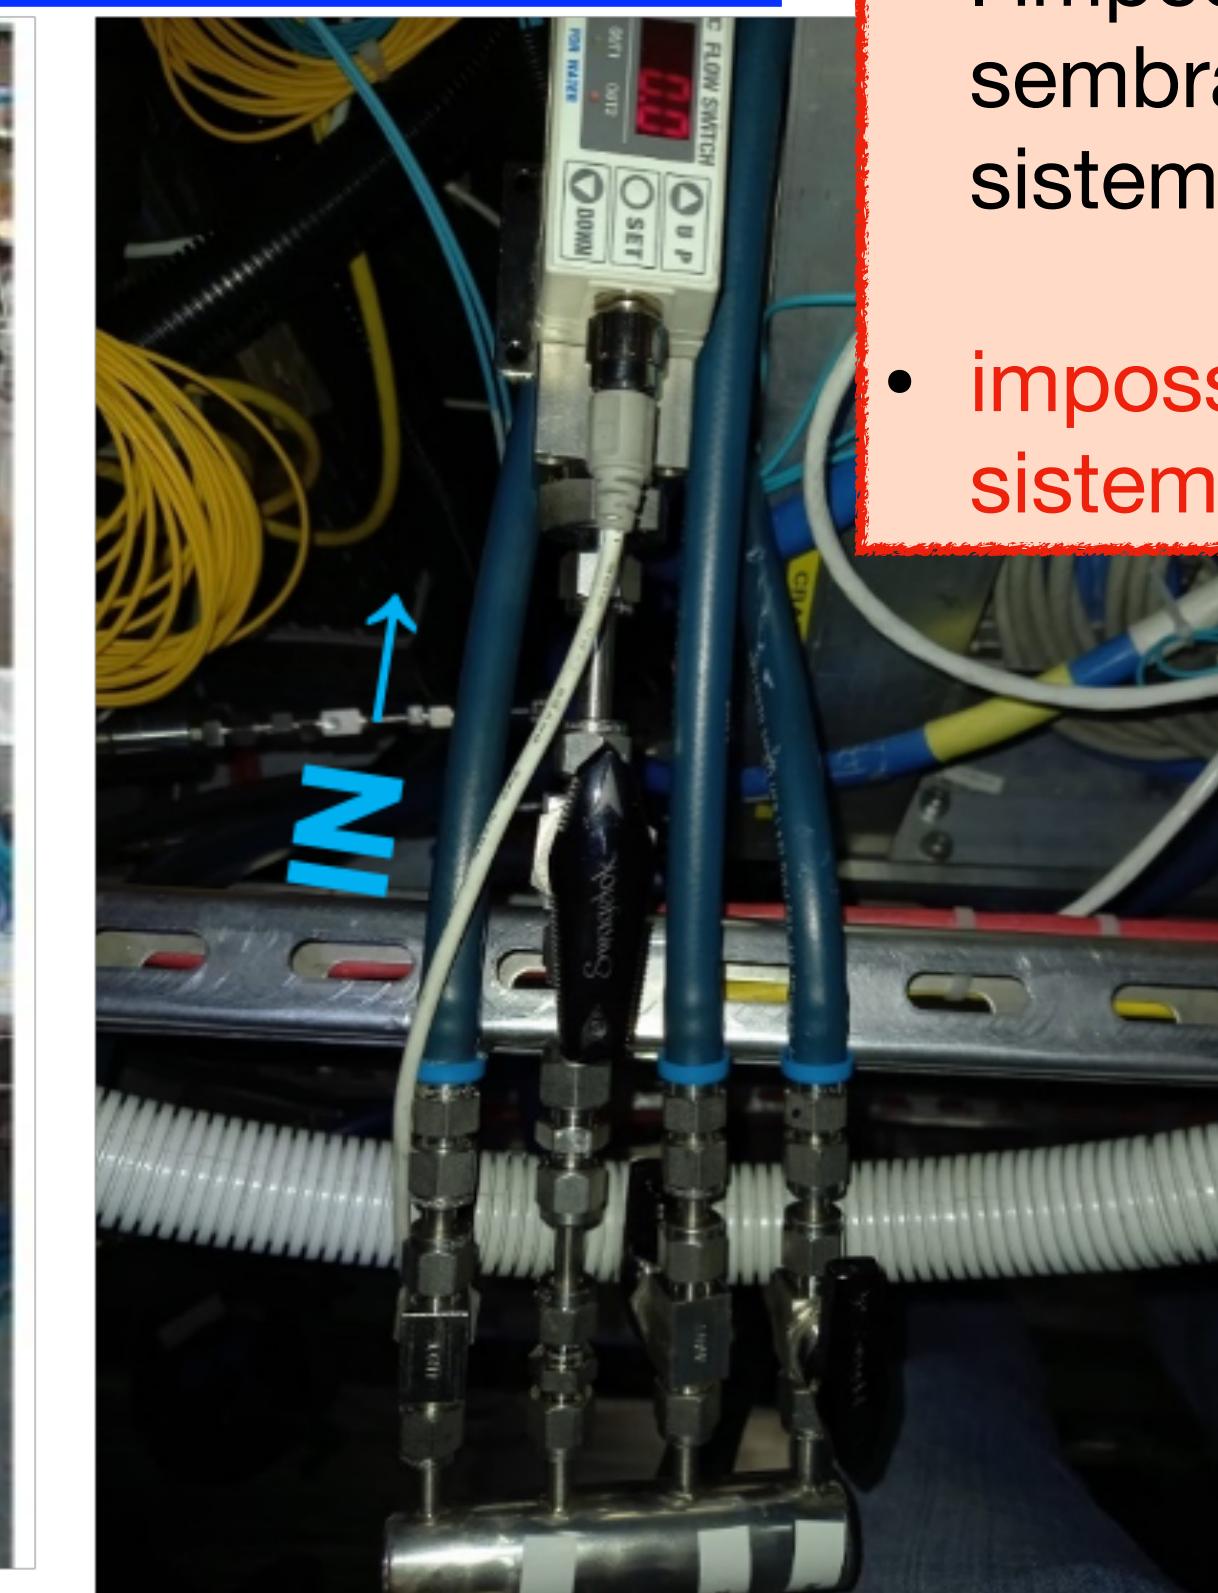
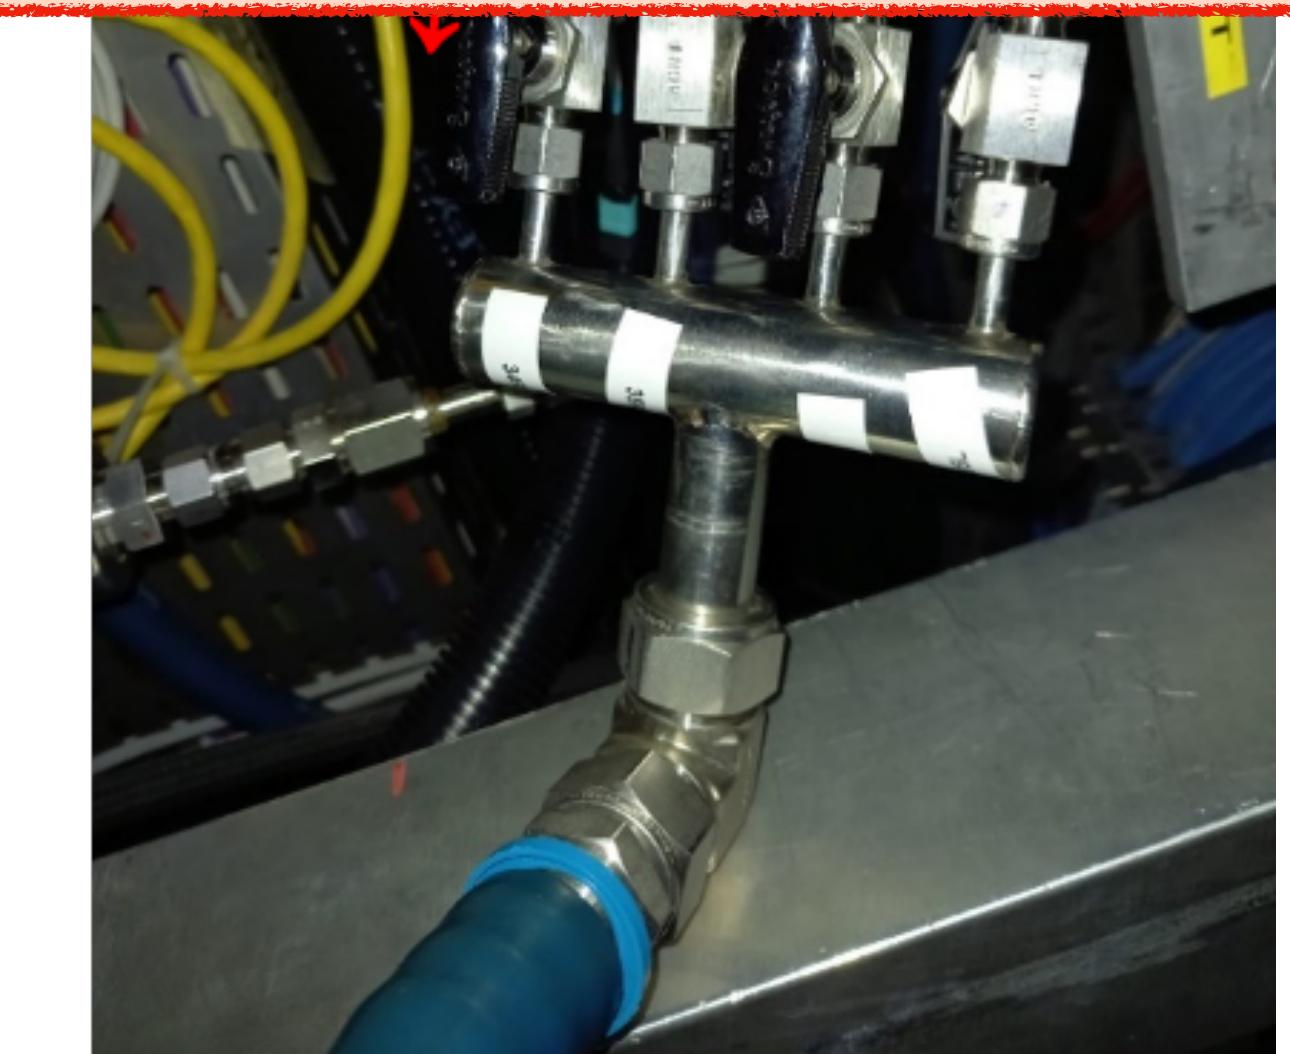
TOF VME crate cooling issue (4)

- Several attempts to fix the problem in the past (included industrial acid usage) didn't solve the problem
- New attempt in January with the installation of **valves + flowmeter** to (try to) balance the water pressure on the 4 parallel lines (forcing the water circulation in the clogged line)

- Anche chiudendo tutte le altre linee e portando il flusso al massimo consentito non siamo riusciti a far circolare acqua nello scambiatore intasato
- l'impedenza dello scambiatore di calore sembra dominare l'impedenza totale del sistema
- impossibile risolvere il problema agendo sul sistema esternamente al crate

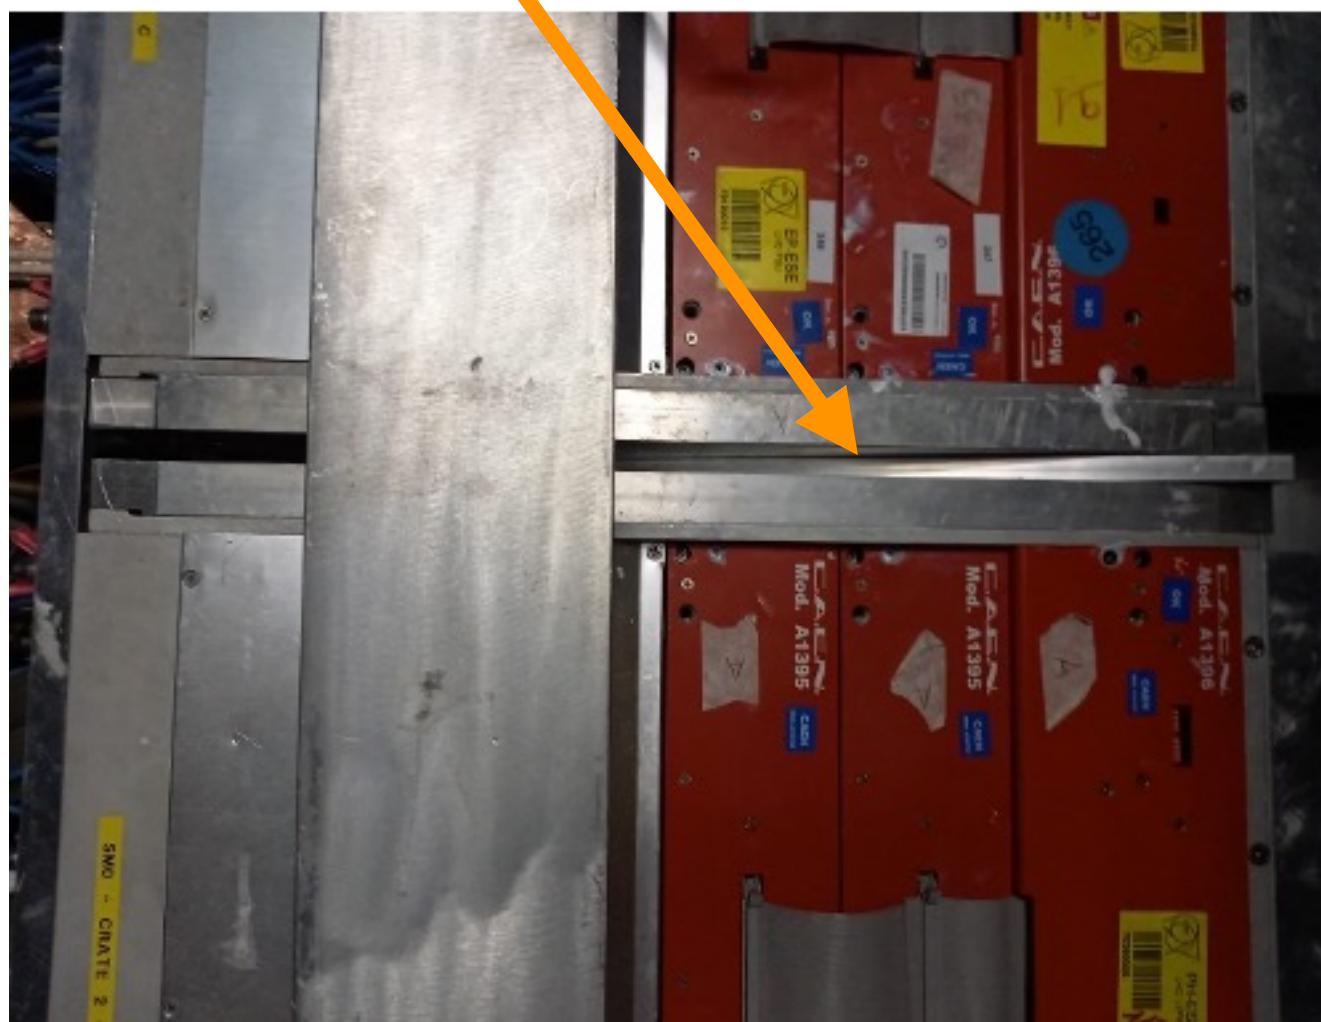
Side IN: only 14 mm between the two cooling plates

- reintroduce a anti-corrosion inhibitor as a matter of priority
- invasive intervention during the next YETS:
 - option A: uninstall (replace) the cooling plates (heat exchangers) —> many mechanical interferences, surveys indicated that likely this solution is not feasible...
 - option B: free the heat exchangers from springs and deposits with a kind of tunnel digger —> many technical issues (lack of space, **rimozione dei detriti...**)
 - option C: new cooling plates on top (in close attach) to the clogged ones —> lack of space...

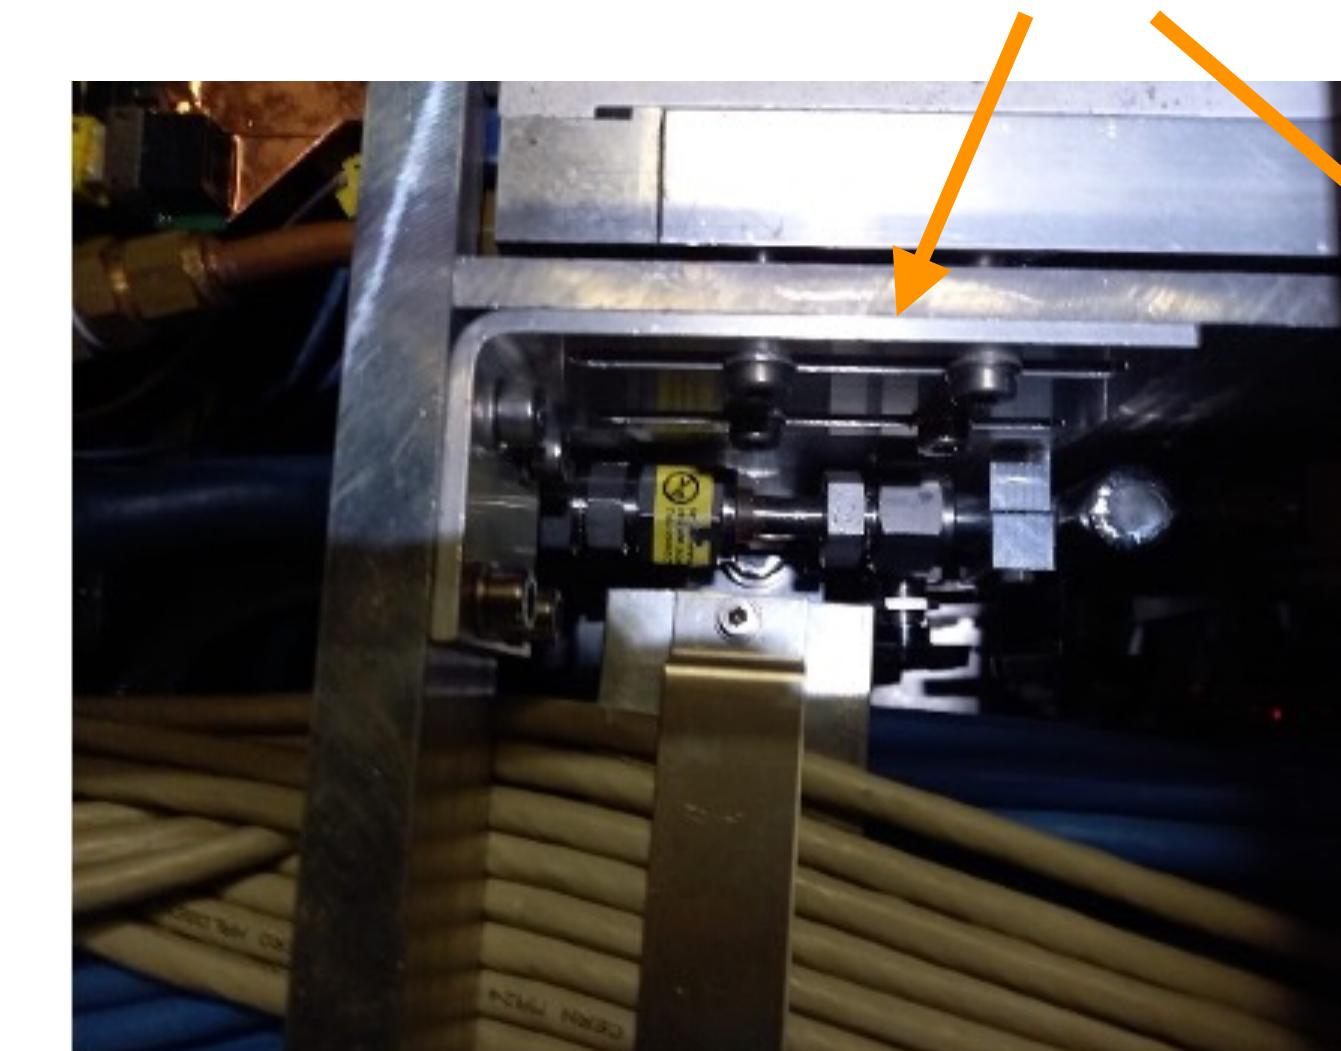
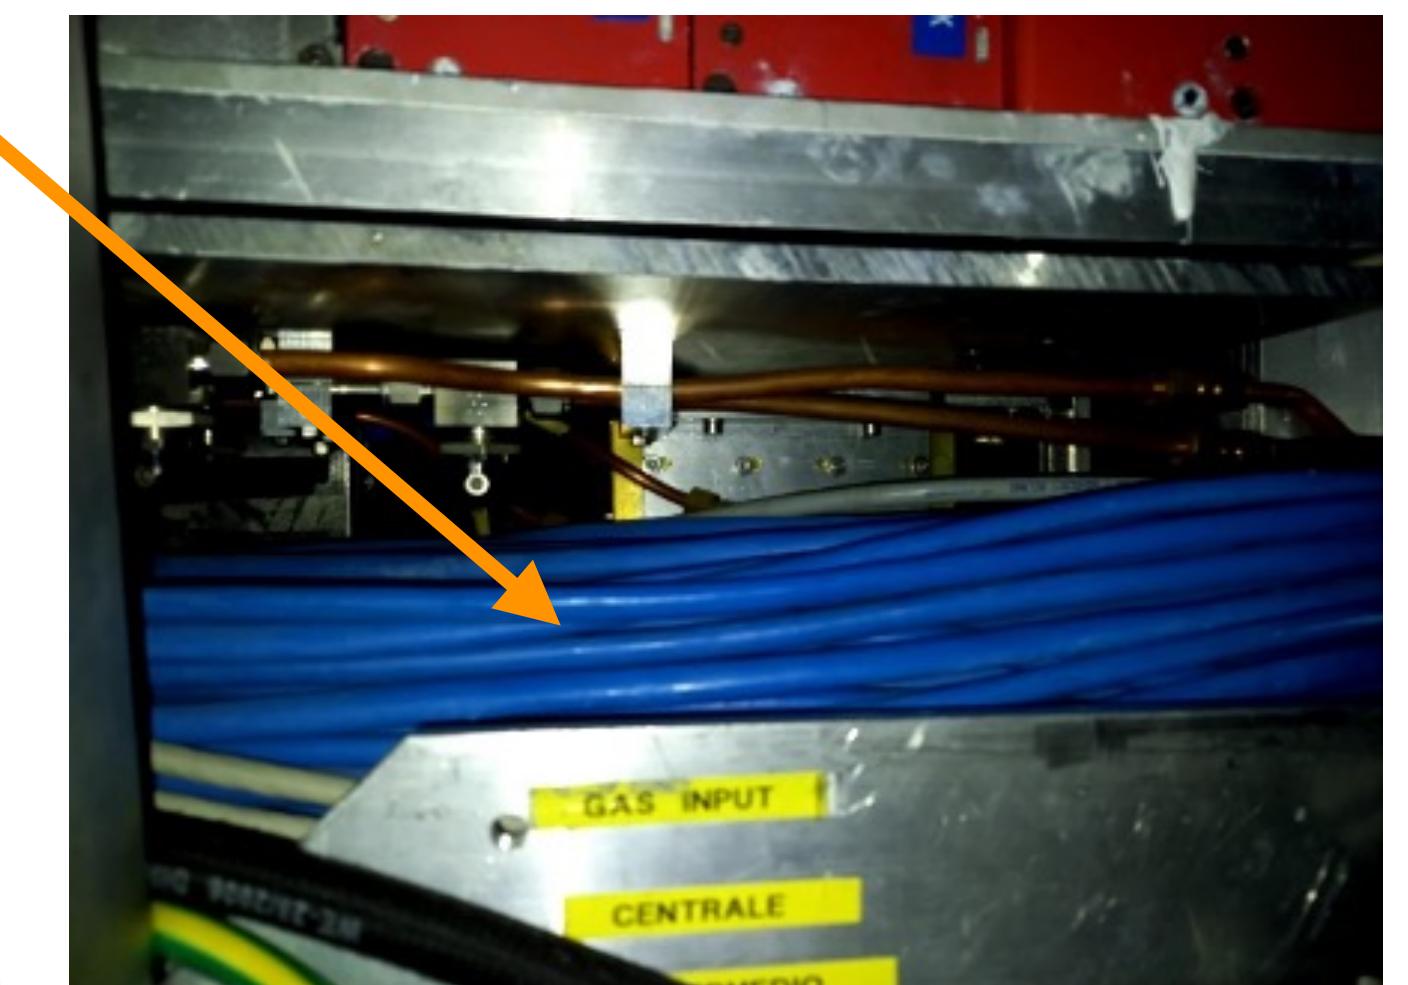
Side OUT: gas and FEA cooling valves, HV distribution boxes, signal cables... we need to dismount all to uninstall the plates...

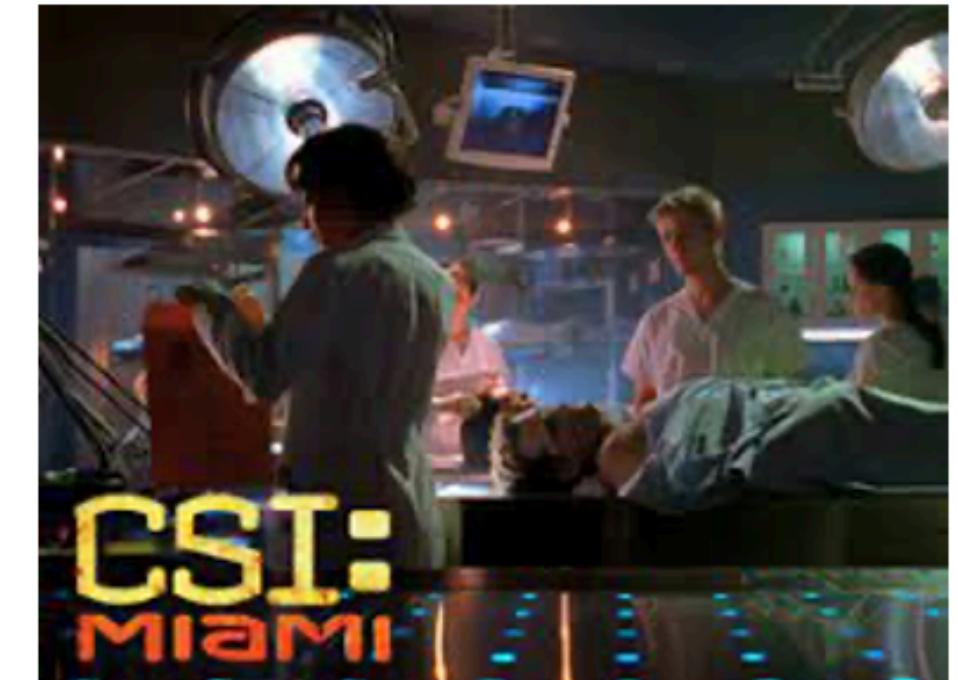
TRM autopsy

"extraction" year	not repairable TRM
2010	3
2017	5
2018	4
2022(3)	11

24 TRM already lost in action

Point of failures of not repairable TRM

- FPGA AP750 Actel - no longer produced
- rework of FPGA is however challenging
- difficult to make additional HPTDC piggy back (many failures in soldering, "old" chips/BGA damaged?)
