Status of the LVPS Transformer Problem

TileCal Maintenance Meeting

Gary Drake
Argonne National Laboratory, USA

CERN
Nov. 7, 2013

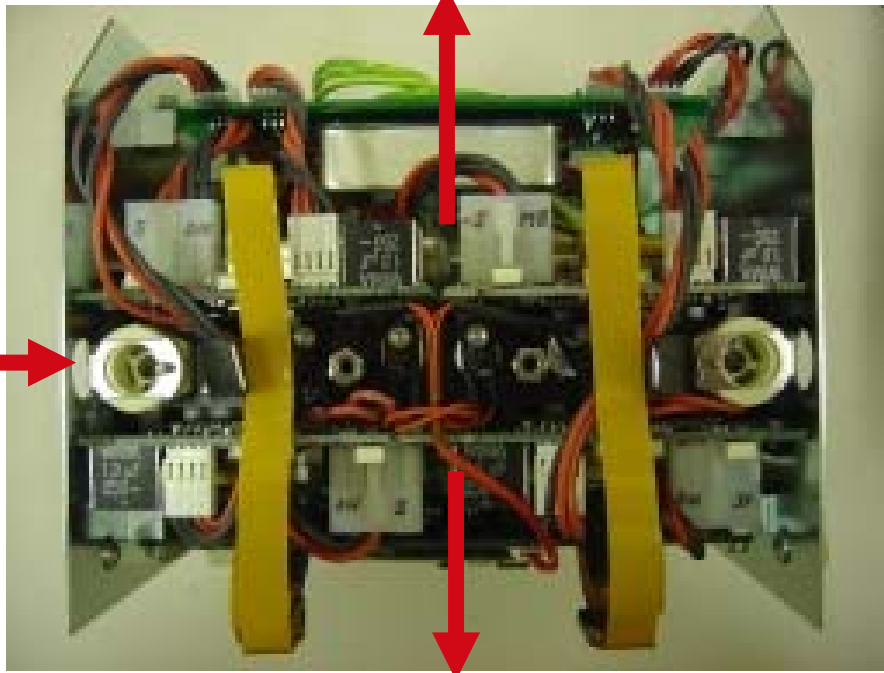
Transformer covers face up

- Covers on the transformers are coming off after installation in the detector
- Since bricks are installed back-to-back on the cold plate inside the LVPS box, loose covers can fall onto live circuitry...
- Boxes also have 360 degree orientation on the detector, so no box is "safe"...

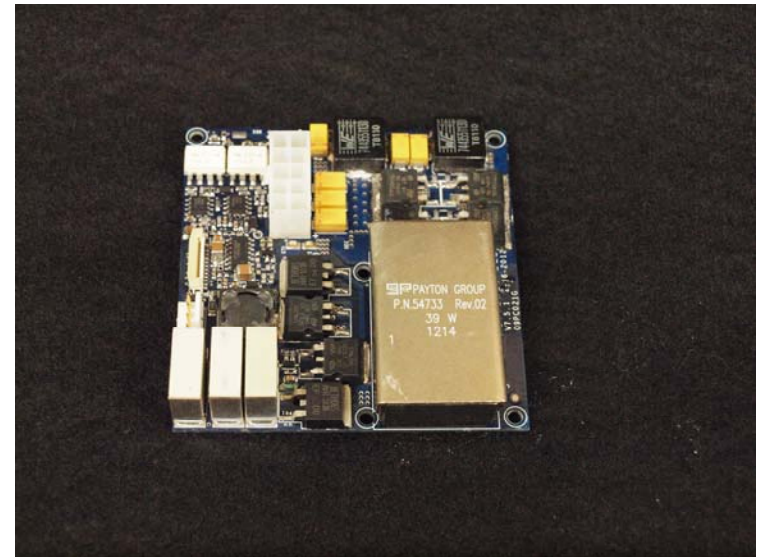
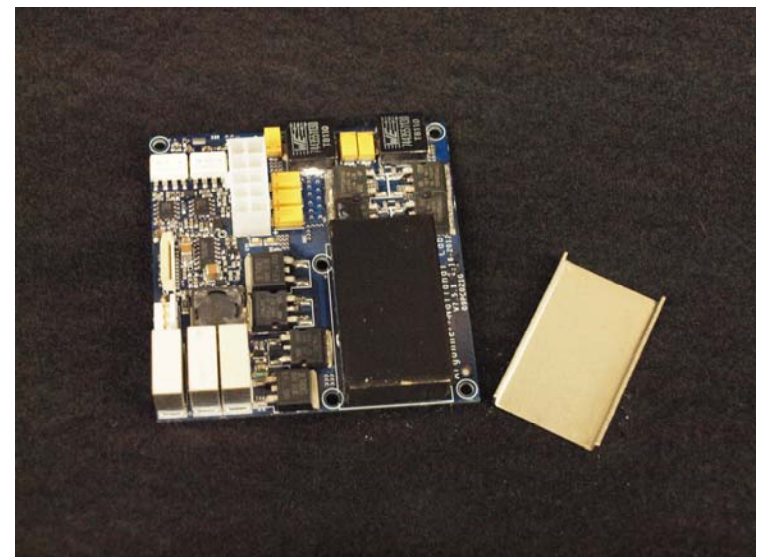
- What is known from the checkout:
 - “A few” loose covers were noted during checkout at Argonne
 - These were glued back on with RTV
 - “Approximately 10” loose covers were noted during QA at CERN
- ⇒ *No “red flags” raised at the time, but maybe there should have been...*
- Spot check of ~30 bricks currently at Argonne found 0 loose covers
- ⇒ *This is a subtle problem*
⇒ *Problem not present in all bricks at $t=0$*
⇒ *Problem may develop in time...*

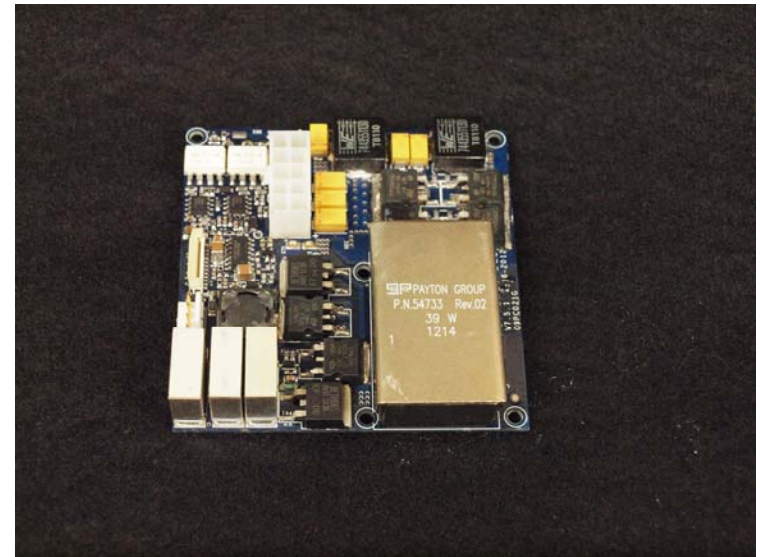
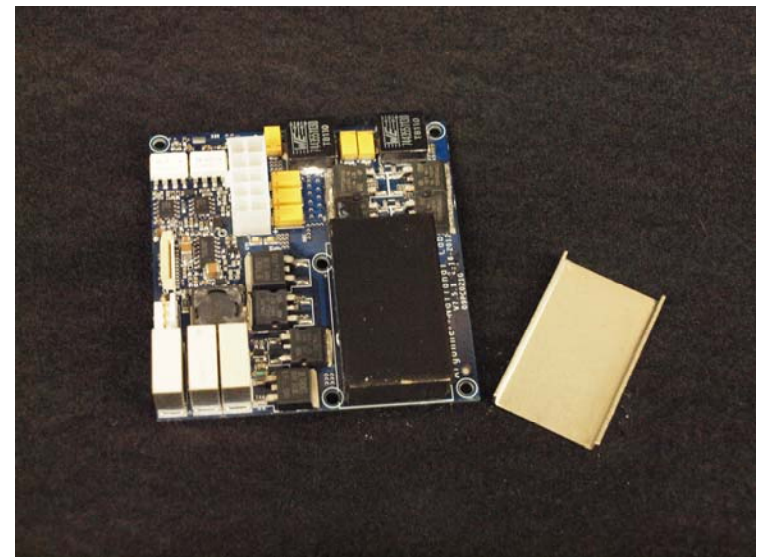
- What is known from the experiment:
 - First occurrence of loose covers occurred only recently
 - 3 boxes failed to start after planned power outage
 - Inspection after removal from detector found covers that had fallen off (See Stan's talk)
 - These boxes have been on the detector for a while...
 - (As far as I know) No loose covers were observed in the (5) V7.3 boxes that have been operating on the detector for ~2 years
 - (As far as I know) No loose covers were observed in the (40) V7.5 boxes that have been operating on the detector for ~1 year
- ⇒ **Conclusion: Problem likely to be batch-dependent**
- ⇒ **Indications of dependence on thermal cycling....**
