# Installation progress

Antonino Sergi

University of Birmingham

September 2014

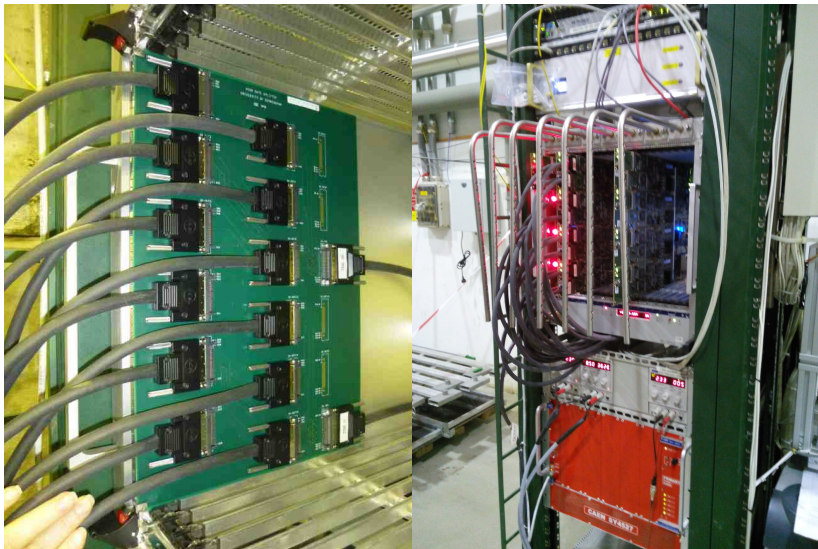
Just a bit flexible: we gave up for the stiffener

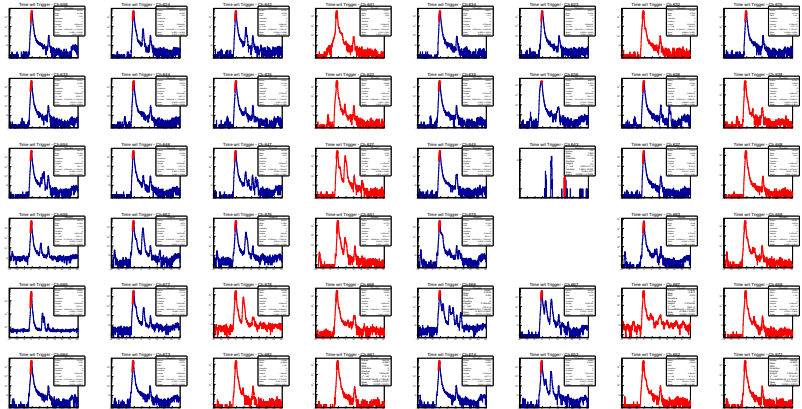
Lightbox 2 with NINO board 10

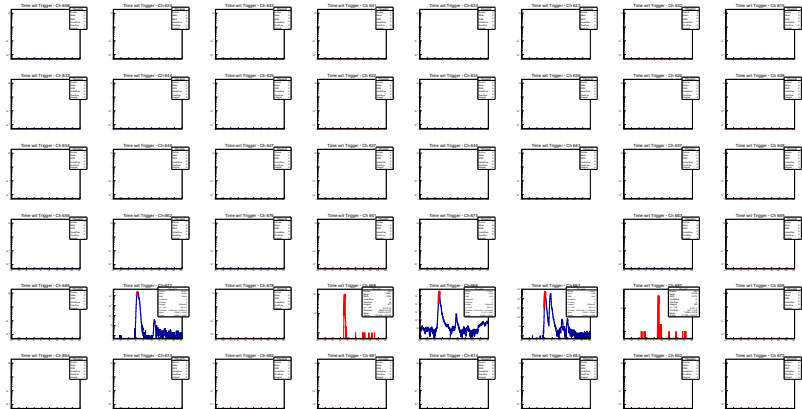
PM66 (J52) extracted from lightbox and moved to small box

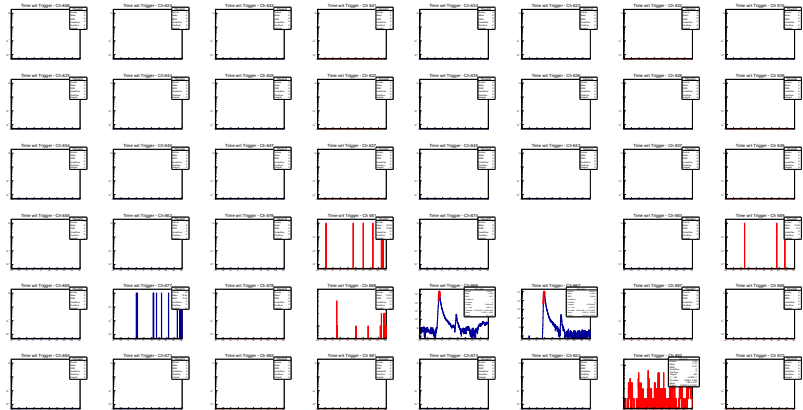
Detached all other cables related to the mezzanine of PM66

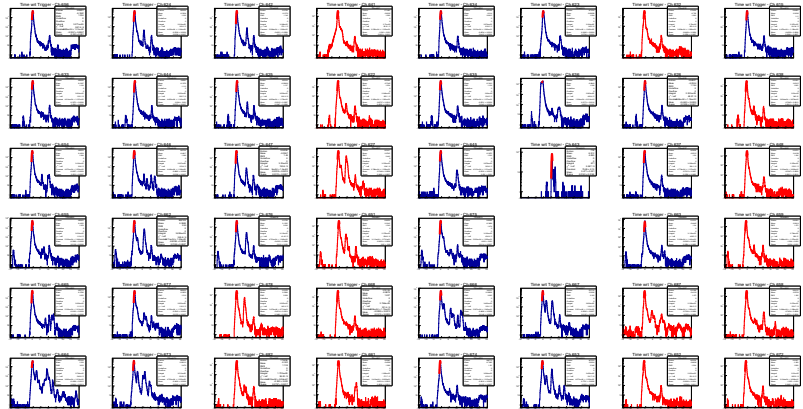
Lightbox 2 after replacing the NINO board (10 → 14)

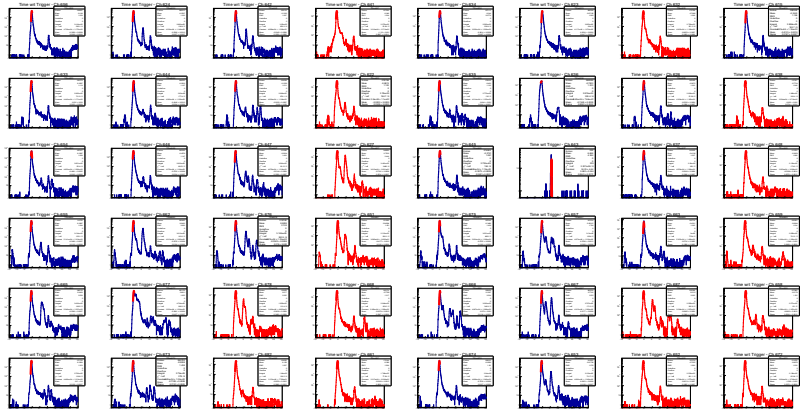
Lightbox 2 after replacing the NINO board (14  $\rightarrow$  15)

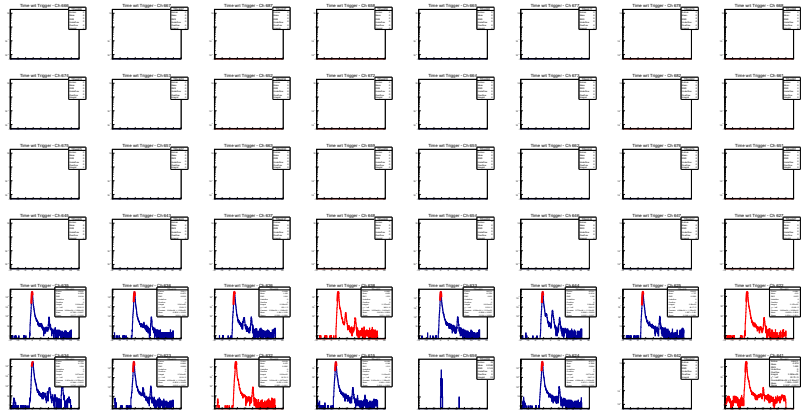
Test of box 7 @115mV with few PMs using box 3 map NINO 14

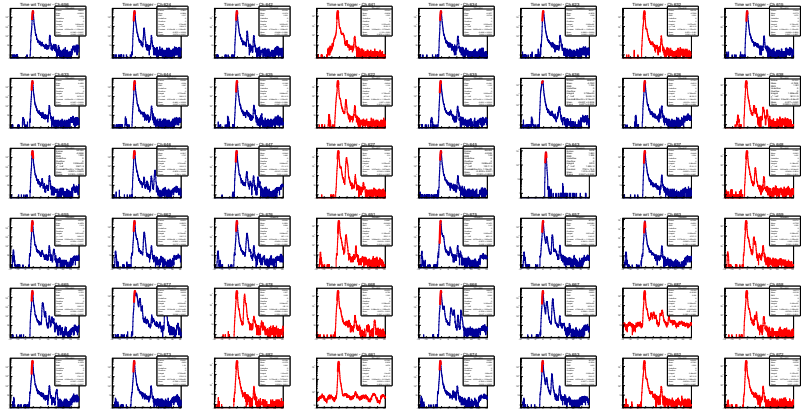
Back to box 2 after disconnecting PM43

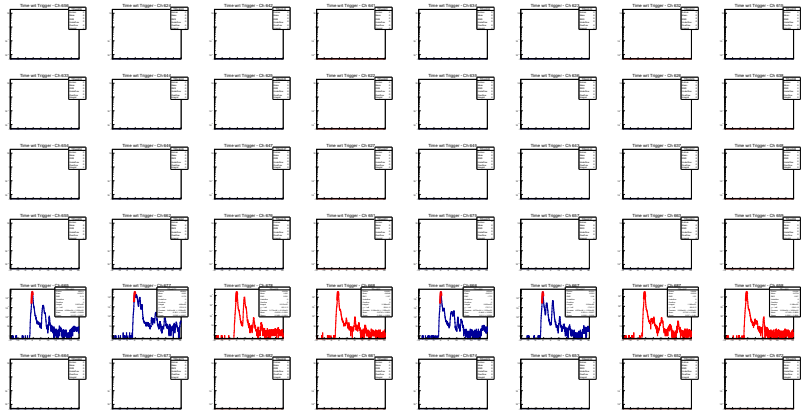
Detached all signal cables but those on mezzanine 6

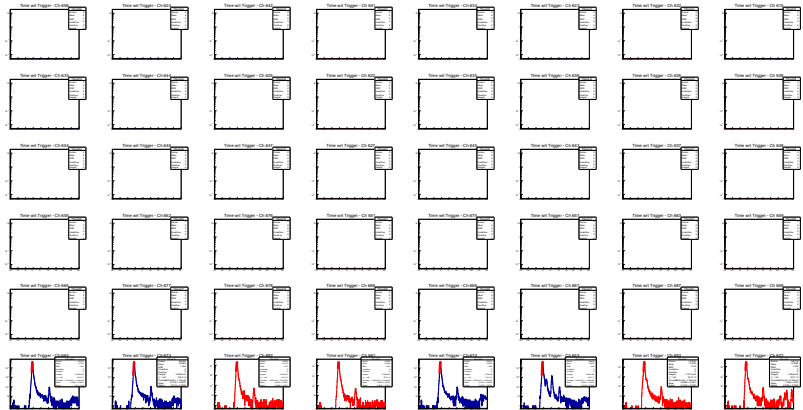
Detached all signal cables but those on mezzanine 7

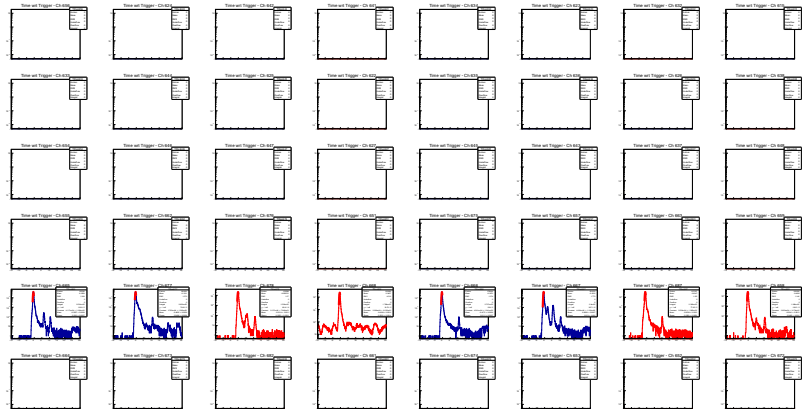
Moved cables from mezzanine 7 to 6

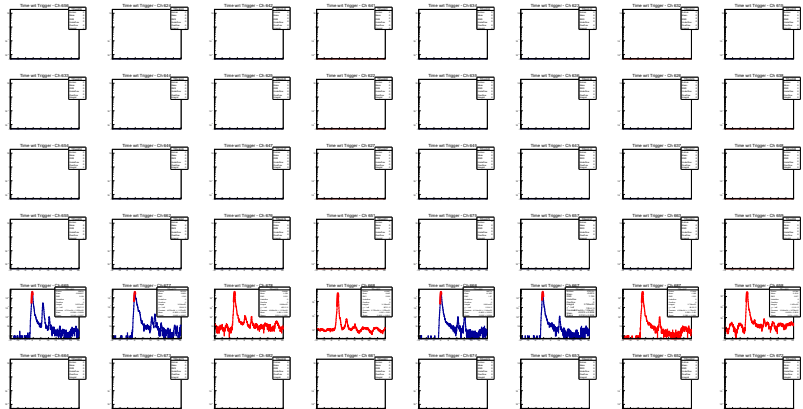
Moved cables from mezzanine 1 to 6

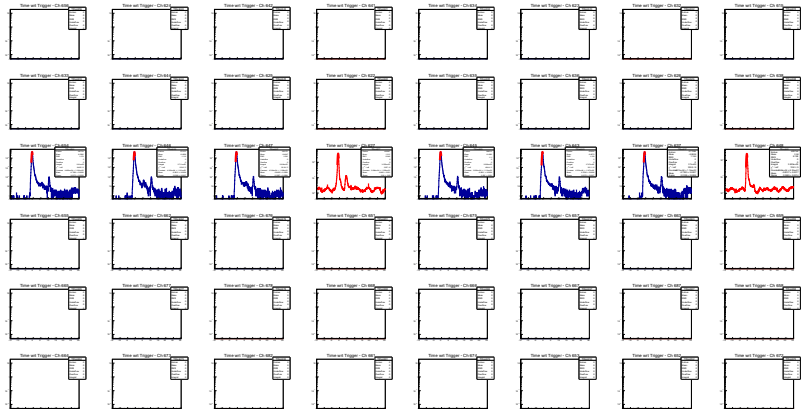
Moved cables from mezzanine 1 to 2

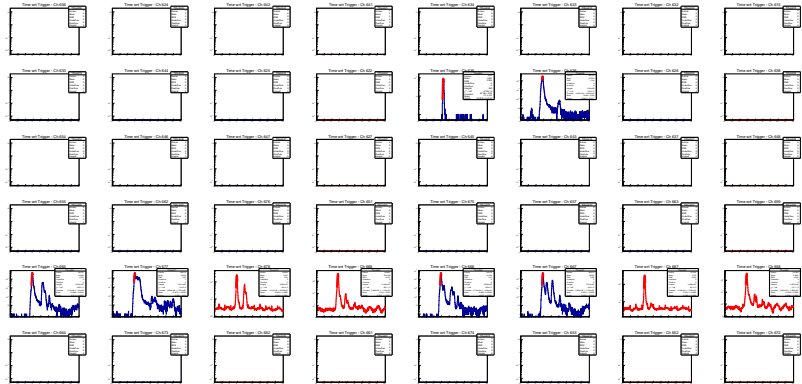
Replaced signal cables for mezzanine 6 with those from 1
