DAΦNE: results and consolidation activities

Catia Milardi
on behalf of the DAΦNE Team

DAΦNE activities

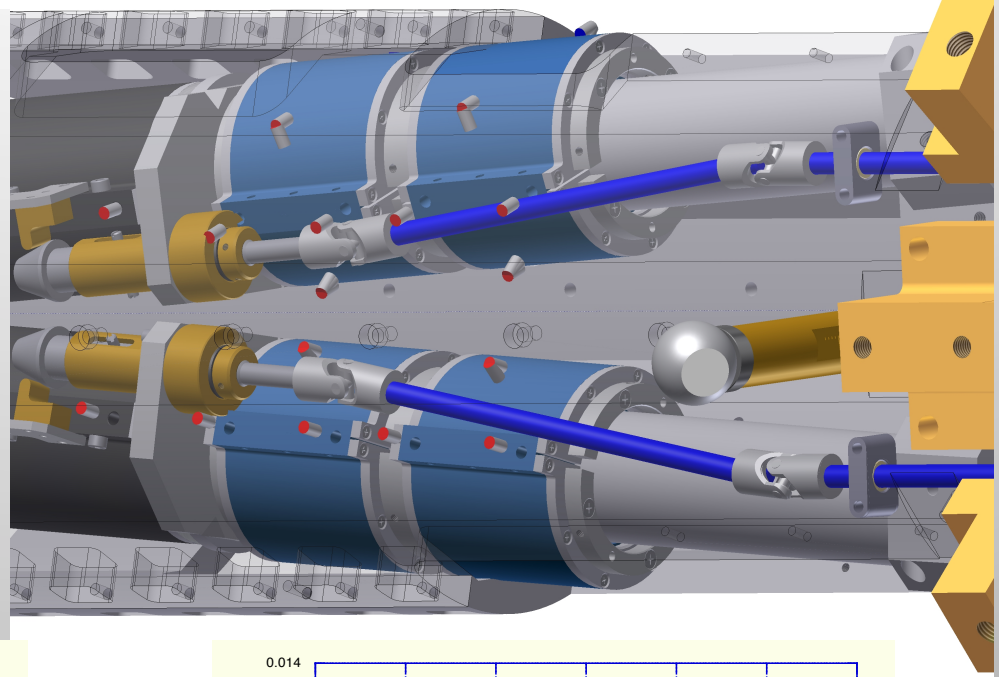
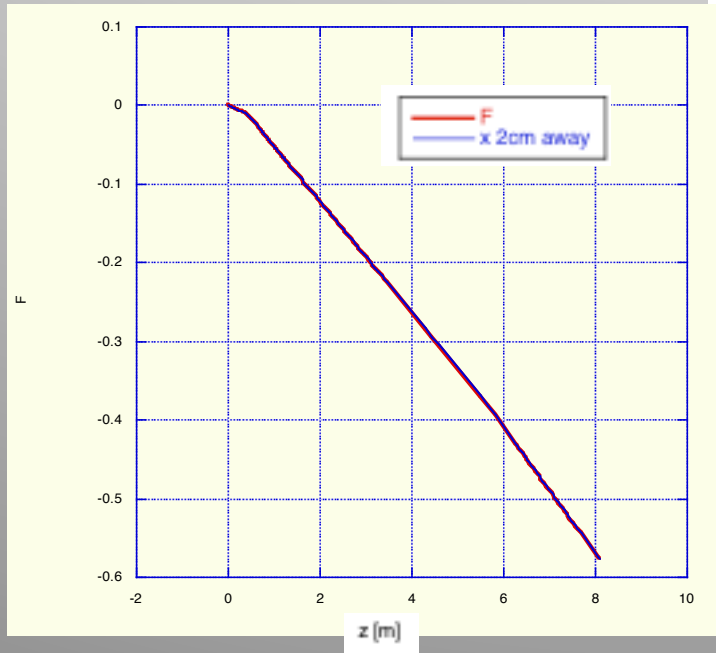
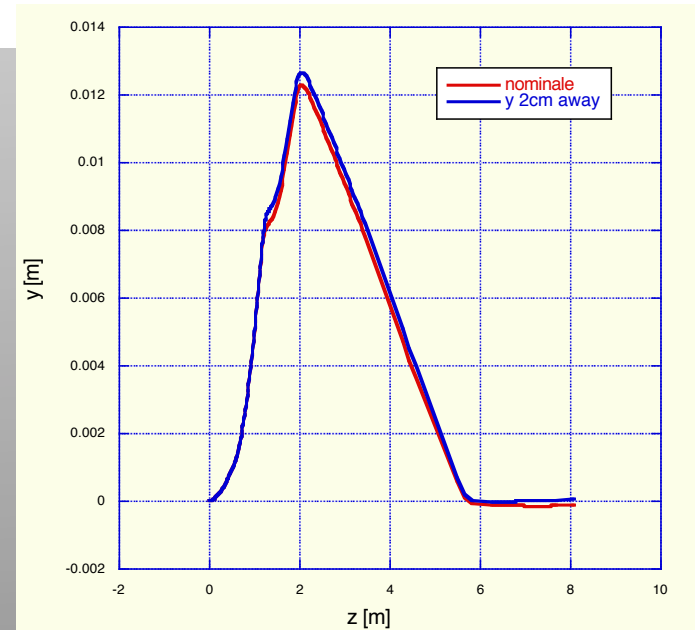
Positioning the PM dipoles in the
short branch of the MRe IR

Mechanical interferences imposed to shift the dipoles, in the short IR branch of the MRe ring, 2cm away from the IP in the longitudinal direction

Permanent magnet dipoles installed deep inside the detector had a wrong rotation (this aspect has been understood in few days of operation and fixed in 15 days)

*permanent magnet dipoles in the right position
thanks to the fantastic collaboration between
DAFNE & KLOE people (Sensolini, Paris, Putino,
Mascio & Martini)*

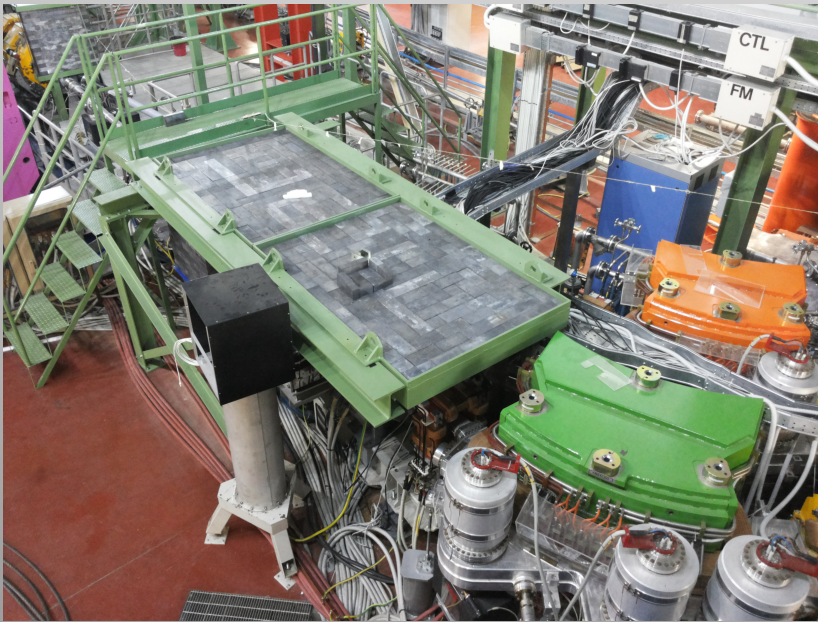
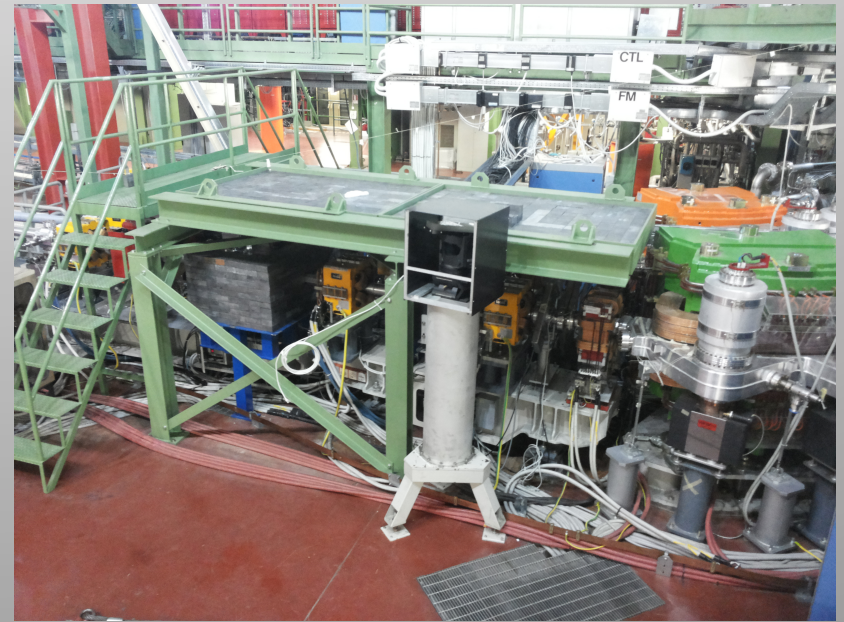
Radiation level in the Control Room

Electron beam losses in the DAΦNE hall caused anomalous γ photon level in the control room mainly during injection and some times during coasting

Following the indication of the radio-protection group a lead shield has been installed around the collimator just after the RCR in the MRe without any relevant improvements

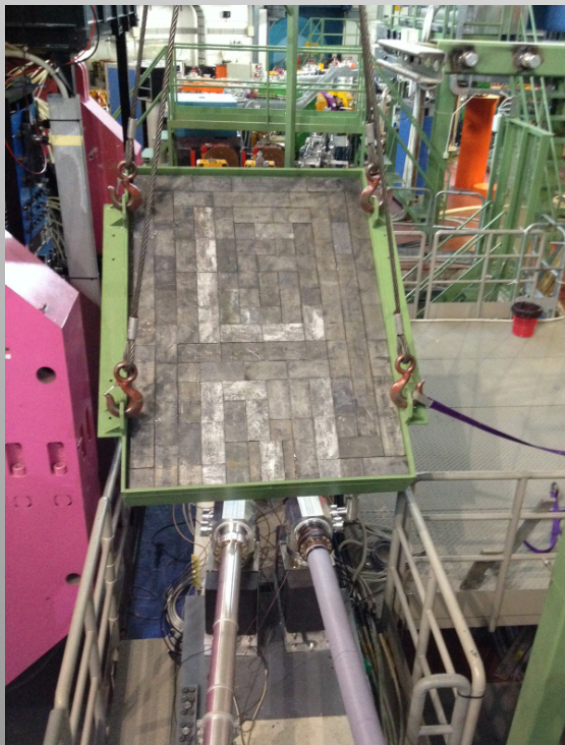
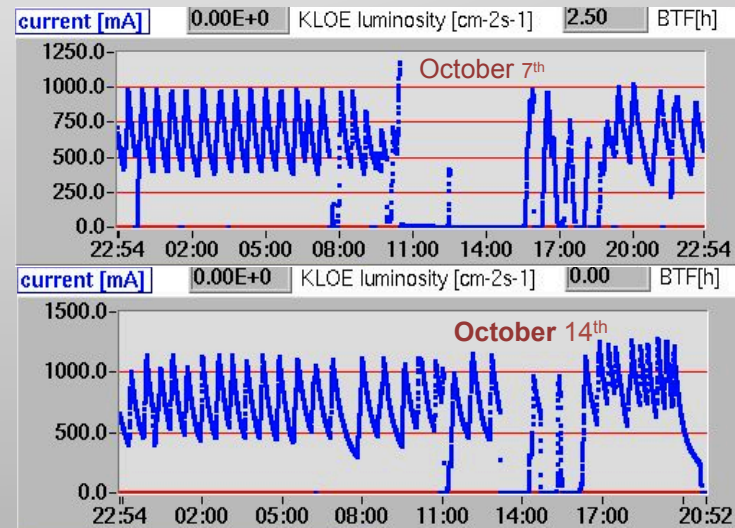
Identifying the radiation source

Optimizing the TLe optics produced a 15% reduction in the average level of the γ photons detected in the Control Room (*less particles lost during injection means less background on the KLOE detector during data taking*)

On October 14th a lead screen has been suspended at the exit of the RCR bended by 37° toward the incoming beam and with the lower side 50 cm far from the center of the vacuum chamber

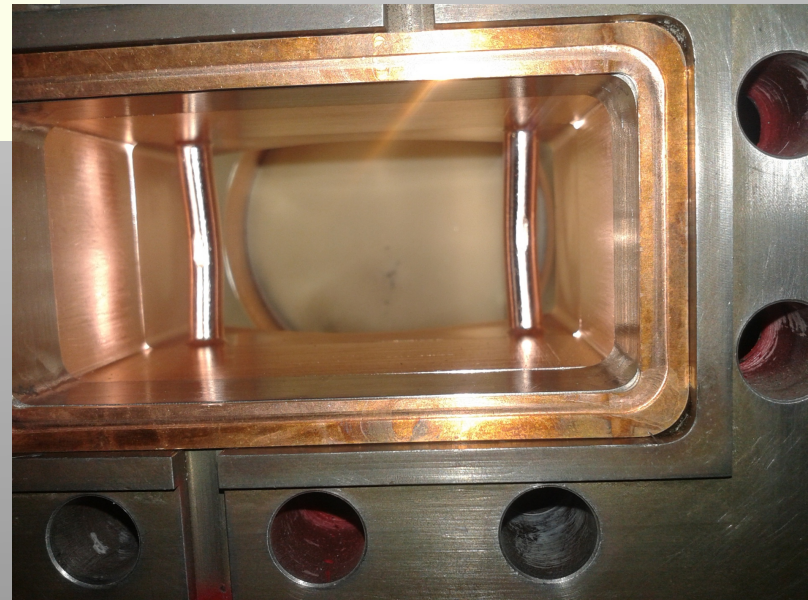
Conditioning klystron D

Klystron D had several faults during conditioning (vacuum interlock downstream the output window)

Regardless the new components the **D** RF power plant did not achieve the nominal working point

By the end of August the following components have been replaced:

- klystron (second time)
- vacuum section between klystron and Linac (RF elbow)
- vacuum gauge

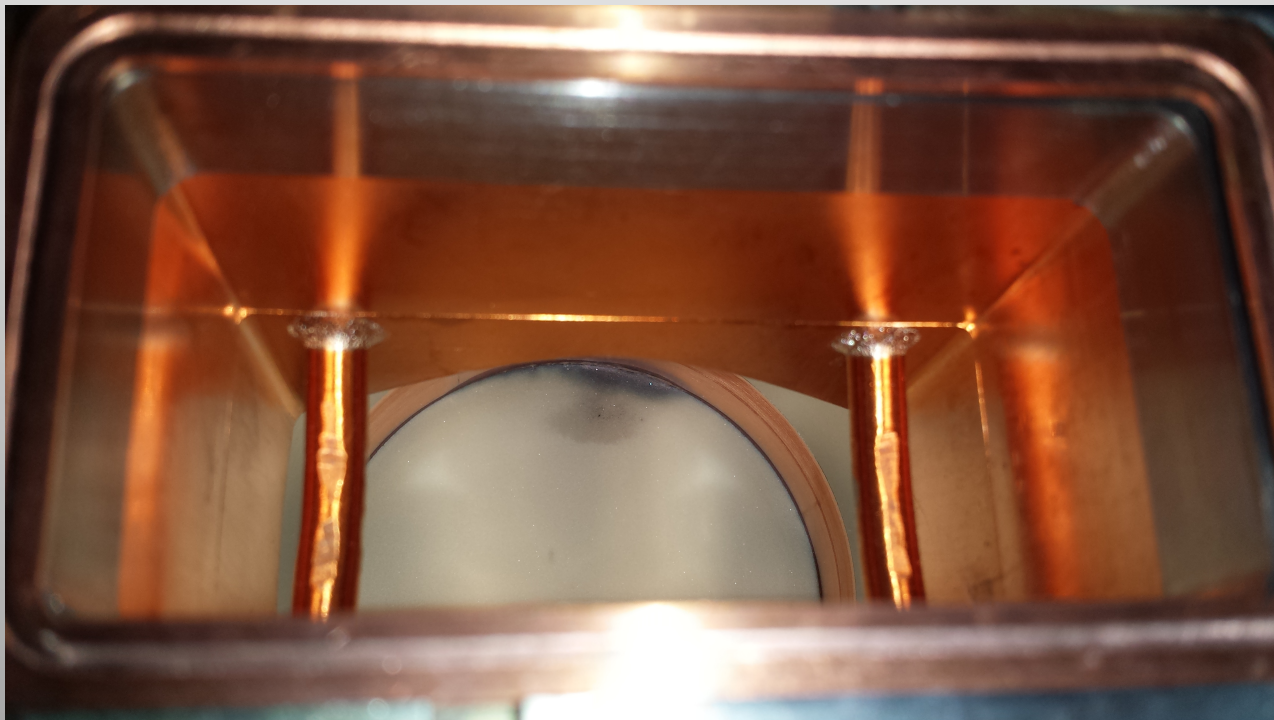
Removing the RF elbow a black spot has been observed close by the brazing of the ceramic window

This Klystron was new and under warranty

B klystron replaced for the third time

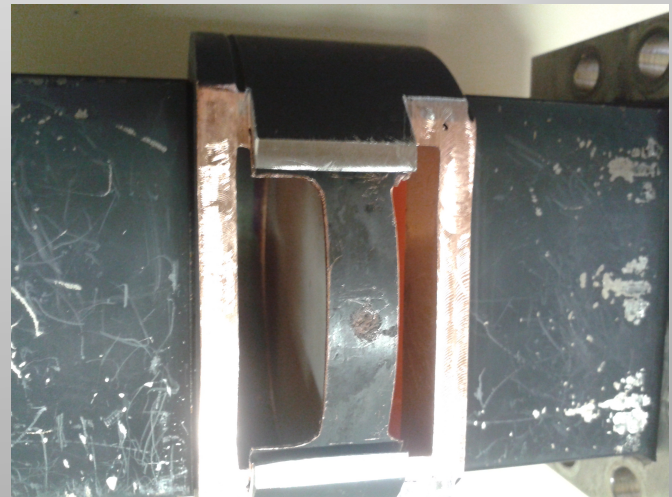
B RF power plant fault

Fault concerning the modulator blower

Water leakage in the ceramic window before the SLED system (20 years old)

Ceramic window has been replaced

Thyratron of the D modulator replaced
