# Experiences with the INFN Mezzanine 23 Sep 2015

### **INFN Mezzanine**

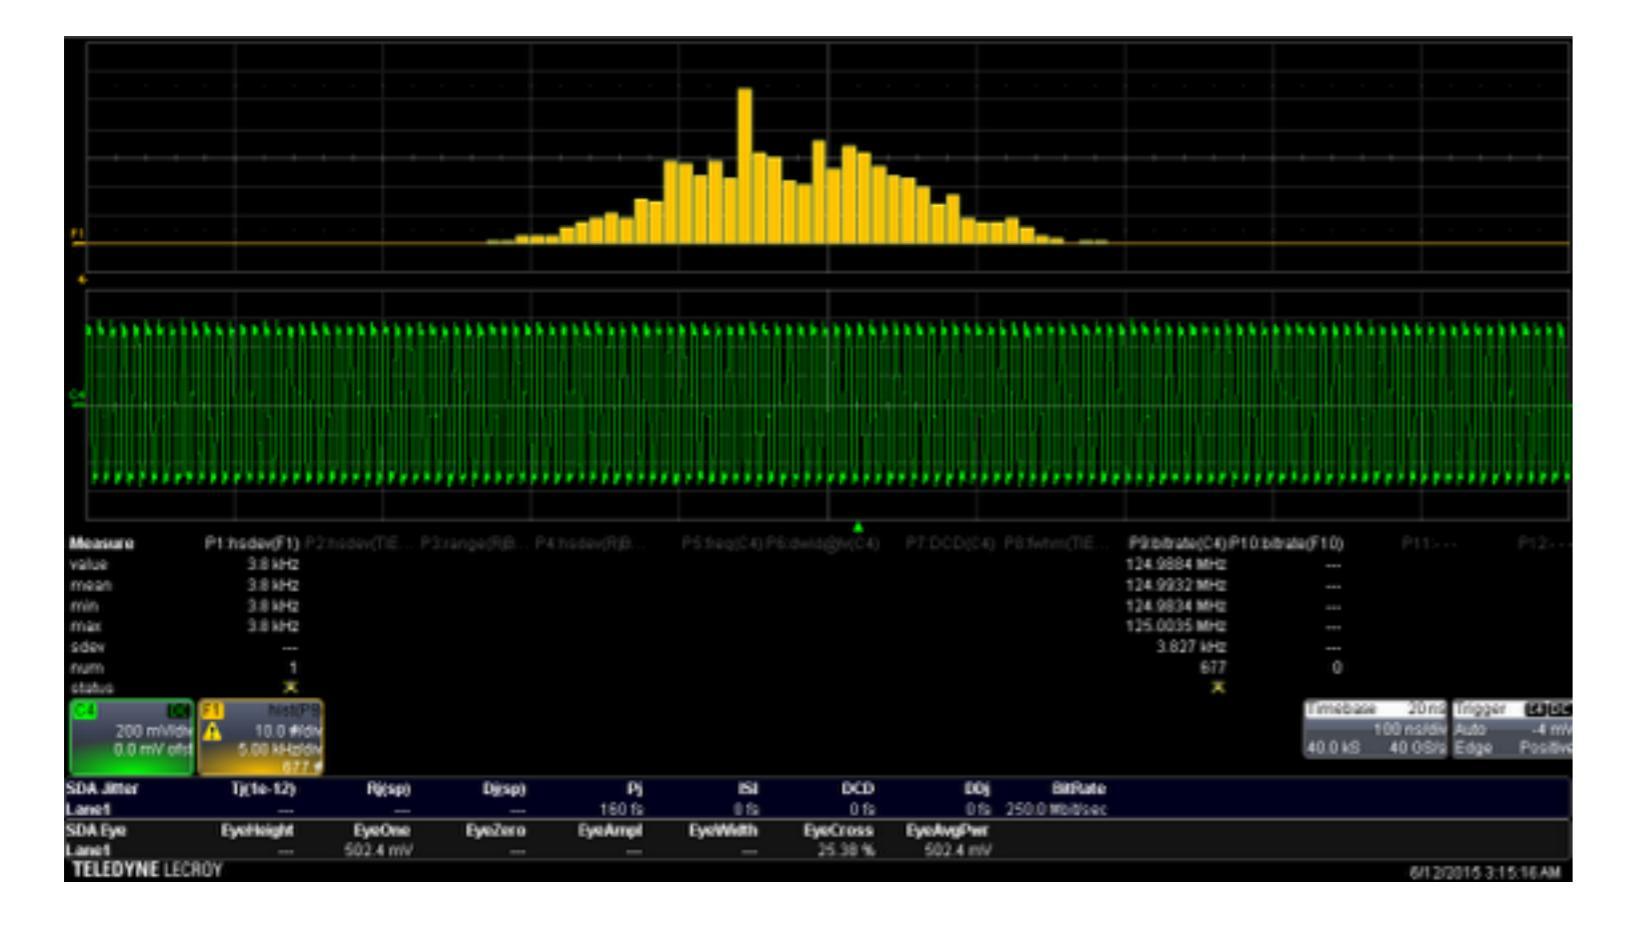
# **GTX reference clock**

- The Kintex7 (mezzanine) GTX bit rate is 2 Gbps with a reference clock of 125 MHz.
- The 125 MHz clock is generated by ICS844021I (clock multiplier x5) and by a crystal @25 MHz.
- The crystal component had a wrong pin assignment
- The issue was **fixed** by crystal rotation

Correct the pin assignment

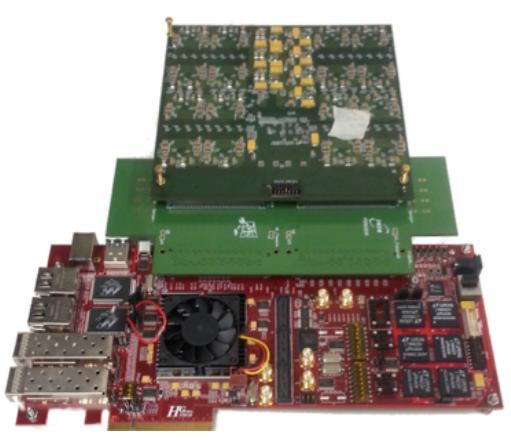
## **FMC** issue

- VADJ FMC pins are connected with the 3.3 Volt pins.
- The evaluation board use the VADJ to bring 2.5 Volt ->
- $\cdot$  The evaluation board didn't work
- $\cdot\,$  Fixed removing the VADJ pins from the adaptor FMCs

Remove the VADJ connection?

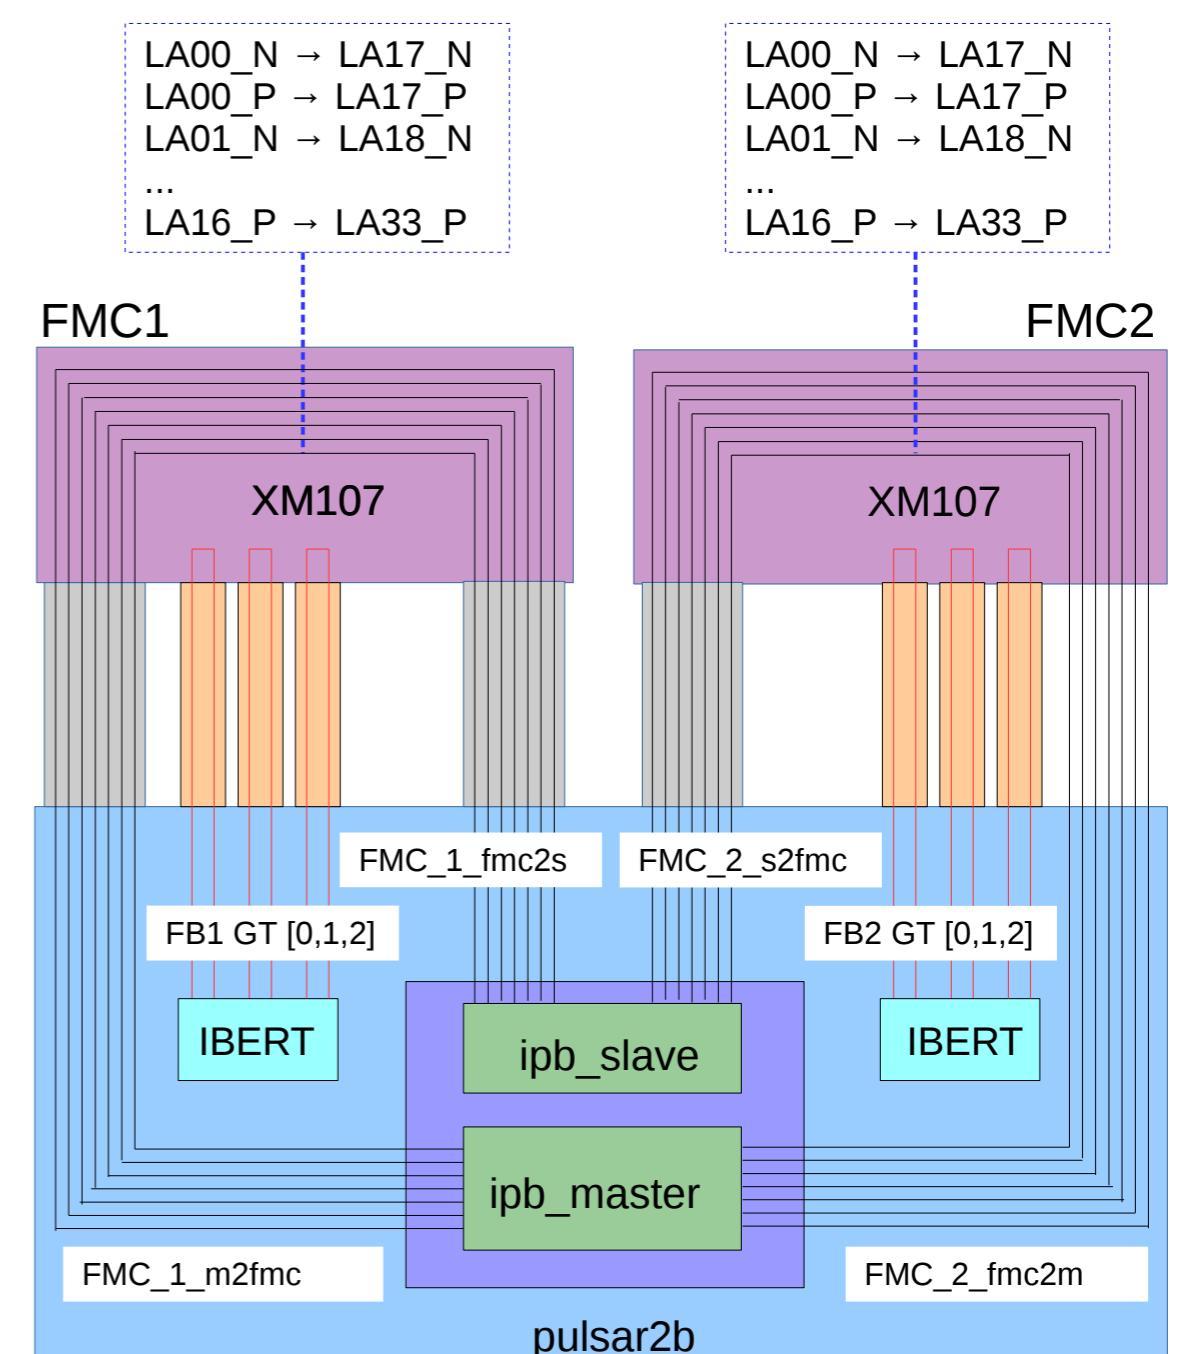
# LVDS links

- The mezzanine+Pulsar were mounted on an ATCA shelf slot.
- We developed a Pulsar firmware which permitted to test the LVDS links (in a static way). The schematic on the right shows the principle of the tests.
- The Pulsar LVDS links were tested using the loopback cards and no problems were found.
- Then, the two loopback cards were removed and the mezzanine took their place. The green blocks were substituted by a VIO instance.
- I developed a mezzanine firmware which, paired with the Pulsar firmware, checked the LVDS lines using VIO.
- All the 68 LVDS links worked properly and no swaps were found.
- In case we need more links we could use the DDR technique to double them.

~half of the LVDS and GTX links are swapped (PulsarIIb)

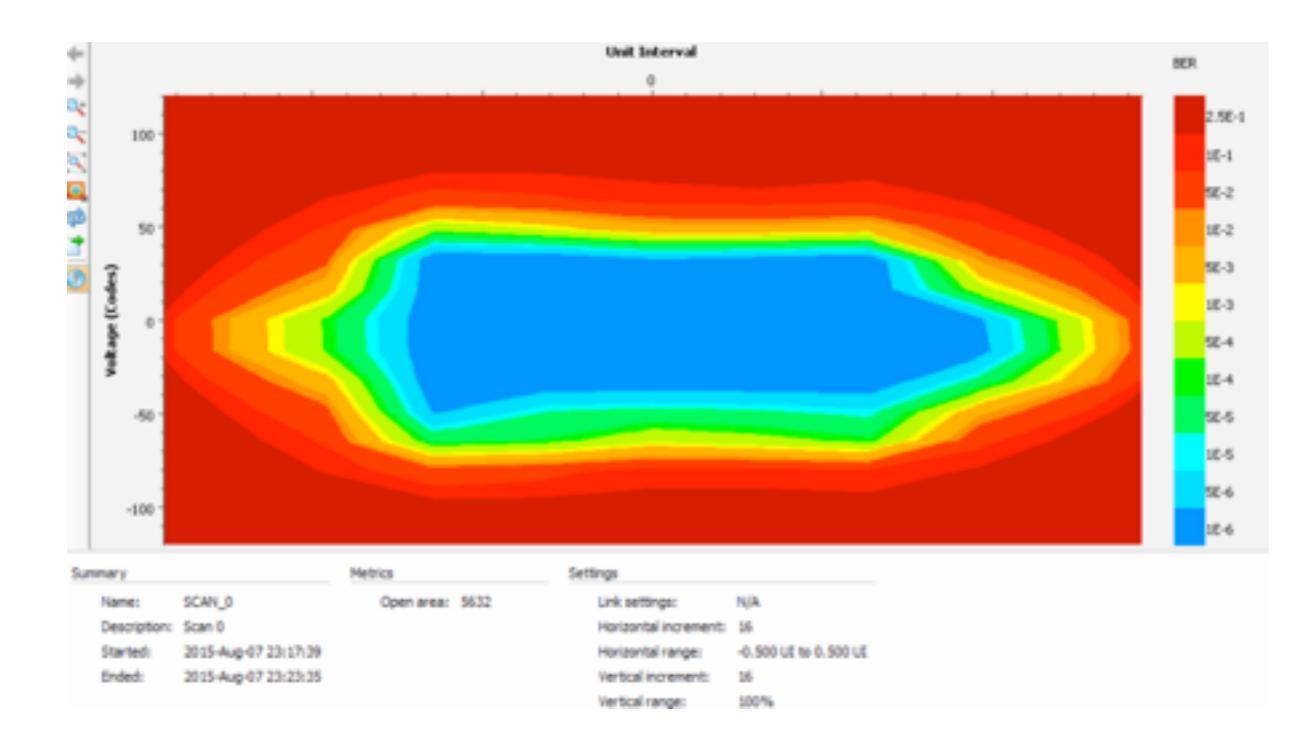
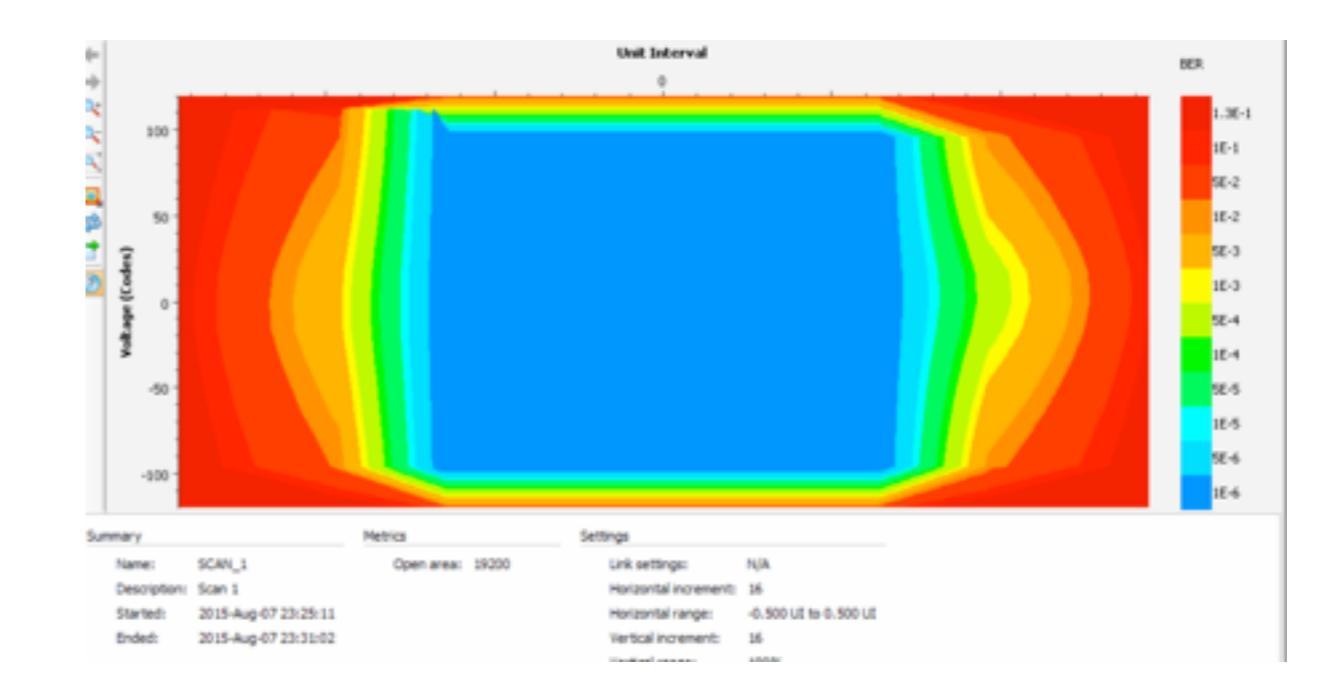
## GTX links @8Gbps

- The links were not ok running at 8Gbps
- A lot of errors and link instability were found

• No time to address this issue, since it was discovered at the end of the testing period

-In order to run at 8 Gbps
we need to configure properly the TXDiffSwing
-Same feedback from Kristian who tested the Pulsar links with a loopback card

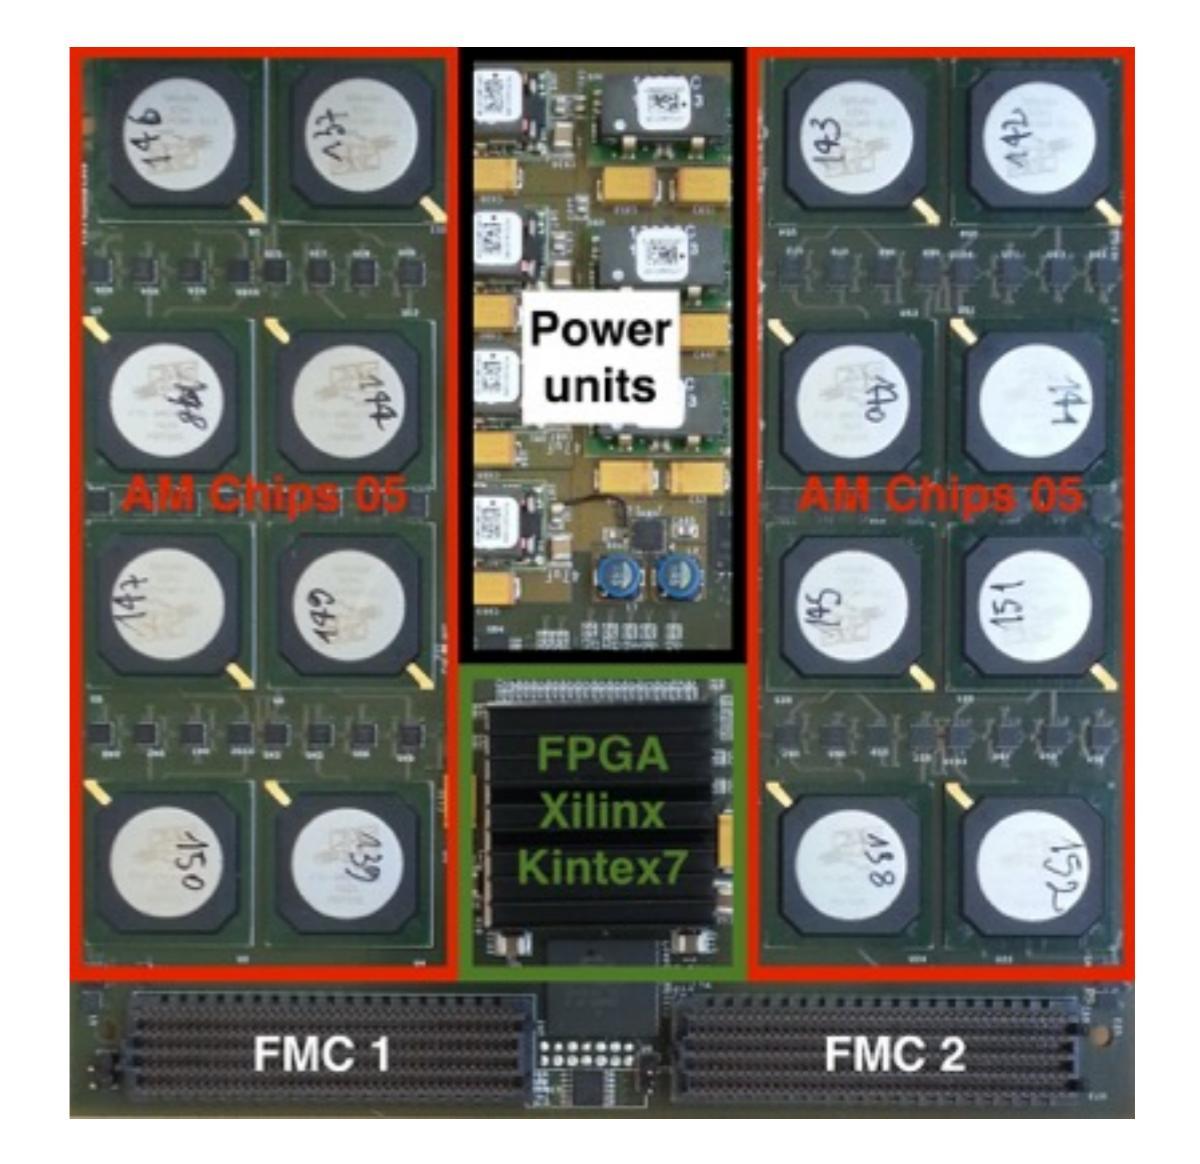
# 16 AM chip mezzanine

- We received the 16 AM chip mezzanine
- Smoke tests were ok
- JTAG connections to the FPGA and to the first chain of 4 AM chips is ok
- The GTX reference clock was fixed and improved
- We received the board with only one rotated crystal (we asked for both crystals to be rotated) and it was even broken
- Ordered new crystals

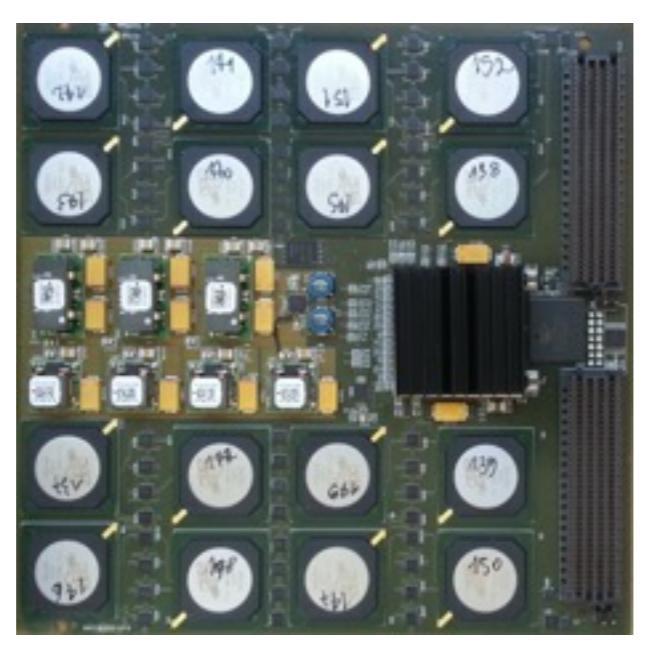
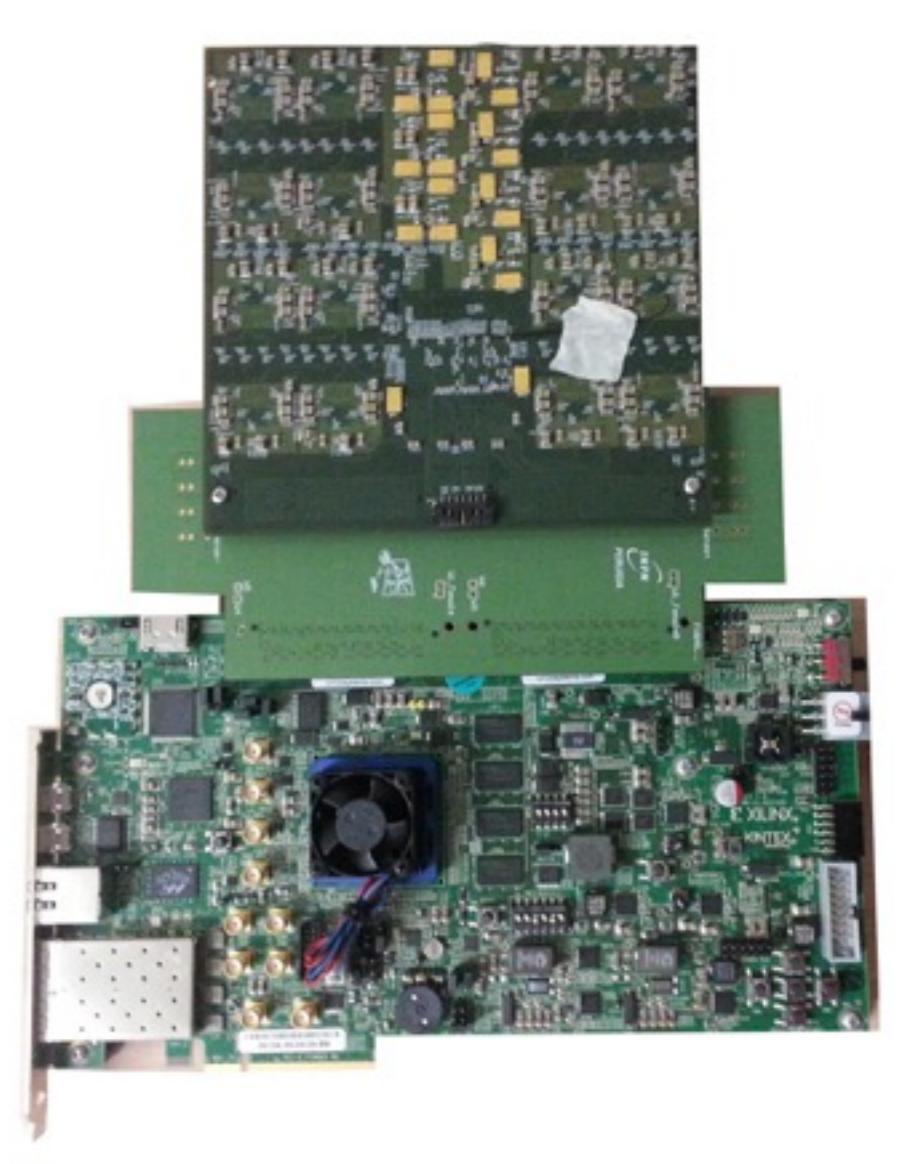
# GTx link test @Pisa

- We used an Xilinx Ultrascale evaluation board
- Test stand configured similar to the PulsarIIb+mezzanine setup (IBERT in both FPGAs)
- We make the GTx links working at 8 Gbps configuring the GTx of both FGPAs
- The evaluation board has only 5 links connected out of 8
- Sporadic errors were anyway found. Using the data analyzer we found that the reference clock may inject too much jitter into the GTx signal

- For the 16 AM chip mezzanine we decided to use a better quartz component of the GTX reference clock
- Indeed, the jitter of the reference clock was reduced and the GTx didn't show any error in some hours of continuous working

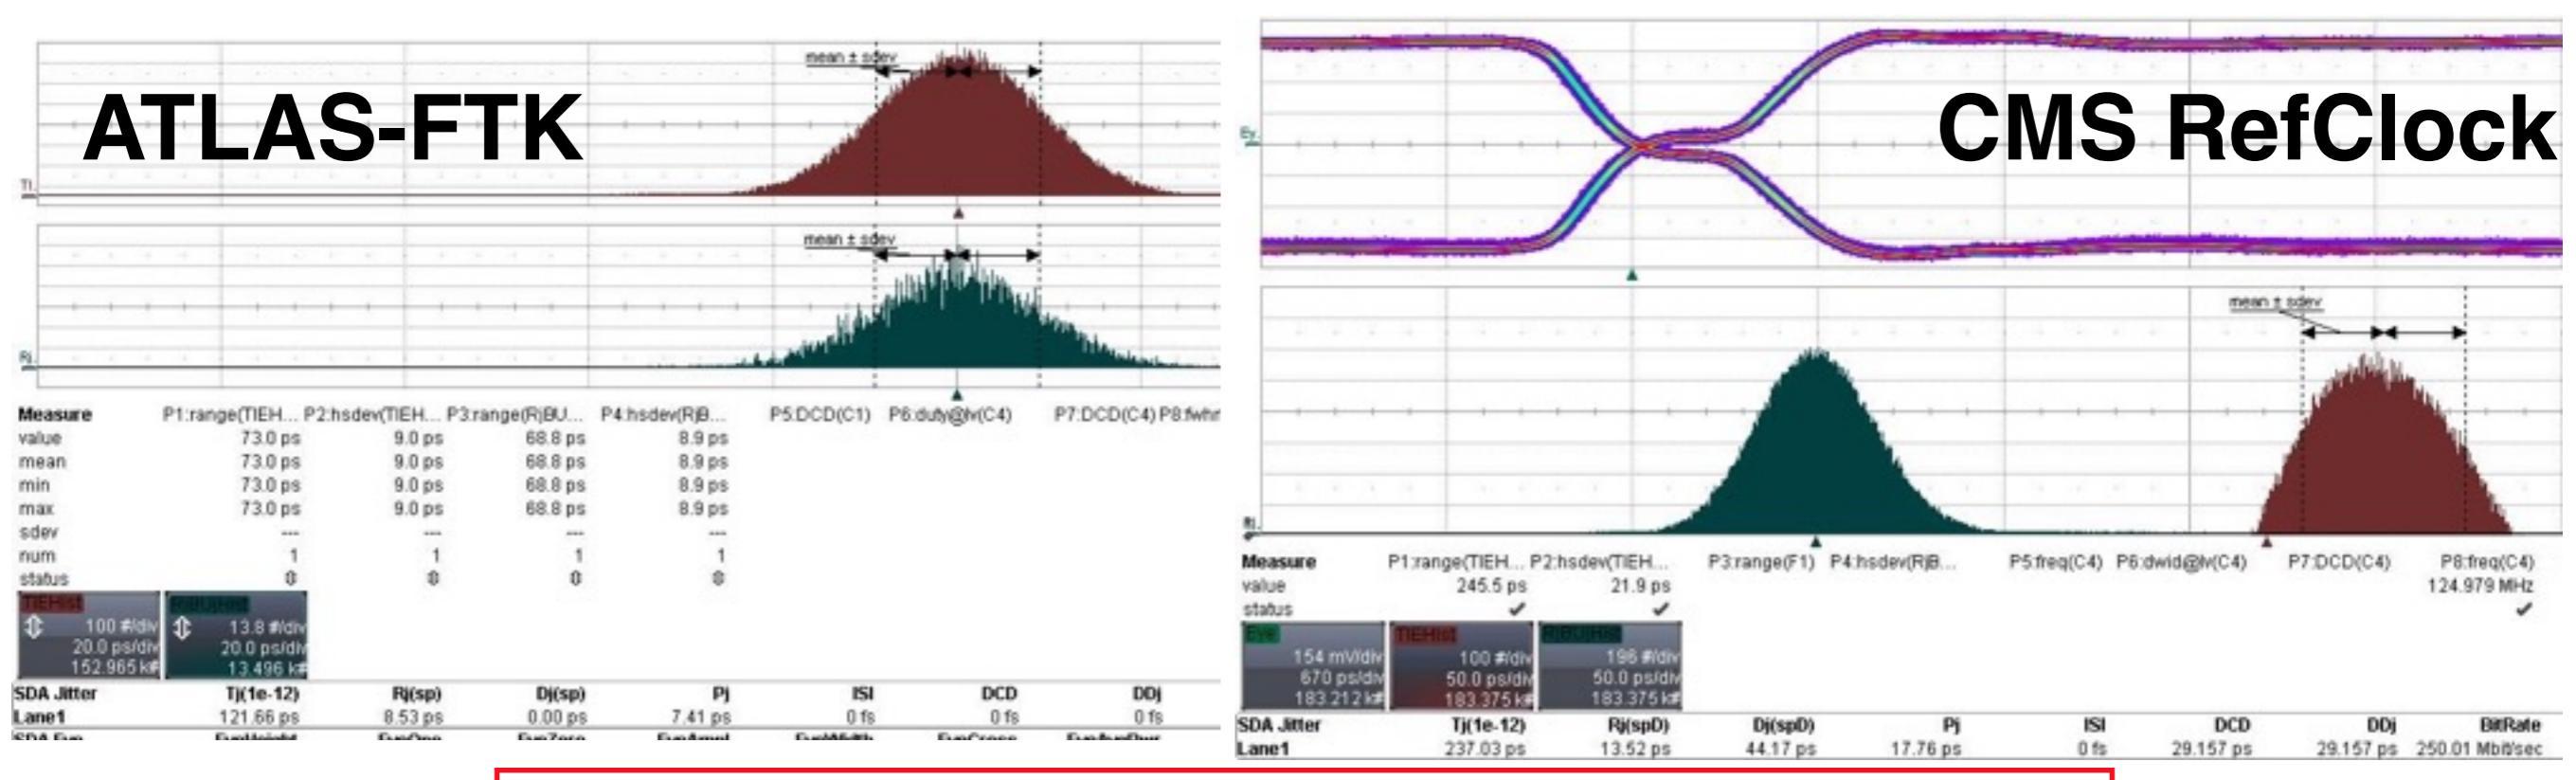
## Clocks

- 100 MHz clock for the FPGA
- 4x100 MHz clock for the AM chips (fanout)
- 2x125 MHz clock for the GTX RefClock
- 100 MHz clocks are ok
- 125 MHz source of issues (pin assignment, jitter)

- To simplify the clock it's maybe better to use a single component
- It may be useful to have programmable clocks (I2C) at least for the GTX RefClock

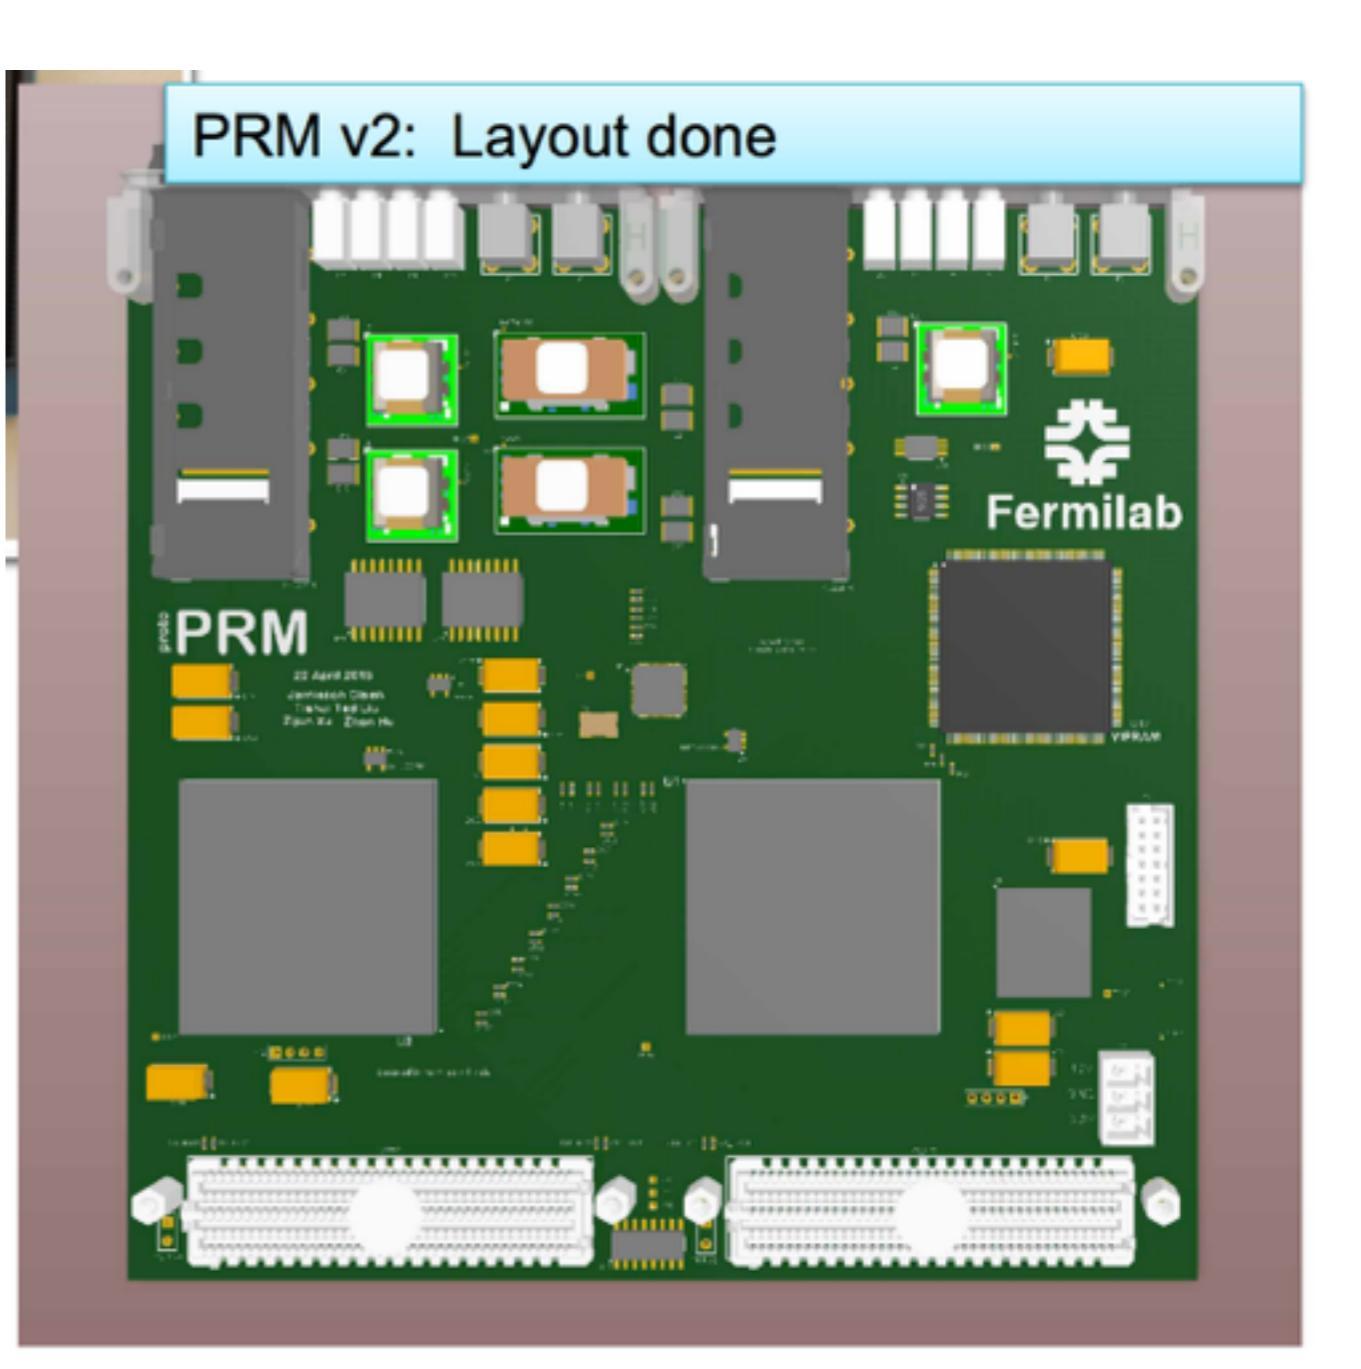
# **Additional feedbacks**

- Temperature sensors (connected with the ATCA shelf manager?)
- Test points and leds
- Mechanic connection: add screws in the middle of the FMC connectors, the current screws are too close to the components
- Additional power close FMC (Jumpers) connected to GND-12V while in the mezzanine is 12V-12V
- Power connectors
- Ethernet connection
- Problem of space: mezzanine's mezzanine?
- GTX max. speed.
