Conductive polymer and TPB tests at Carleton

Marcin Kuźniak and Jeff Mason
mkuzniak@physics.carleton.ca

Carleton University
Ottawa, Canada

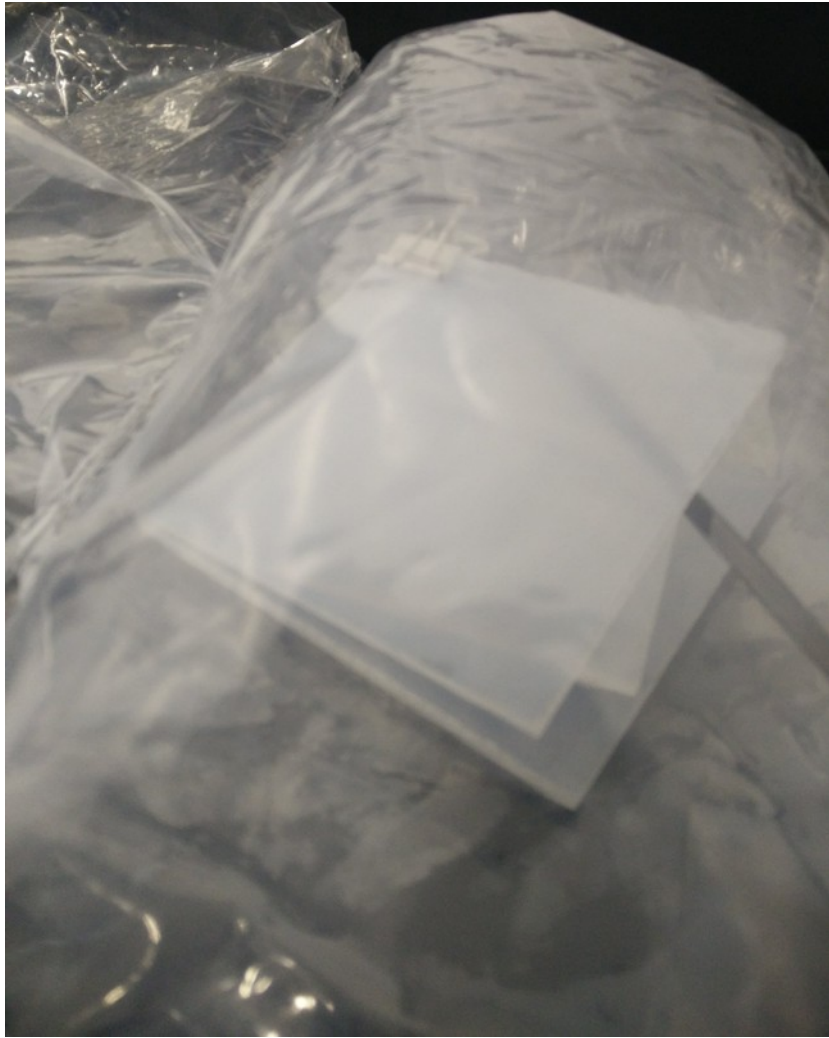
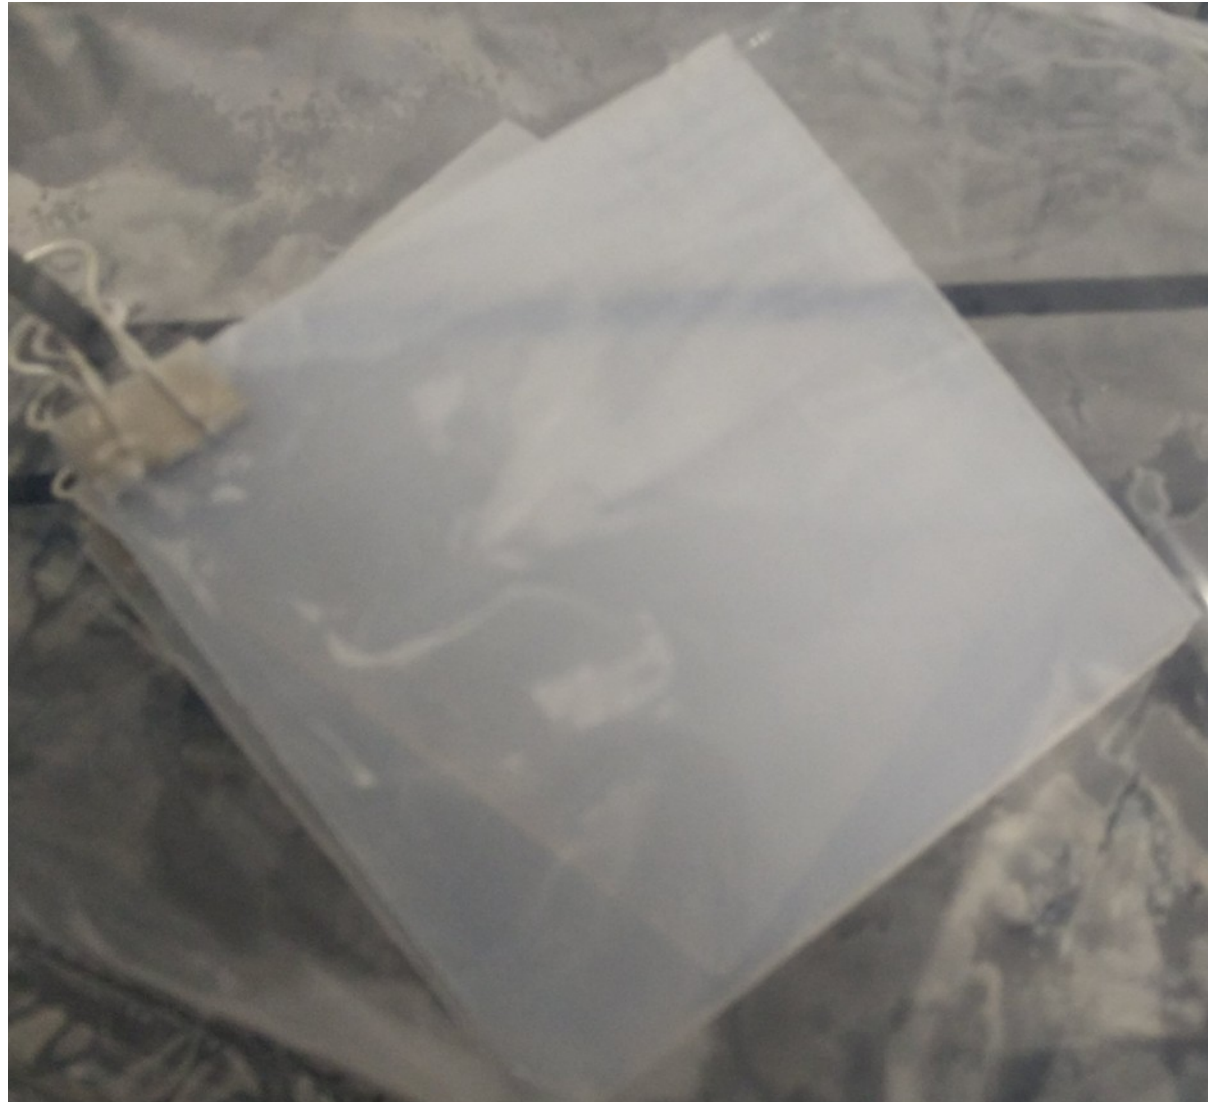
After dunk test

- Left for warm-up in a sealed bag filled with boil-off N₂
- No visible damage to the coating upon visual inspection through the plastic bag
- **Very promising**

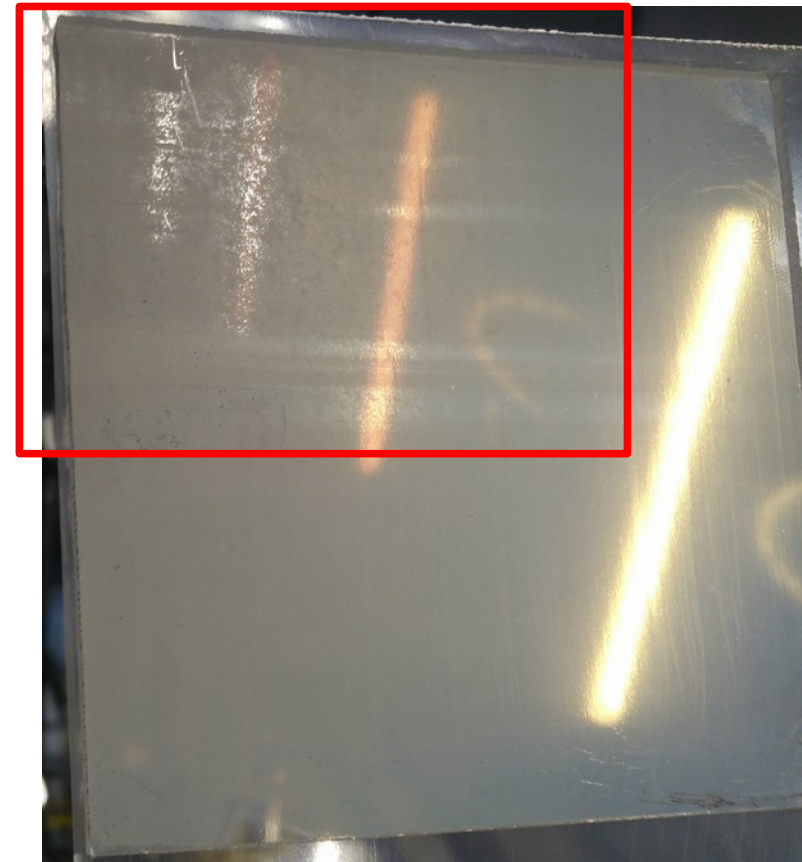
after

Signs of deterioration in one corner of one Clevios sample

- This is the thicker of two Clevios coatings
- This is the thicker side of the TPB coating
- This is also the edge of the sheet, where I fear Clevios could have been too diluted or pressure on the coating rod uneven
- Chance of mechanical damage through contact with neighbouring sample?
