Visual investigation of possible degradation in GEM foil under test

15th Pisa Meeting on Advanced Detectors, 22-28 May 2022, La Biodola - Isola d'Elba, Italy

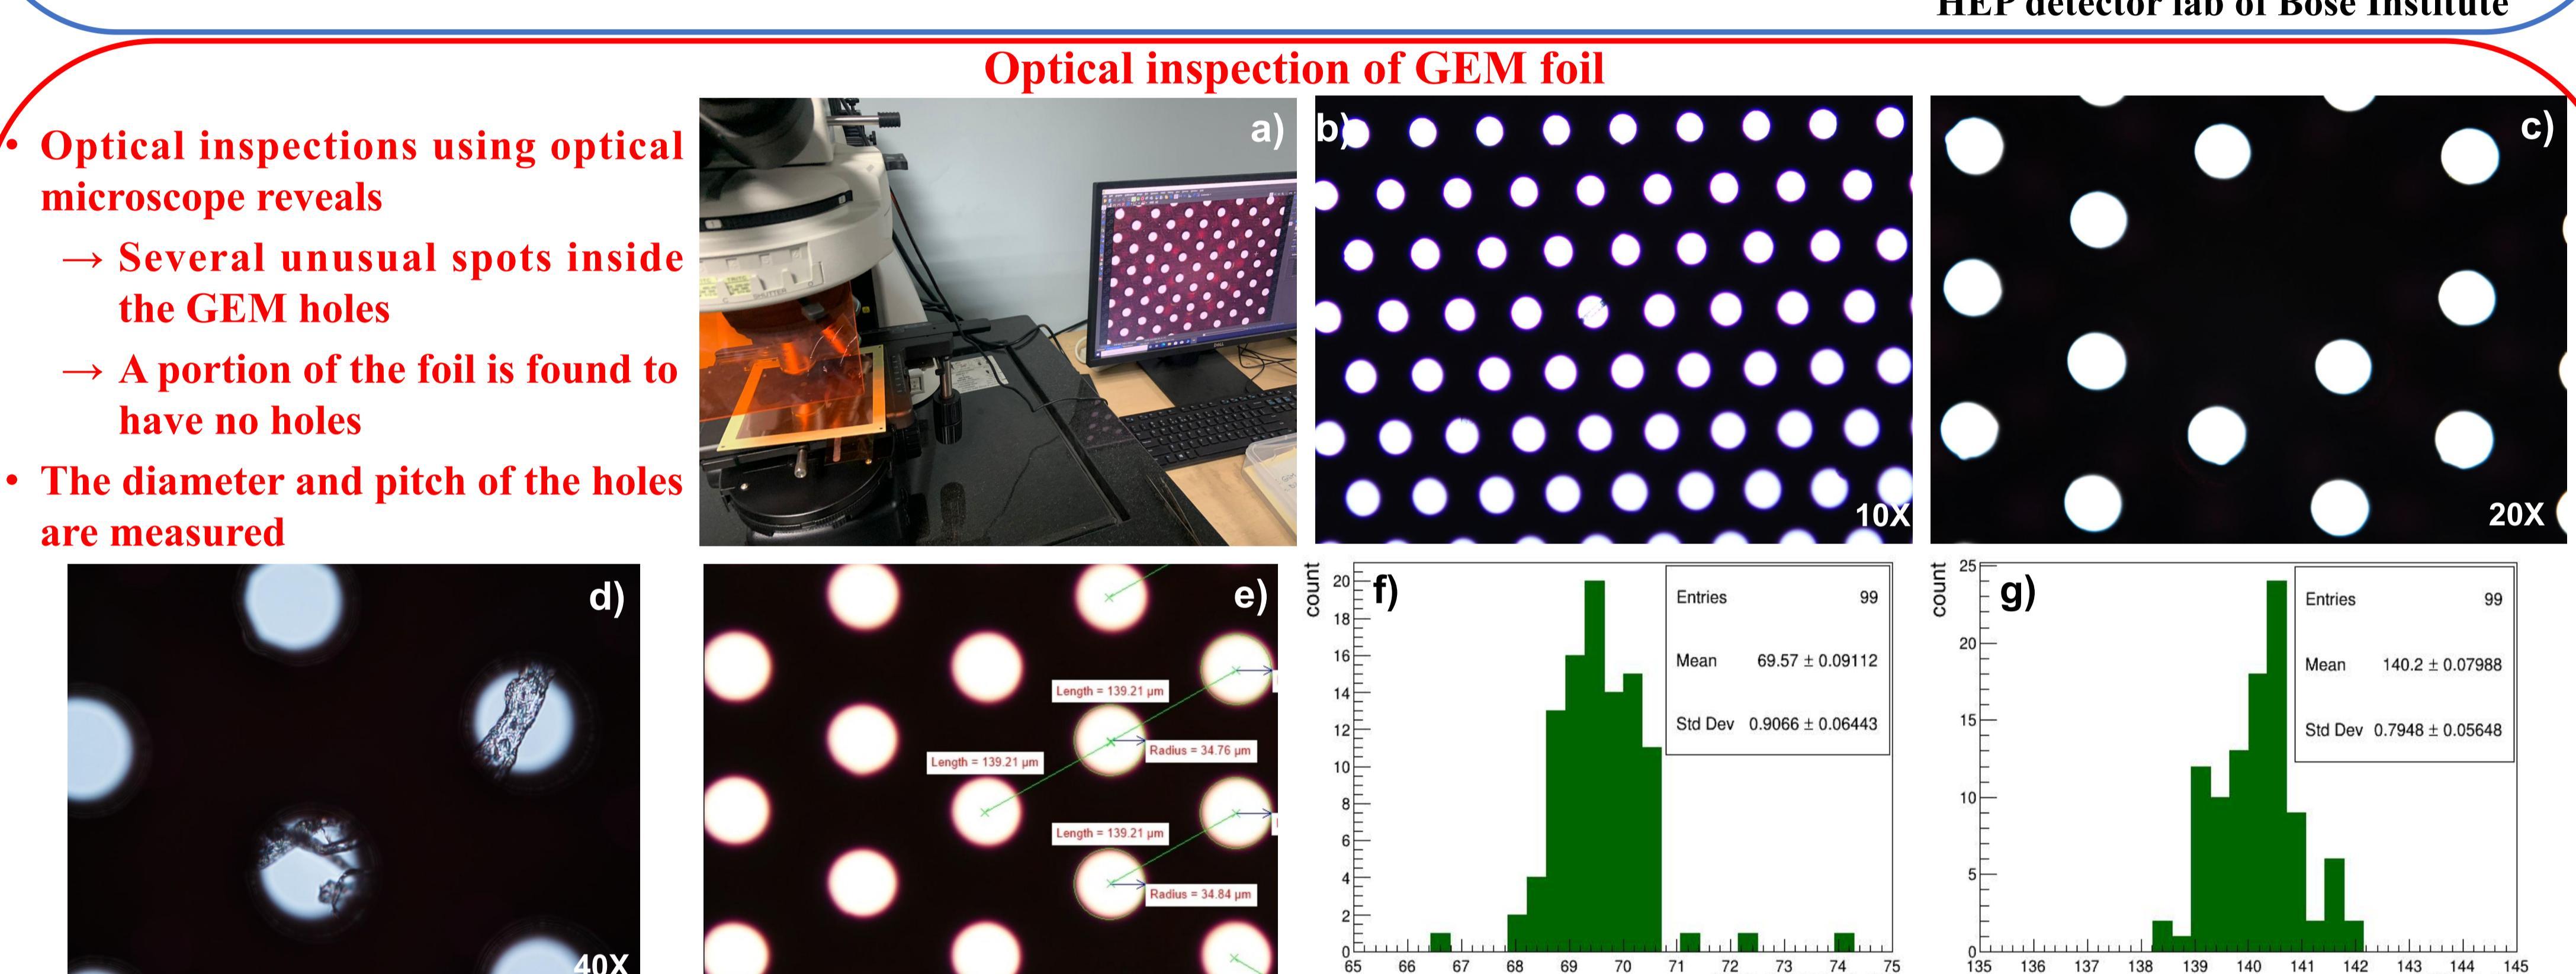
- \rightarrow After investigation, it is found that some short paths are created in the 3rd GEM foil of the chamber by measuring the foil resistance (~ 40 k Ω)

a) Microscope setup to measure the GEM hole diameter and pitch, b), c) & d) Microscopic images of the GEM hole showing imperfections at different magnifications, e) Measurement of GEM hole diameter and pitch, f) Distribution of GEM hole diameter, g) Distribution of GEM hole pitch

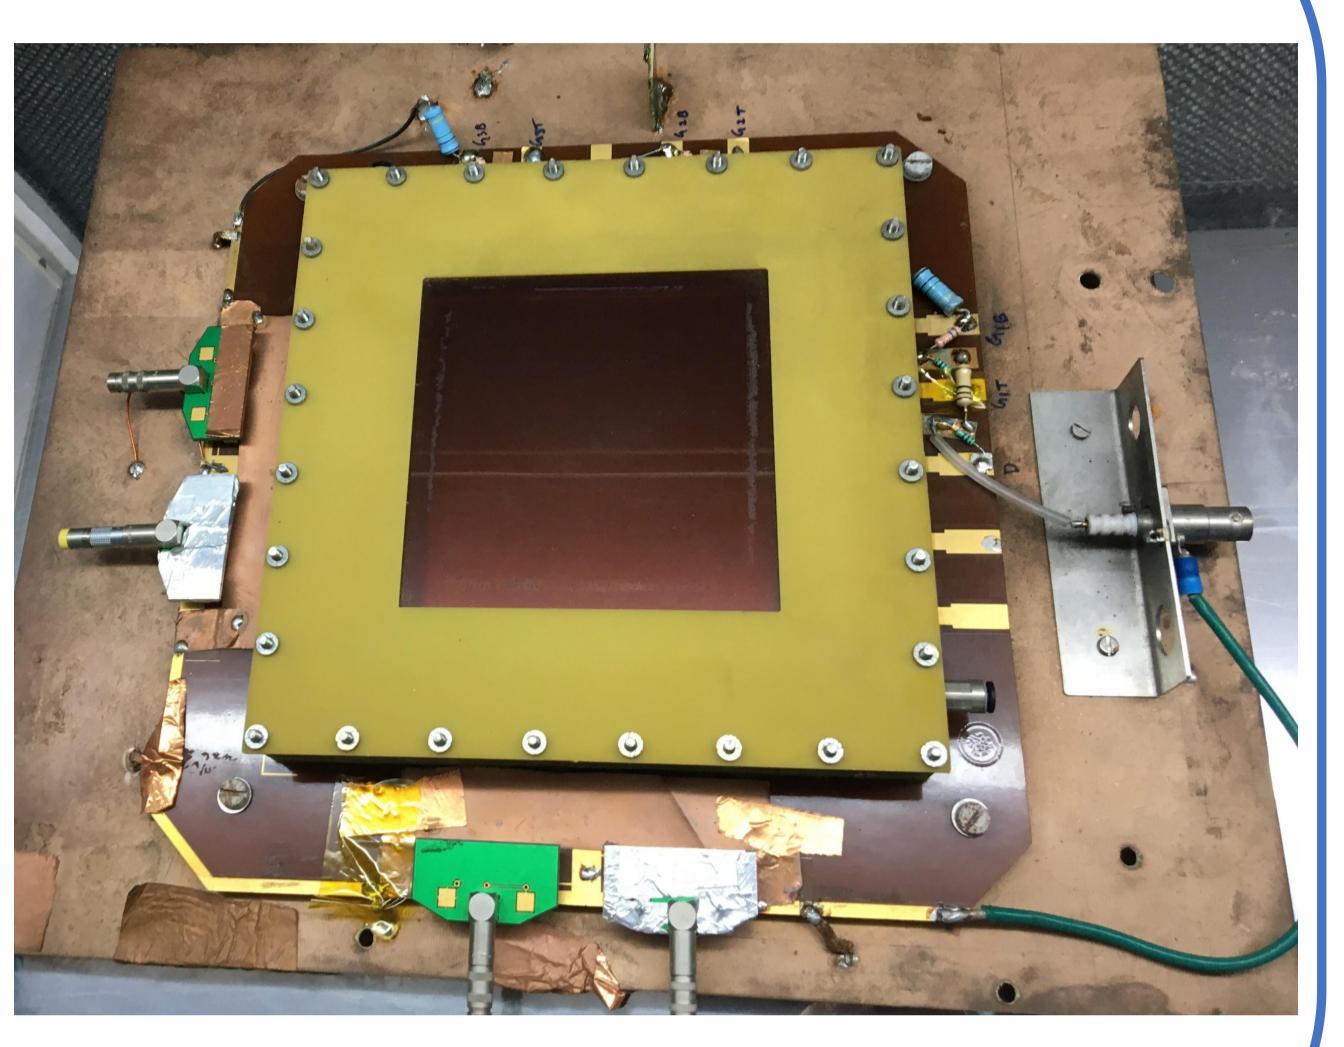
- Long-term stability is one of the important criteria for any detectors in HEP experiments
- During the long-term study of a Single Mask (SM) triple GEM chamber it is observed that the detector suddenly stopped giving the signal

SM triple GEM chamber under testing at **HEP detector lab of Bose Institute**

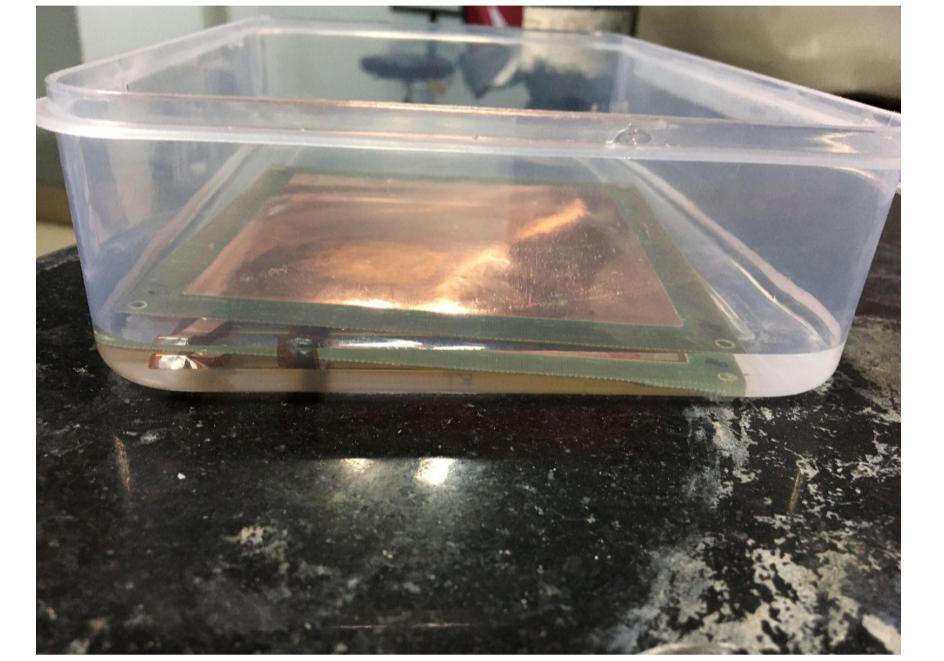
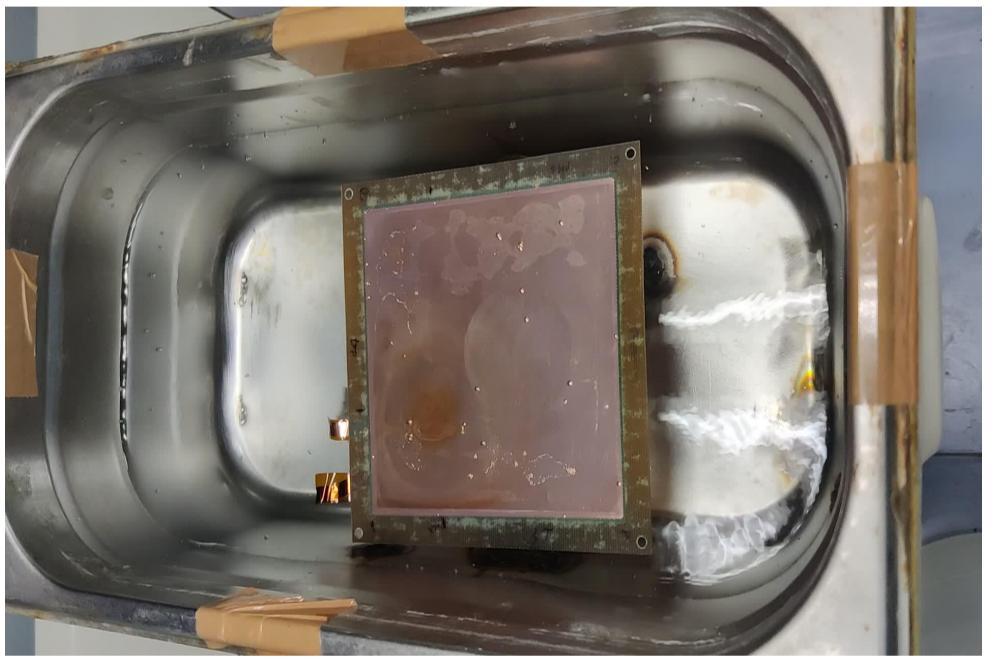
Cleaning of the GEM foil using water bath (left) and using the ultrasonic bath (right) with millipore water as the medium

- The resistance of the GEM foil is measured after removing the foil from the chamber and is found to be ~ 40 k Ω
- The foil is immersed in the millipore water
 - \rightarrow The foil is immersed in the water bath for ~ 60 minutes
 - \rightarrow The foil is taken out and kept for drying under continuous heat flow ~ 30 minutes and after that the foil resistance is found to be $\sim 1 \text{ M}\Omega$
- The foil is cleaned using ultrasonic (~ 20 kHz) bath with millipore water
 - \rightarrow The foil is kept in the ultrasonic bath for ~ 5 minutes

- \rightarrow The foil is dried for \sim 30 minutes under continuous heat flow and after that the resistance of the foil was found to be high
- The leakage current of the foil is measured with the continuous flow of Ar/CO₂ gas mixture using Keithley picoammeter after cleaning with the ultrasonic bath
- The leakage current performance of the foil is found to be reasonable (at $\Delta V \sim 300$ V, RH ~ 50%, leakage current ~ 0.3 nA)

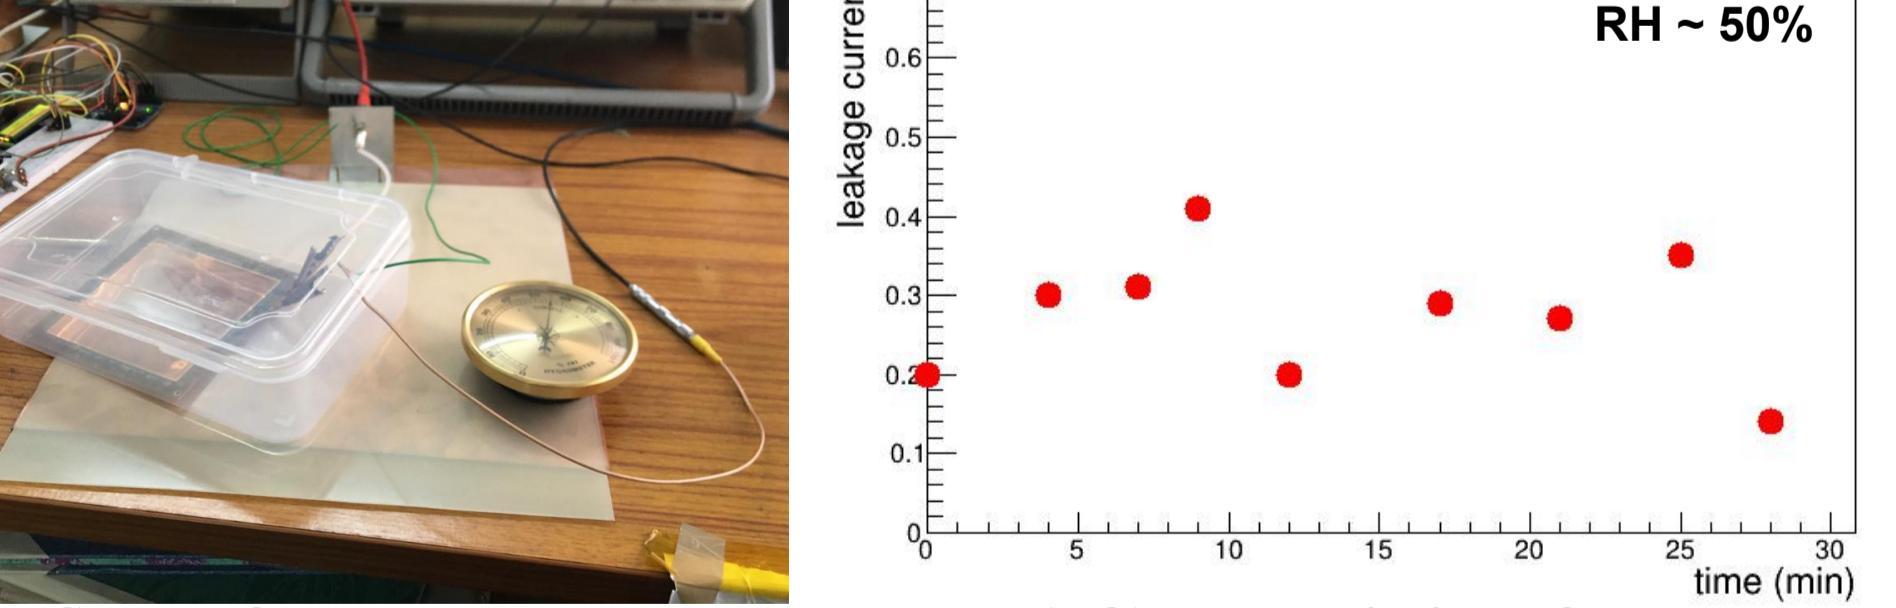
Setup of leakage current measurement (left) and variation of leakage current as a function of time (right)
