# Updates from Pavia

Ilaria Vai for the Pavia Team

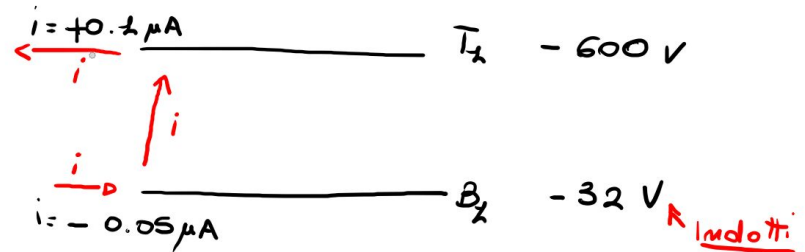
on B1 we measure an induced voltage of the order of 30 V, while if we have a look at the currents:

- $i(T1) = 0.1 \text{ uA}$
- $i(B1) = -0.055 \text{ uA}$

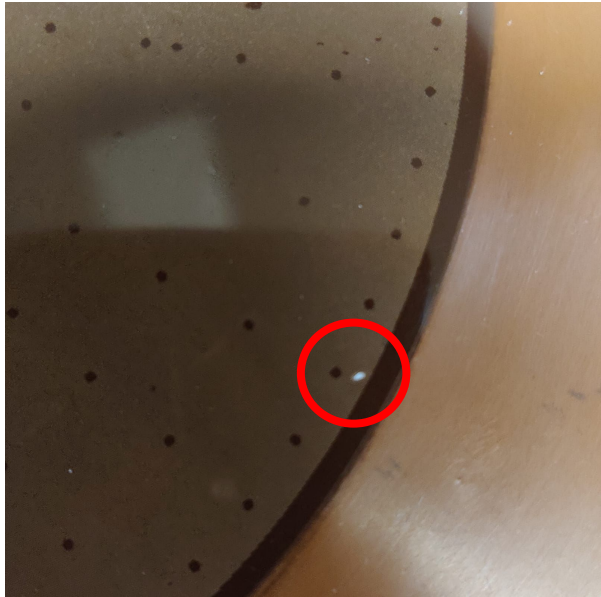
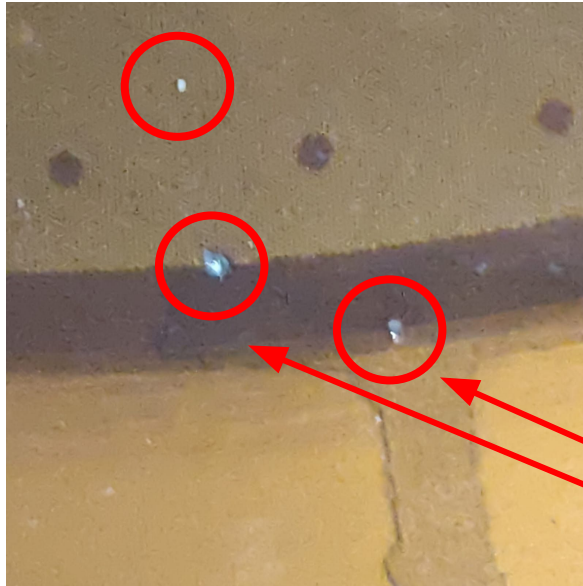
Really close to the HV path!

*The detector couldn't be operated* due to serious issues detected in the T-type foils, in particular:

- diffused damages
- problems with the HV paths and the conducting paste as shown in the video

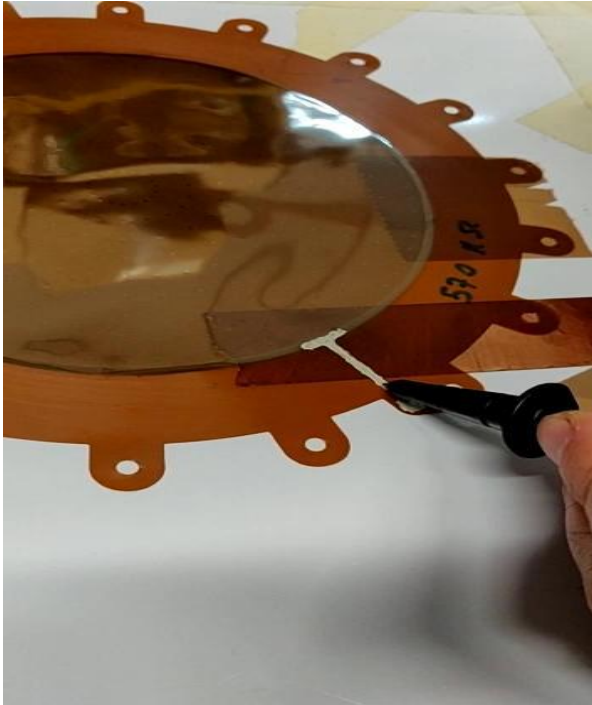
The conducting paste seems to have pierced the kapton foil → there's a short that we couldn't see with the tester but we can observe here with the megger

→ the same problems are present in all the T-type foils we currently have in Pavia (4)

The consequence is that the T-type foils are not well insulated from the B-type, i.e. a stable and sufficiently high electric field cannot be established in the amplification regions.

1. ***Move to a simpler readout board***
  - a. designed to host only 2-3 foils
  - b. no strips, just one big readout pad
  - c. no samtec connectors, just a simple LEMO
2. ***Produce new T-type foils***
  - a. avoid the usage of conducting paste for the HV paths
  - b. is it possible to create a mask of the shape of the HV path so that when the copper is chemically removed we keep the HV path “visible”?
3. ***Need to have a couple of GEM foils that can be exchanged with the FTM foils for debugging purposes***
