ALICE chamber GIF++ TB July 2021

Luca Quaglia¹ and Livia Terlizzi¹

¹Università degli studi di Torino e INFN Torino

ECOgas weekly meeting 22/07/2021

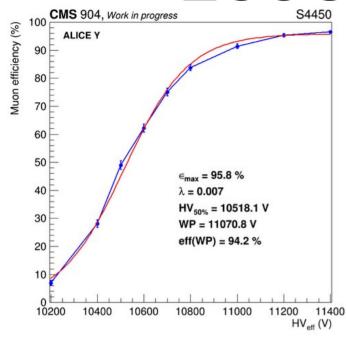
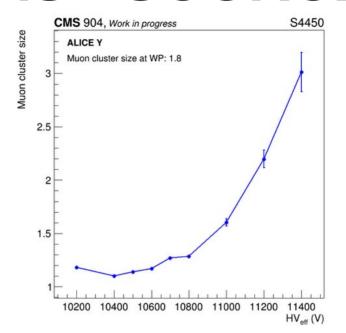
ECOGAS - SOURCE OFF

Very noisy even at source OFF

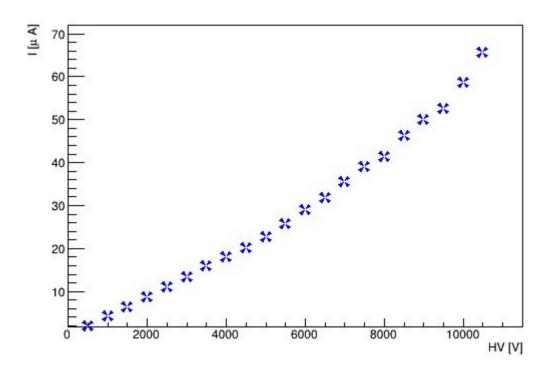
Standard gas mixture (1)

- Really high current absorbed even at source OFF
 - → probably due to damages in the transport since in Torino this was not observed
- In any case the efficiency reached acceptable values

- Source OFF
- Beam OFF
- Important Ohmic component

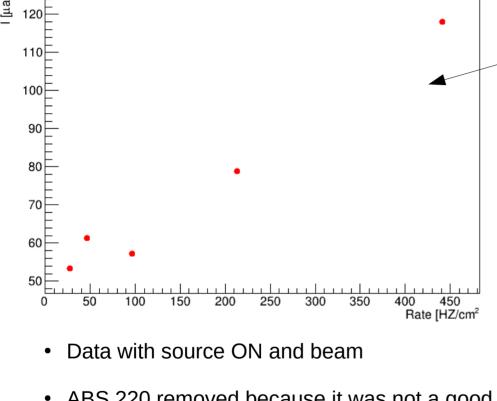
Standard gas mixture (2)

- ABS 220 removed because it was not a good run
- Decrease of efficiency if the radiation is increased

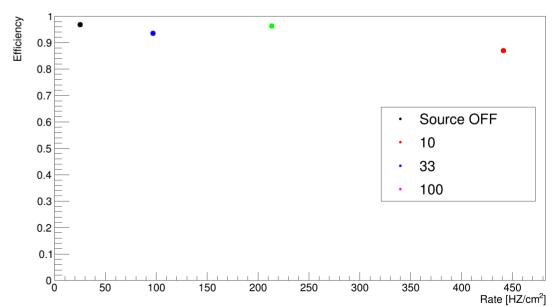
- Data with source ON but no beam
- Trend should be linear
 - → fluctuations due to ALICE chamber instability

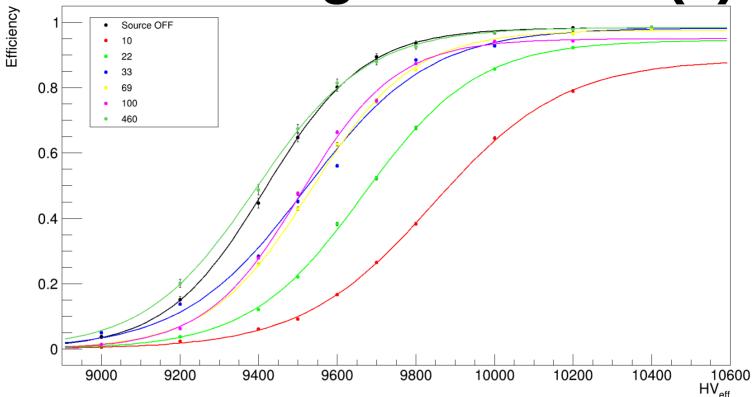
Standard gas mixture (3)

- Removed the curve at abs 220
 - → not a good run
- Efficiency curve is shifted to higher voltages only for low filter values (high rates)

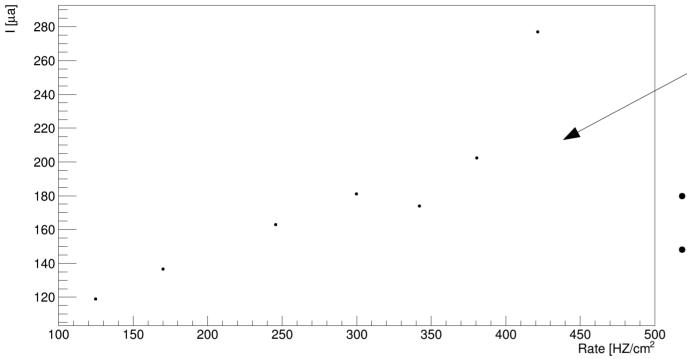
ECO mix 2 (1)

- Trend is linear
- Only exception is ABS 460

→ when we did that scan the current absorbed by ALICE had increased a lot

- The current absorbed by the detector increased during the irradiation
 - → due to bad quality of ALICE chamber

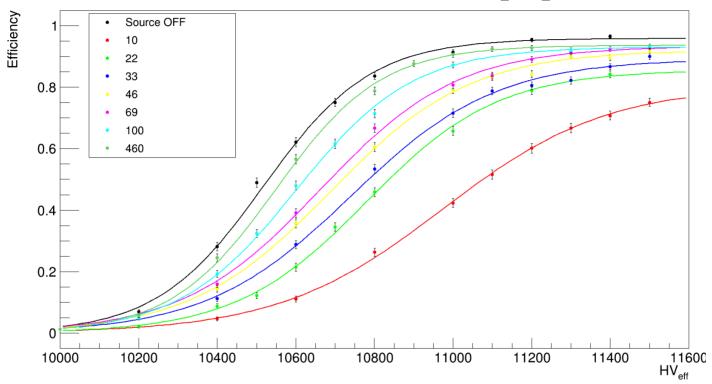
ECO mix 2 (2)

- Efficiency curved is shifted of around 1000 V to higher values
- Effect of the shift to higher voltages is visible when the abs factor decreases
- The plateau moves to lower efficiency values when the abs decreases

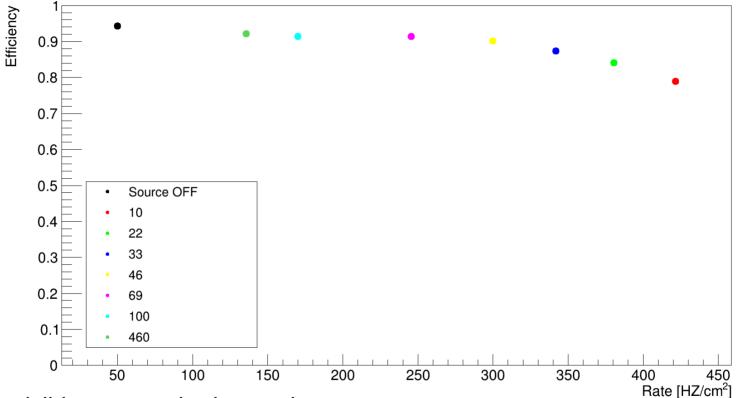
ECO mix 2 (3)

- Drop is more visible wrt standard gas mixture
 - → around 15% from source OFF to abs 10
- To be kept in mind: during the ECO gas measurements the abs downstream was also changed

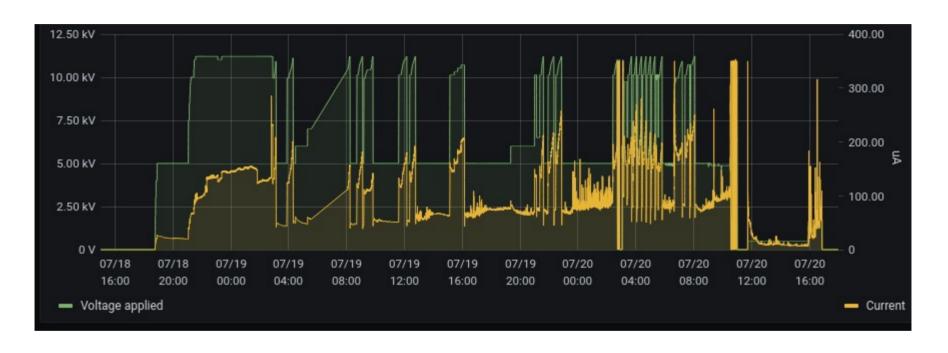
Current absorbed with ECOgas

- Trend of current shows an increase with time
- I do not believe it is due to the gas mixture but to some problems with the chamber

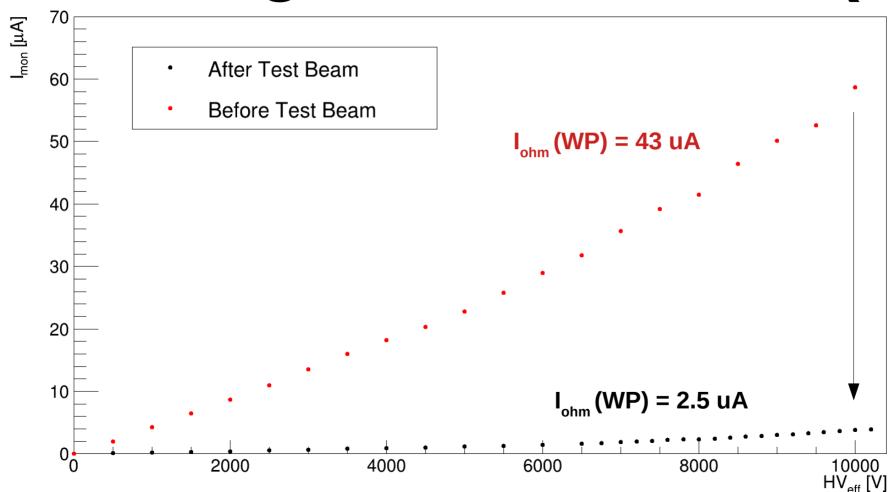
Investigation on ALICE (2)

- At the end of the TB period ALICE chamber showed very high currents
 - → We brought it to 904 to investigate the issue
- We installed a resistor + capacitor on the return line of the HV to measure the presence of leakage current
- Chamber flushed for 2 days at 2 ln/h with STD gas mixture
- When switched ON the current went up to 10's of uA
 - → we investigated
- The mechanical frame was opened and it was observed that the gap without frame did not have such high currents
 - → current leak somewhere in the frame
- Eventually the frame was slightly modified and now the issue is not seen anymore
