## Laser Alignment System Status Update

## VIM Modifications

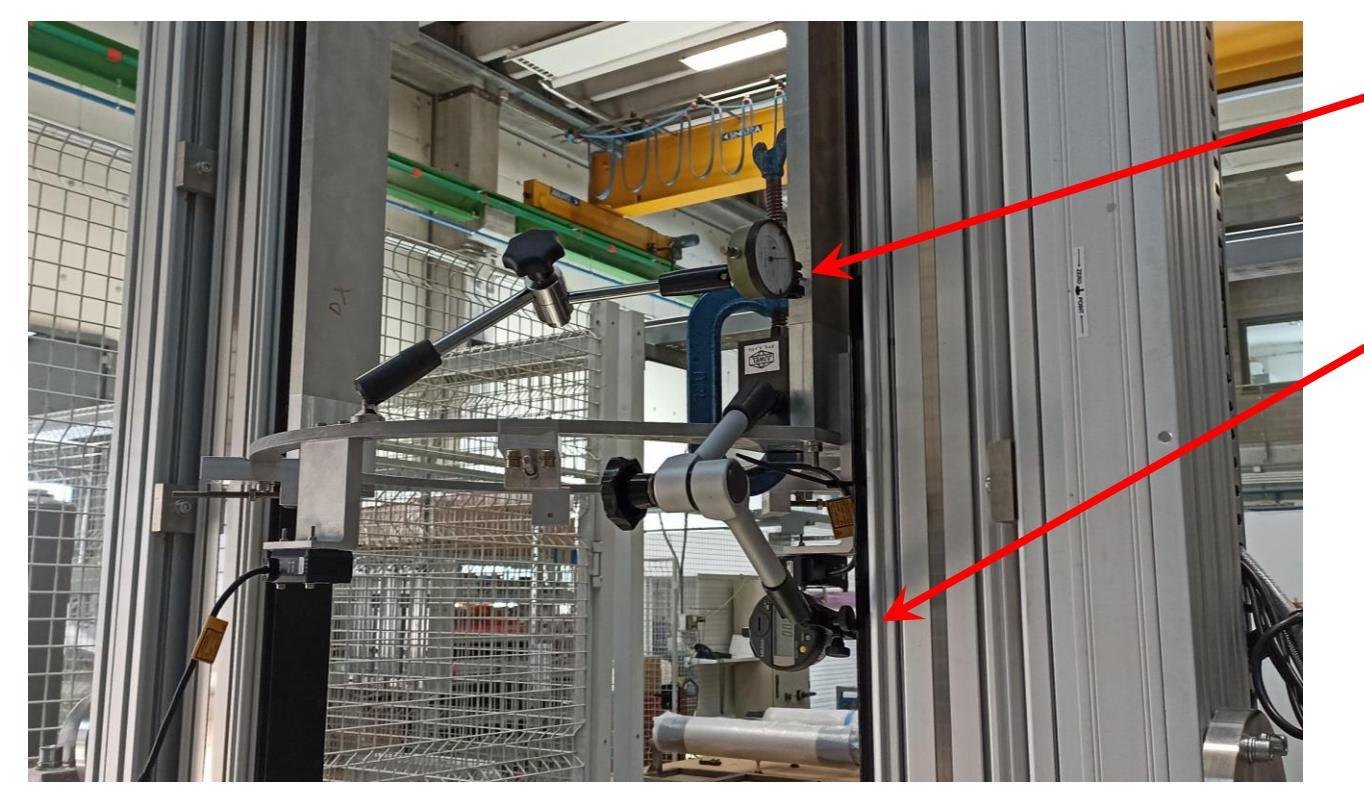
#### Check of the VIM Movements

Measures the deformation of the flange with respect to the rod

Measures the displacement of the rod with respect to the rail

Deformations up to 0.08 mm Displacements up to 0.06 mm

#### Some modifications to the flange are needed to limit unwanted movements

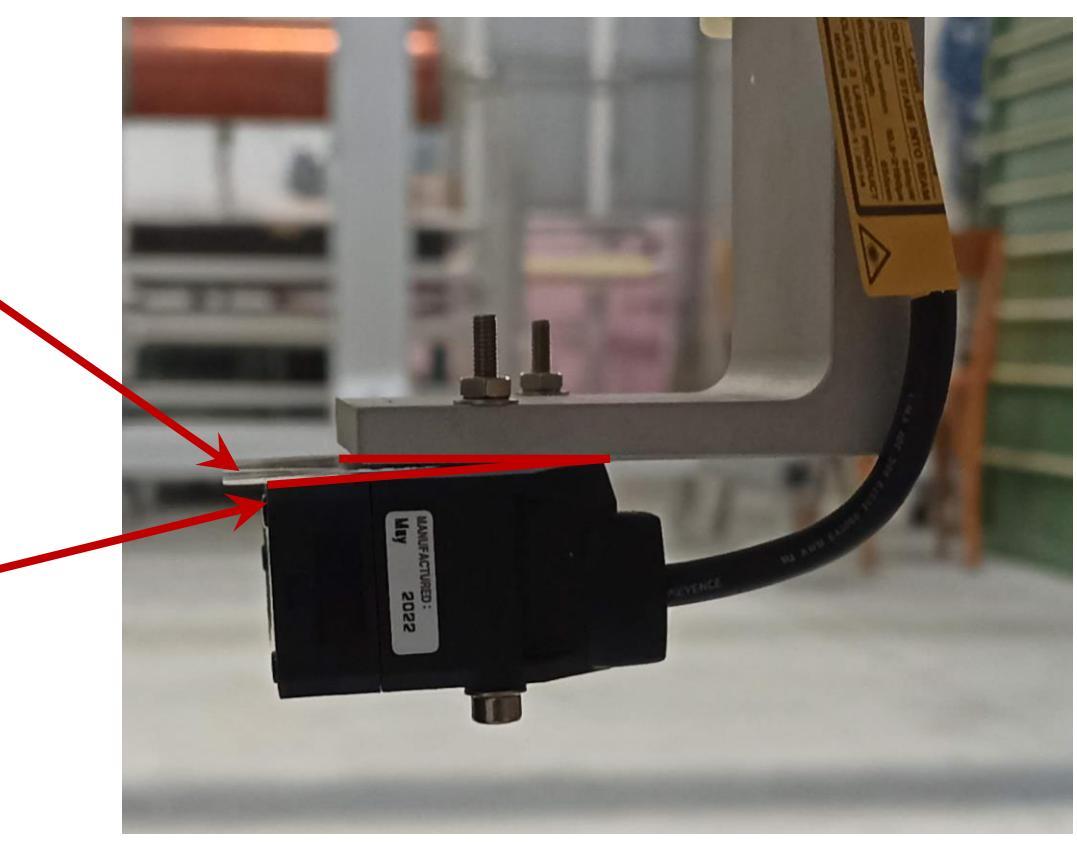
### Sensor mounting

This insulation should be here according to the instruction manual but I do not know why

Bad sensor placement, not an issue for the bottom lasers such as this one

#### Check top lasers position when reinstalling

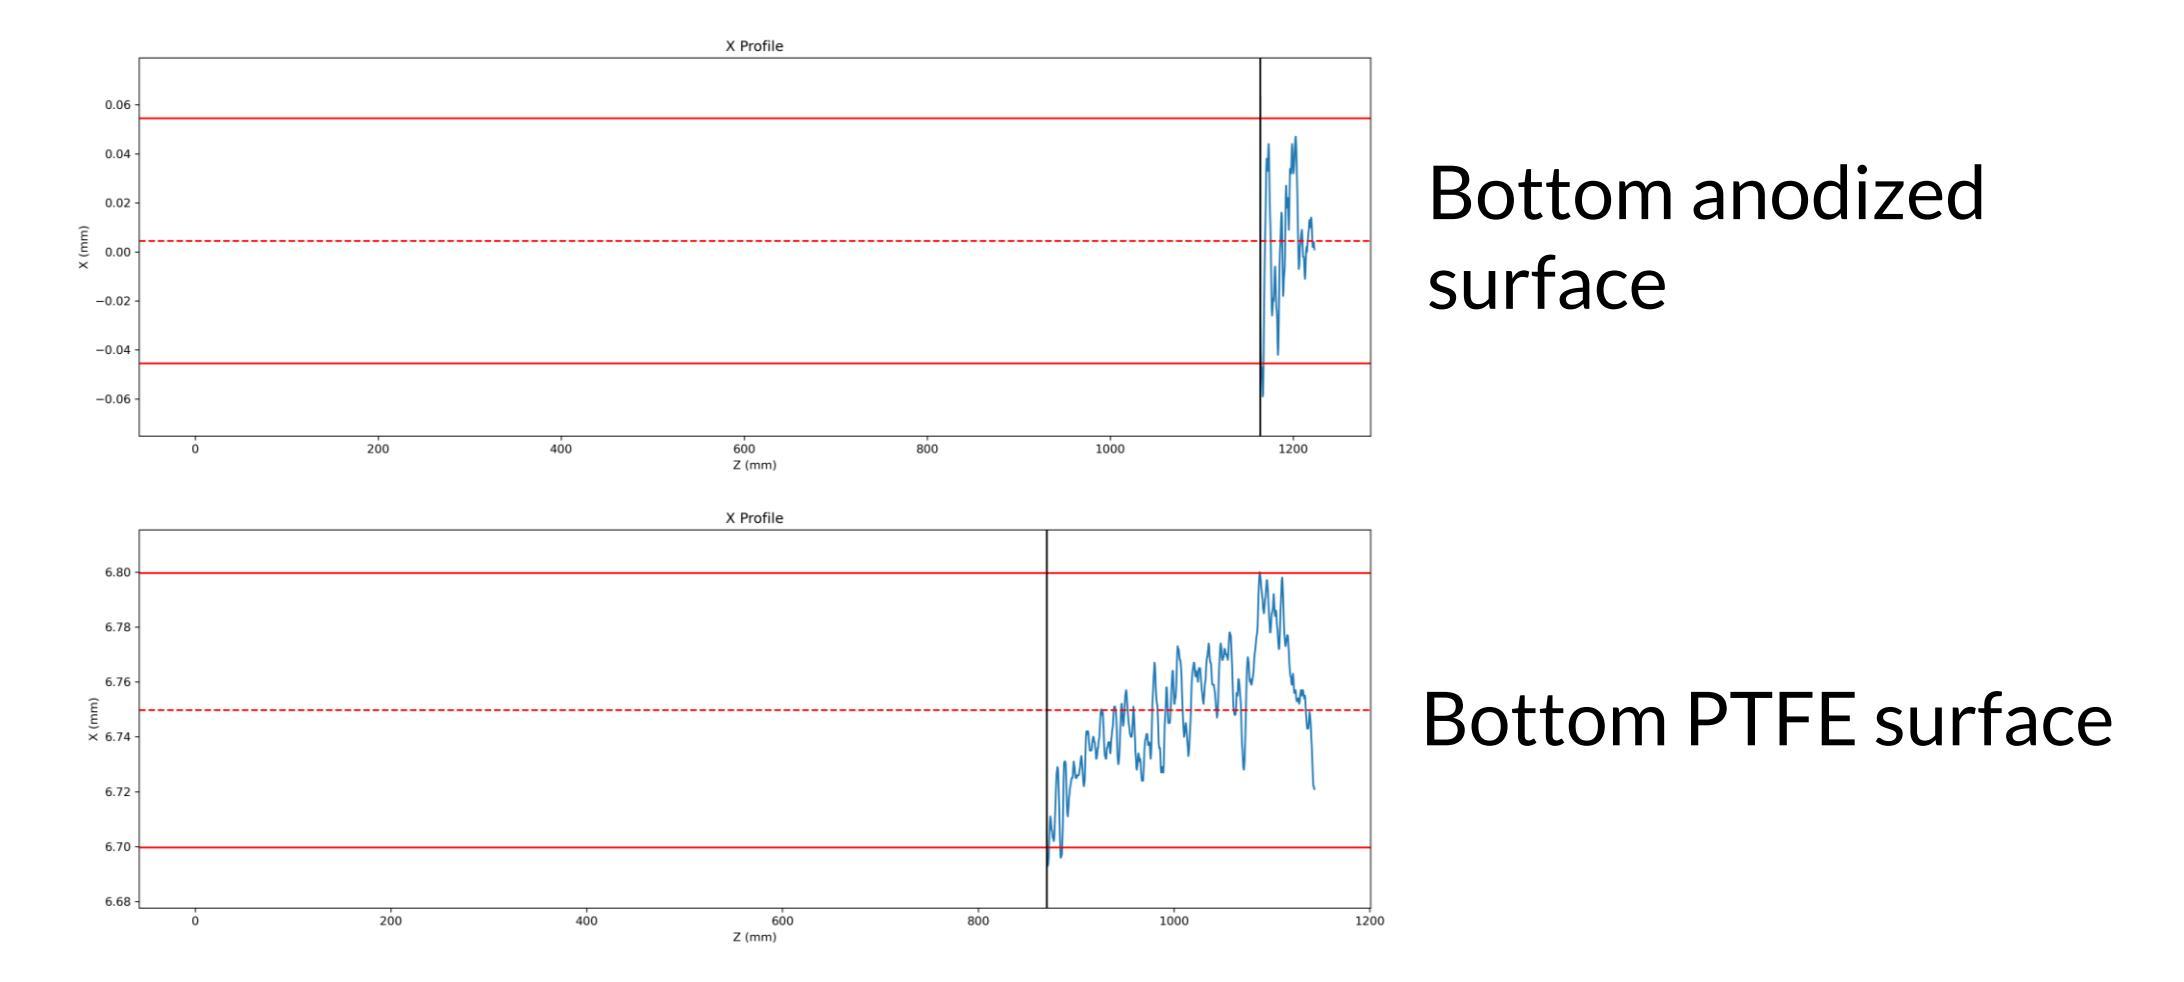
#### Variance and Profiles

The alignment is within the acceptable tolerance, still I expected better repeatability

Measurements taken on the anodized aluminum surfaces show much more variance than the ones taken on the Teflon surface...

Surface roughness? Reflectivity? Can it be mitigated with better grounding of the sensors?

- Check variance when measuring on different roughness/reflectivity surfaces Tape different materials on the molds and collect profiles
- Check variance when moving at slower speed
   Take a profile on the anodized and PTFE-coated surfaces using the VIM control software to move
- Alignment repeatability test and assessment of the positioning error Lift the mold, place it back down, is it still aligned?
- Proceed to the XY alignment test
