### **Observations of Spontaneous Field Emission Occurrence with Subsequent Cavity Performance Degradation – or,**

### "What Just Happened?"

Joe Ozelis

TTC Meeting, 28 February - 2 March, 2011, Milan

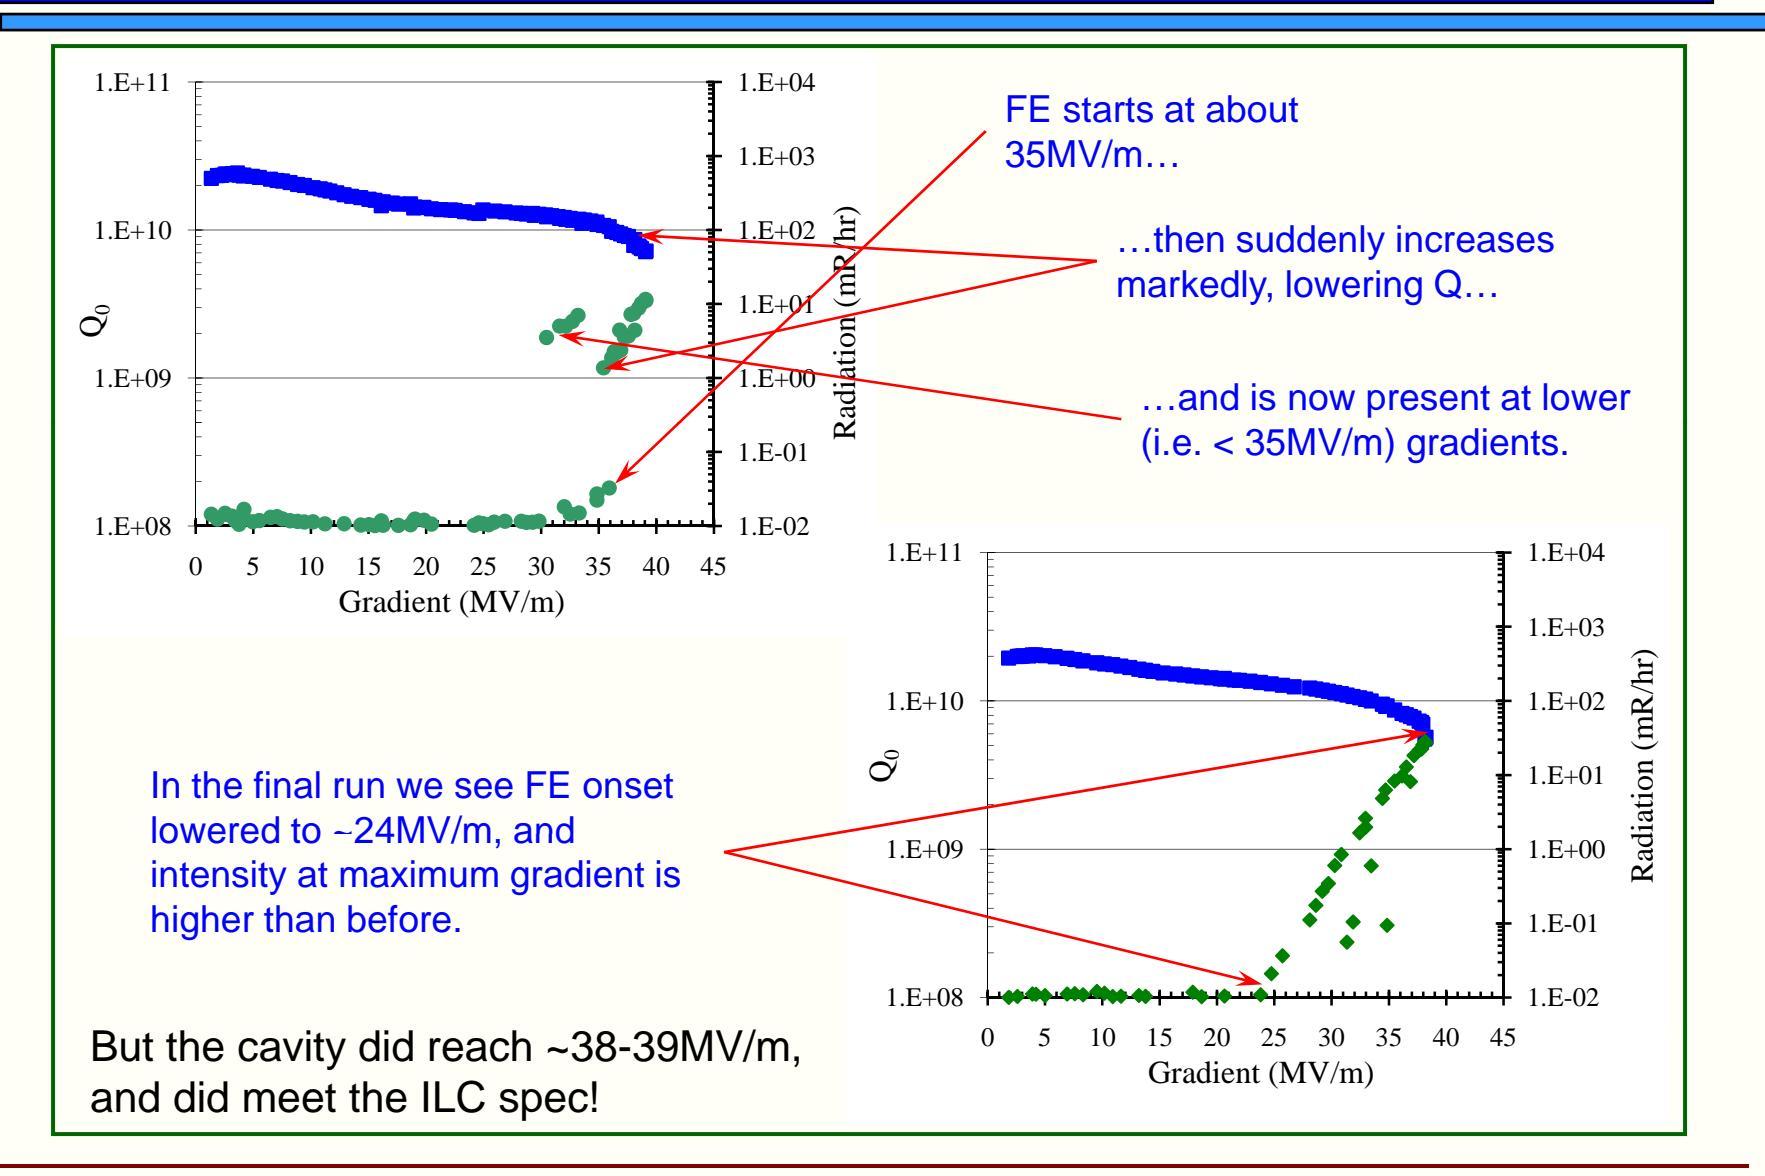
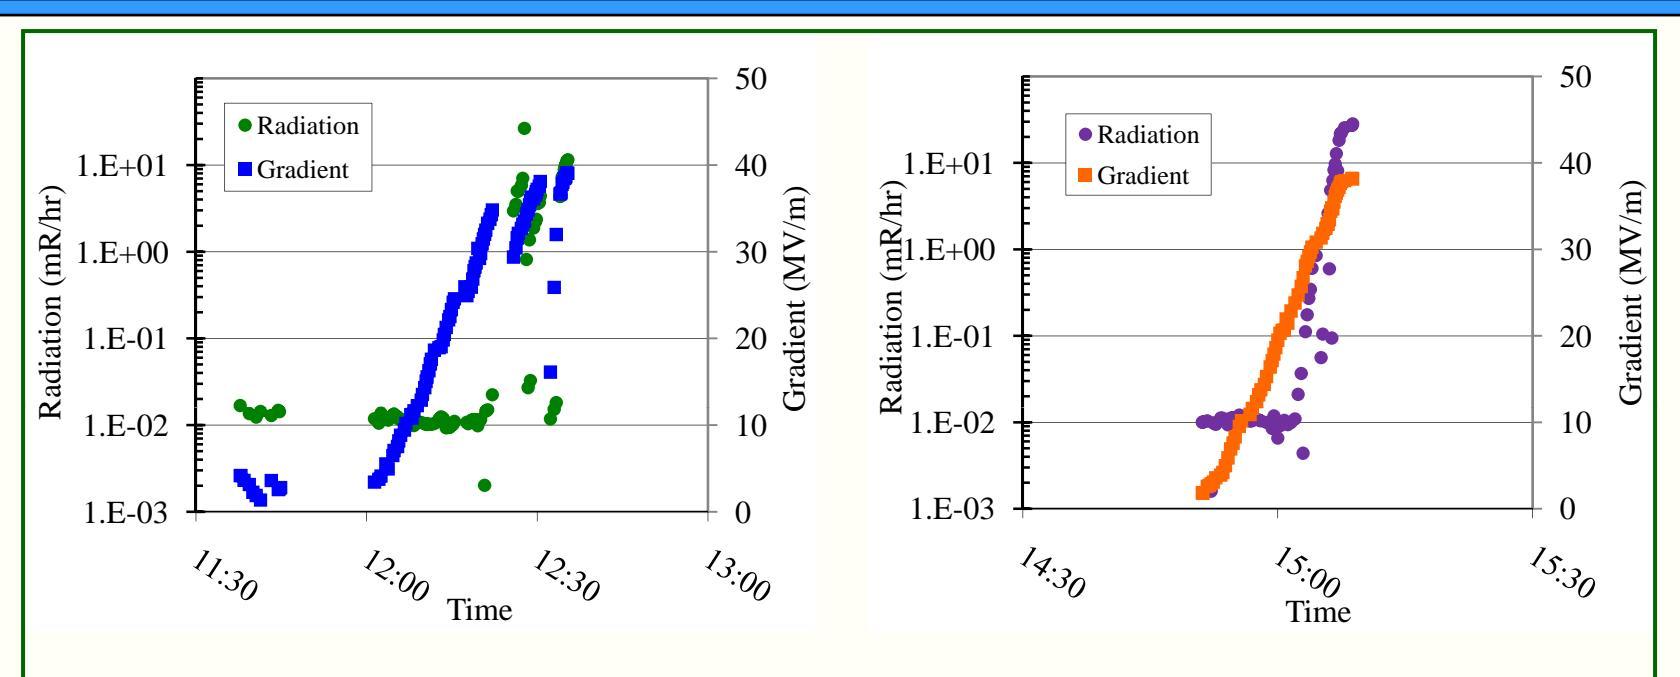
# TB9ACC014 – "Dejavu all over again"

Plot of gradient/radiation vs time also clearly shows this change in FE behaviour.

Cavity was subsequently damaged (dent in cell #9), repaired (cell #9 de-tuned by ~20%), and re-tested. Quench limited (FE) to 30MV/m.

The cavity was then given additional HPR and re-tested... quench limited to 34MV/m, with some FE. No more "events".

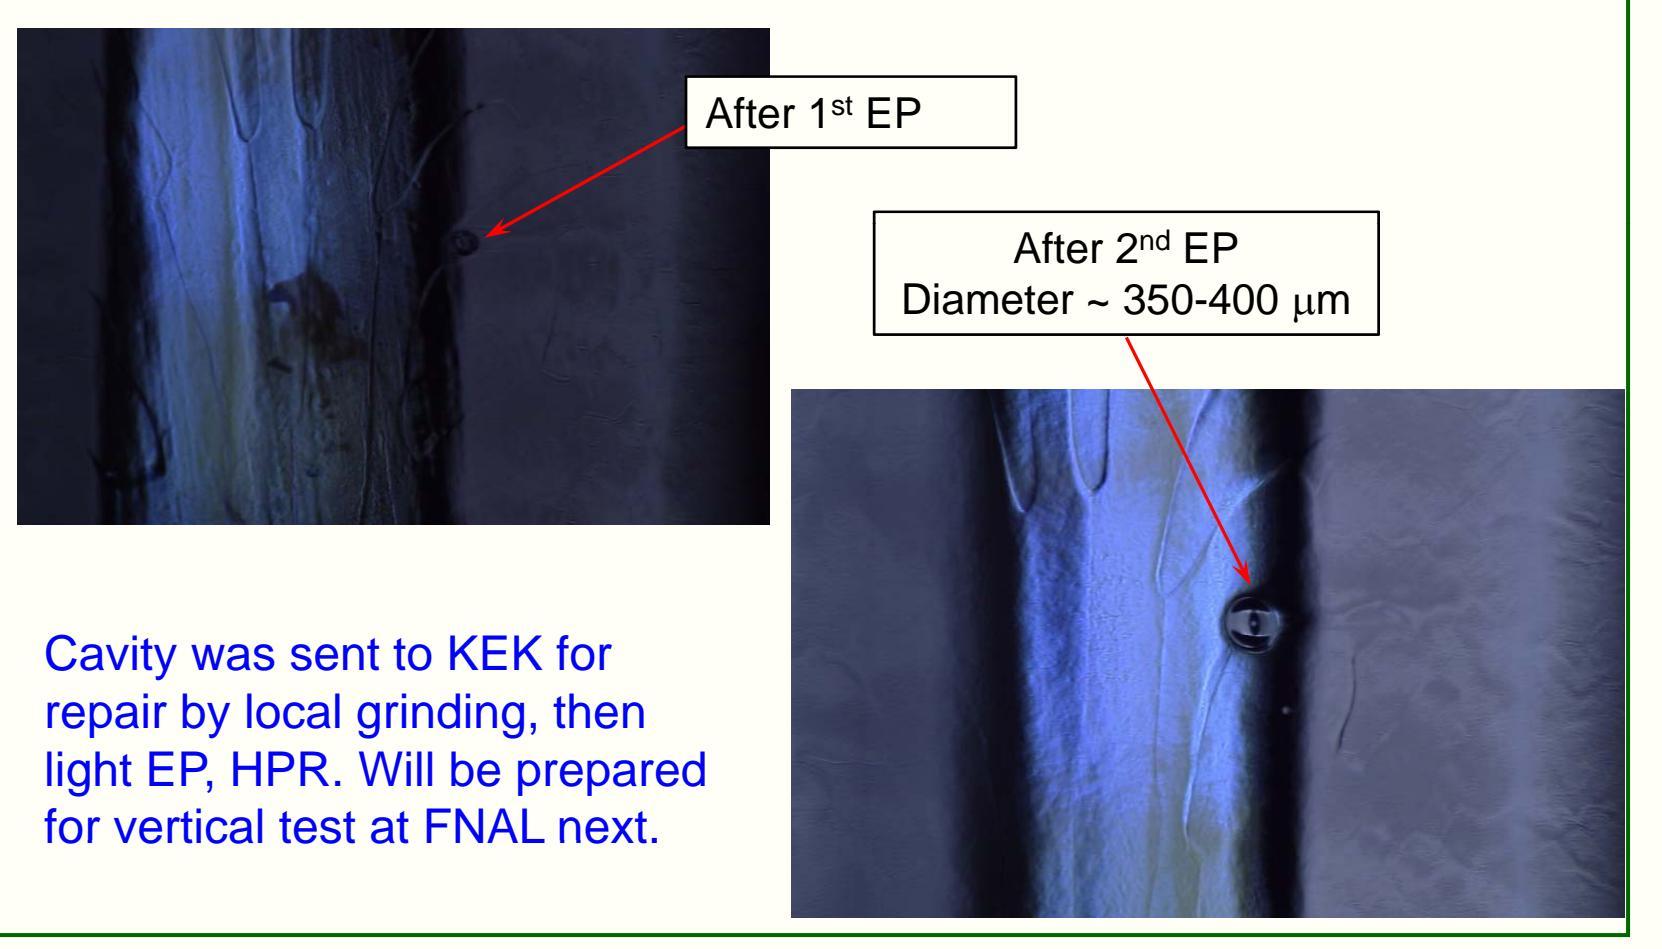
Optical inspections of TB9RI026 revealed a huge "crater" on the iris between cells 8/9, which got larger as EP was carried out.
