#### ECOgas weekly meeting Weekly shift report

06/04/2023

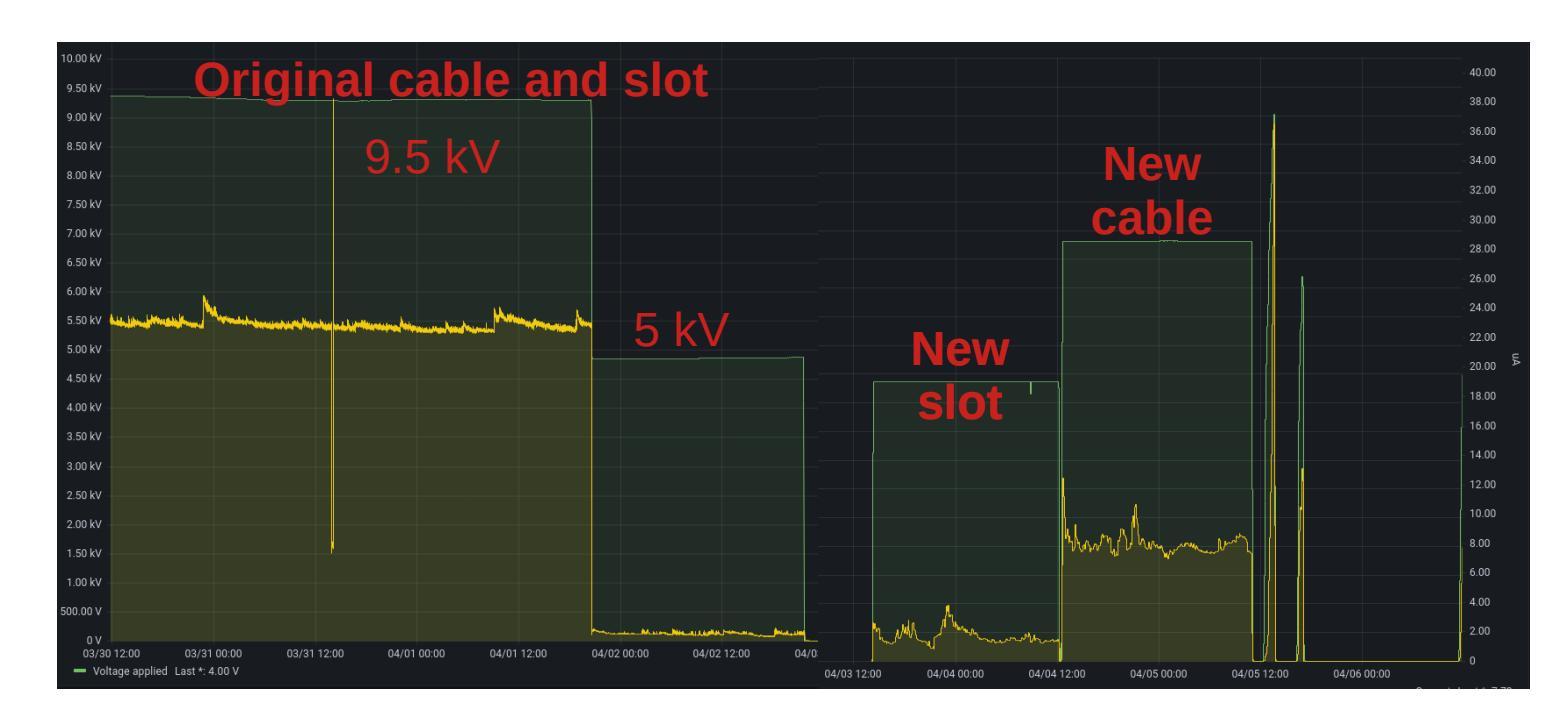
#### **Issues with SHiP chamber**

- During the stability scan a few "bumps" where current increased and then went down were observed
  - $\rightarrow$  Not correlated with source change or other parameters

$\rightarrow$  Occurrence frequency was monitored and it was decided to lower the HV to 5 kV to observe if those bumps still appeared

$\rightarrow$  Change of HV slot and cable to see if they were correlated with the cable

- Bumps are still there, now source off HV scan has been performed with the old cable but in the new slot
- On Grafana, "ShiPtemp" panel to monitor the behavior of SHiP chamber

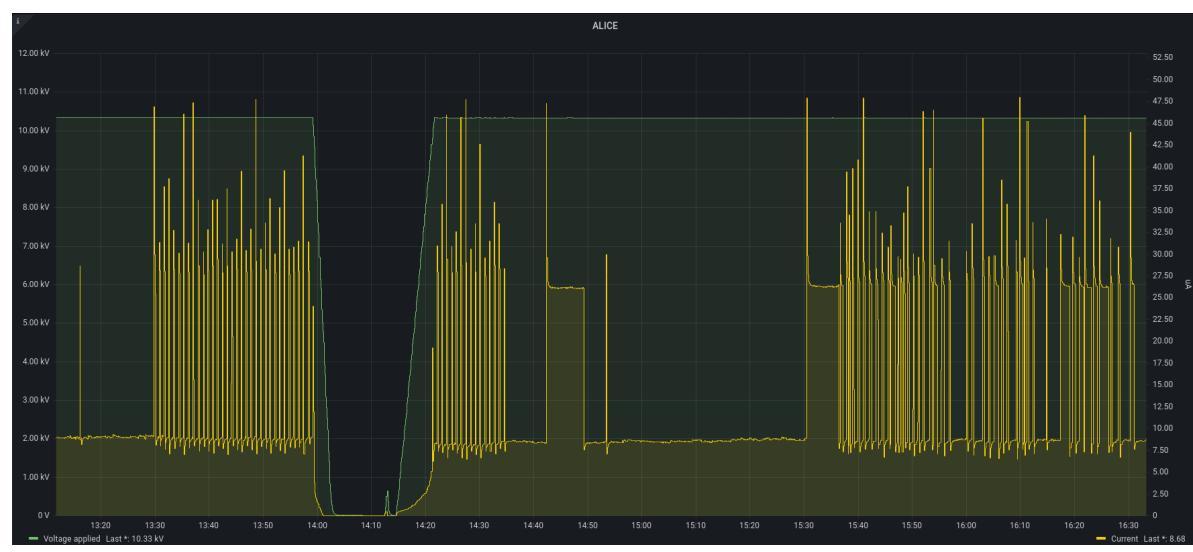
# **Currents during source test**

- There was an issue with the source ON/OFF procedure which has been fixed by the source company
- To test they had to switch ~200 times between source OFF and ON
- Chambers kept on for half a day and had many spikes in the absorbed current, due to the source switching
  - $\rightarrow$  Eventually they were switched off to avoid damaging
