# Ecogas summary

# Shift report

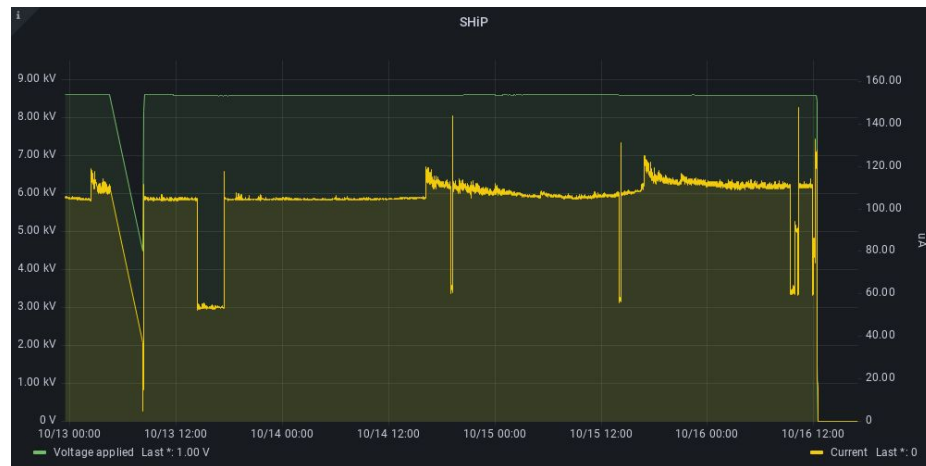
- LHCb-SHiP currents unstable: [entry 428](#)
  - It seems this issue happens regularly when detector is under irradiation
- Argon scan done by Luca

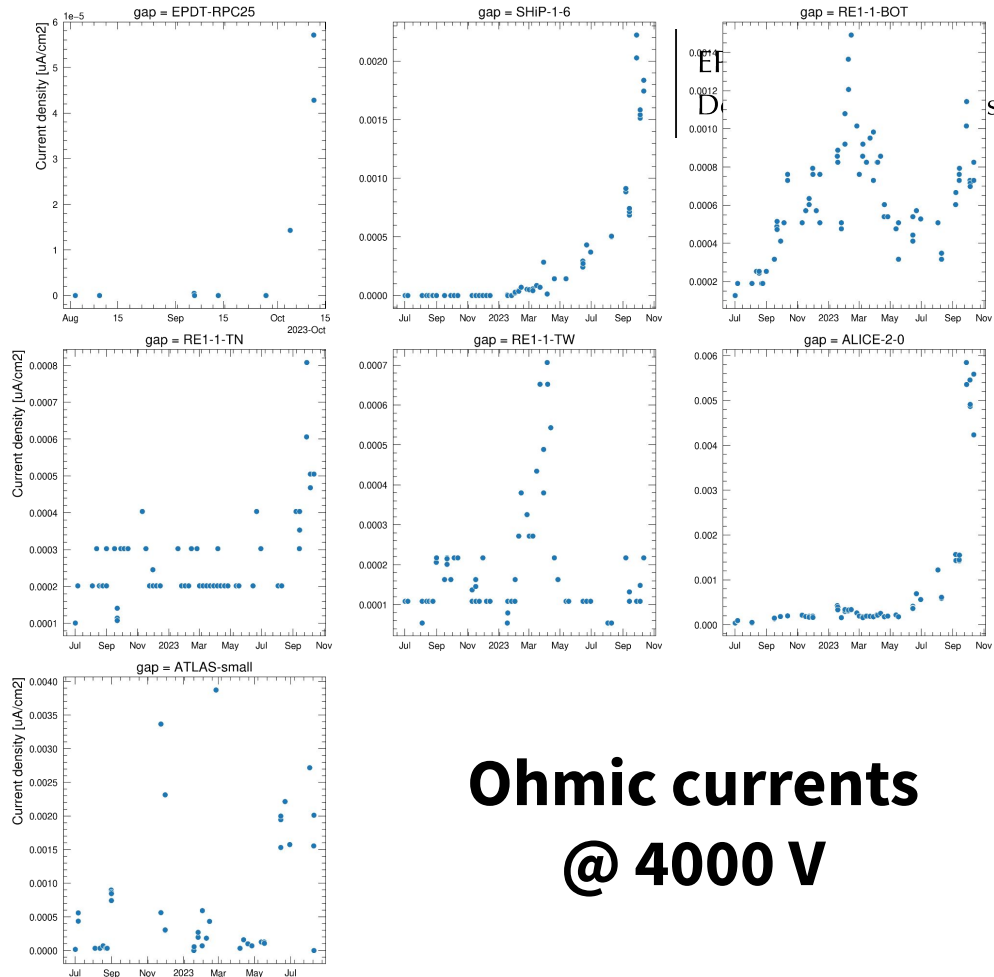
**Ohmic currents  
@ 4000 V**

- Increase in ohmic currents after beginning of irradiation at 10.6 kV (before it was kept at standby voltage)

- Exponential increase in currents?

- Increase in currents

- Currents stable

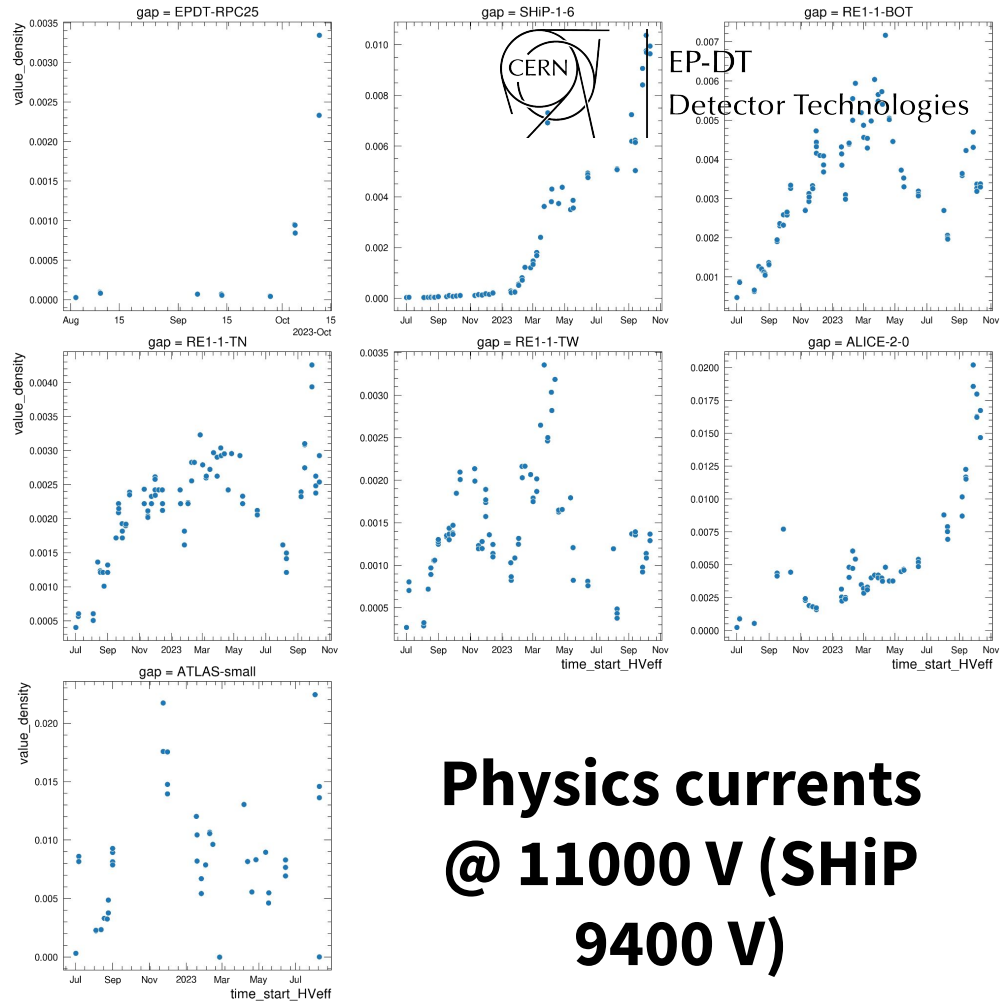
Physics + Ohmic (no ohmic subtraction)

Similar behaviour w.r.t. to ohmics
