3D Model Space Clashes

8th May 2024

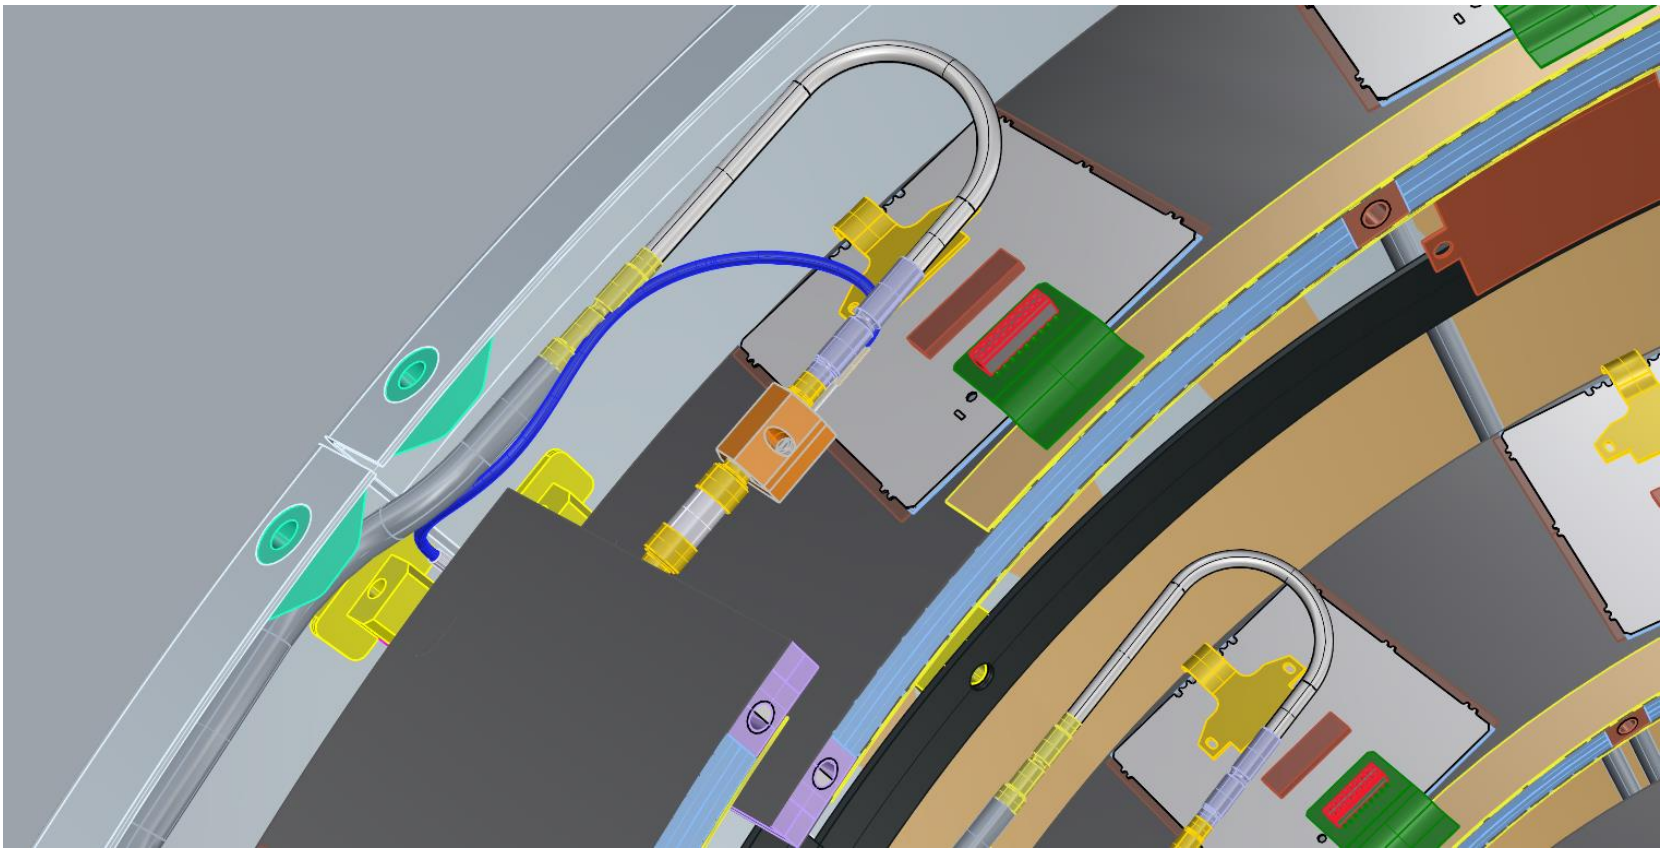
Cooling System Temperature Sensors (Ring 1)

When there are added the Front Support is not blocking access – but we've always assumed access to all fixings (eg half-ring mounting screws, Data PP0s, Power connectors are on the high Z side (except for last HR). Does the HC integration tooling permit access ?

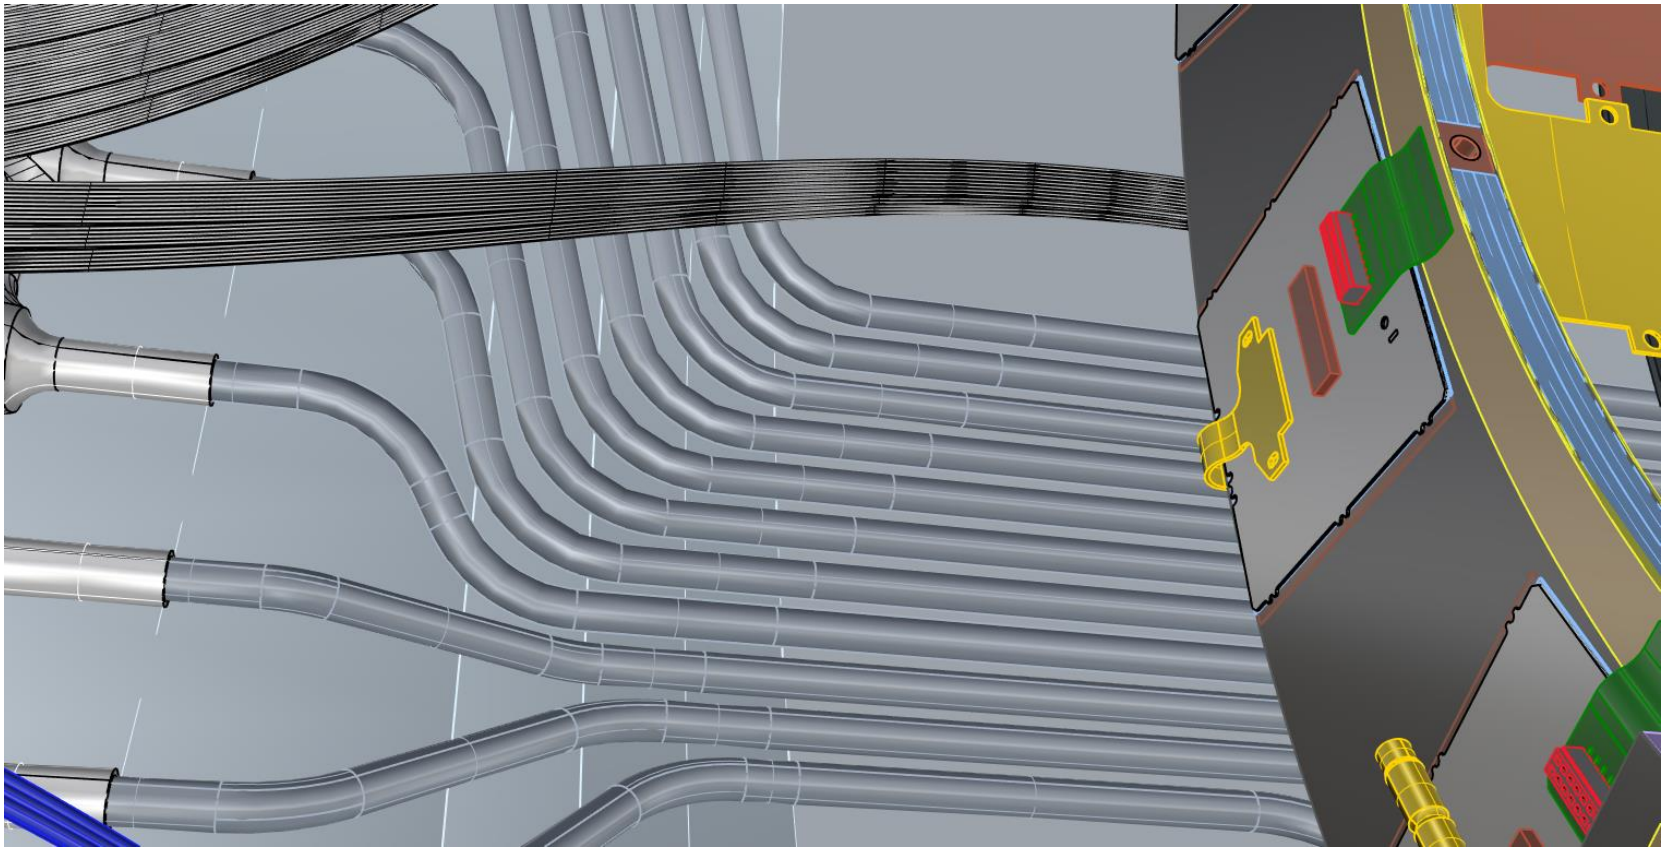
Clash between DataPP0 finger and Type-1 Cooling Exhaust – HR11

I have a DataPP0 here – I do not believe the bends assumed in the 3D modelling are realistic – unless there is a ‘feature’ on the outer rim of the half-ring to fix the DataPP0 finger to. Suggest moving group of 4 exhaust tubes round in phi.

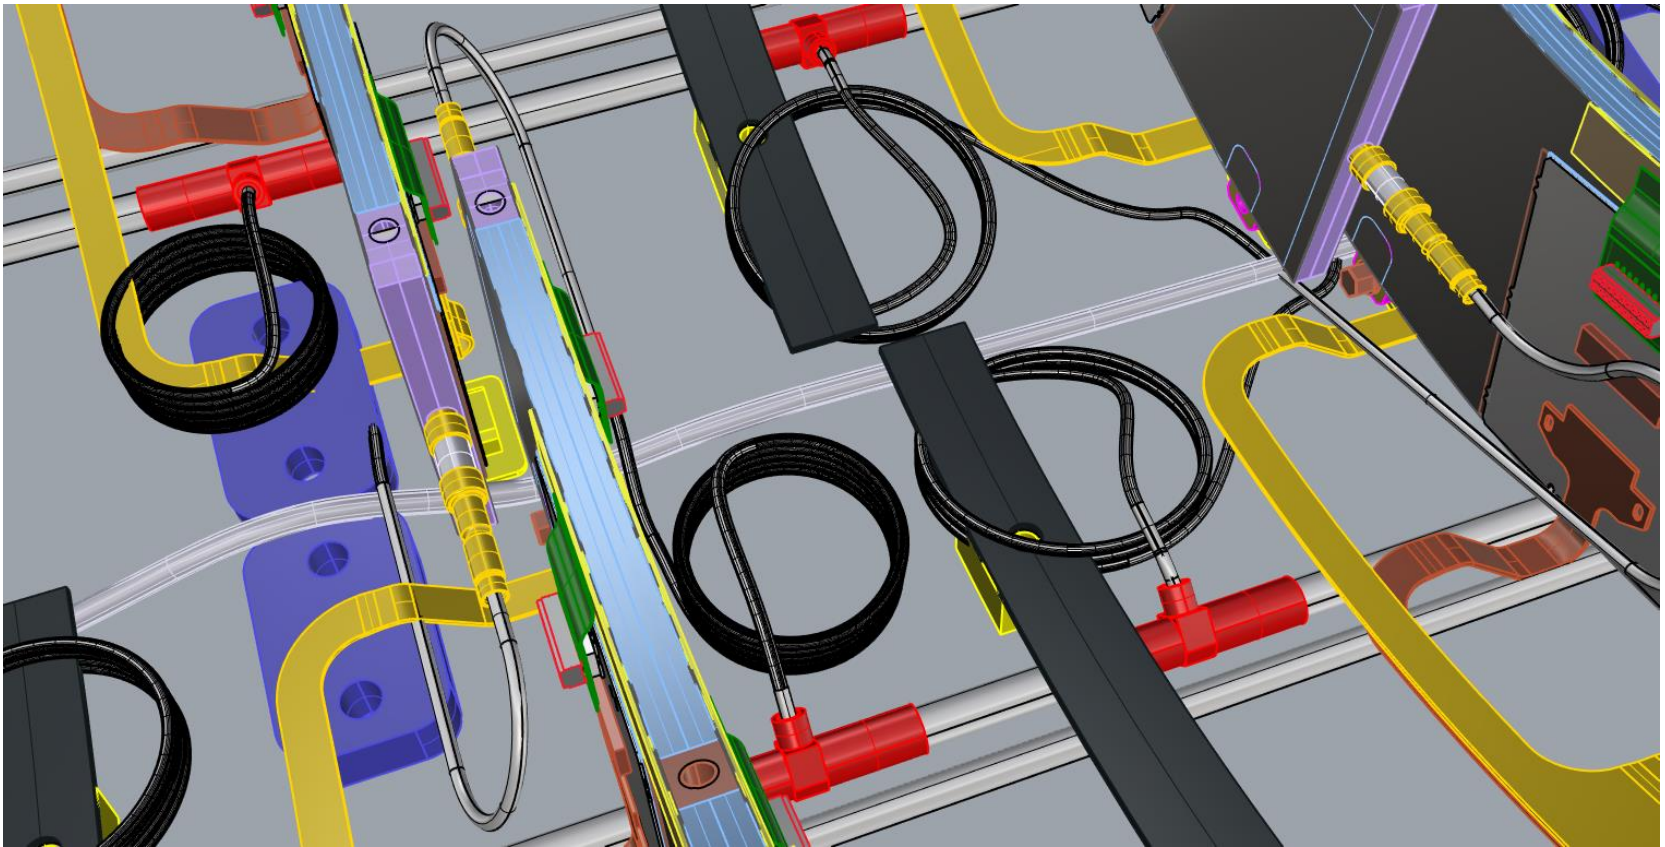
Type-1 Cooling Inlet – many clashes

Identified & discussed at Edinburgh but no time to fix due to preparations for FDR. Plan is to investigate turning capillary coils through 90 degrees – might also help with clashes during HC joining.

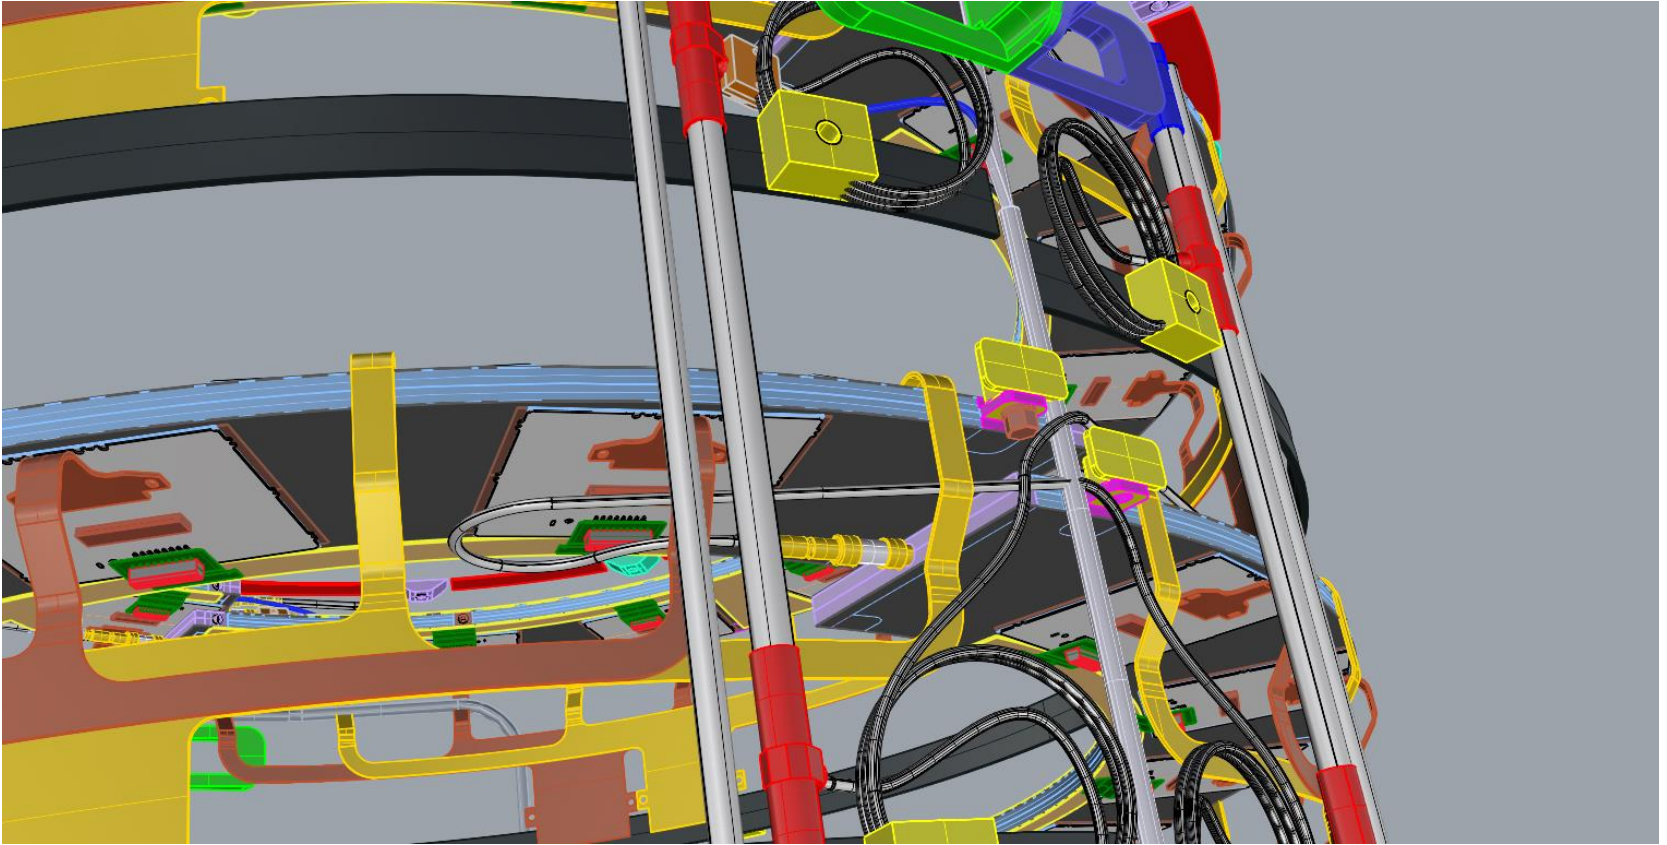
Half-cylinder joining – Inlet side

Long length of capillary loop penetrates into opposite side – what keeps it in place ?
