# **dRICH Back-End: FLX 182 status/updates**

Francesca Lo Cicero  
INFN Roma, APE Lab

September 5<sup>h</sup> 2025

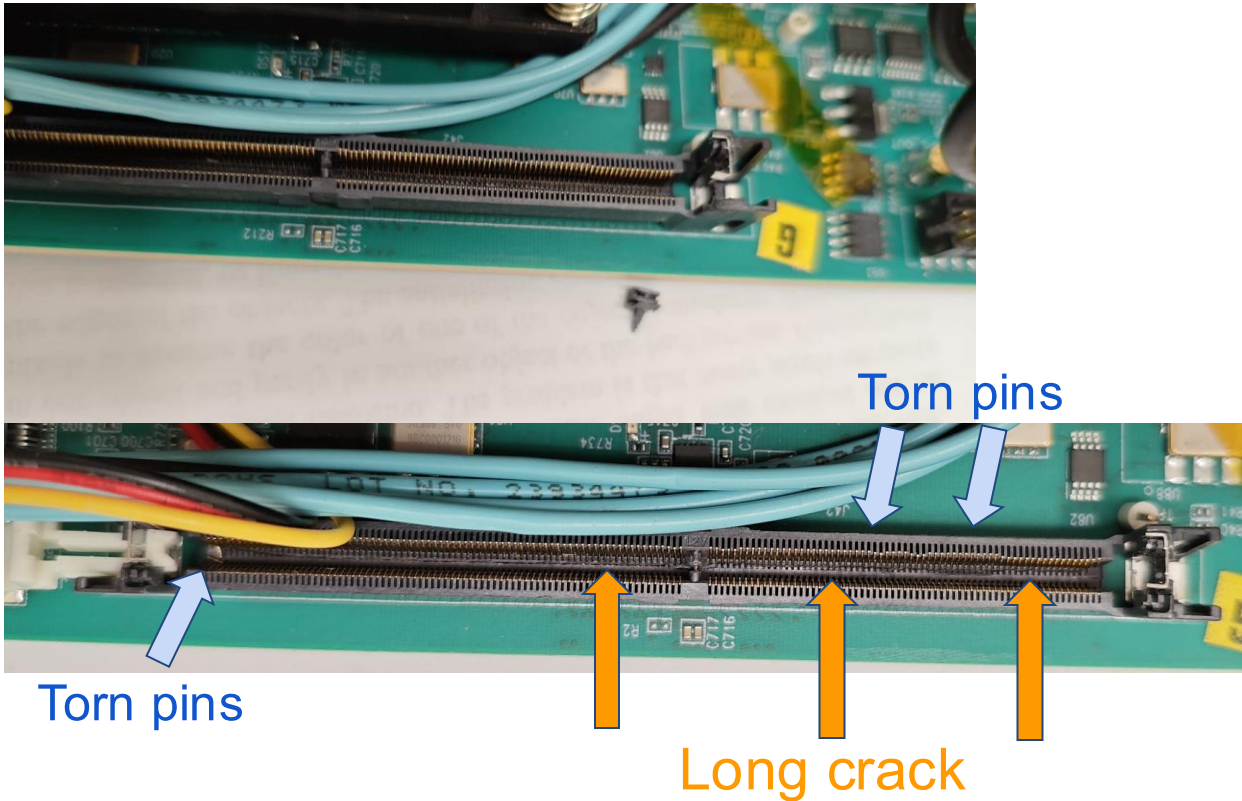
Felix-182 board on loan from Jlab arrived in Rome end of December '24 (thanks David Abbott!).

Unfortunately it showed damages to the DRAM slot:

- **torn contact pins**
- **a crack along the inner side of the slot**

They likely occurred due to the pressure of a DRAM module left in the slot during the delivery.

As a consequence, DRAM is not detected by the system.

We attempted to load official firmware onto the board (<https://gitlab.cern.ch/atlas-tdaq-felix/firmware/>) but the process failed due to a DRAM check error.

**Both agreed that is extremely difficult to repair the DRAM slot and not worth the effort considering the costs and the likely not optimal result, we were ready to send it back...**

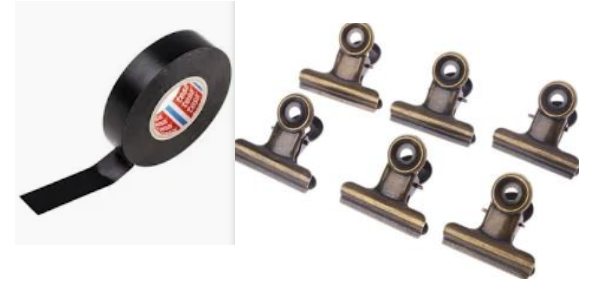
**Homemade fix:** We experimented with various imaginative tools to better connect the DRAM.

**The issue persisted!**

- We got advice from Carlo Alberto Gottardo (Coordinator of the FELIX project) about the fact that the DRAM is used only by the PS (ARM SoC) and that in current FW versions the PS performs just ancillary functions (BIST,...), while all the design core functionalities are implemented in the PL.

**Preliminary solution:** we modified the release FW removing the PS (and DRAM) from the design -> modified FW loaded and board detected!

**The issue was solely related to the unconnected DDR**

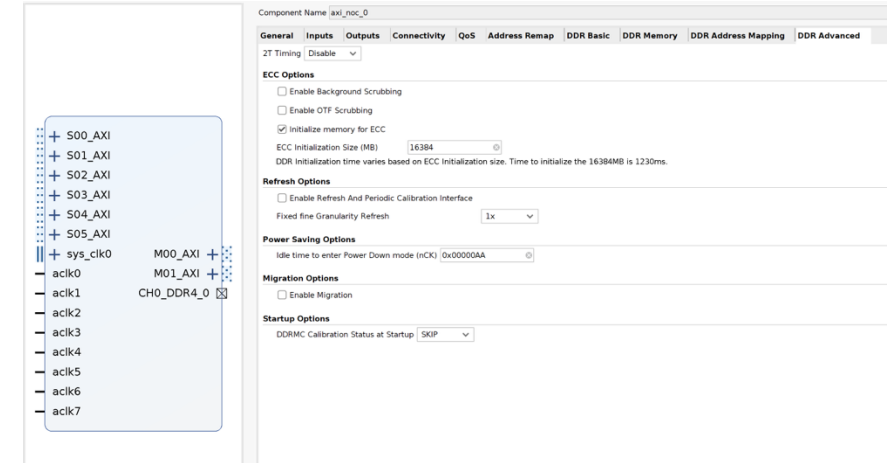
**FW loaded and board detected!**

- in the FELIX-182 FW ( in cips\_BD\_BNL182 block design) there is a component, the Xilinx AXI NoC that functions as a high-bandwidth scalable fabric to connect blocks. Xilinx AXI NoC can be configured to include one or more integrated DDR memory controllers (MCs).
- Startup Options: DDRMC Calibration Status at Startup to SKIP. The default behavior for the Versal PLM at boot is to gate the assertion of the Configuration DONE signal if a DDRMC fails calibration. If this option is set to SKIP then the DDRMC calibration status will be ignored at startup and DONE will assert regardless of the DDRMC status.
