NA62 Collaboration meeting
1 – 5 September 2014, Ferrara (IT)

Mounting of RICH mirrors

M. Piccini, A. Bizzeti

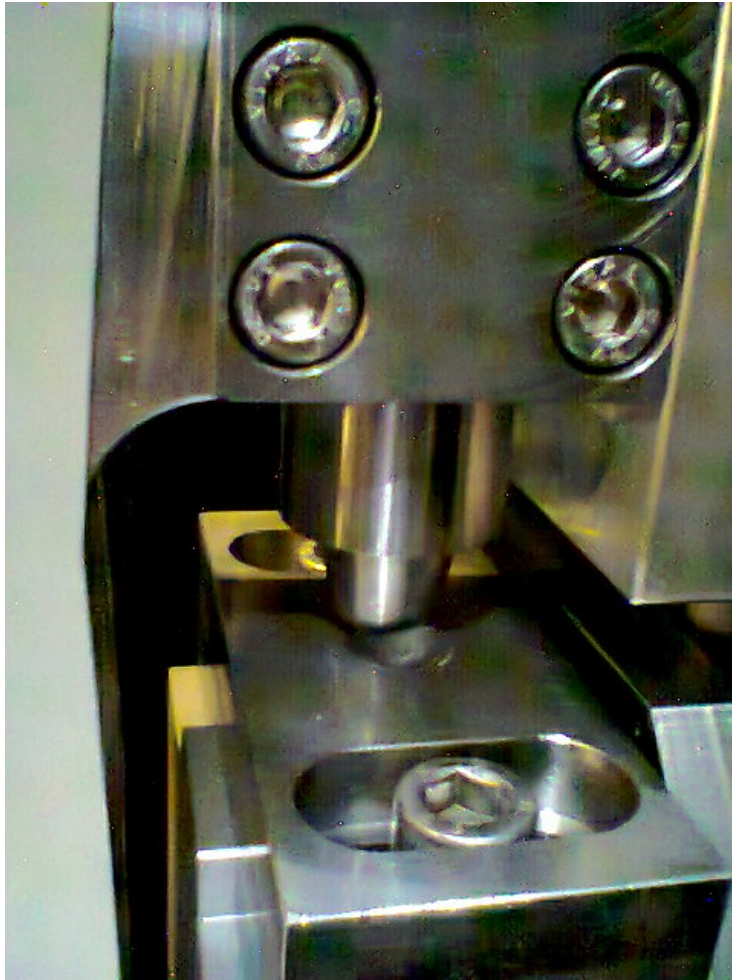
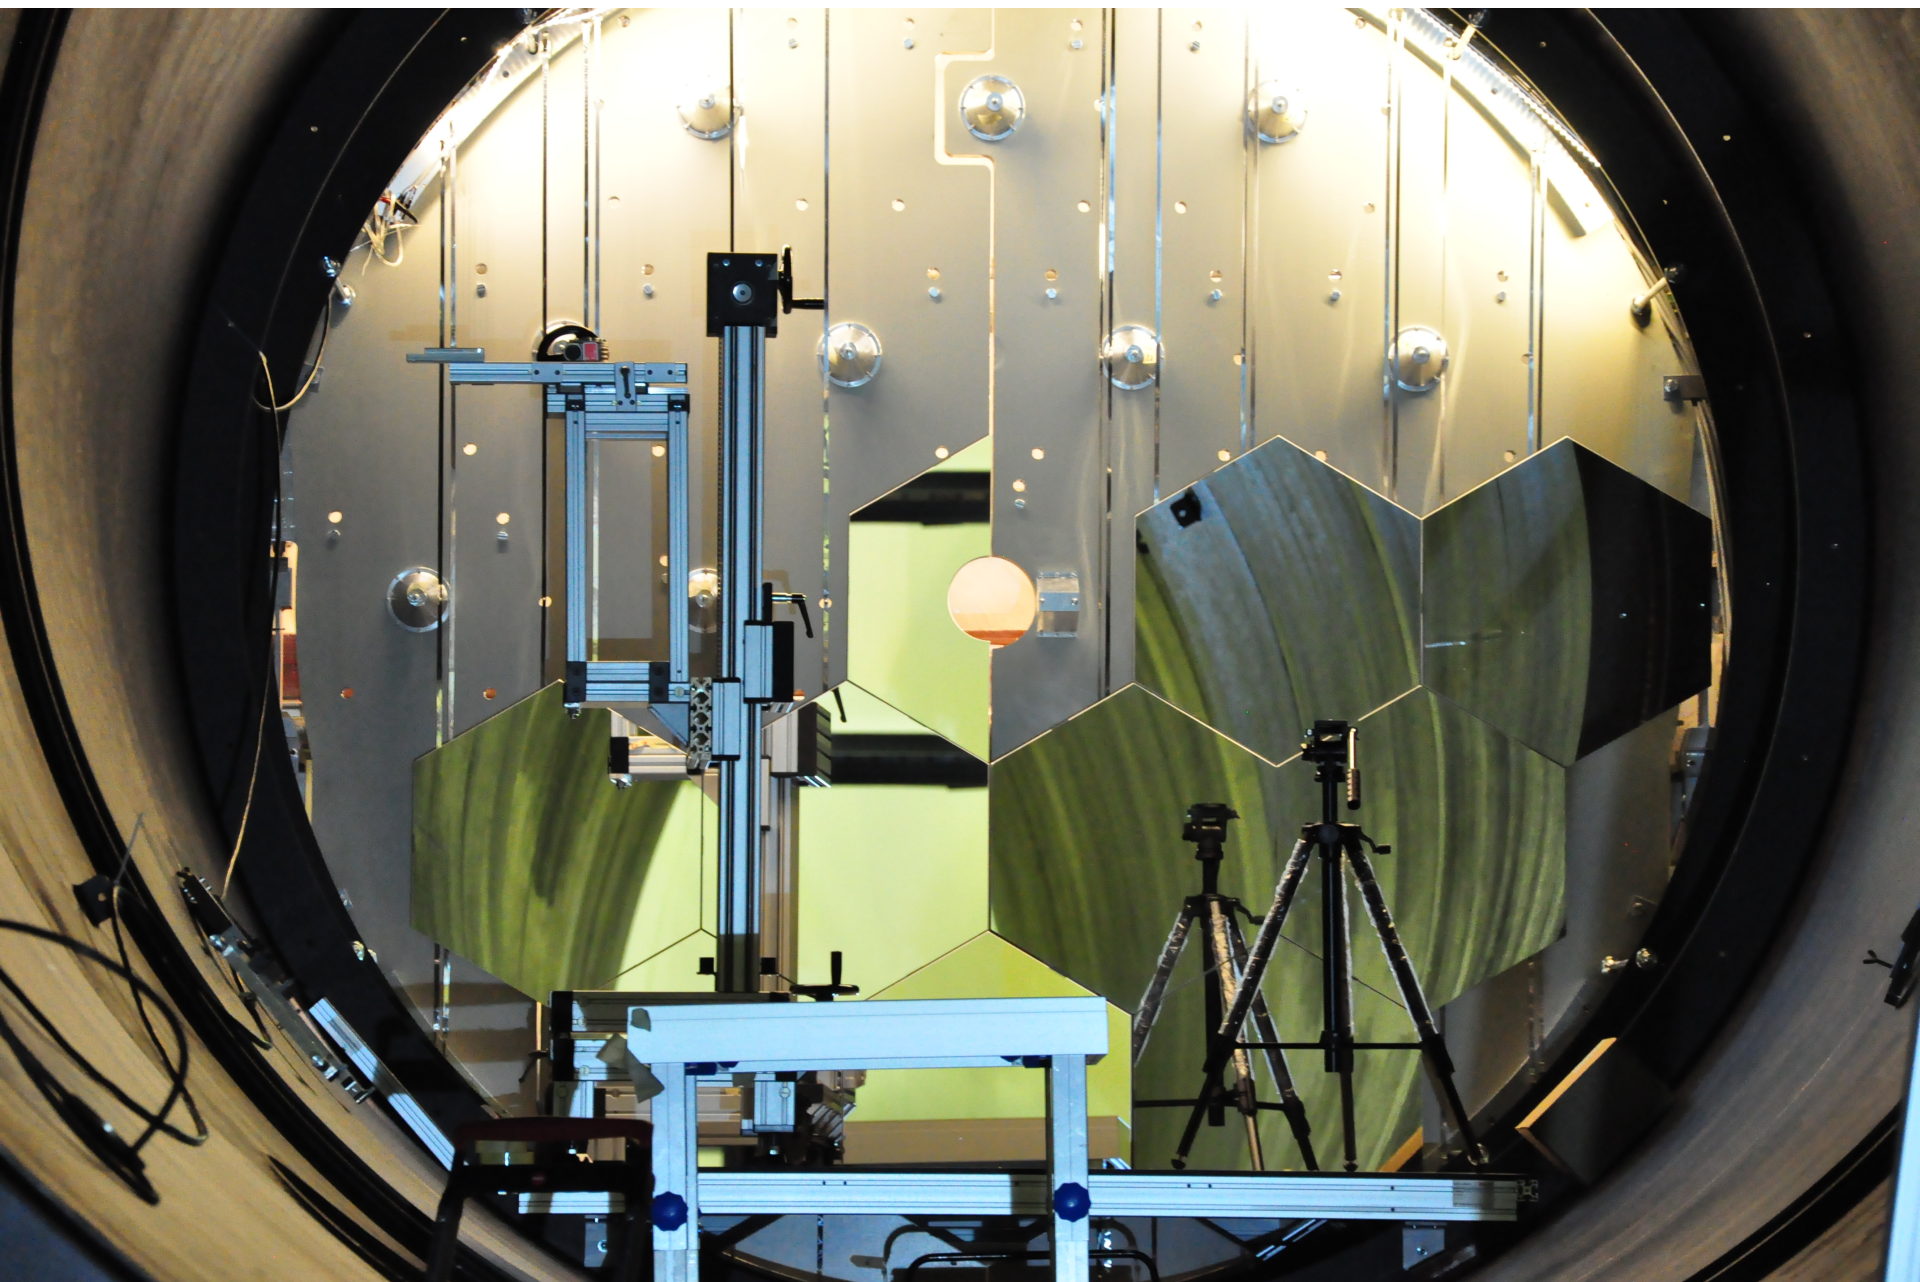
Pannel re-positioned

On 05/07/2014 it has been seen that the support panel was not properly positioned in the Jura side

A tool to safely reposition the support pannel (10 mirrors were already installed!) was immediately produced by Antonfranco and Damiano

On 07/07/2014 support panel repositioned and pin inserted in the proper (and safe) position

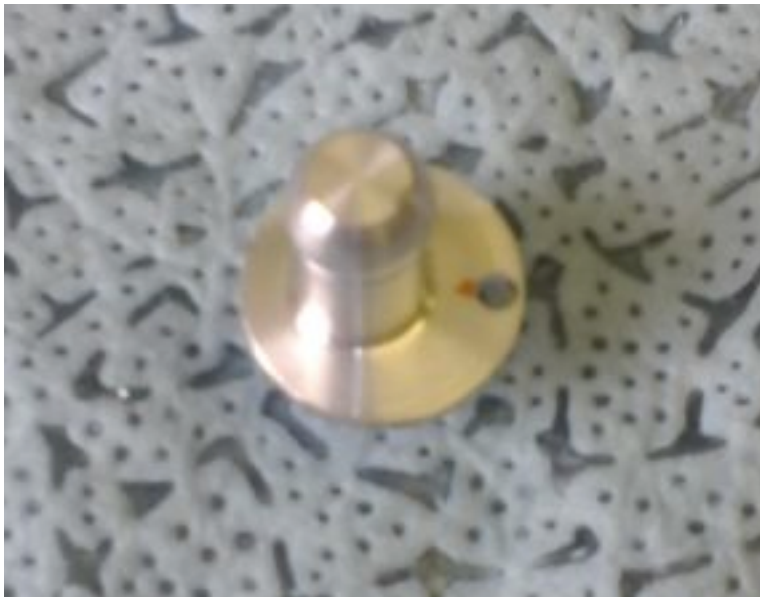
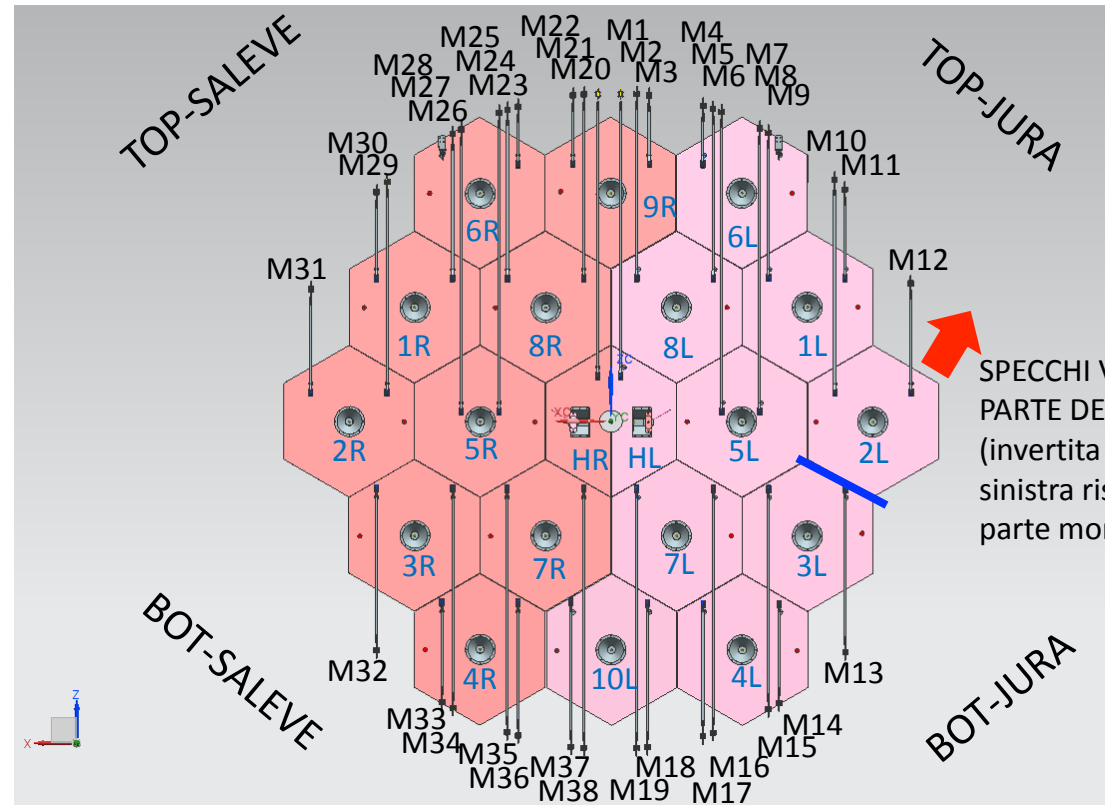
Problems with 02-L

On 08/07/2014 we were trying to install 02-L, it was touching 03-L

A new dowel was produced, with the axis of the screw entering in the cone displaced by **1.5 mm** wrt the axis of the dowel

On 10/07/2014 the new dowel was mounted and the mirror 02_1 was successfully installed

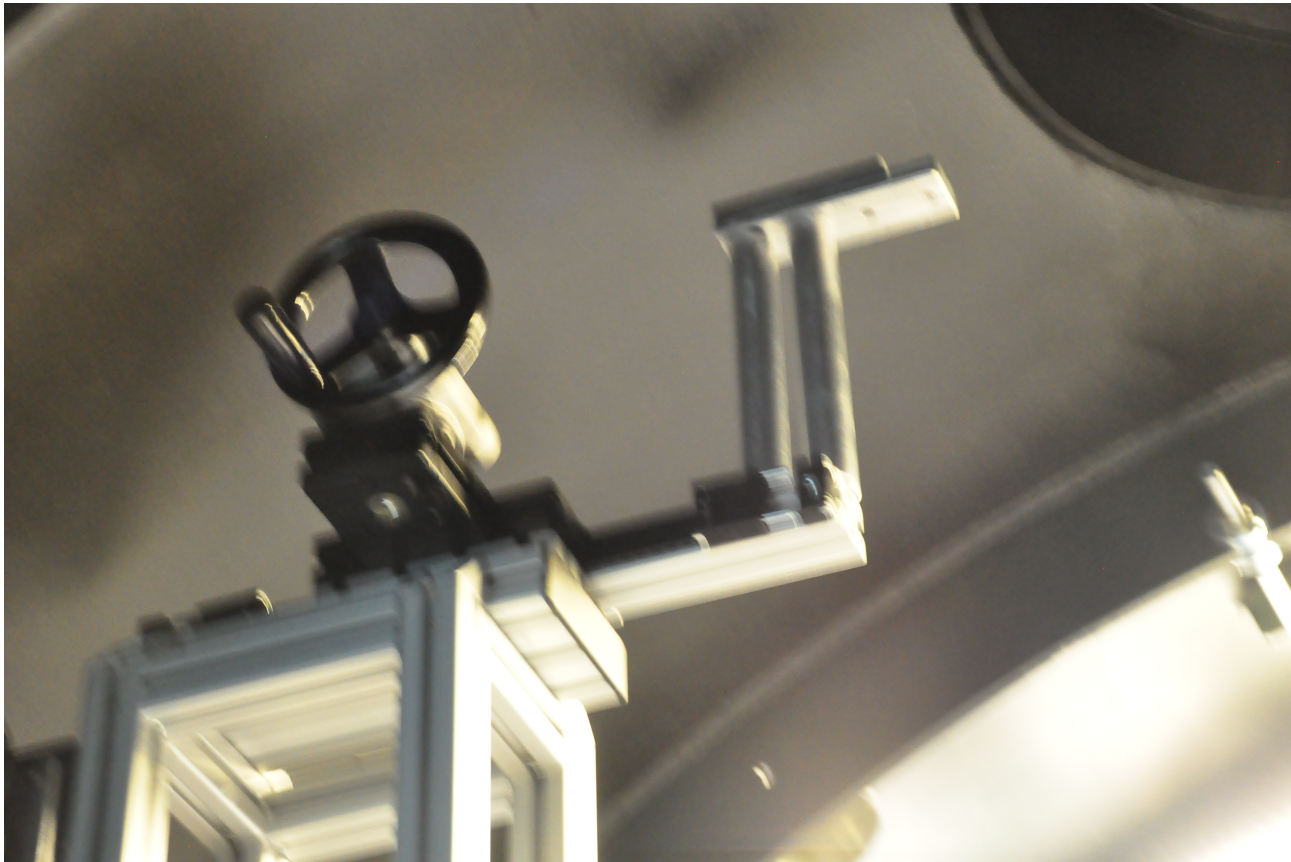
The last raw

For the last raw the top part of the loading tool was touching the vessel, we install the first mirror by hands, just using the crutch, than for the last two mirrors we decide to produce a “nose” to avoid the problem

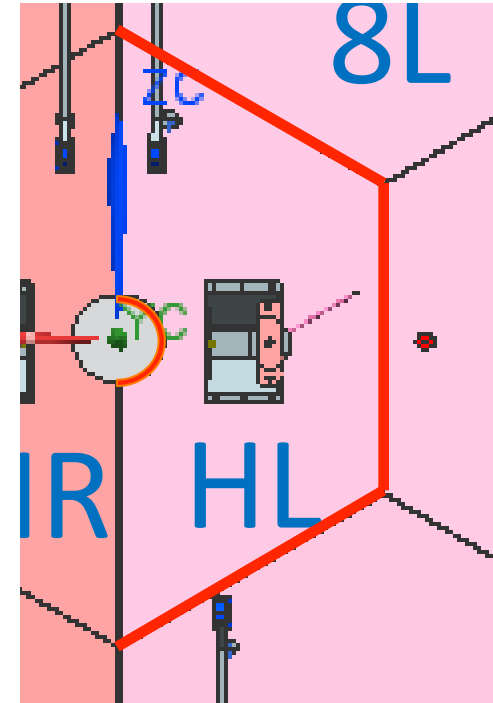
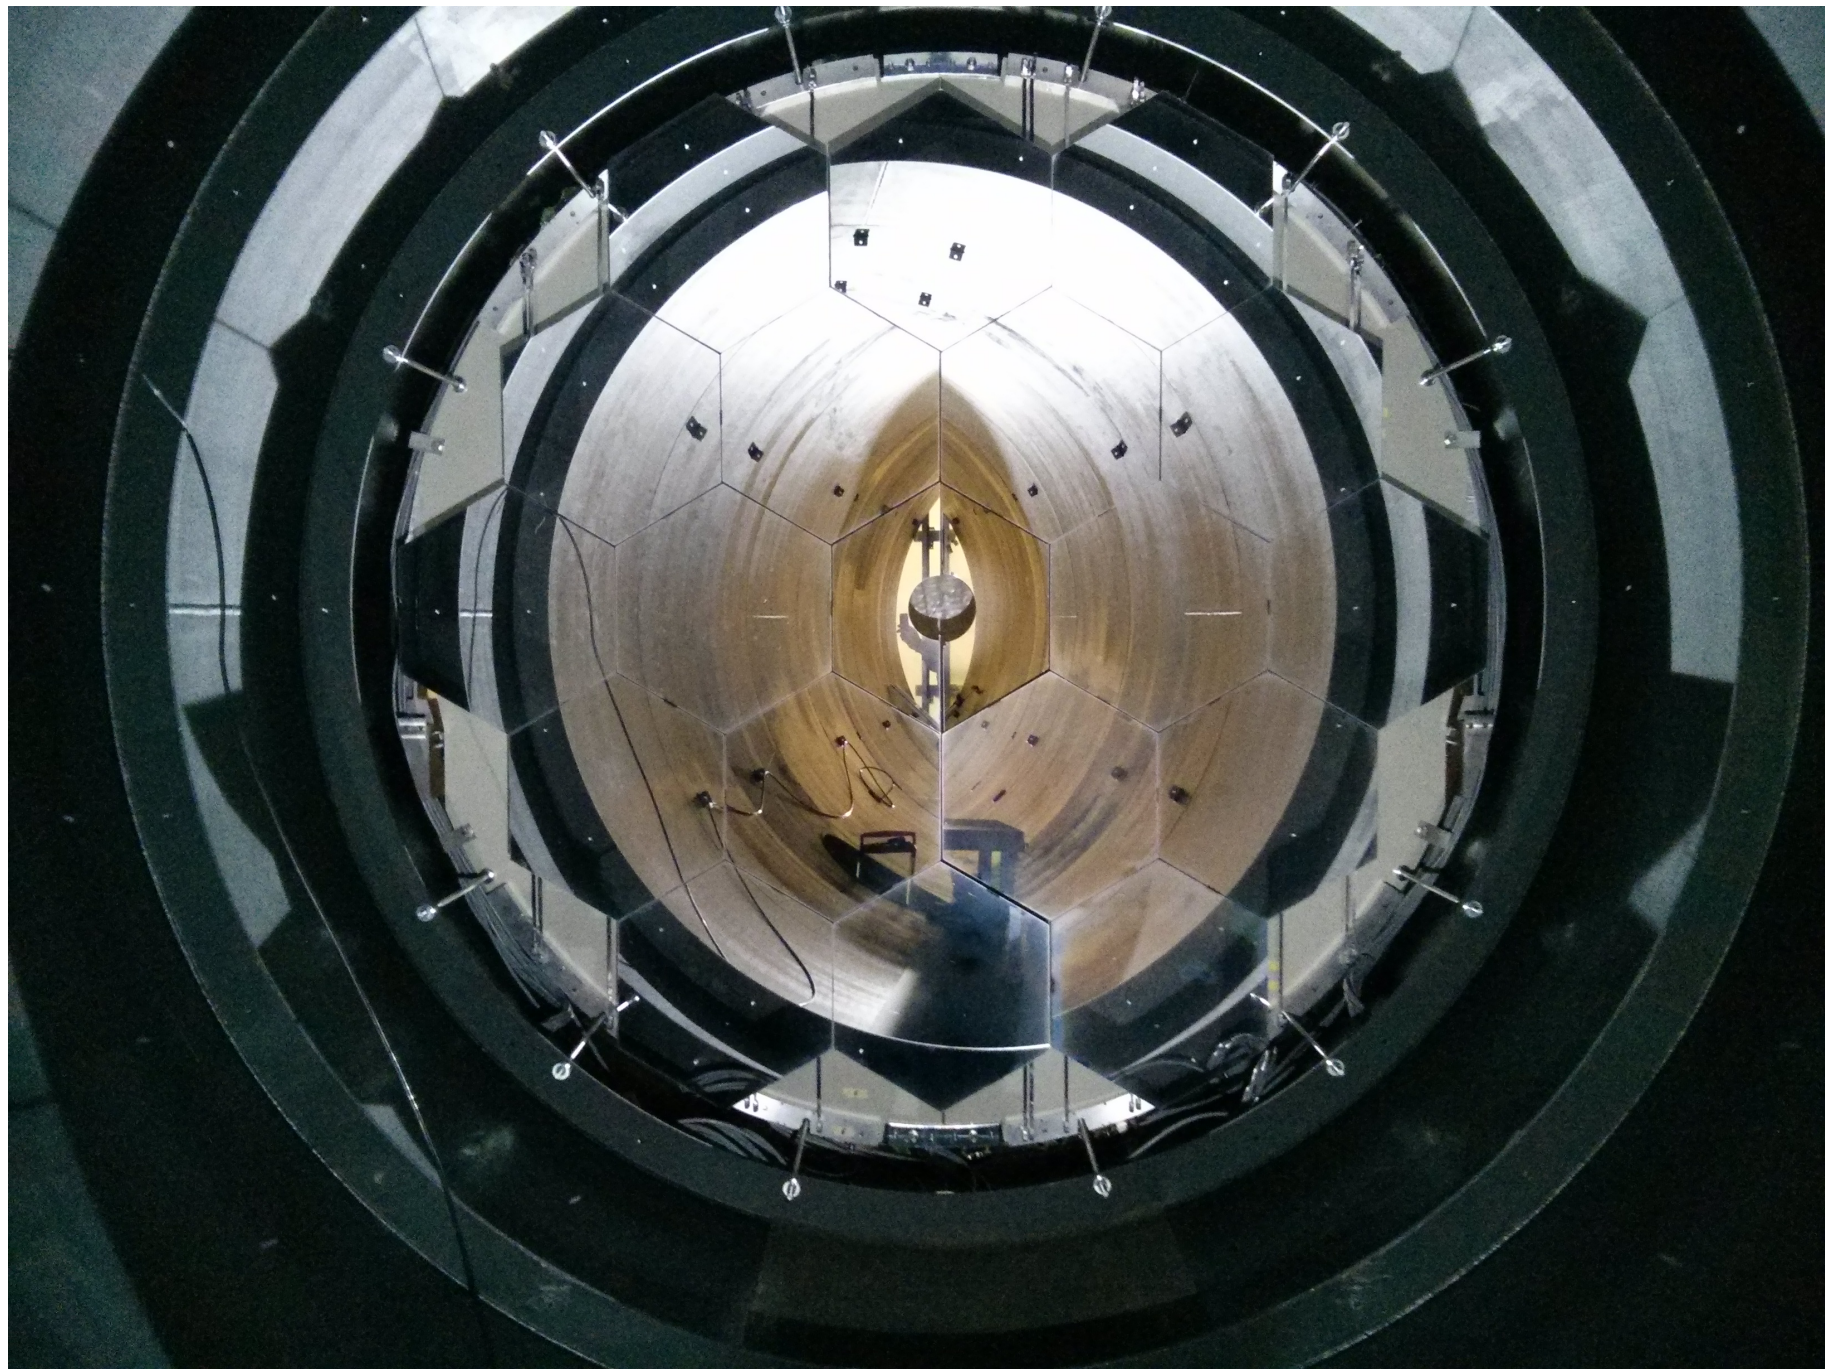
Mirror HR

Already when we try to install HR for the first time we immediately saw that it was conflicting with 07-L (already installed).

Making some calculations we also found conflicts on the two remaining external sides (with mirrors 05-L and 08-L)
Conflict also expected in the inner part with the beam pipe (diameter 180 mm, tolerances included)

All the process was taking 2 weeks, in the meantime the installation was continuing, so we also need to produce a special tool (a clamp) to handle the mirror only touching a small surface around the inner hole. That surface was partially damaged during the installation.

When we decide, with the support of Thomas workshop, to re-machine the mirrors, cutting 5 mm of the mirror on the external sides and on the inner hole. After that, mirror was polished and re-aluminized.

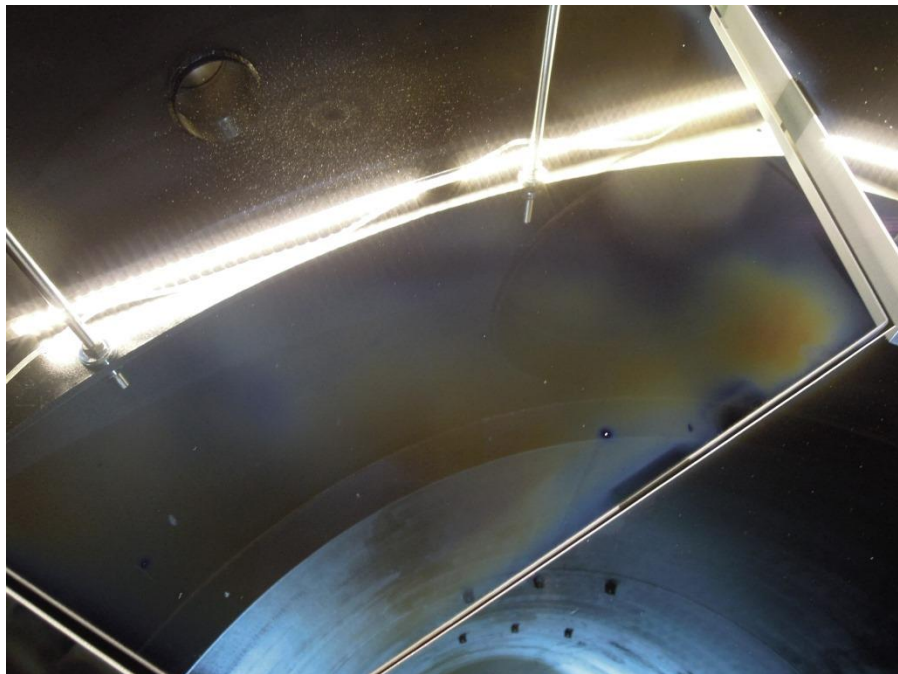
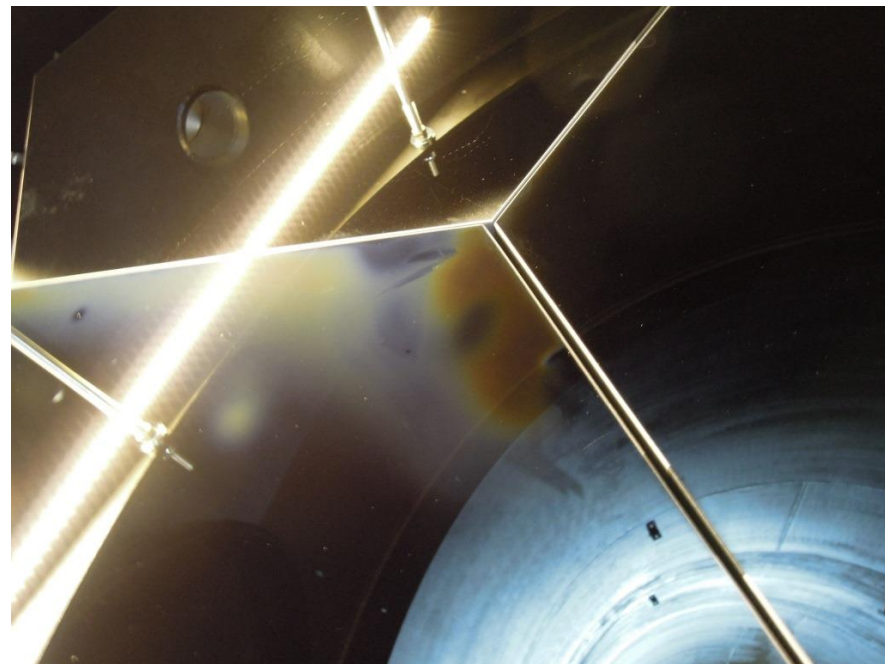
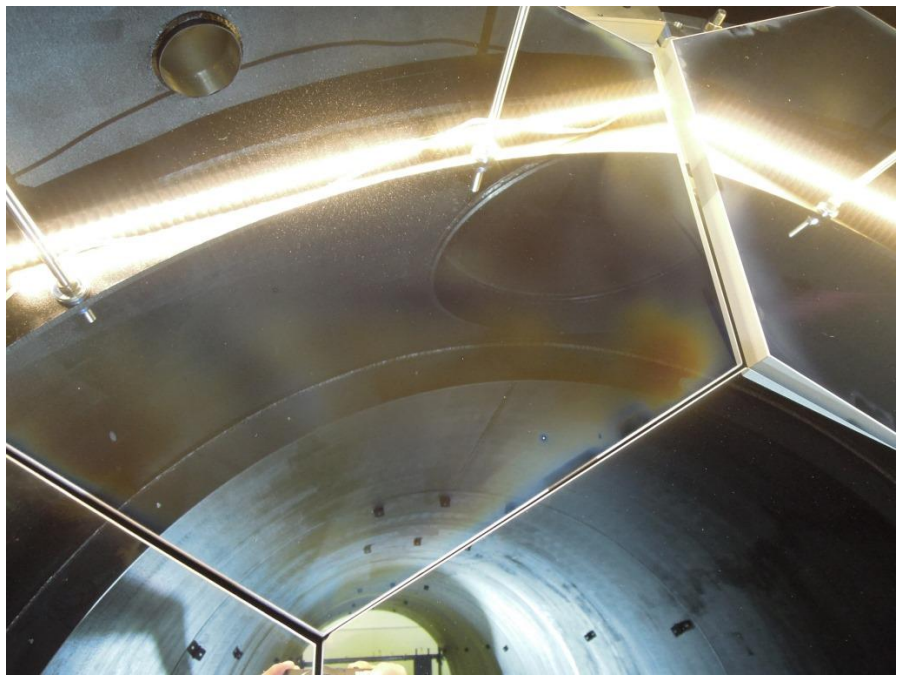
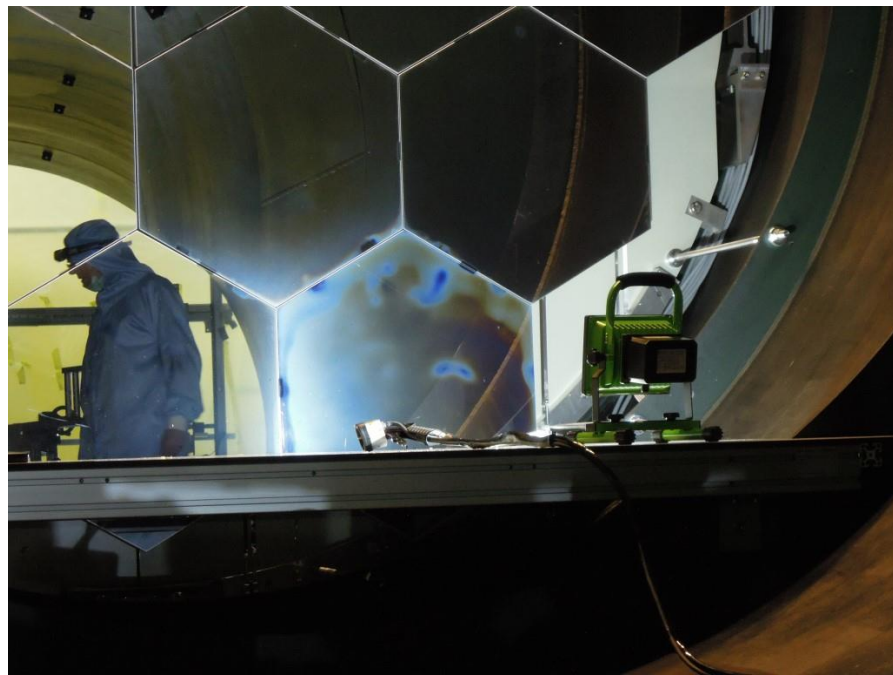
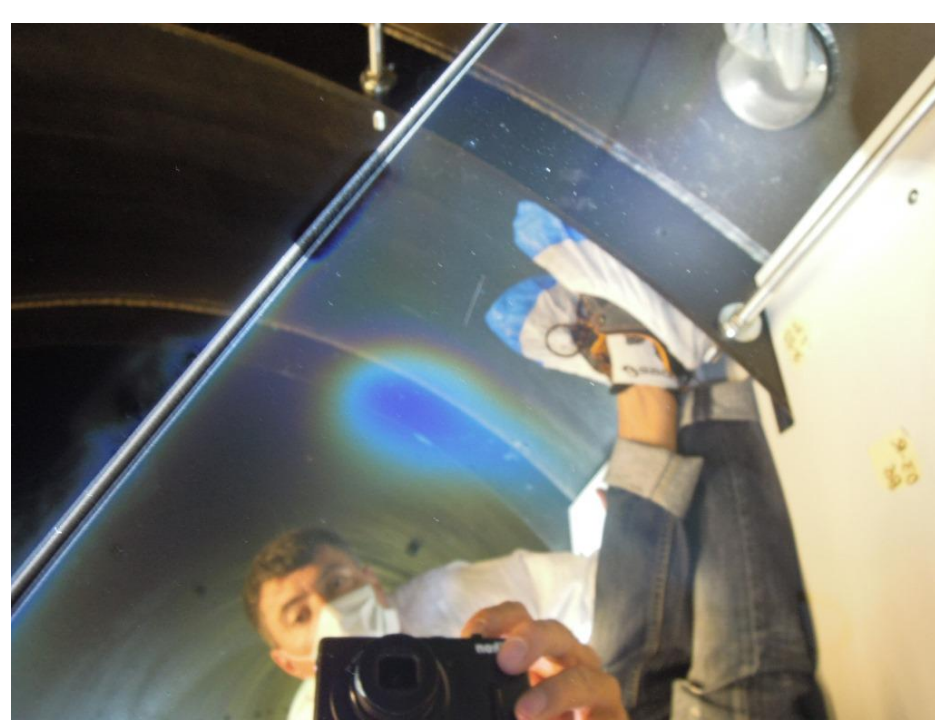
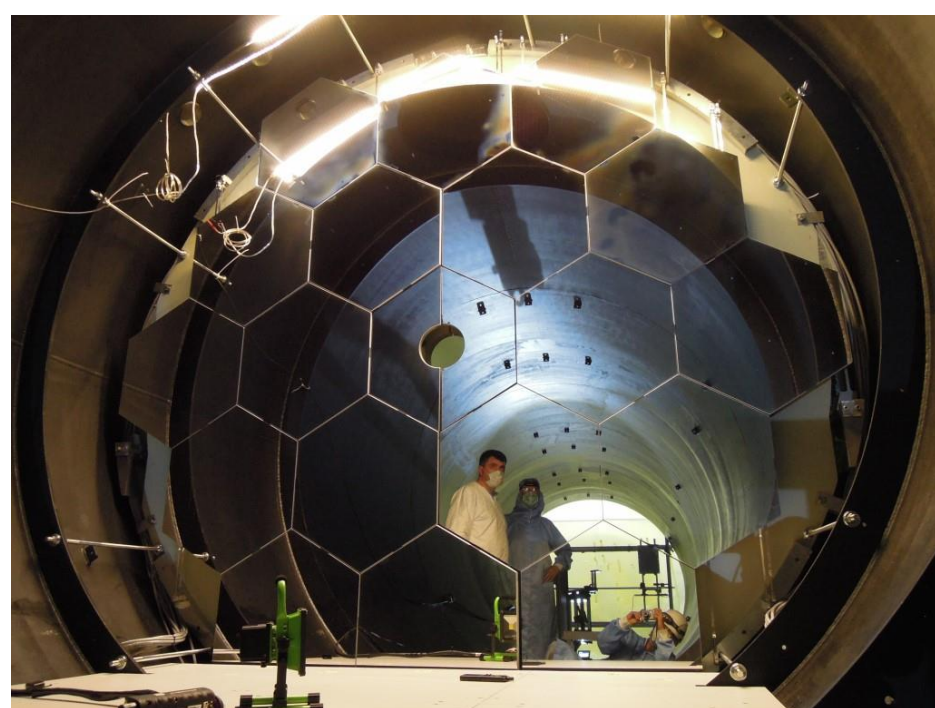
Bad news

After two weeks from the installation of the first mirrors, we start to see a deterioration of the mirror surface.

We were “hoping” to have some condensation effects, but fluxing the mirror with dried air didn’t help.

The deterioration has continued during the past weeks involving many mirrors.

It is only visible looking to the mirrors from some angle (not from the front), no way now to predict what will be the effect on Cherenkov photons.

In the mean-time the conditions inside the vessel have changed, we don’t have anymore ventilation (downstream end of the vessel closed).

To investigate the problem small mirror samples aluminized with the main mirrors has been used as probes. Three were installed inside the Vessel touching the support panel (one is no more accessible) and others were isolated in dedicated boxes with some of the materials we have inside the vessel: carpet, glues, anticorrosive coating of the vessel (?)
