DOM production at Catania

INFN sez. Catania
E.Leonora, V.Giordano, S. Aiello

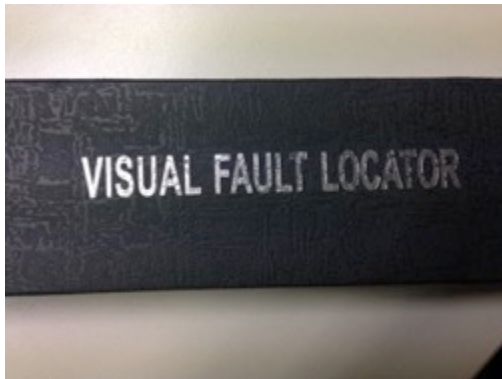
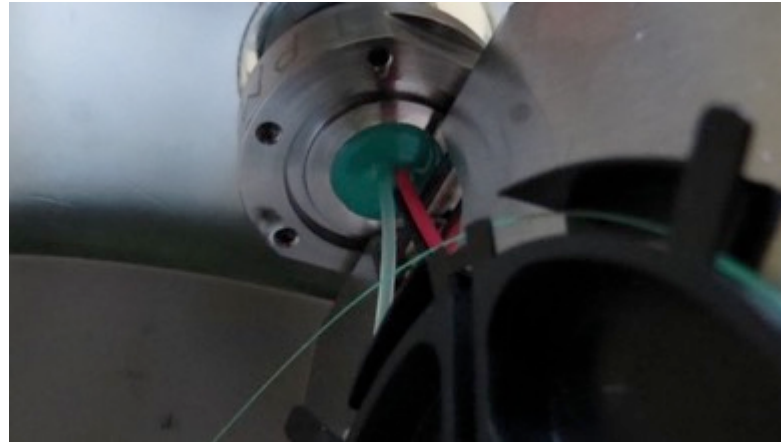
Penetrator that works correctly

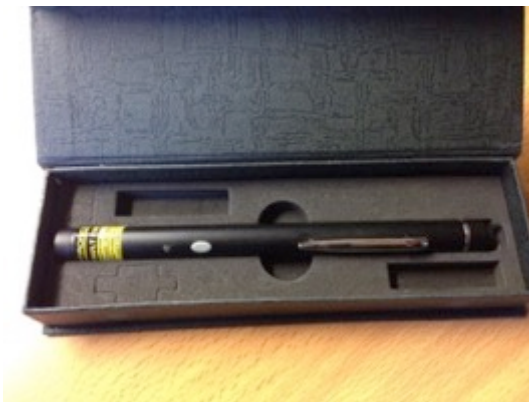
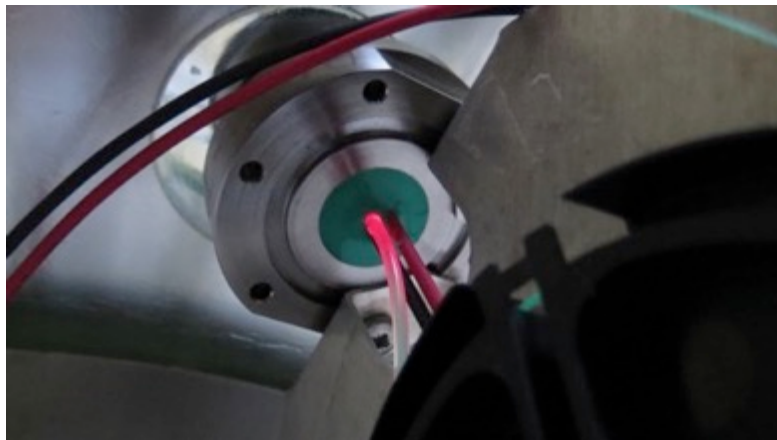
One of the two spliced fiber had an attenuation of about 6 dB

A visual fault locator was used, a red light source that injects light into an optical fibre to illuminate breaks → The optical fiber in the penetrator was broken

Penetrator that doesn't work

The broken penetrator was replaced, and and NCR was opened

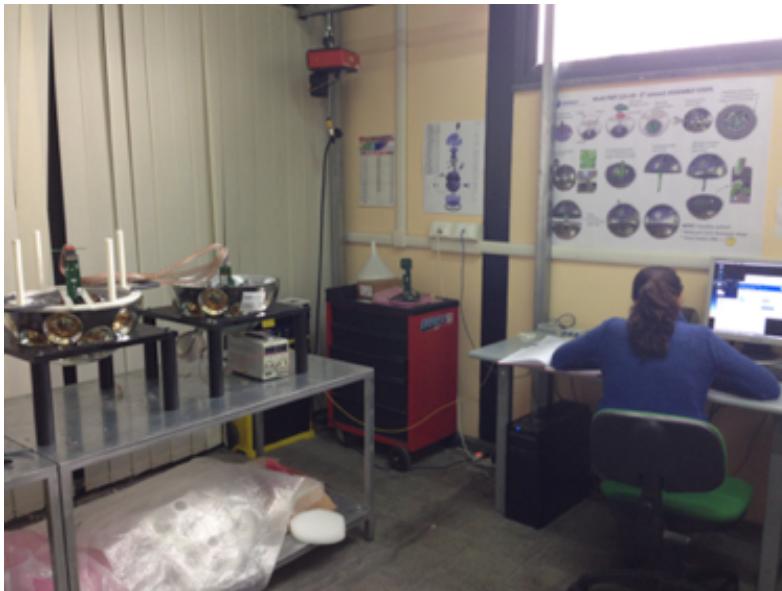
DOM test bench (with operator...)

The small octopus board mounted didn't work.

It was replaced with a correct one

(an NCR was opened...)

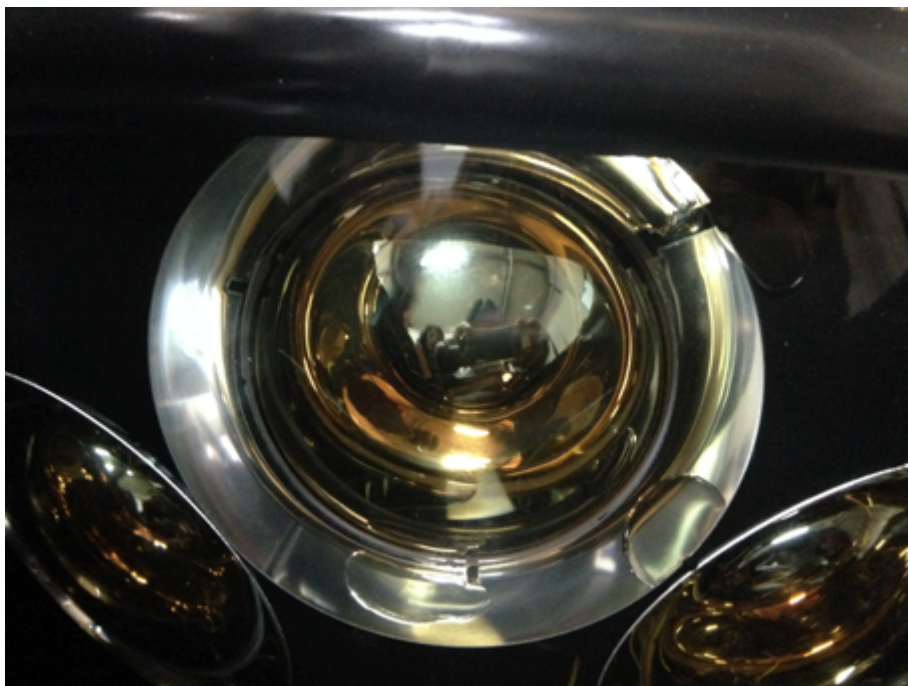
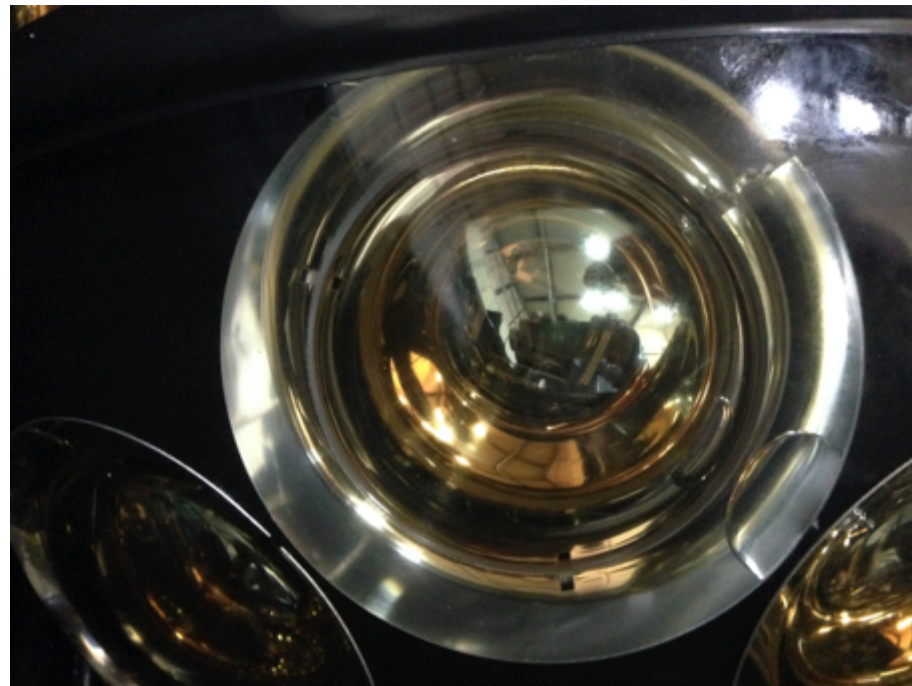
Gel detachments after some few days of closure underpressure @ 200 mBar

An air re-entry in the DOM removed after few days the detachments
