## **CUPID-0**

Laura Cardani on behalf of the CUPID-0 collaboration 3 April 2017

### **Cryogenic Calorimeters with Particle ID**

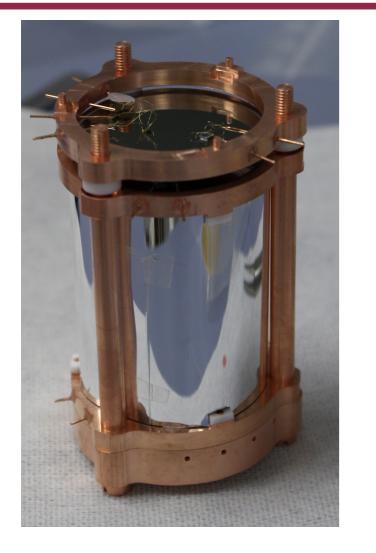
#### **CUPID-0 Detector**

- CUPID-0 scales up this technology
- Modular ~10kg scale detector in Hall-A cryostat
- Data-taking has just started!

- 24 Enriched ZnSe crystals + 2 natural ZnSe
- 10.5 kg ZnSe (5.17 kg of <sup>82</sup>Se)
- CUPID-0 is a demonstrator, still it features
  3.8x10<sup>25</sup> 0nDBD emitters

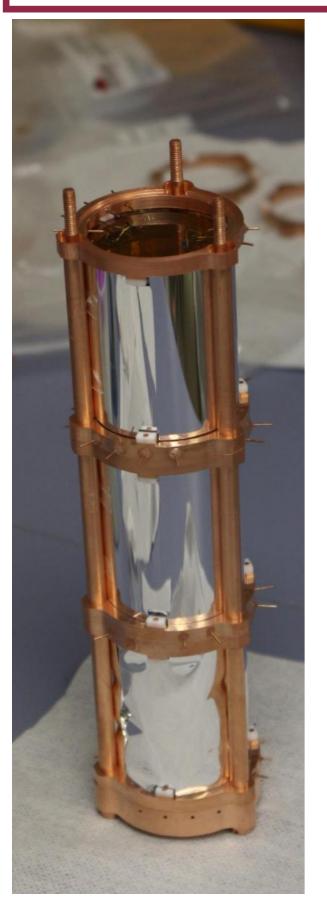
- 3 Zn<sup>82</sup>Se tested in Hall C R&D cryostat (20 mK instead of 5 mK)
- Reproducible FWHM at <sup>82</sup>Se Q-value of ~30 keV (not opt.)
- Complete rejection of a background
- Study of internal contaminations: ok for our target

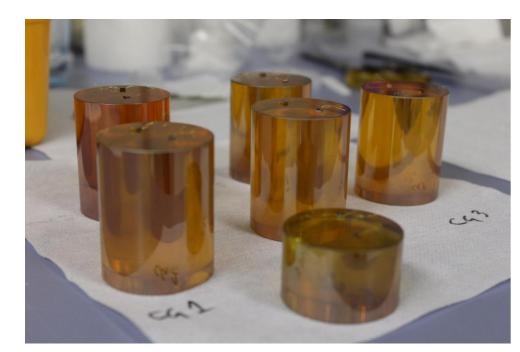
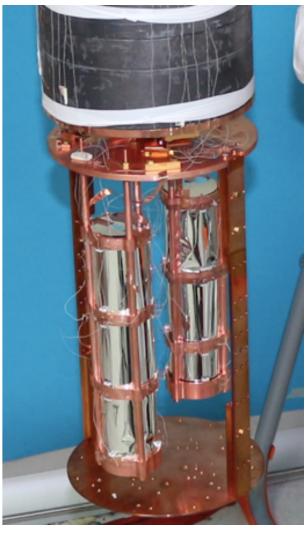
### Cryostat commissioning

- Read-out: 136 channels available [67 used]
- New suspension for noise suppression
- Fixed old leak in the line for mixture condensing
- Electropolishing and passivation of Cu shields
- Thermometry system

- <image>
- Calibration sources system: versatile (different sources), Rn-leak tight
- Monitor of the cryostat parameters
  - Fixed cryostat verticalization system

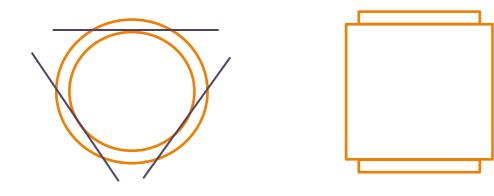
### **Crystal Cut and Polishing**

The entire process of crystal cut and polishing were made at LNGS

- Irregular shape to spare as much <sup>82</sup>Se • as possible
- Several operations to simplify assembly: •
  - Cut of 2 parallel faces and machining of the lateral surface (conic shape)
  - Creation of two 44 mm diameters ring
  - Cut 3 slices on lateral side

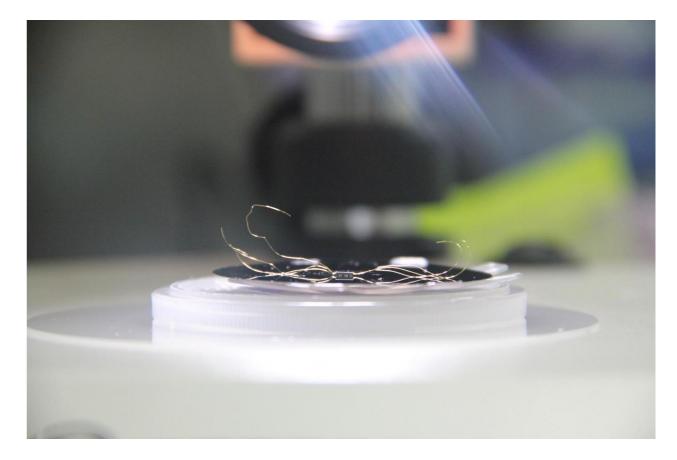
#### **Sensors Gluing**

Glue of thermal sensor on each detector (ZnSe or Ge light detector)

Sensor: NTD Ge thermistor attached via glue spots

- ZnSe crystals different sizes
- LD and ZnSe thermistors different sizes
- Radio-purity

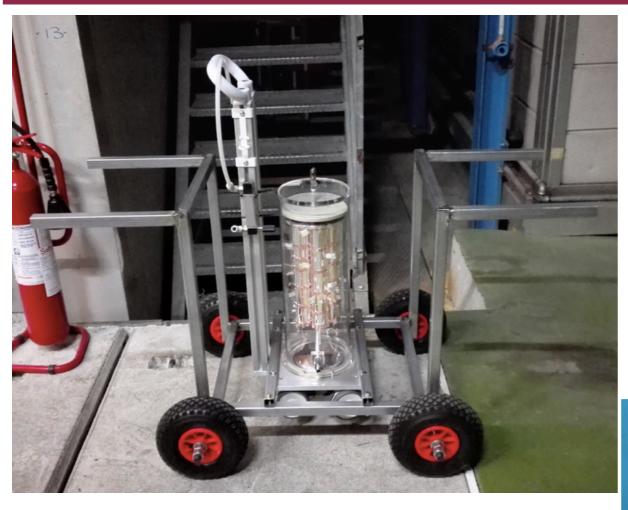
#### **Detector Cool Down**

- January 2017: other technical problems (snow + earthquake)
- February 2017: start commissioning

- October 2016: end of the assembly
- November/December 2016: cool-down [cryogenic problems described before]
- January 2017: solved all cryogenic problems
