# OB Stave: highlights from PRR preparation

## ALICE ITS Upgrade Plenary Meeting

*CERN, 2 May 2017*

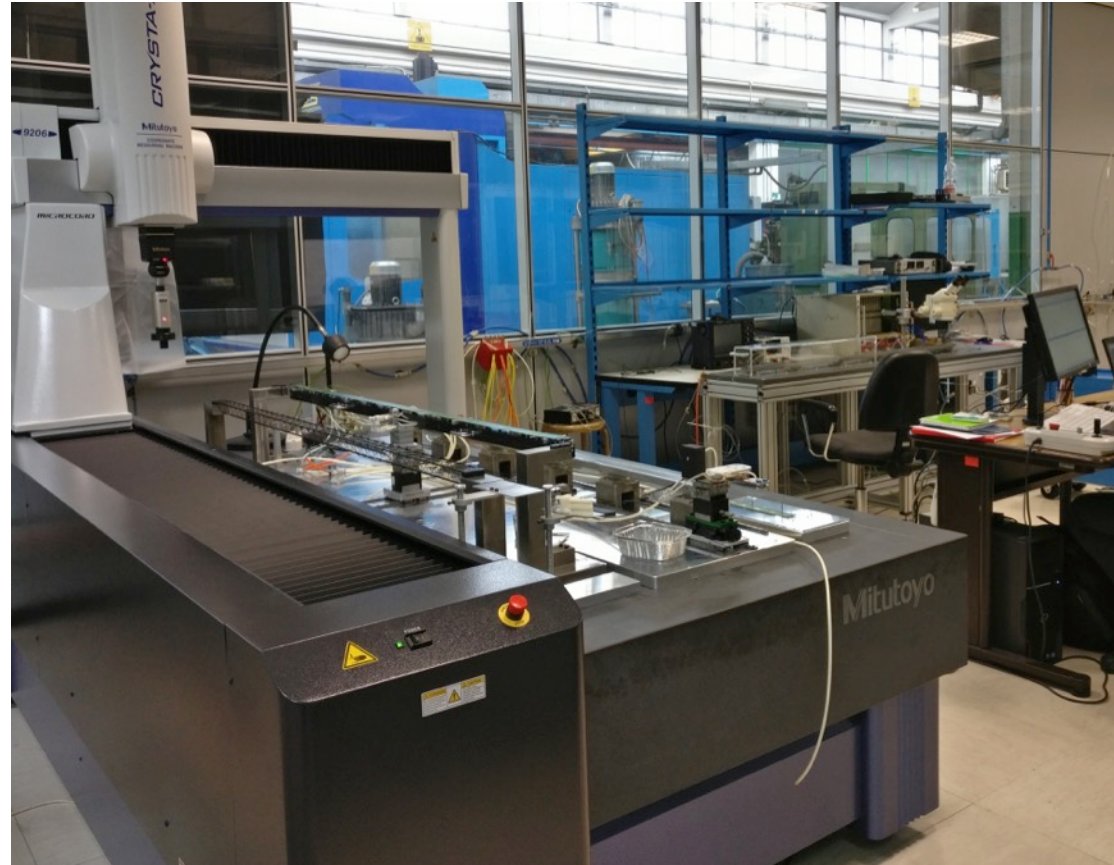
- Clean Room space optimized
- Plants:
  - Vacuum
  - Compressed air
- Mitutoyo Crysta Apex S 9206: operational
- All jigs installed and used for production of mechanical prototypes and stave 0

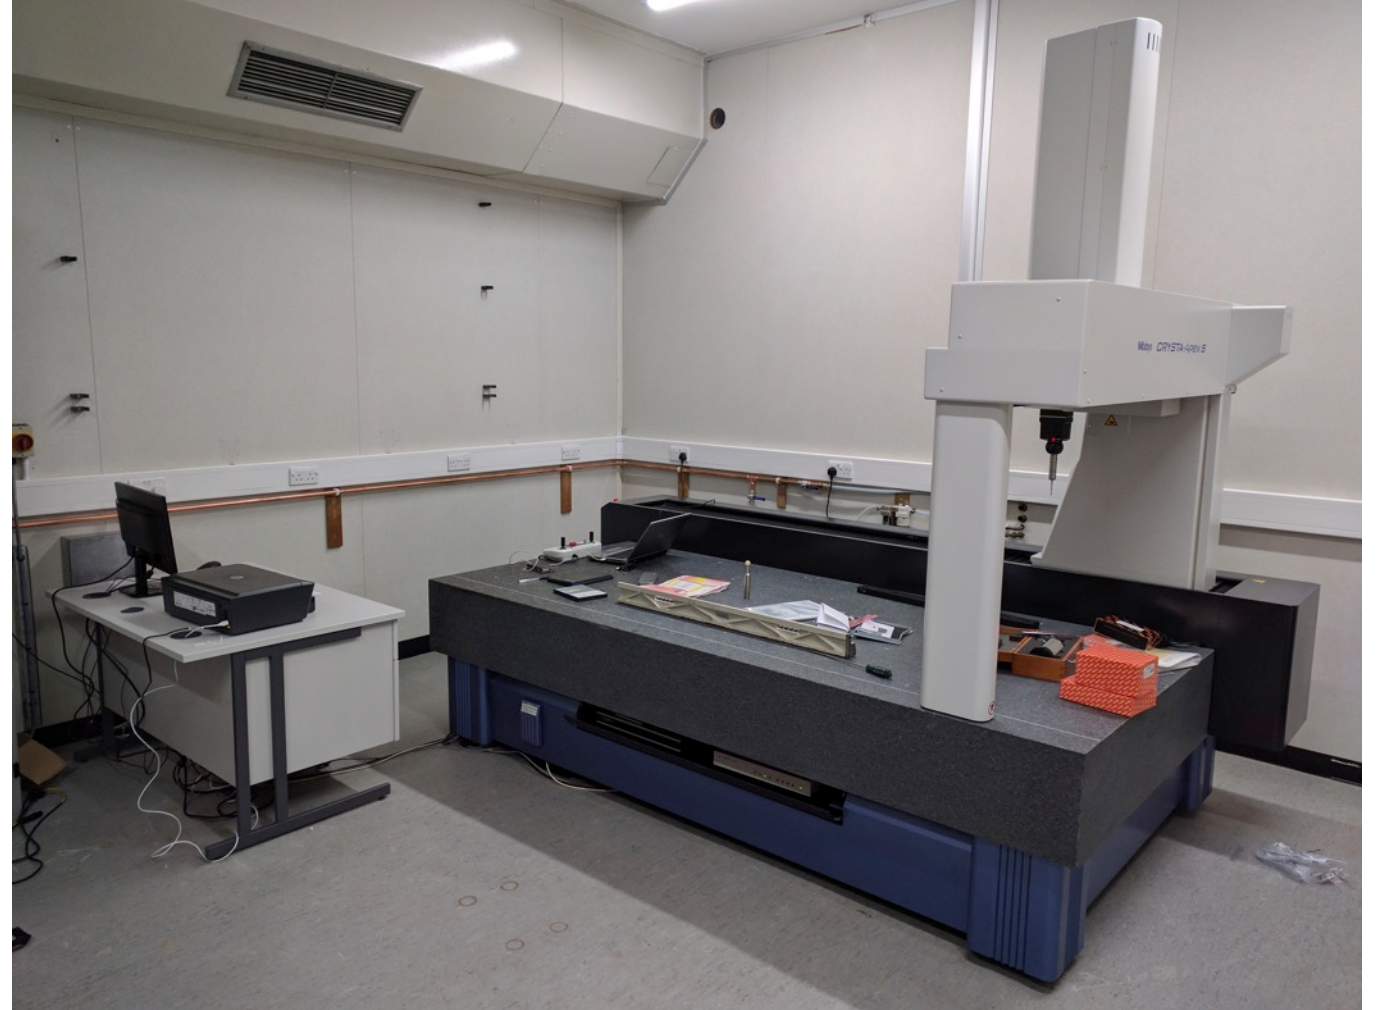
- **New Clean Room available**
- **Plants:**
  - Vacuum**
  - Compressed air**
- **Mitutoyo Crysta Apex S 9206:**  
**delivered and being commissioned**
- **Tools will be installed in the next 2 weeks**

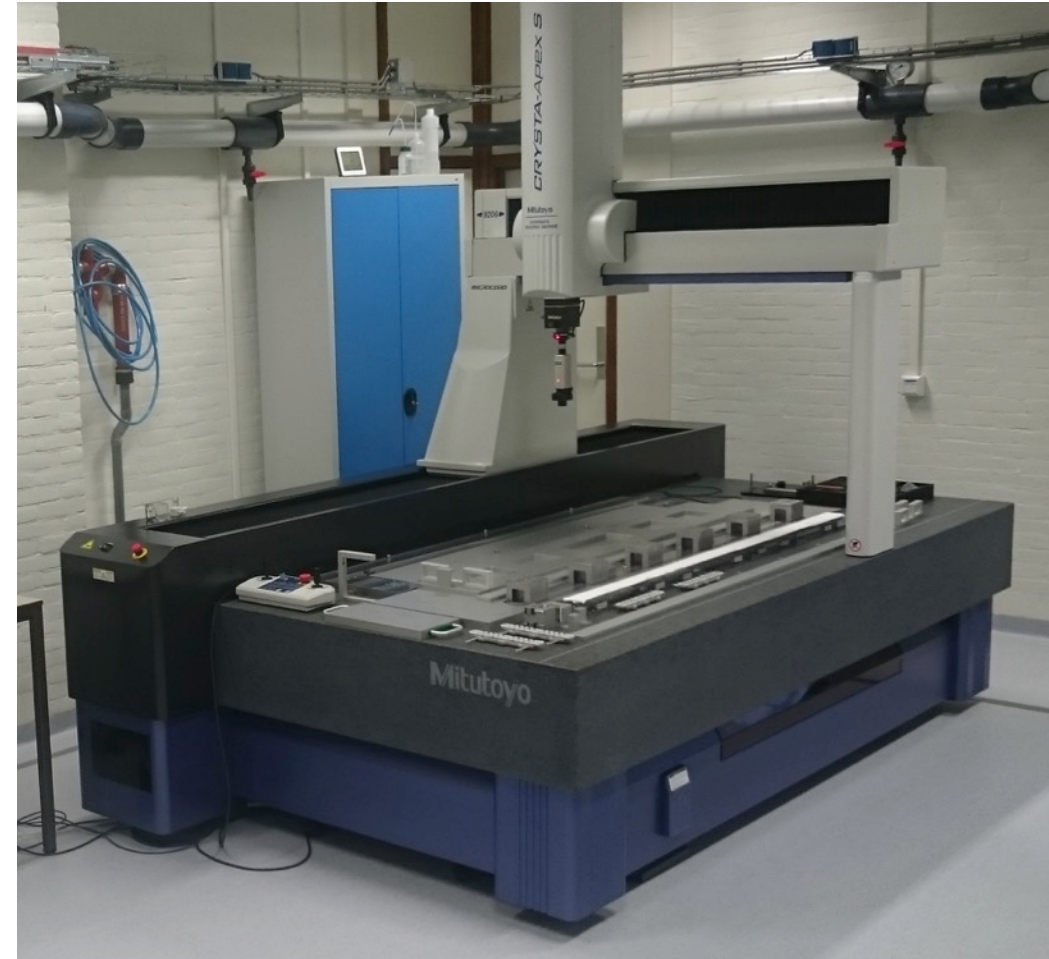
- Clean room ready
- Mitutoyo Crysta Apex S 9206 operational
- Plants:
  - Vacuum
  - N2
  - Compressed air
- Glue dispenser
- Tables for additional stations: To be done
  - Soldering station
  - Gluing station
  - Test station
- Stave assembly tools received
- Ready for training session

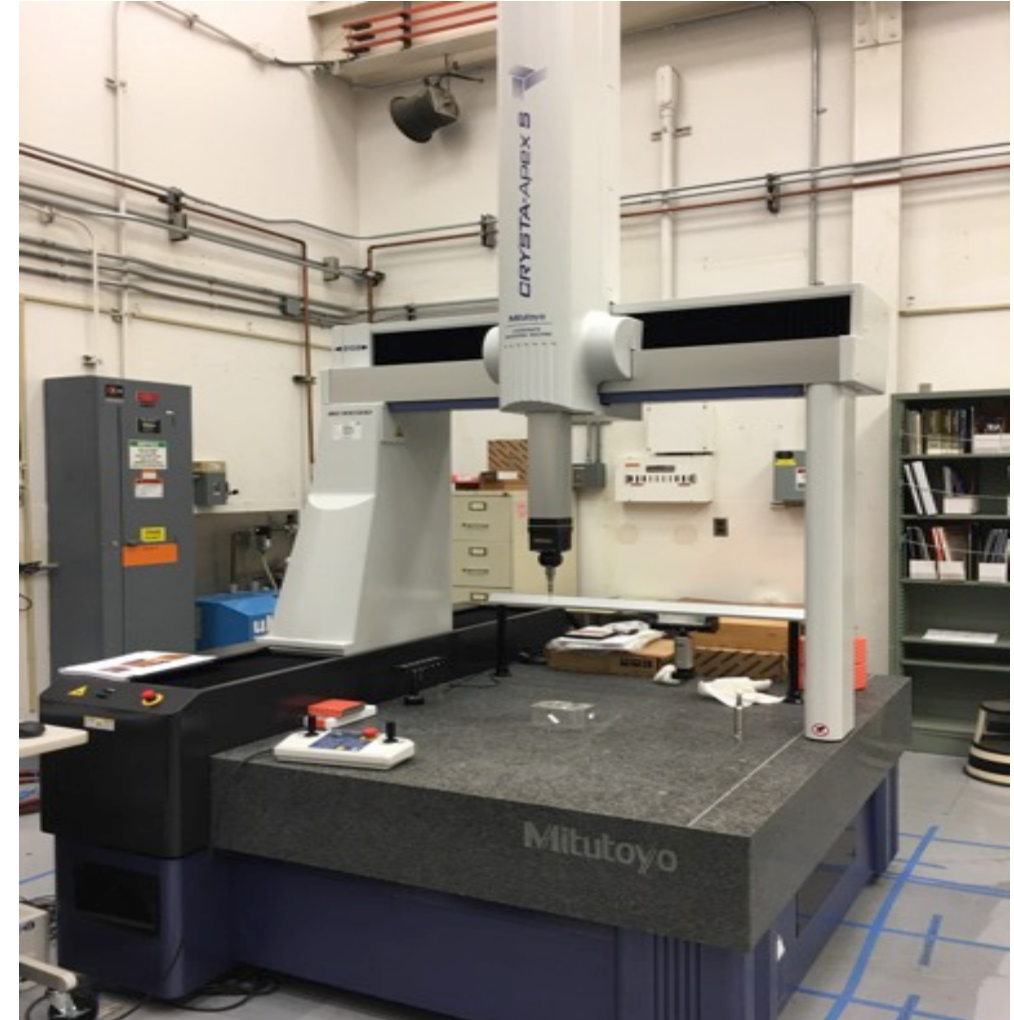
- Clean room being prepared
- Mitutoyo Crysta Apex operational
- Stave assembly tools being revised at SEL
- ready for training on site early summer
