Ecogas studies

Ecogas meeting
31/05/2019

Stability - Run ID 0023

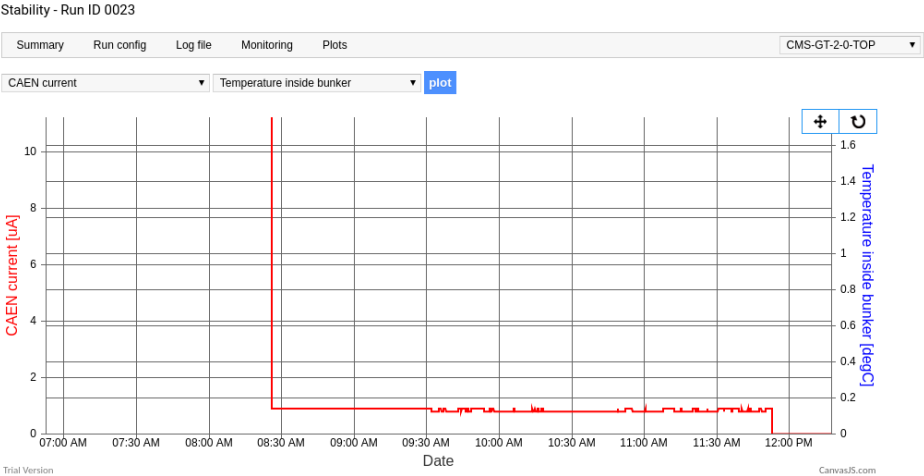
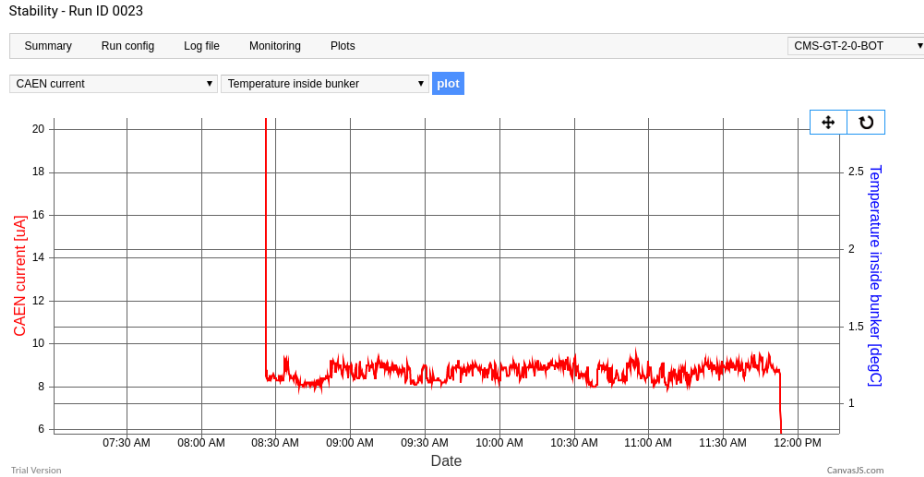
Source off dark current decay: no evident and significant recover after 8h

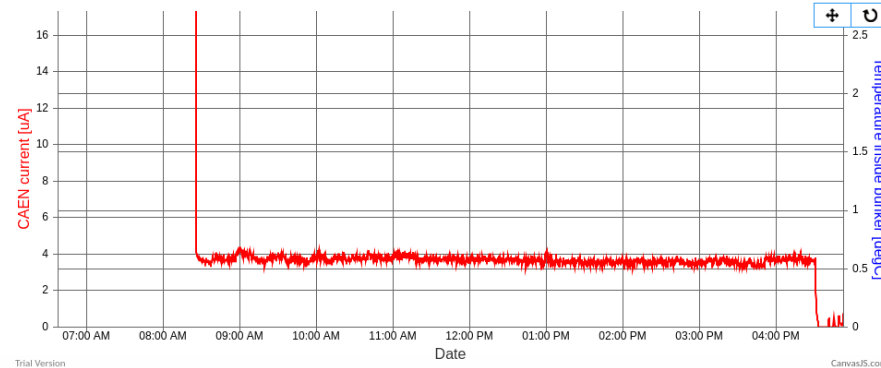
Summary Run config Log file Monitoring Plots EPDT-RPC3

CAEN current Temperature inside bunker plot
