RPC ECOGAS

Ecogas meeting
21/06/2019

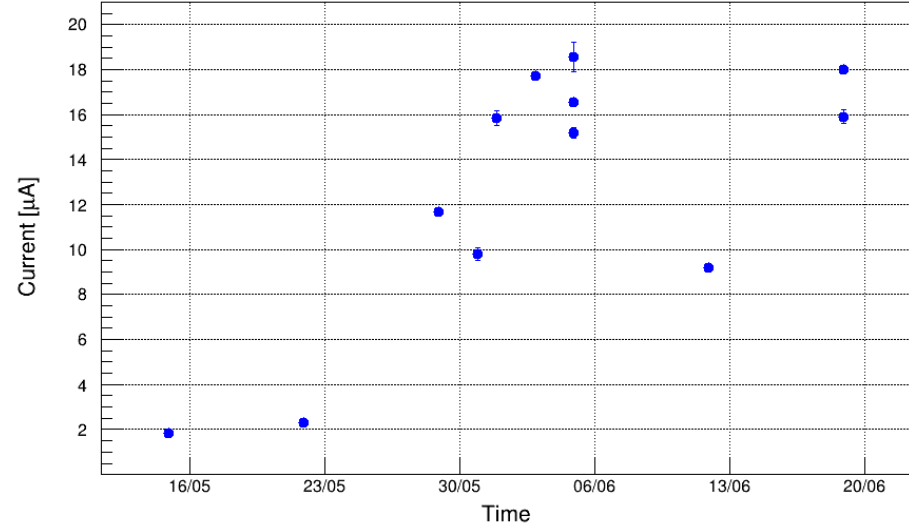
Dark current monitoring 2mm

CMS-GT-2-0-BOT @ 12000 V

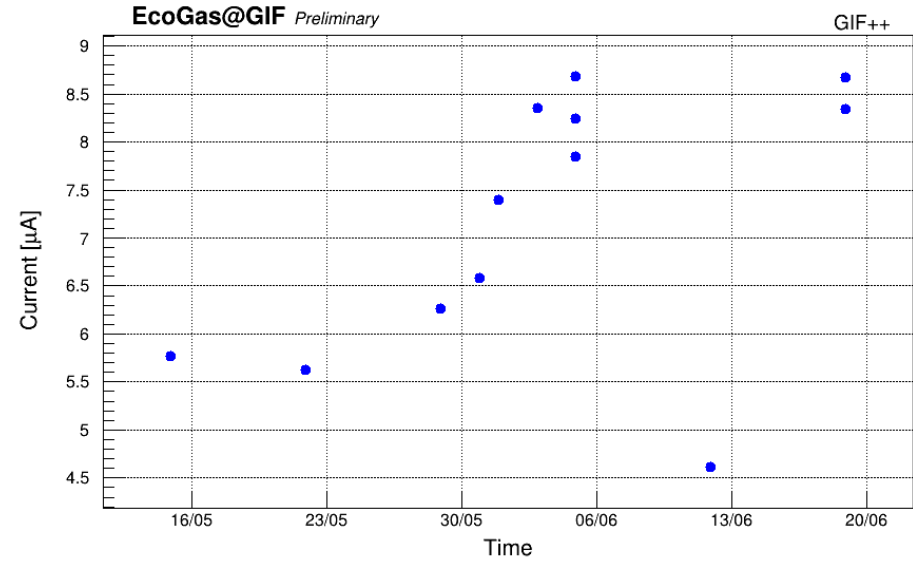
Dark current monitoring 1.4mm

CMS-KODEL_1-4-BOT @ 8500 V

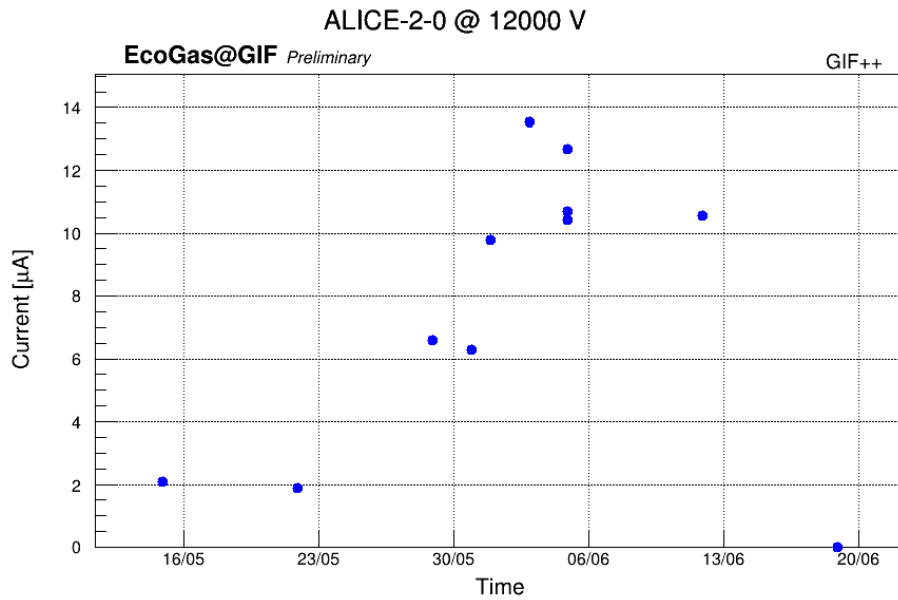
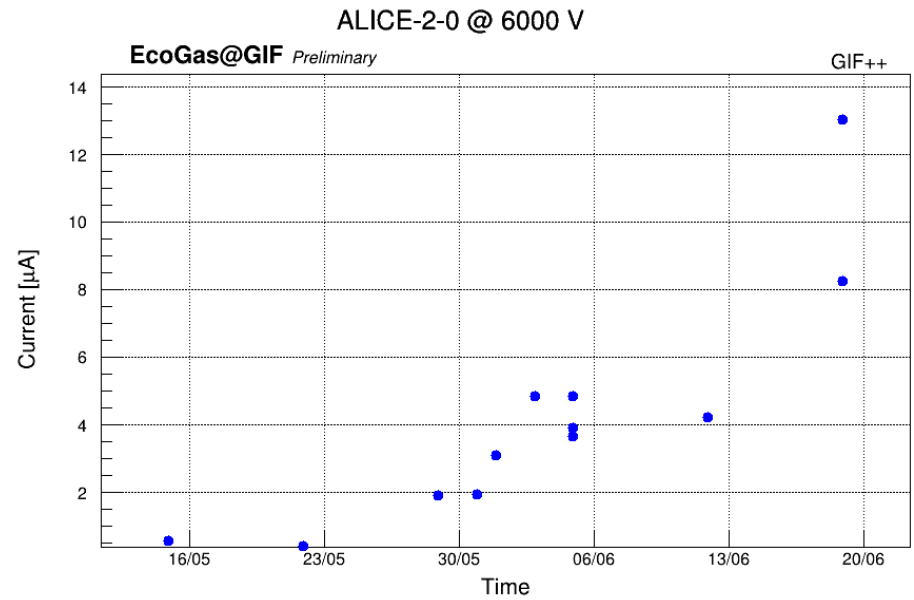
Dark current monitoring 1.4mm
