LABORATORI NAZIONALI DI LEGNARO

HOST LABORATORY FOR AGATA DEMONSTRATOR

R. MENEGAZZO
INFN - SEZIONE DI PADOVA

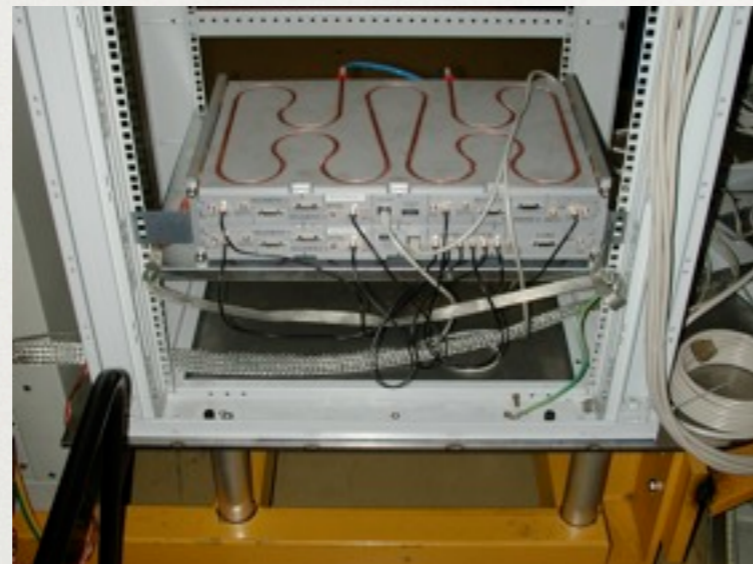
AXIS POWER SUPPLY
GROUNDED PT100 SHIELDING

THE GROUNDING

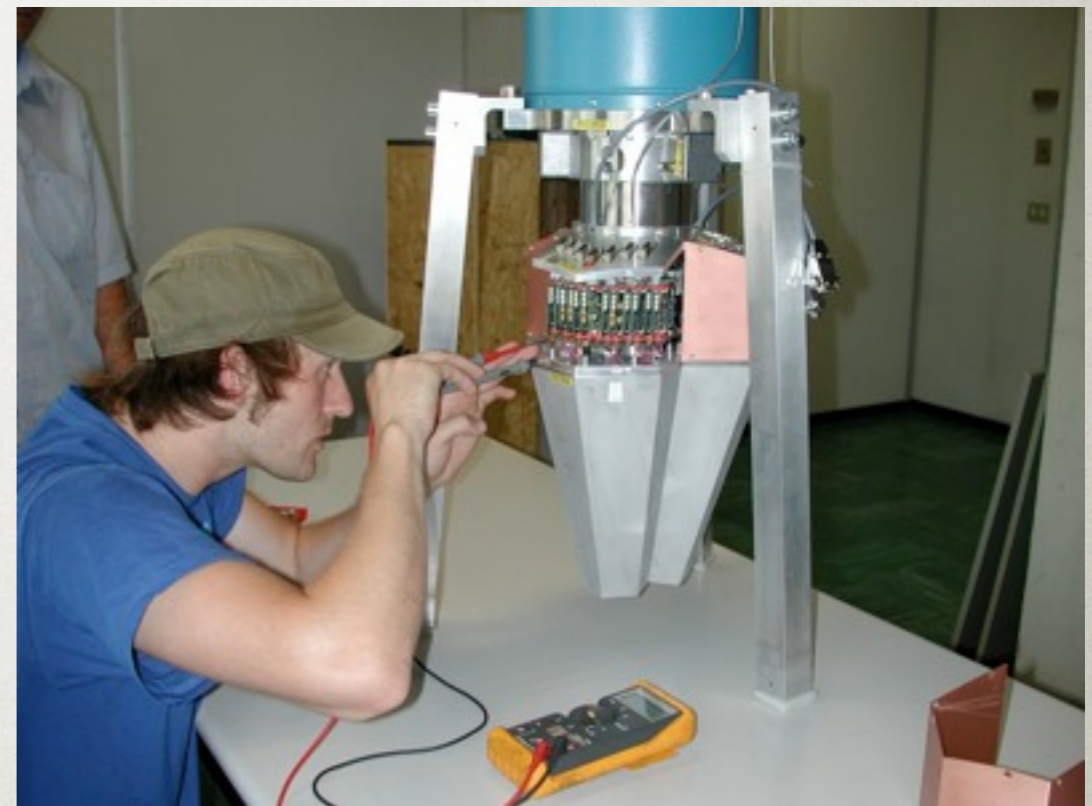
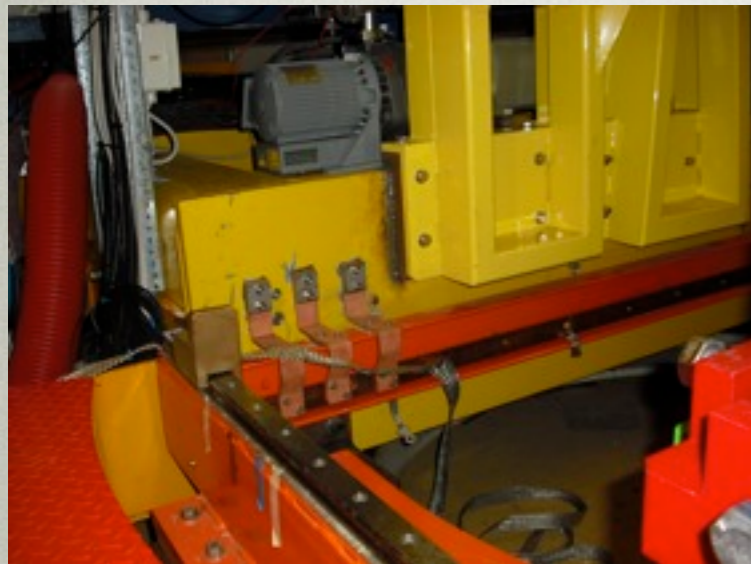
DETECTOR
REFURBISHMENT

COPPER BARS AND WIRES
INSULATED LN₂ AND BEAM LINE

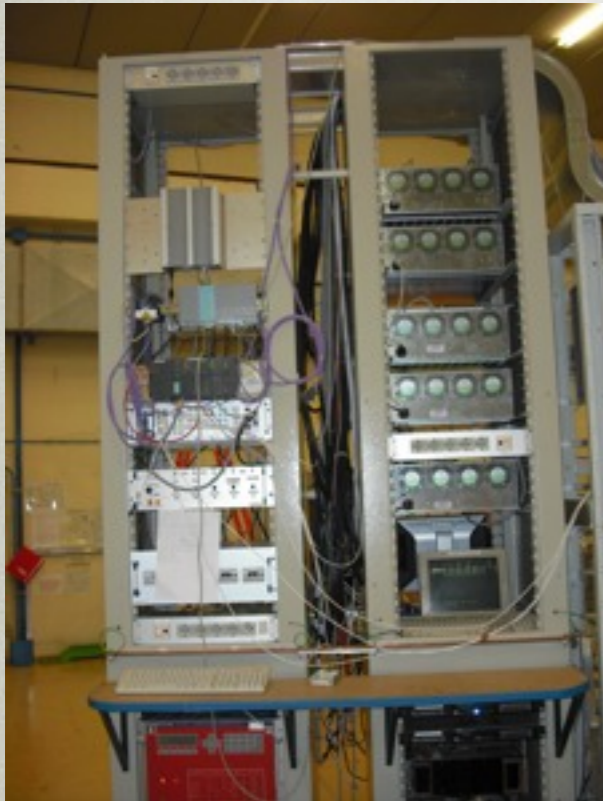
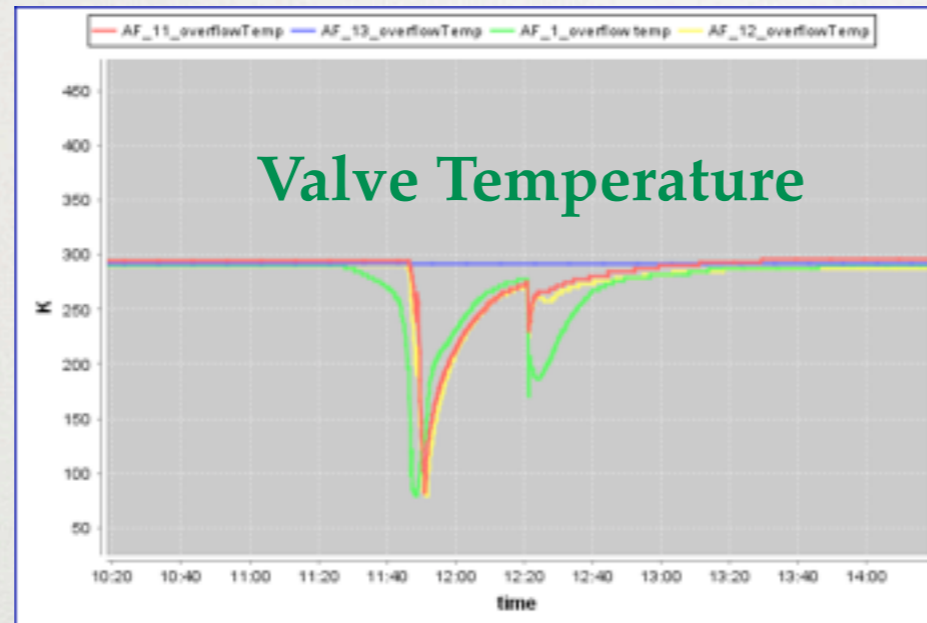
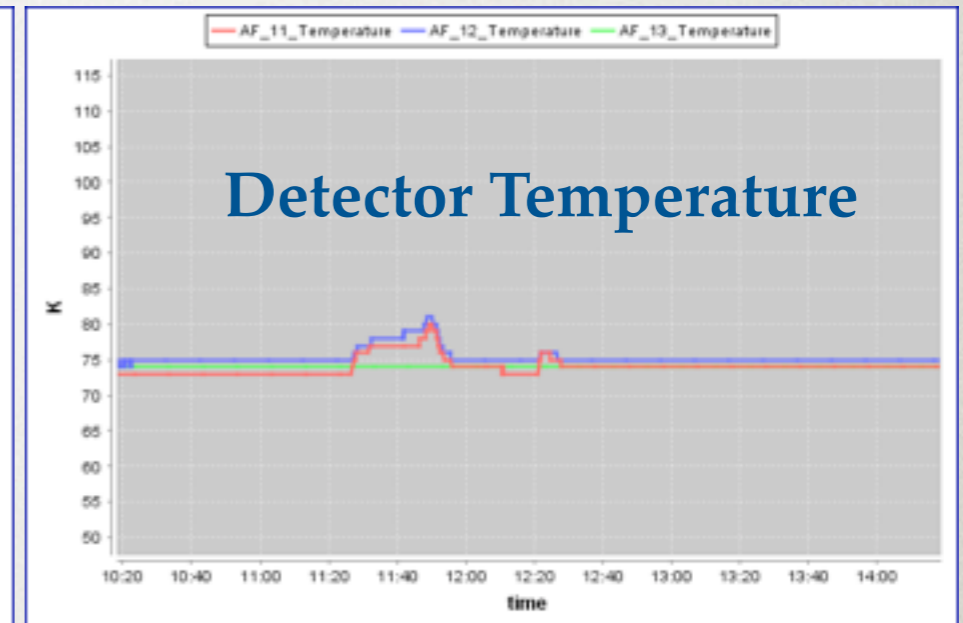
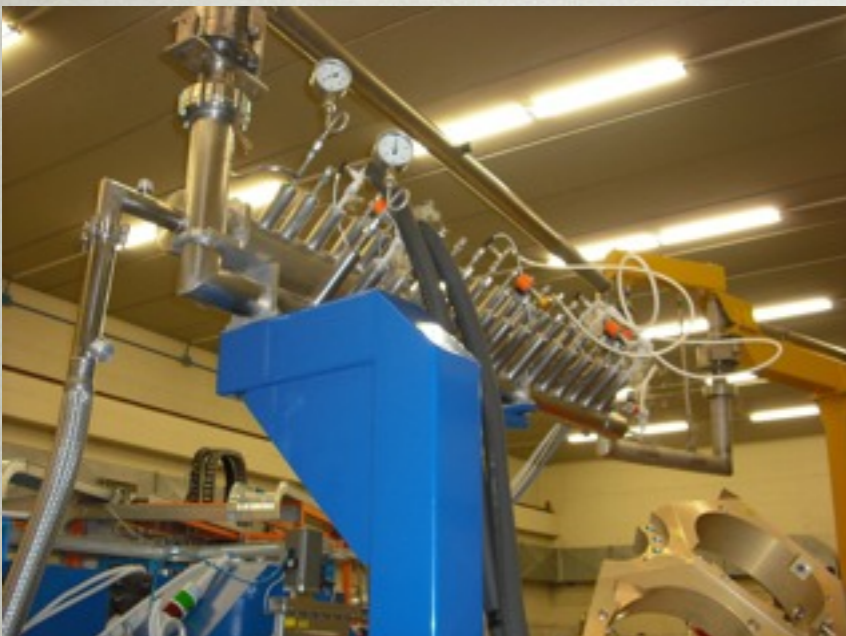
AUTOFILL SYSTEM

(MAXIMUM THREE CLUSTERS)

AUTOFILL IN RELIABLE OPERATION SINCE DECEMBER 2008 DESPITE MISSING FINAL VCC. CONTINUOUS MONITOR BY LOCAL PEOPLE

ONLY PROBLEM SO FAR (HUMAN MISTAKE TRIGGERED BY GUI BUG) LEAD TO ACCIDENTAL WARMUP OF ATC1 AND ATC2 IN NOVEMBER 2009

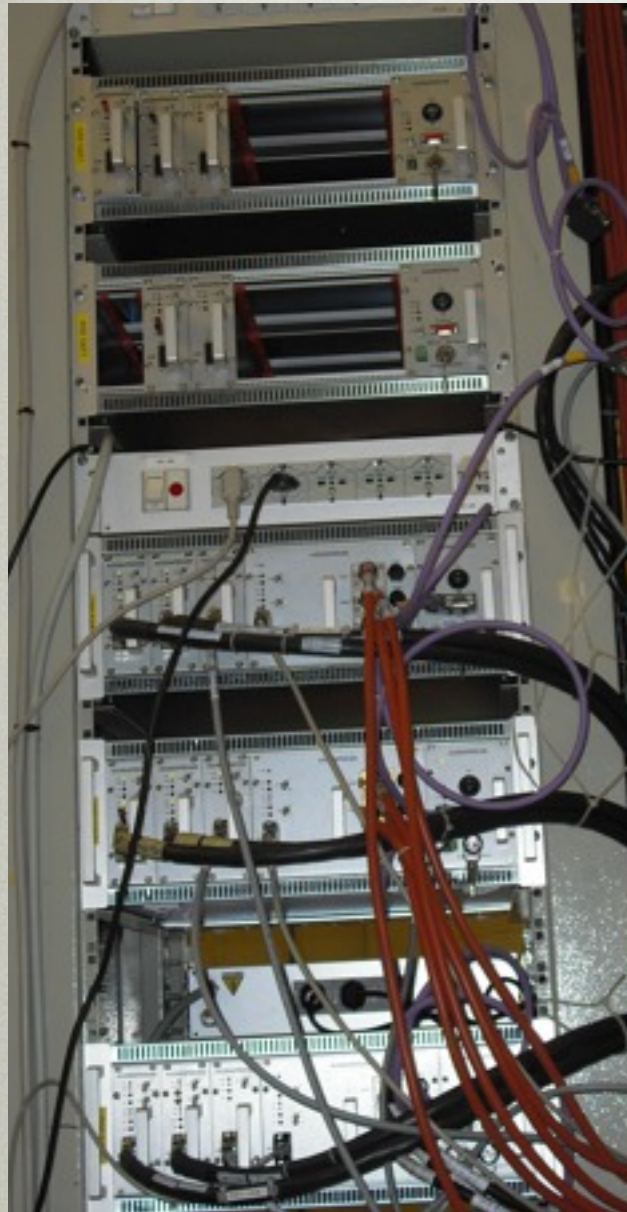
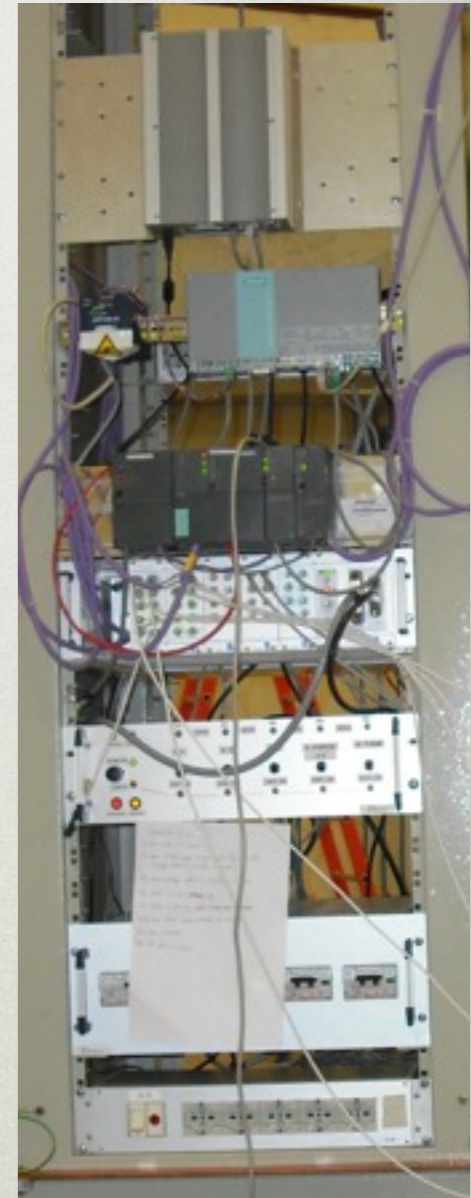
MOST OF THE TEMPORARY DSS WAS REMOVED AND A FRESH INSTALLATION OF A “FINAL VERSION” WAS COMPLETED.

CURRENTLY WE HAVE AXIS FOR 3 (+2) DETECTORS, ATC2 AND ATC3 HAVE HV CONTROL. OPC SERVER AND FIELDBUS NETWORK ARE FULLY OPERATIONAL.

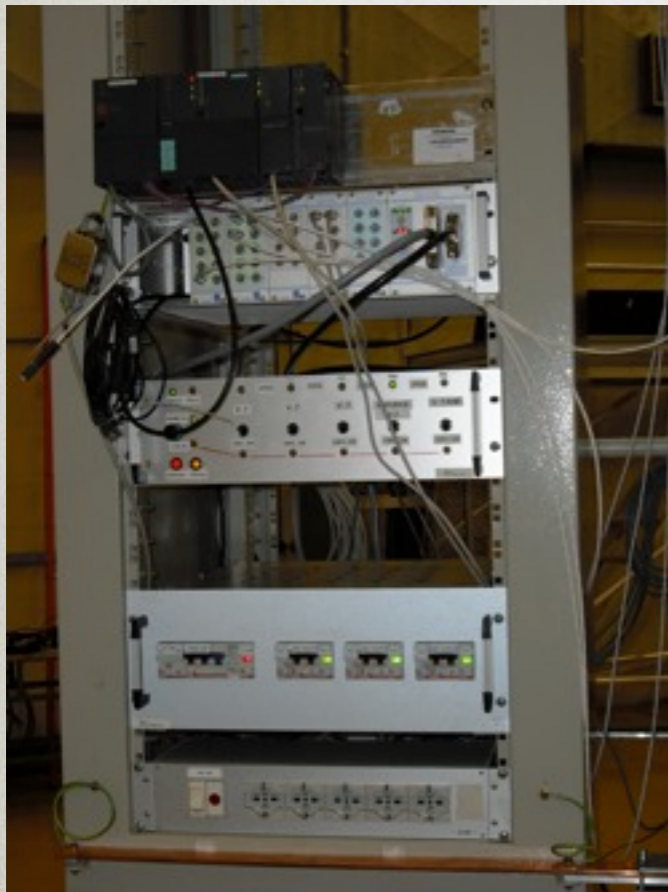
VALVE POWER SUPPLY
AND CONTROL CRATE

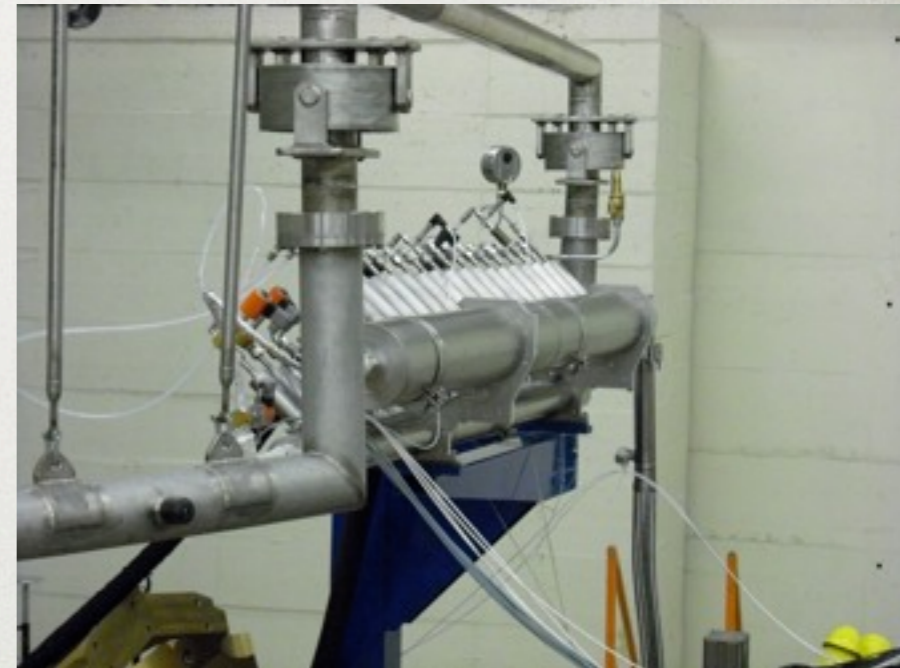
AUTOFILL HARDWARE
MAINTENANCE

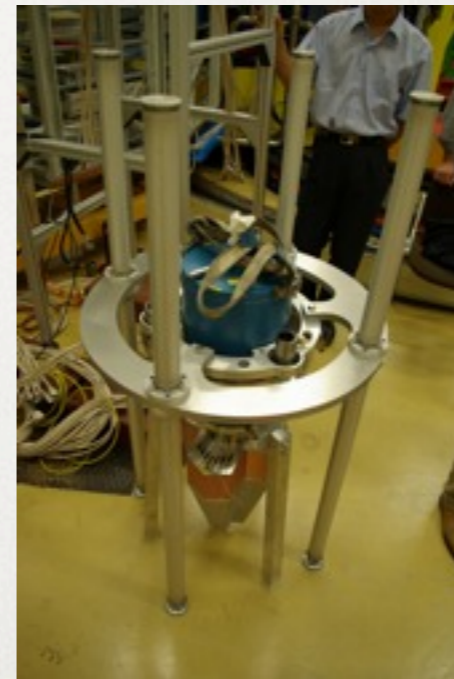
DETECTOR GAUGE

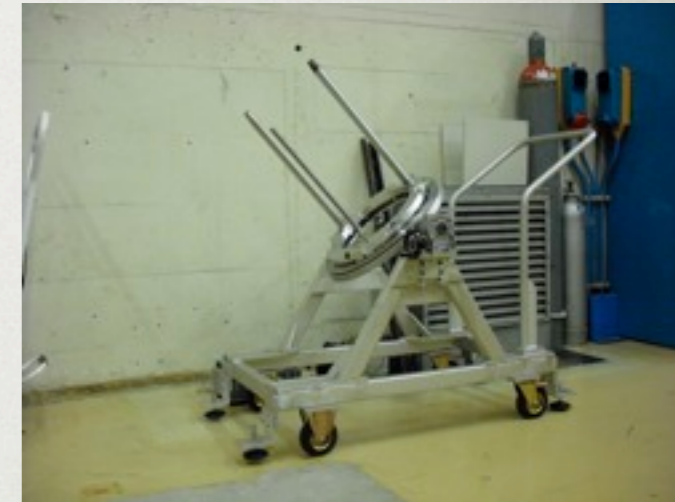
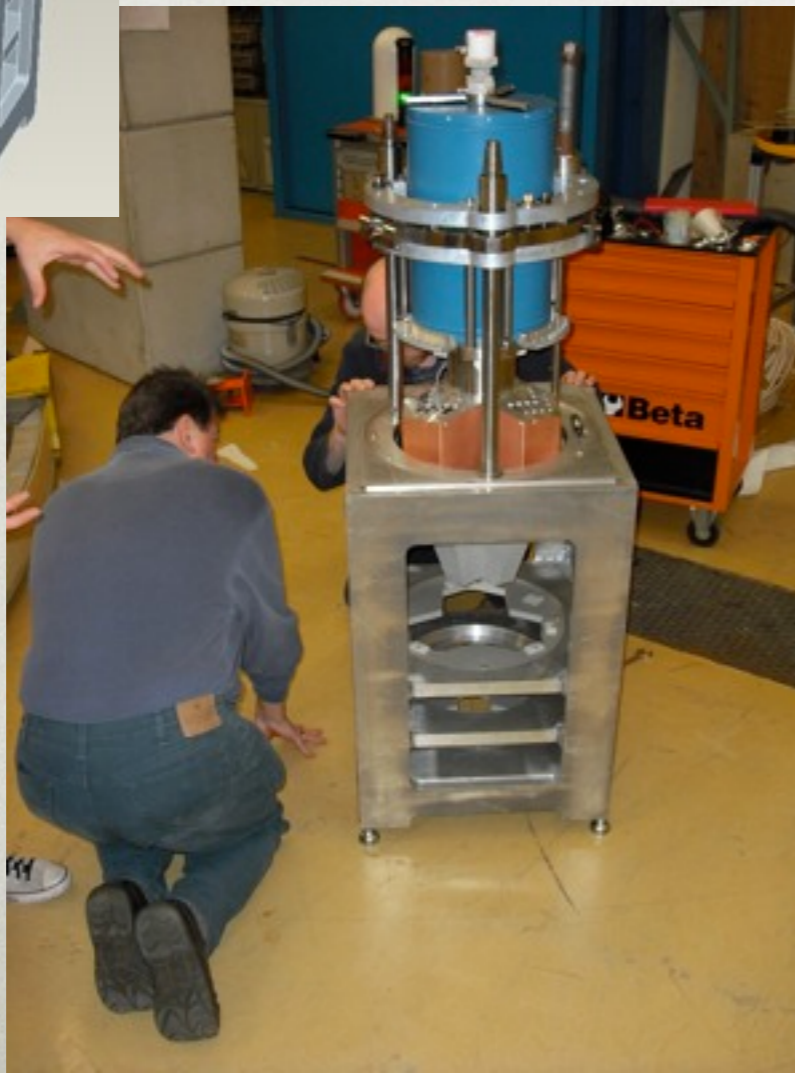
TABLE TOP FRAME

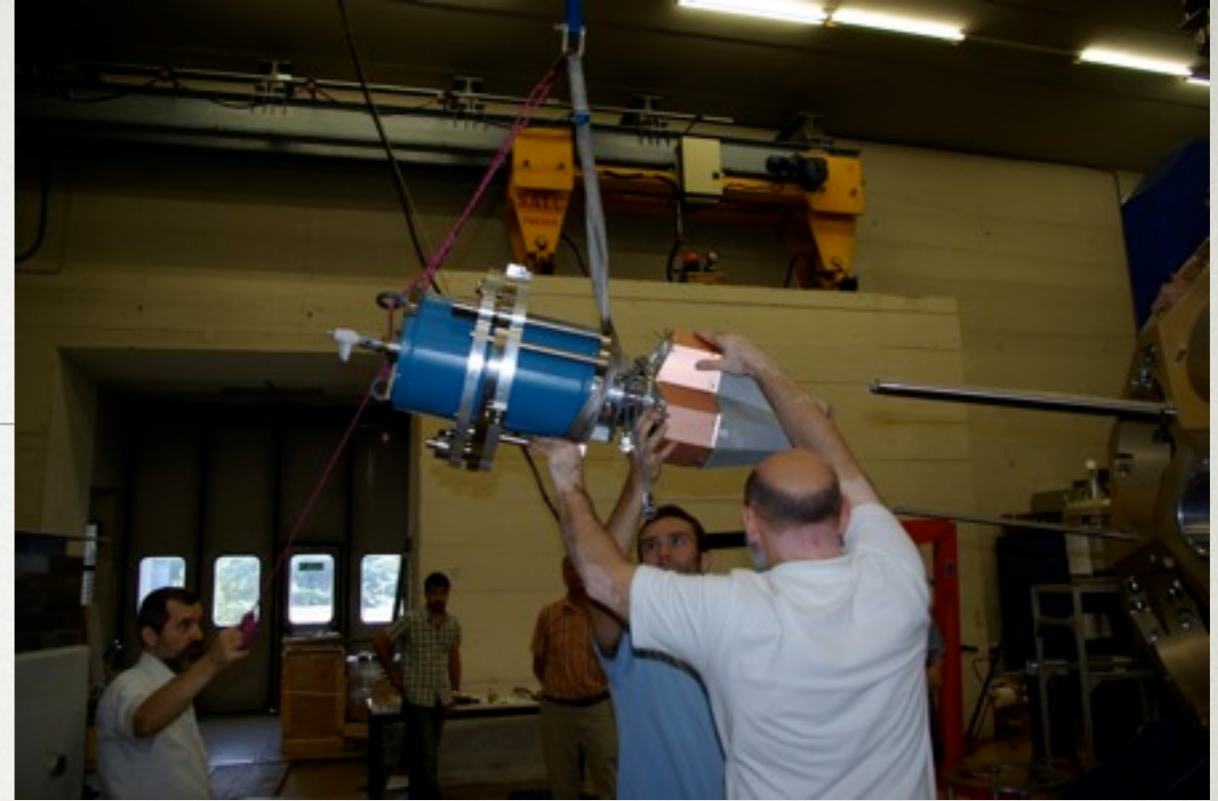
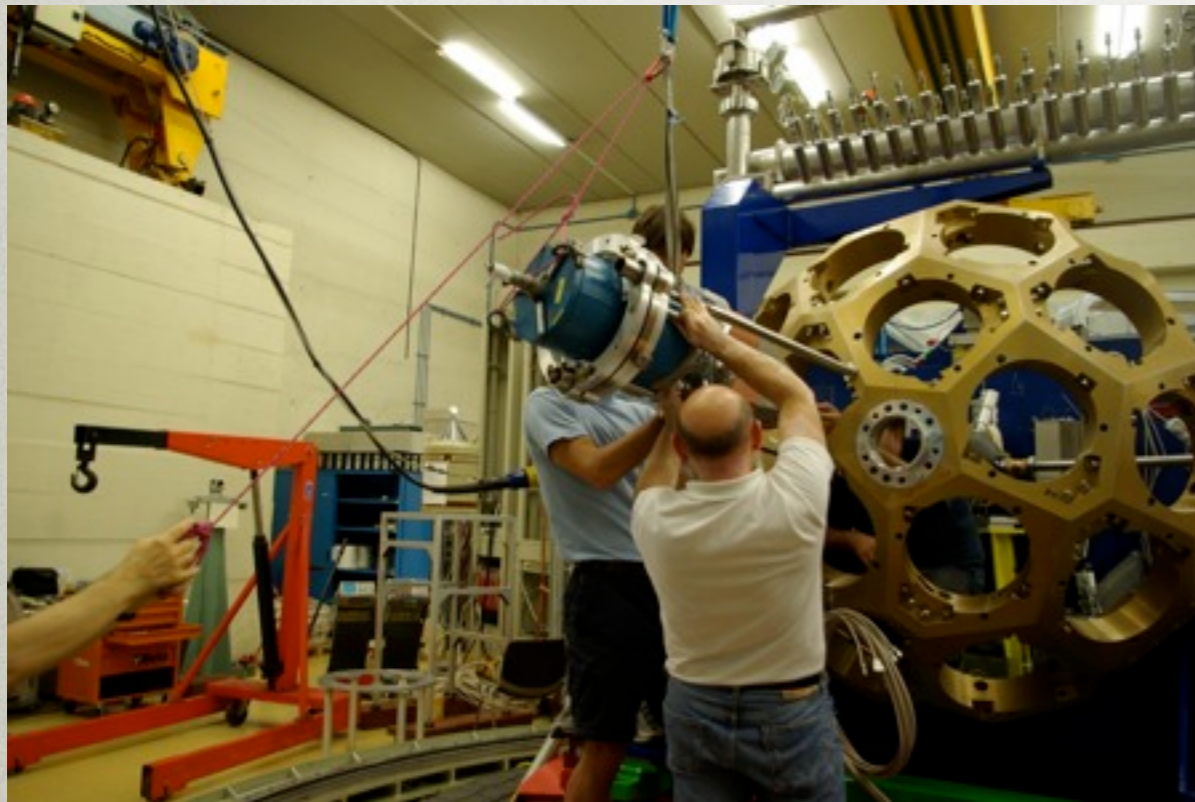
MOUNTING THE ATC

DIFFICULT TASK
ALREADY WITH ONE
DETECTOR

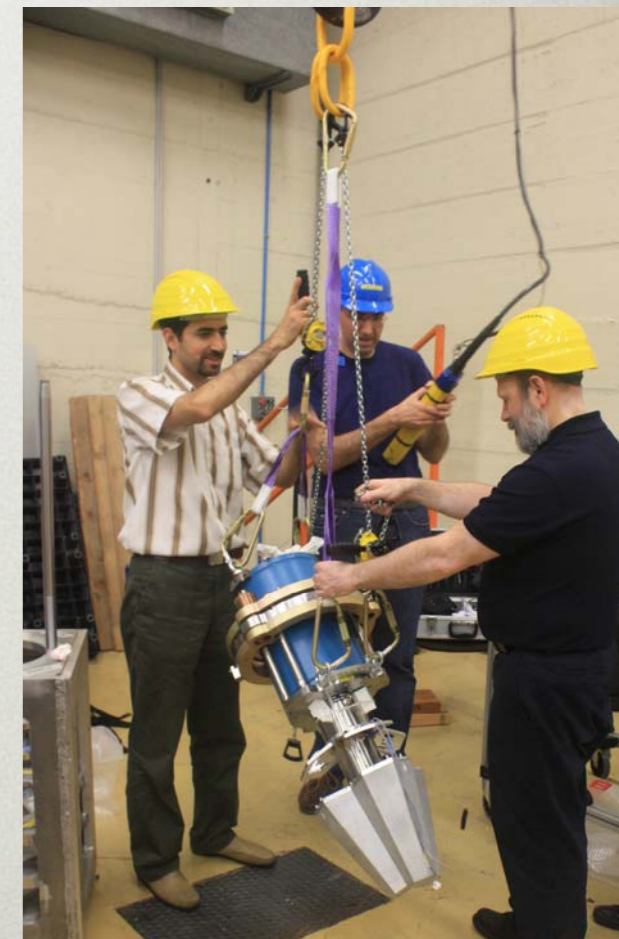
NEW USER'S MANUAL
"PROCEDURE FOR
INSTALLING A DETECTOR
IN THE ARRAY"
(BY JOHN STRACHAN)
