CGEM-IRC MEETING INTRODUCTION AND MECHANICS

G. Cibinetto on behalf of the CGEM group

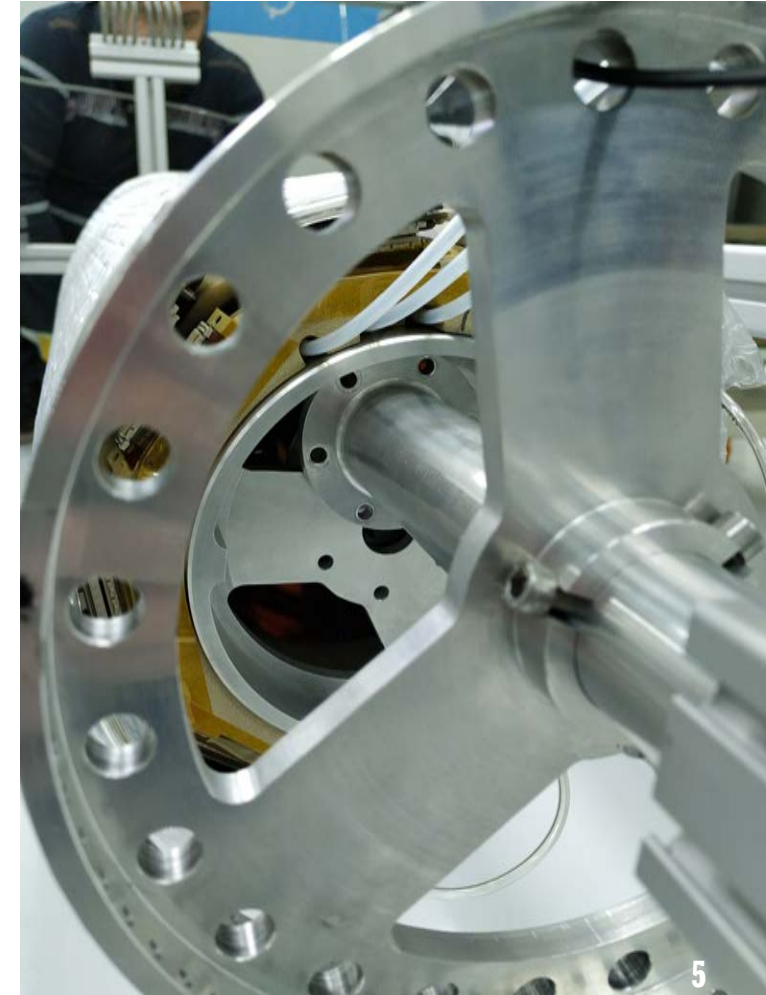
This side collapsed → vibrations removed the fixing screws

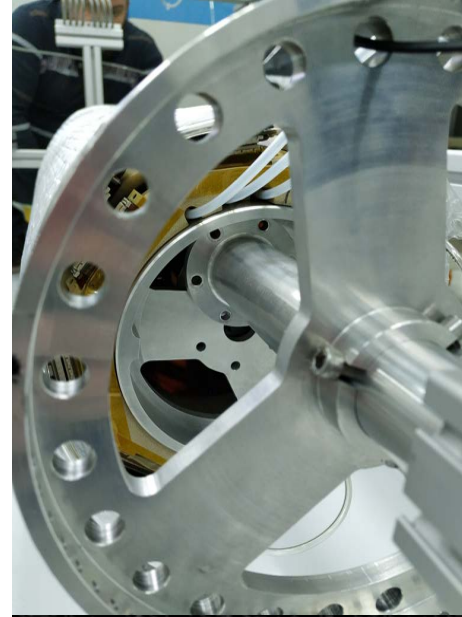
CT SCAN ON LAYER 1

This is the
fixed side

That is the floating
side, the one bouncing
for hours

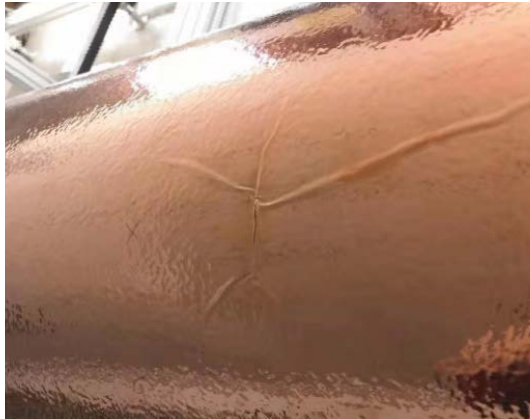
The external hit on the anode

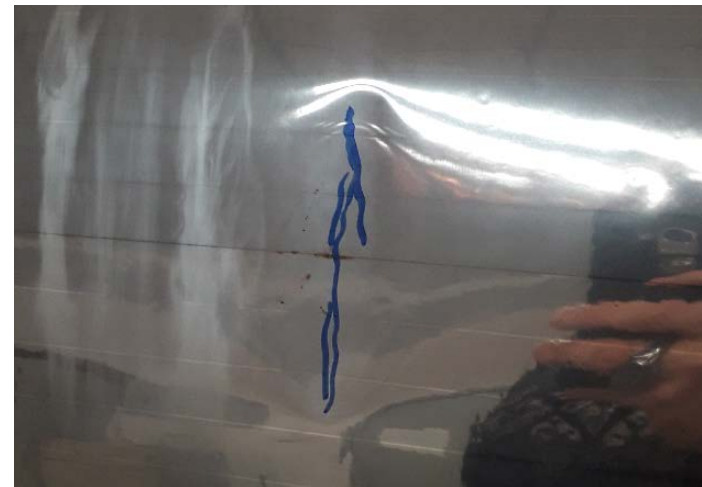
The rohacell structure was fine

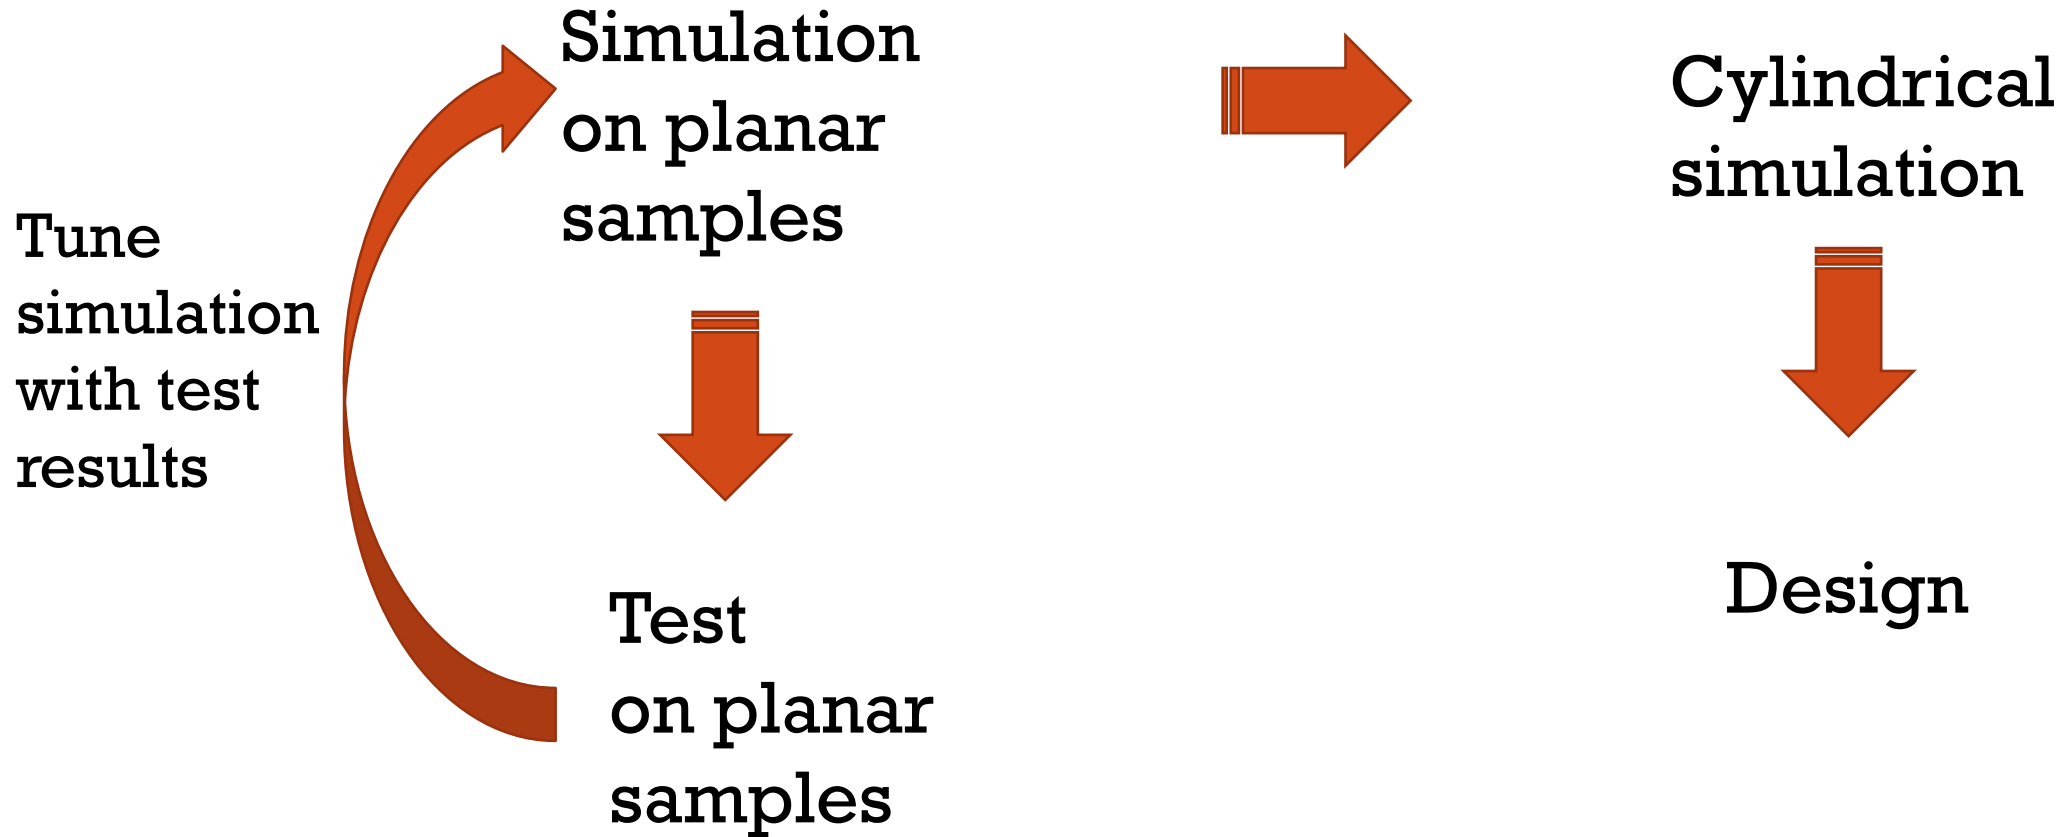
PROCEDURE

comparative analysis using 70 x 10 mm² planar samples (cylindrical shape is supposed to be more robust)

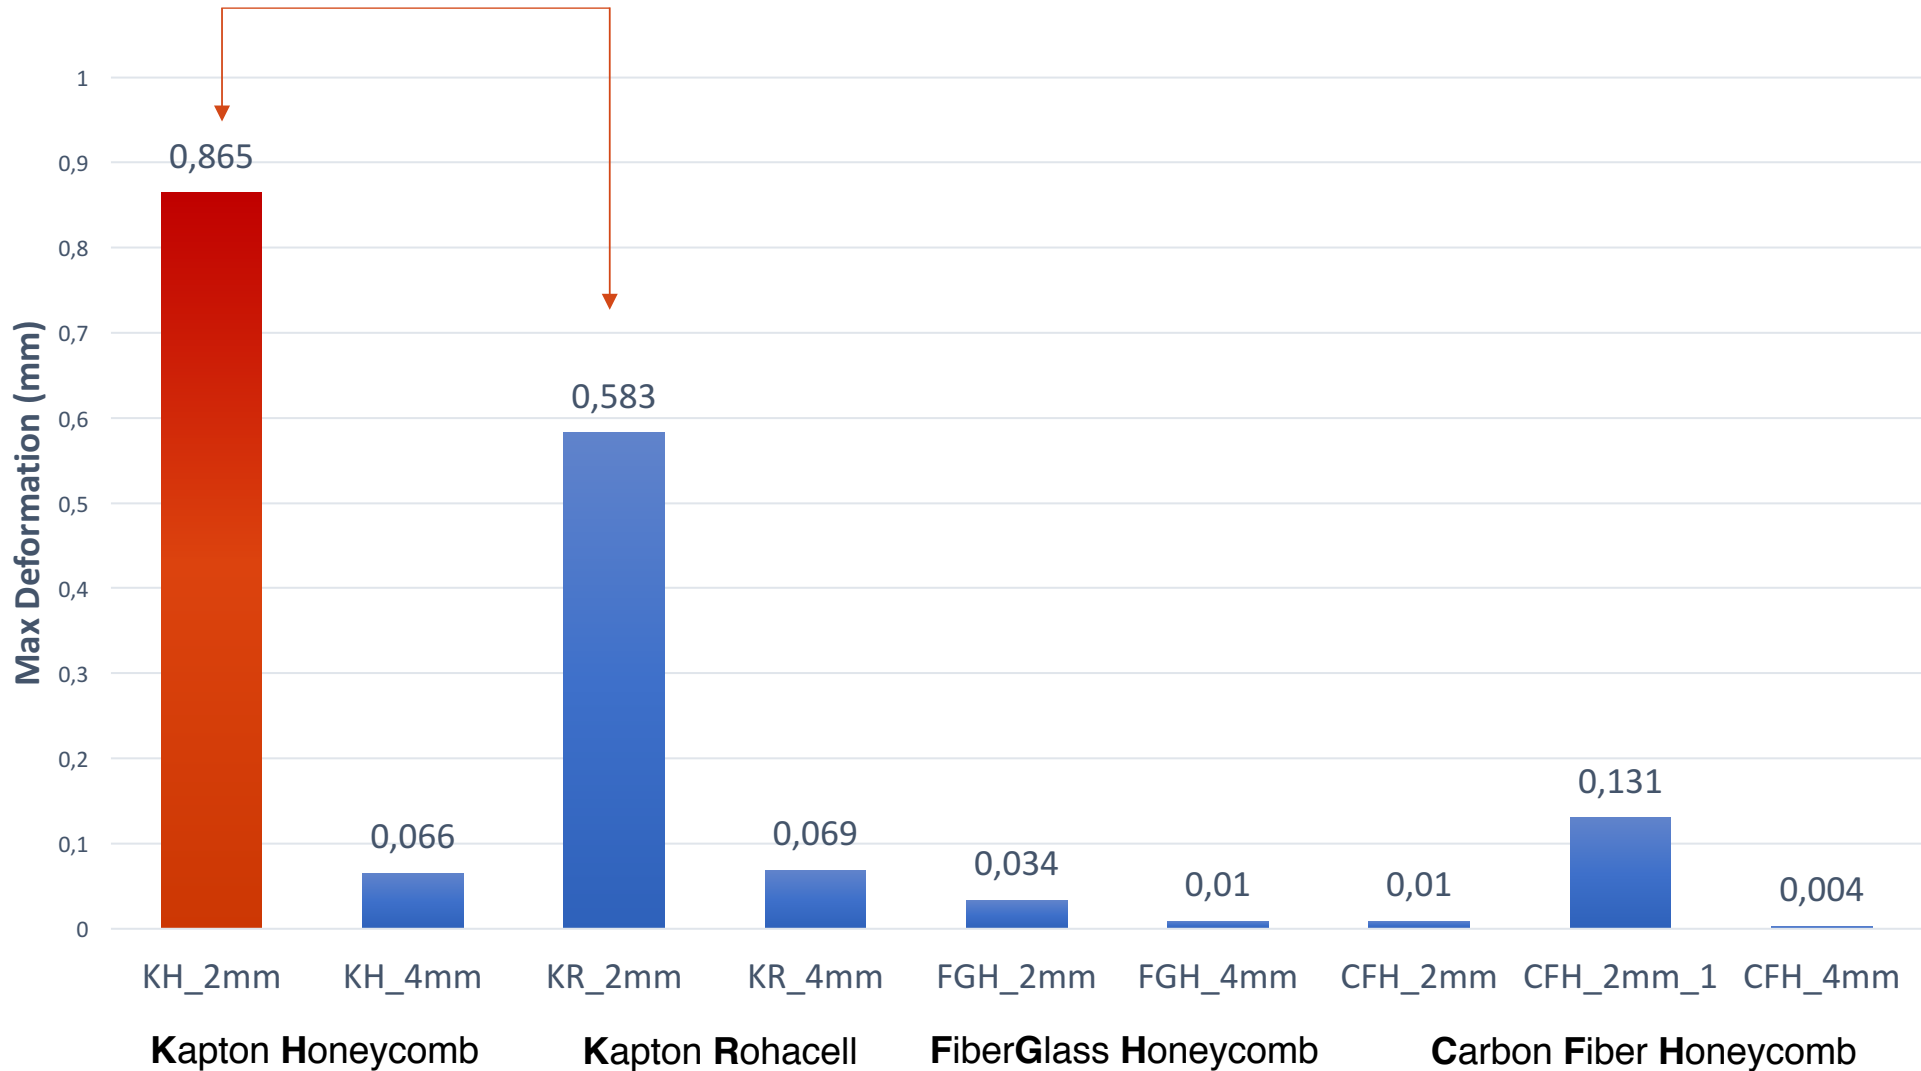
PLAIN HONEYCOMB VS ROHACELL

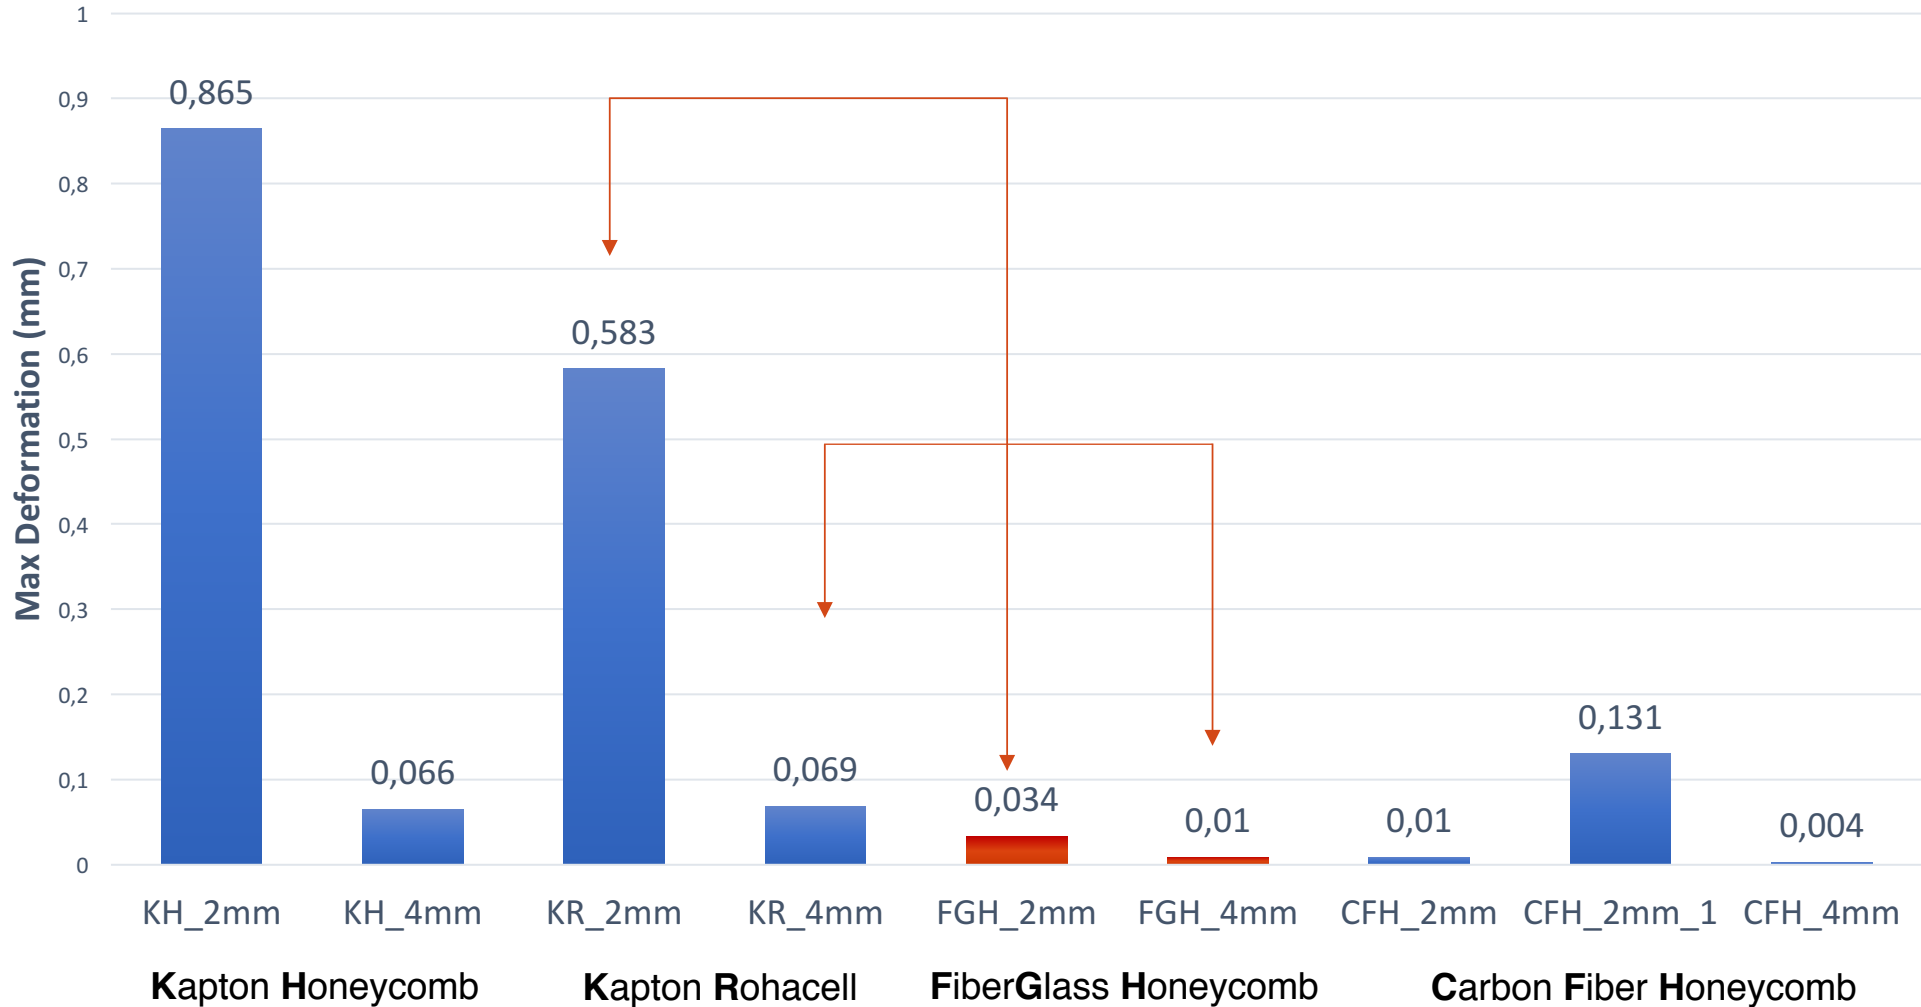
FIBER IMPROVEMENT EVIDENT

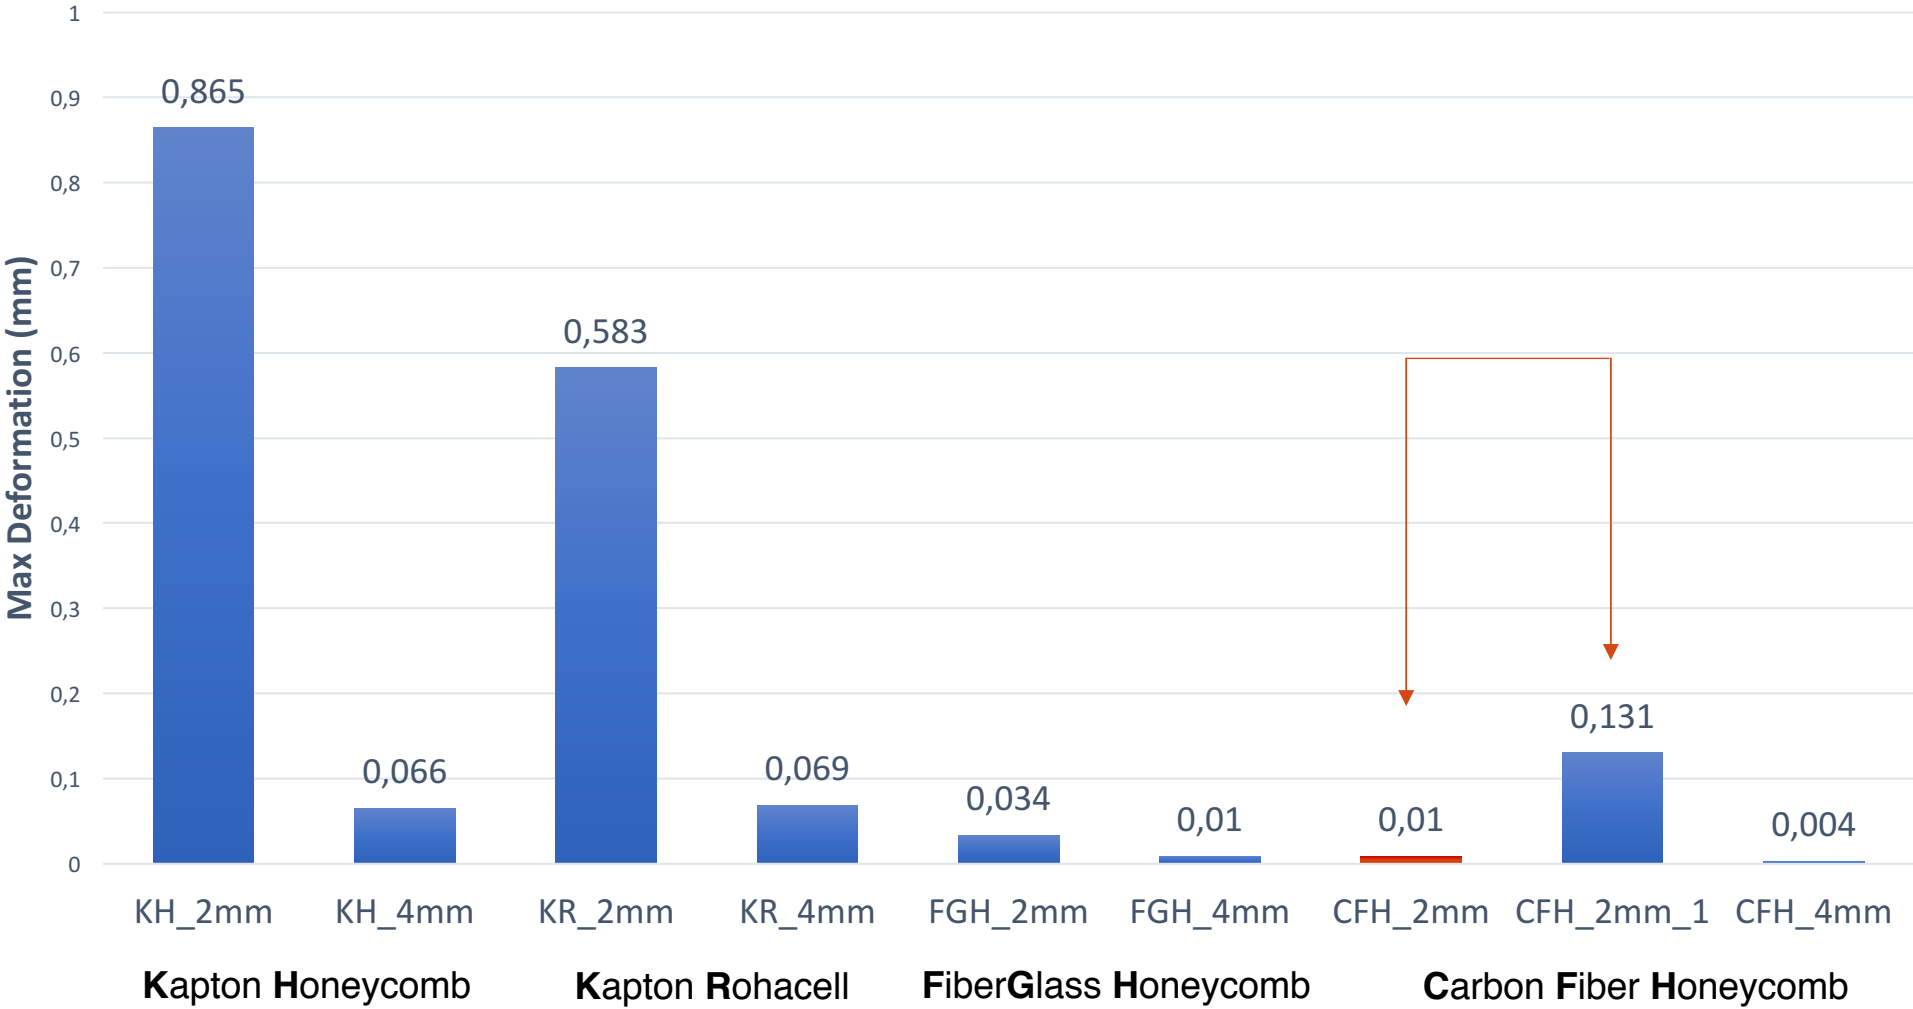
TWO SKINS X10 BETTER THAN ONE

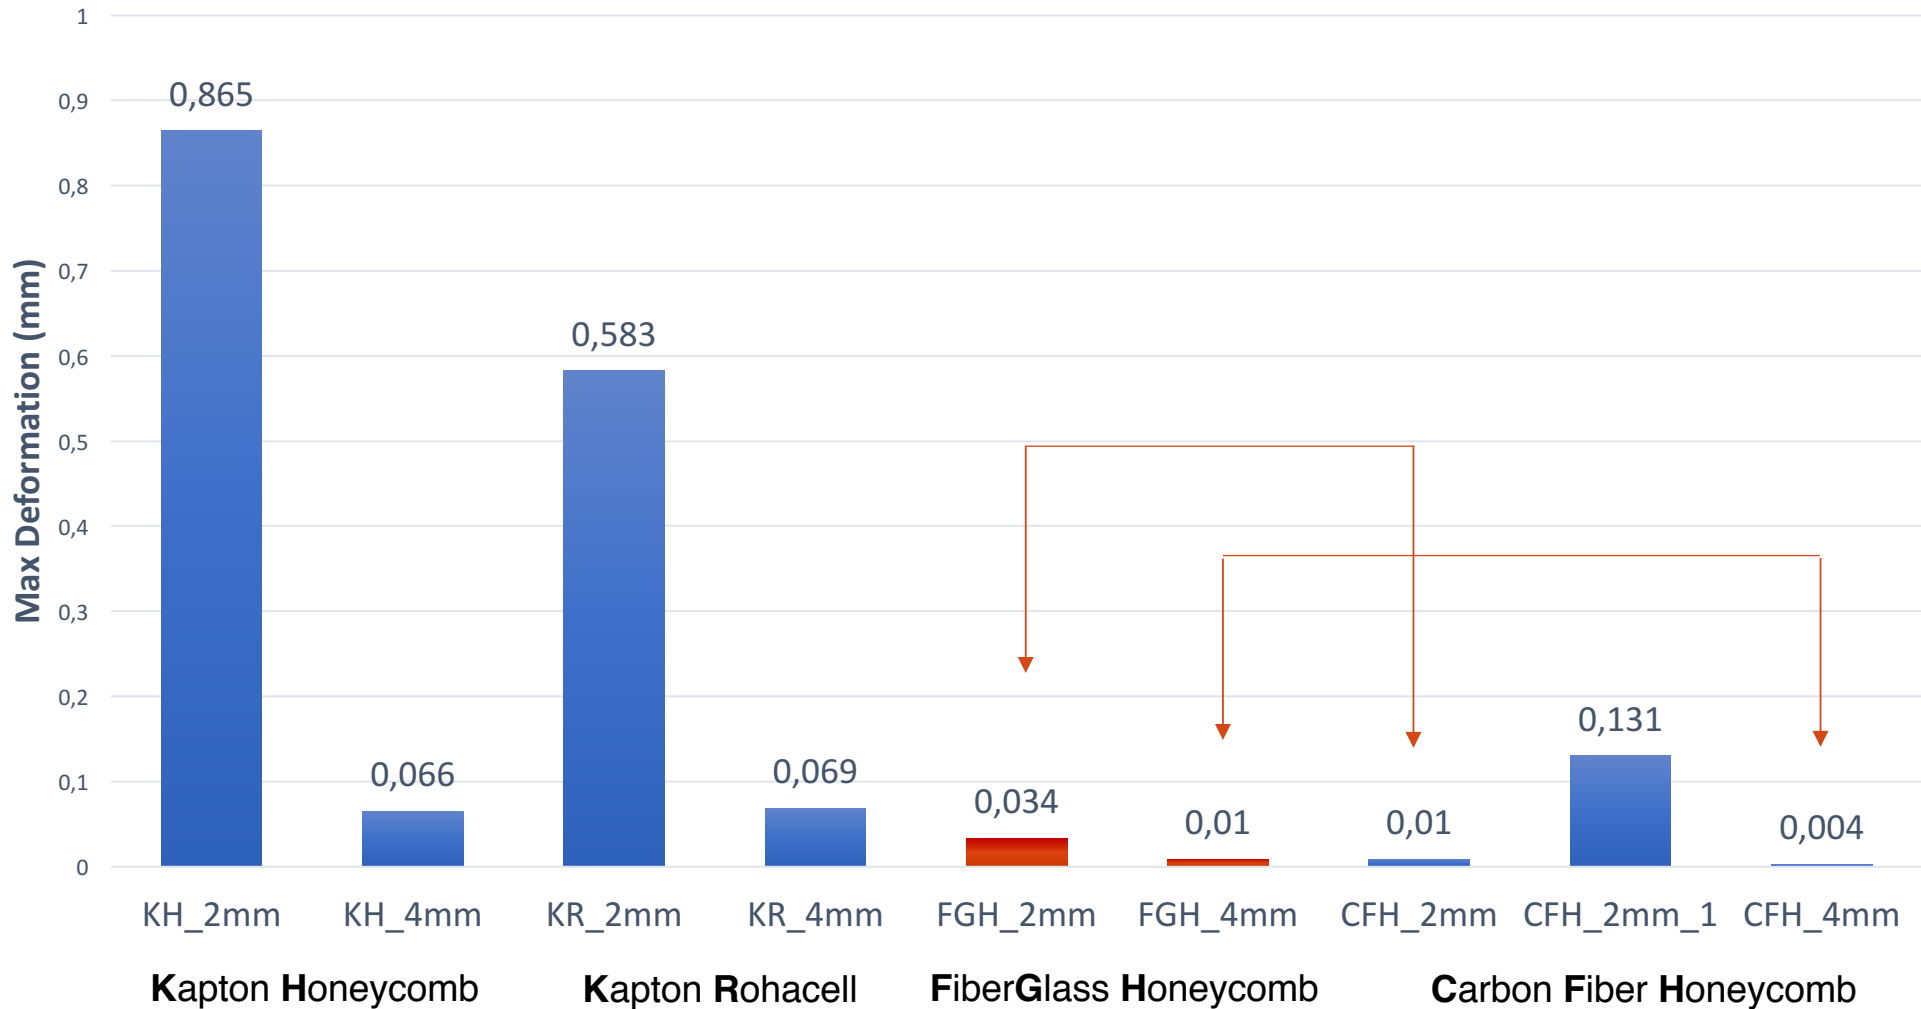
CARBON BETTER THAN GLASS

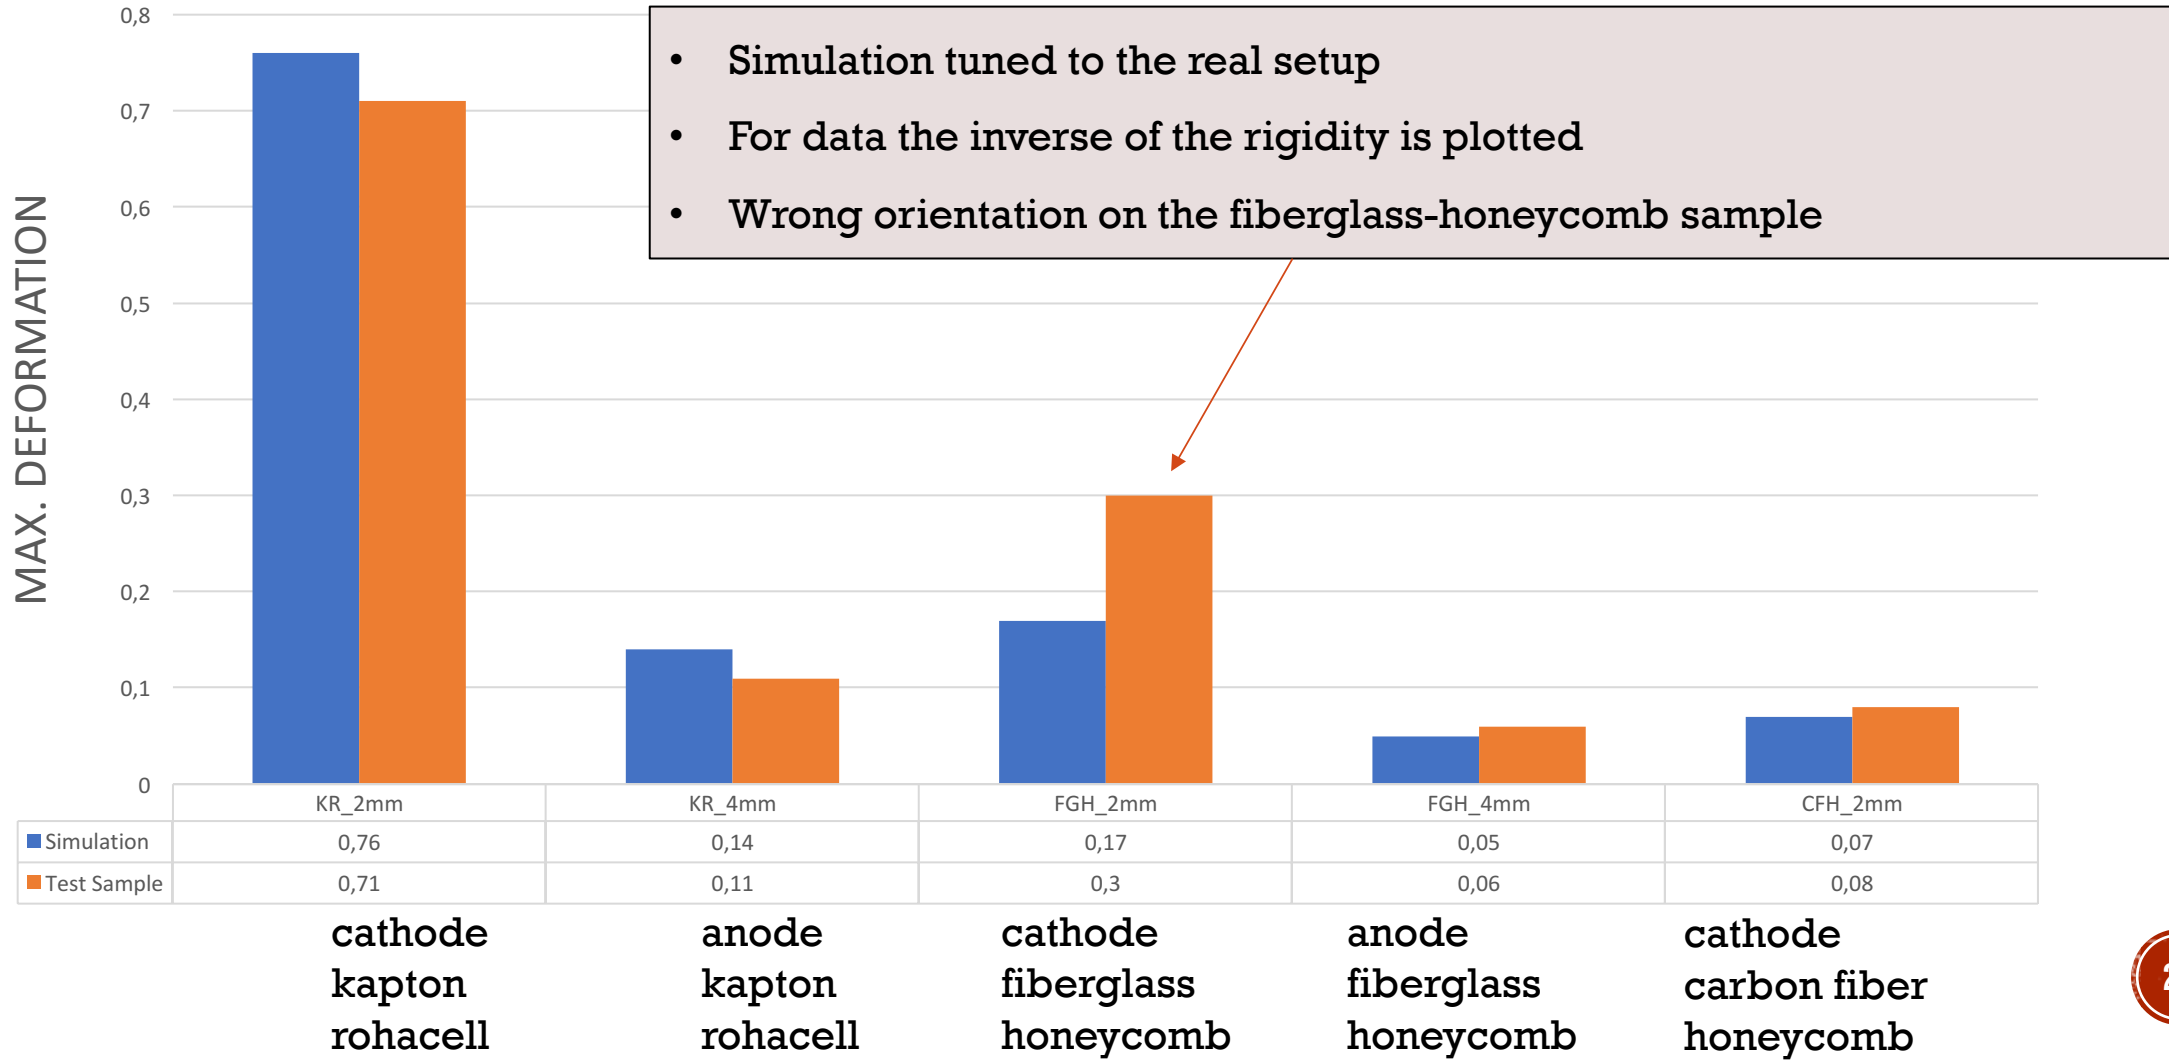
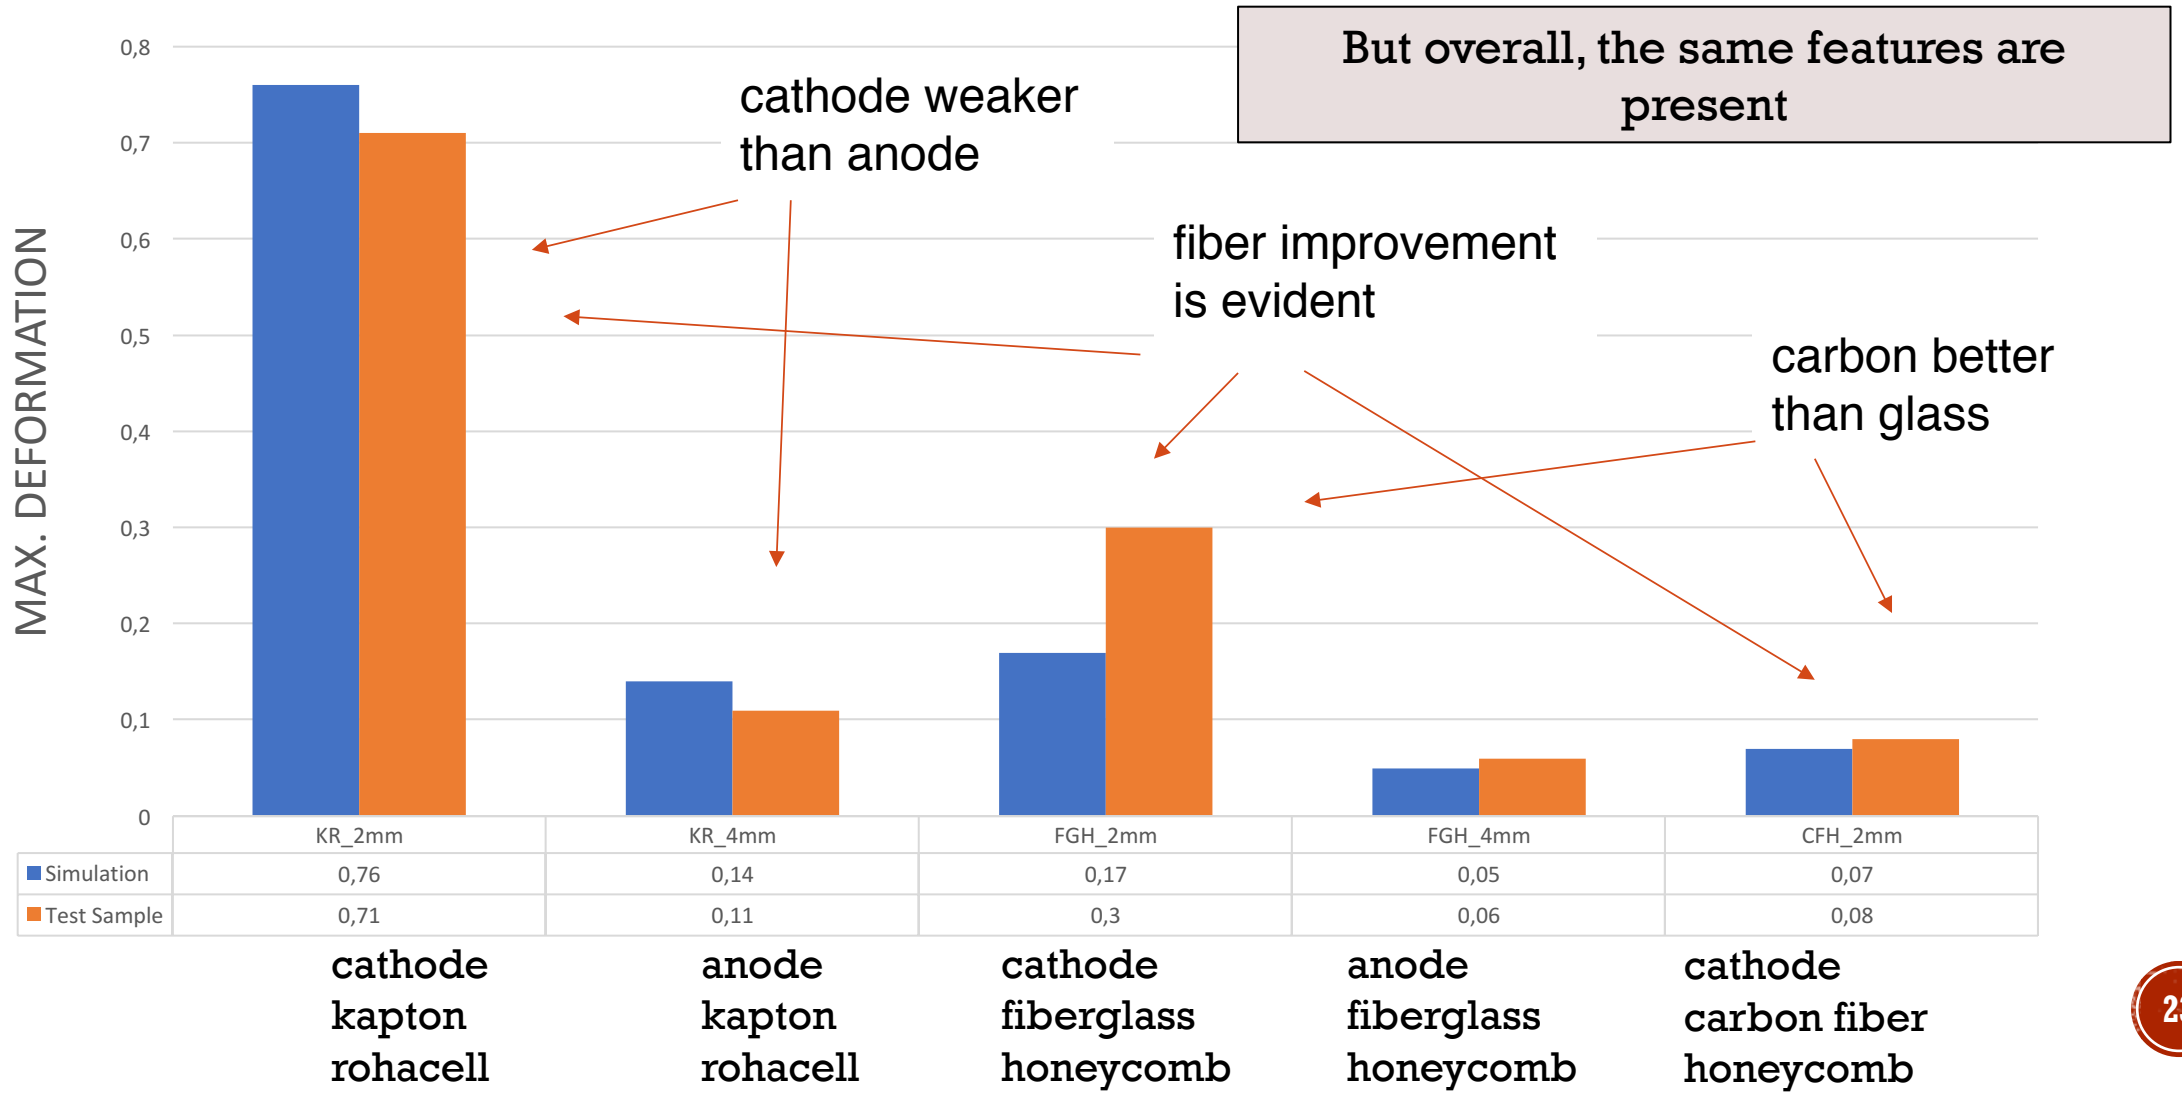
DATA/SIMULATION COMPARISON

- Two skins of carbon fibers are the best solution to reinforce the CGEM structure.
 - almost 10 times more rigid w.r.t. the present design from test sample
 - more than 50 times more rigid from simulations
- Is that enough? See next slides
- Additional modification to the permaglass rings will be added in order to improve the grip of the gluing.
 - for the rings already ordered the modifications will be done at LNF.
