CGEM mechanical design upgrade

July 2nd, 2019

1. Investigation on the mechanical issues of Layer 1 and Layer 3

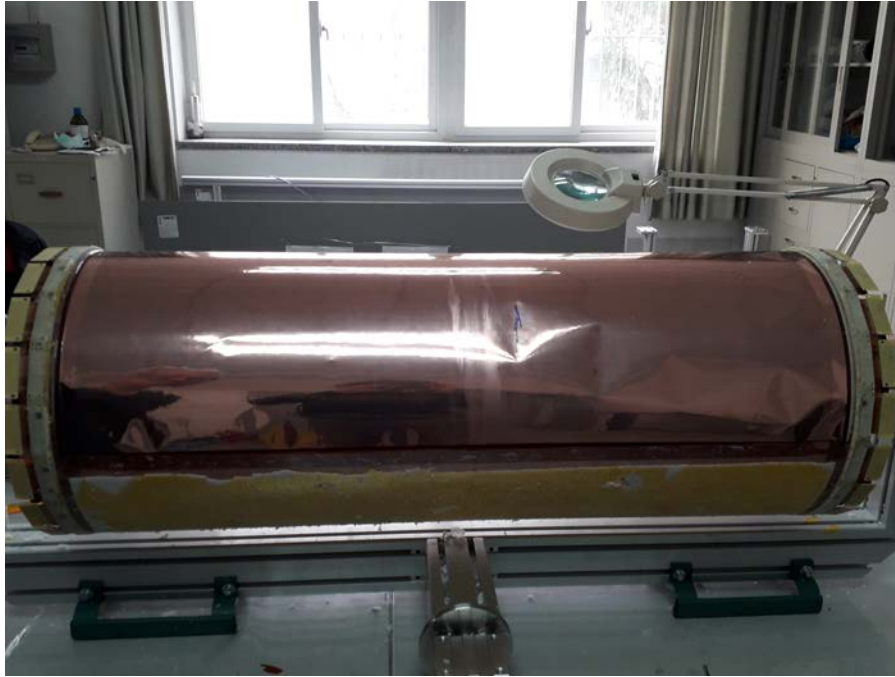
Figure 2 – The Layer 3 opened. The damage to the GEM foil is visible.

For Layer 3, the CT scan showed a similar situation to the picture on the left shown before all along the detector. We than decided to proceed with opening the detector to have a look inside. The procedure foreseen to remove one layer at time starting from the anode, then the GEM foils and finally the Cathode. This way we learned that the damage that occurred during the construction reached also the GEM and there were several defects probably due to the amount of vibration during the shipment. The picture below shows the detector were on the top half there is the GEM 3 damaged.

Therefore, we can conclude that the most of the damages for Layer 1 and Layer 3 happened during the shipment due to an excess of vibrations that have been transferred by the external supporting structure to the GEM foils. We can also conclude that the Kapton-Rohacell sandwich is not enough rigid to prevent inner damage from unexpected events.

For the reasons described in the previous paragraph, we decided to improve the mechanical rigidity of the detector. Simulations have been performed to compare different structure configurations in order to find the one that maximizes the robustness of the detector while keeping the material budget within the limit of 1.5% of a radiation length.

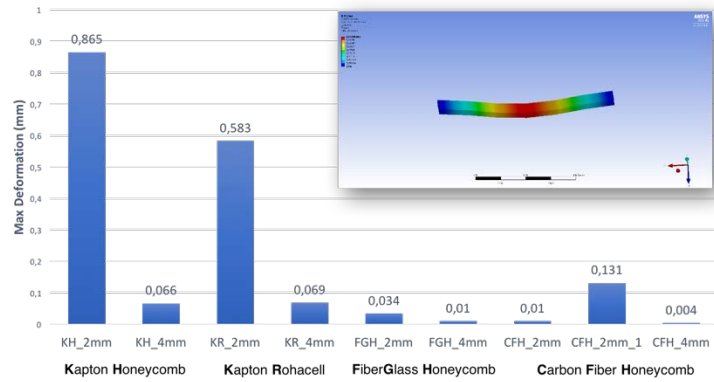
Figure 3 – Simulation of planar samples

Fig. 3 shows the maximum deformation for simulated planar samples. Each sample is $70 \times 10 \text{ cm}^2$ and is composed of a filling material (either Rohacell or honeycomb) and two skins (made of either Kapton, fiberglass or carbon fiber). On top of each sample a homogenous force of 10 N is applied and the maximum deformation is reported.

The following configurations have been simulated:

- KH_2mm → Cathode of kapton and honeycomb (2 mm)
- KH_4mm → Anode of kapton and honeycomb (4 mm)
- KR_2mm → Cathode of kapton and honeycomb (2 mm)
- KR_4mm → Anode of kapton and honeycomb (4 mm)
- FGH_2mm → Cathode of fiberglass and honeycomb (2 mm)
- FGH_4mm → Anode of fiberglass and honeycomb (4 mm)
- CFH_2mm → Cathode of carbon fiber and honeycomb (2 mm)
- CFH_2mm_1 → Cathode of carbon fiber and honeycomb (2 mm) with only one skin of carbon fiber
- CFH_4mm → Anode of carbon fiber and honeycomb (4 mm)

- Rohacell and honeycomb have about the same rigidity;
- The anode is more robust than the cathode (anode thickness is 4 mm and cathode is 2 mm);
- Fiber glass or carbon fiber are a big improvement with respect to Kapton-Rohacell or Kapton-Honeycomb sandwiches;
- Carbon fiber is better than fiberglass (and also lighter);
- Using two skins is better than one skin.

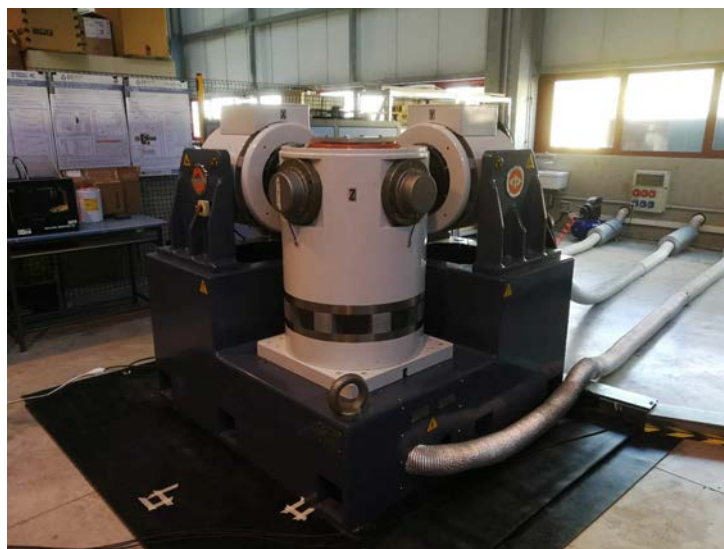
Figure 12 – vibrating machine.

In order to fully validate the box before any shipping, a full test on a vibrating machine that is available in Engineer Department of Ferrara University will be carried out. This machine can operate in the full 3D space and thus provide a complete characterization of the vibration profile of the box. A photo on the machine in Ferrara is shown in Fig. 12.

The shipping procedure has now a renewed scheme, with the foam suspension instead of springs. The design of the box is done in collaboration with Angst+Pfister, an international firm specialized in shipping technical materials. The box will be also characterized in its vibration profile thanks to a vibrating machine that can operate in the 3D space.
