Status at CERN

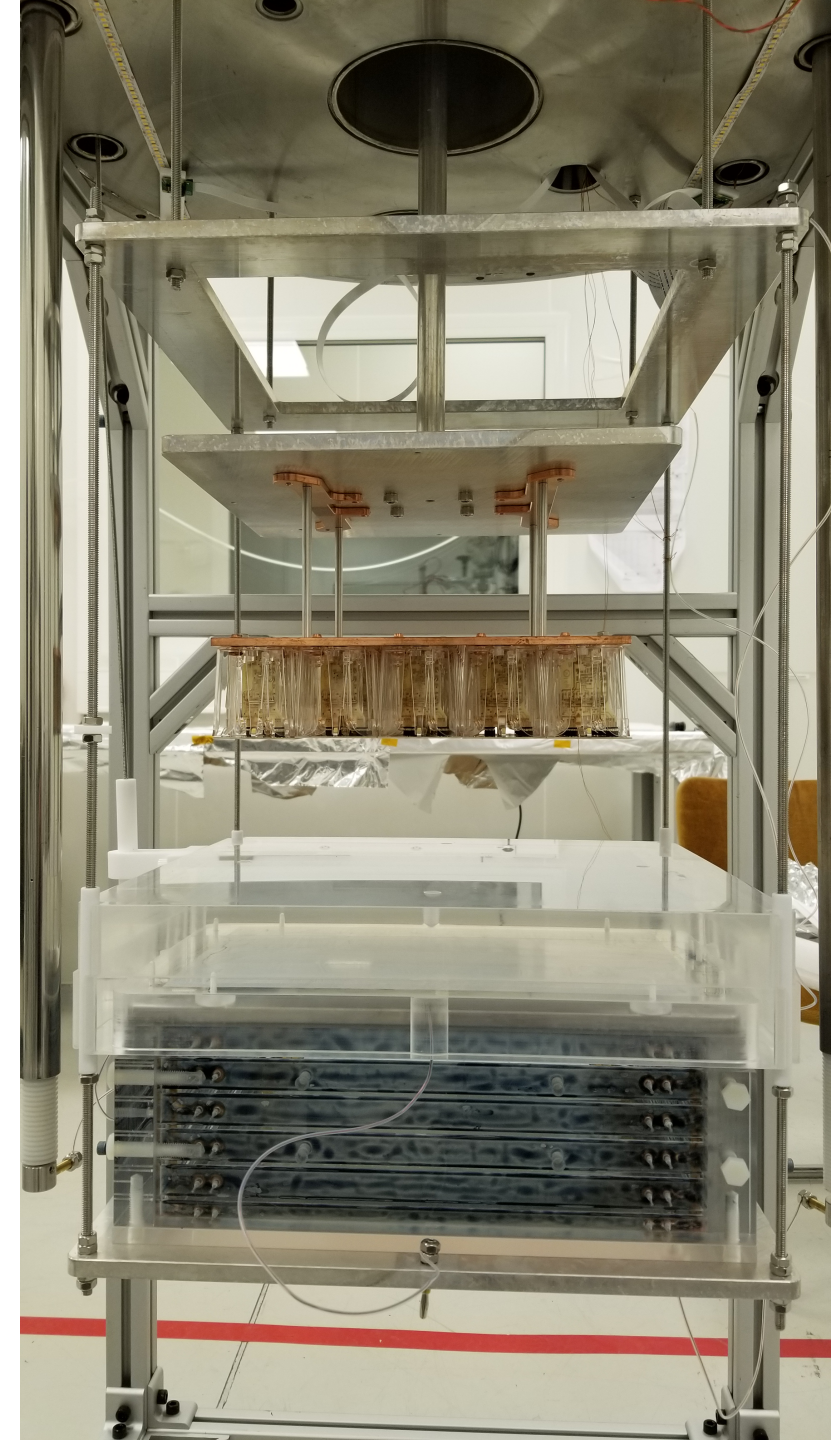
Operating Position

- The plan was to disassemble the TPC completely, install MB2, then reassemble the TPC
- However, it is possible to install MB2 without completely disassembling the TPC
- Remove the four Teflon rods holding the anode and let the anode rest on the field cage
- Turn adjustable support all the up to give ~10cm of space between MB and anode
- The movements of the anode and the removal/installation were tested with the mockup
- It is no more stressful than installing the MB first and then the anode
- This is likely the safer option as well
