ADAMO-Analysis, Diagnostics and Monitoring for Cultural Heritage project, a technology transfer experience in the Latium Region

TECNOLOGIE DI ANALISI, DIAGNOSTICA E MONITORAGGIO PER LA CONSERVAZIONE E IL RESTAURO DI BENI CULTURALI

Identification of pictorial materials and High resolution 3D model: Multidisciplinary study on pigments, binders and consolidants on Vincenzo Pasqualoni fresco in the apse (1865-1866)

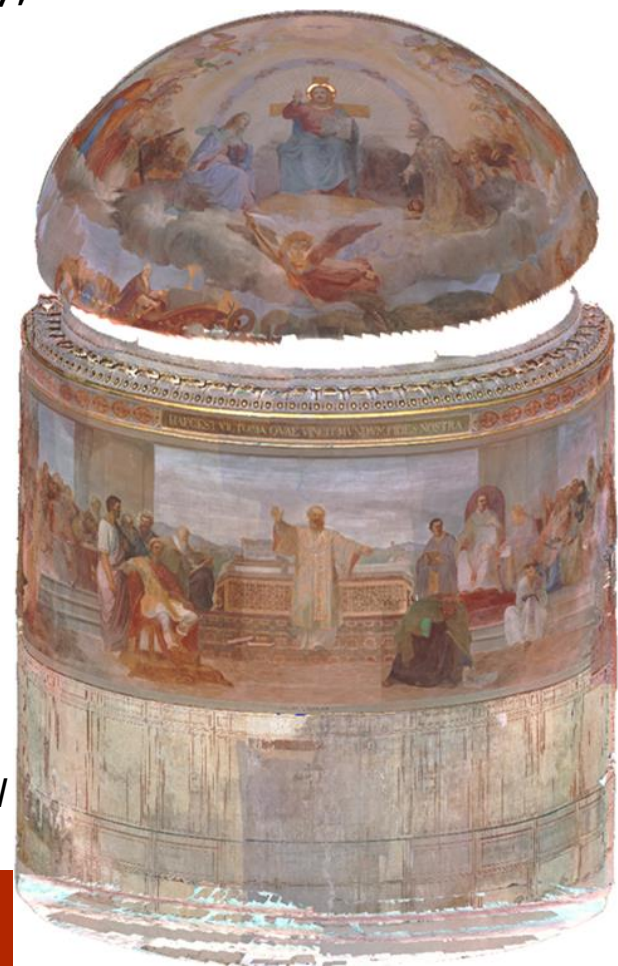
Identification of surface consolidants by means of laser induced fluorescence and FT-IR spectroscopy.

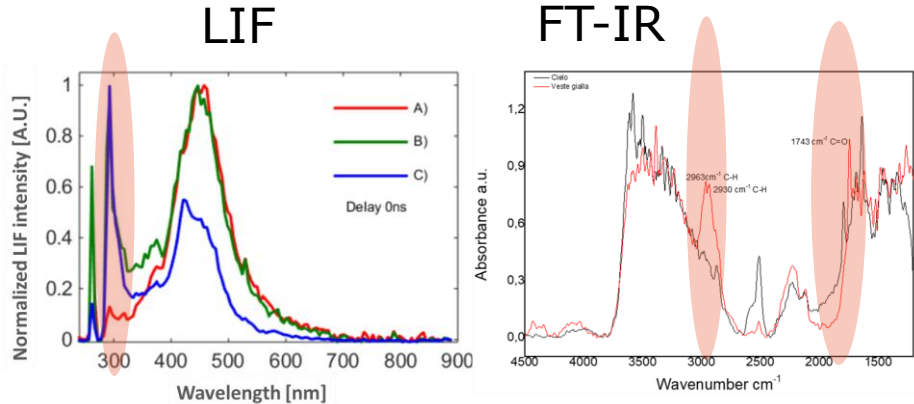
Presence of a synthetic product

Presence of different consolidants: Paraloid and acrylic compounds

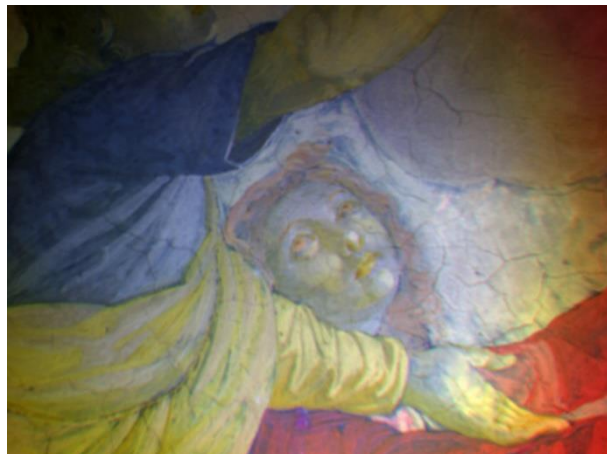
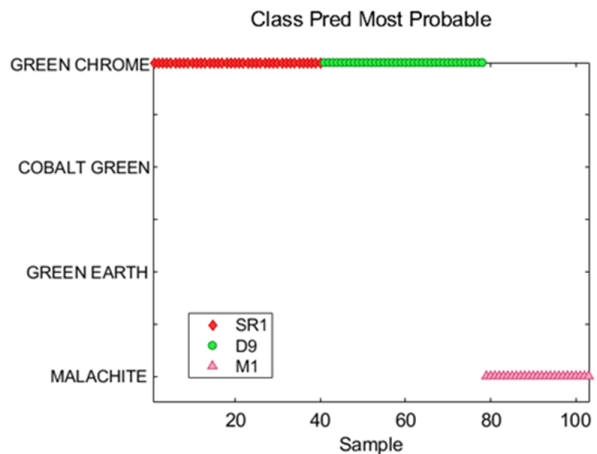
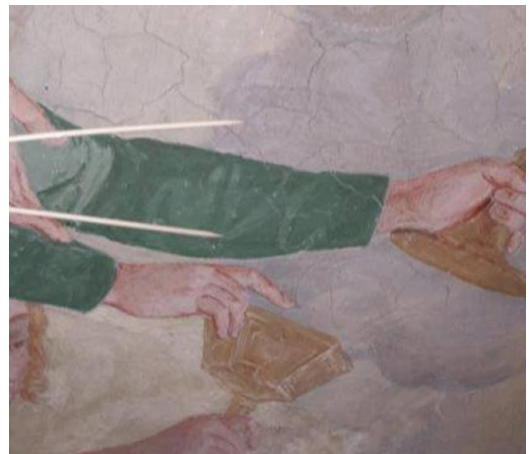
Identification of pigments and dyes by means of XRF, Raman, VIS-SWIR reflectance

1. Assign used pigments as:

Main traditional pigments: earths (yellow and red ochres, green earth), orpiment, cobalt blue, calcite, gypsum.

Main modern pigments: ultramarine blue, phoenicochroite, green chrome, zinc white.

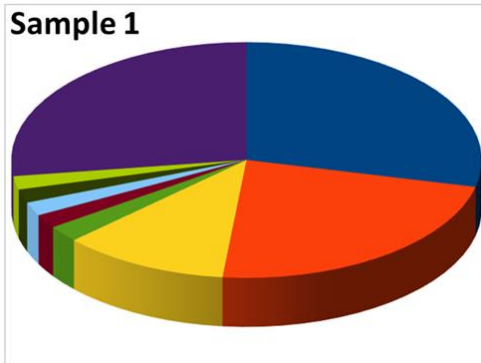
A bio-informatic pipeline, capable to perform a taxonomic analysis by means of BLAST, was developed in order to identify, for each single reading, the corresponding species and so to characterize micro-bioma present in the analyzed sample.

In the cake plot, the percentages of the seven most abundant species found are reported.

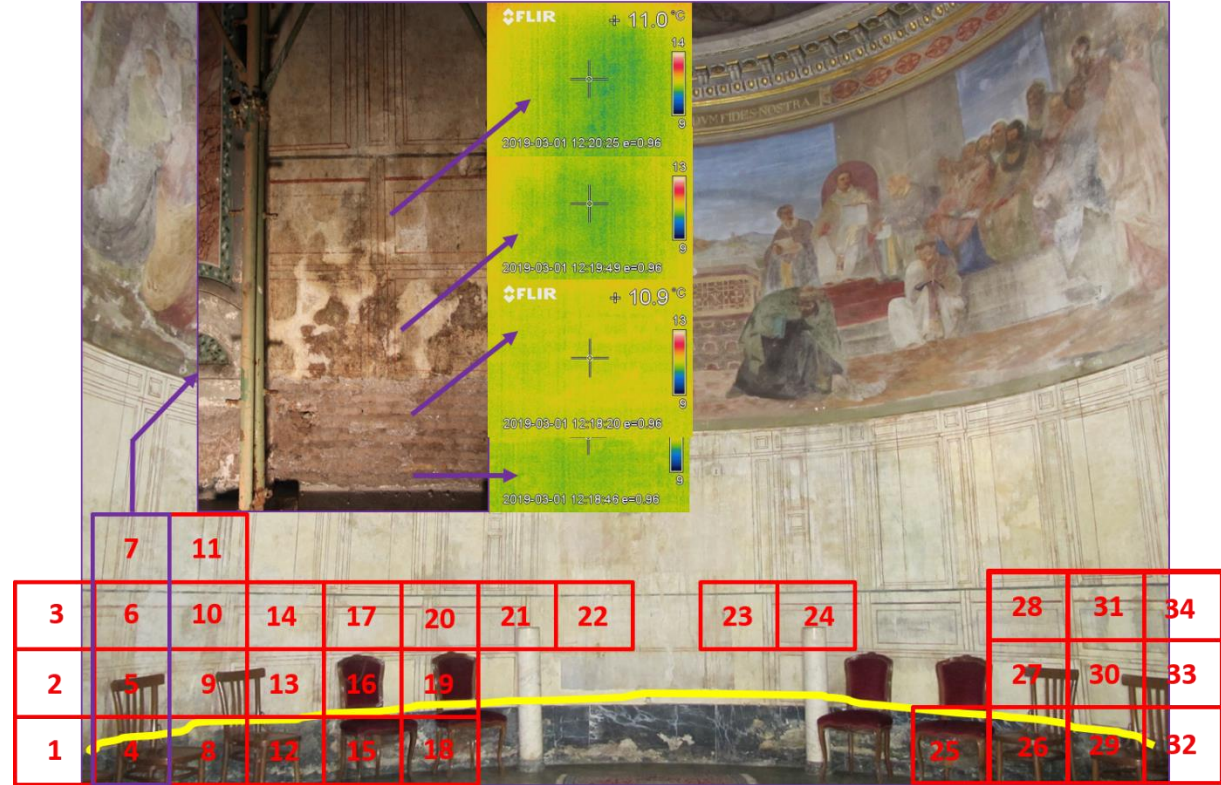
A significant difference in behavior was observed between the «wetter» left side and the «drier» right side.

Areas investigated by thermography imaging (CNR-ICVBC)
a detail of the column 4-7 characterized by high humidity is shown in the inset

Abside di San Nicola in carcere, particolare dei rilievi termografici delle aree 4-7 interessate da elevata presenza di umidità

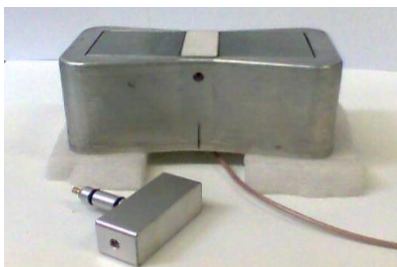
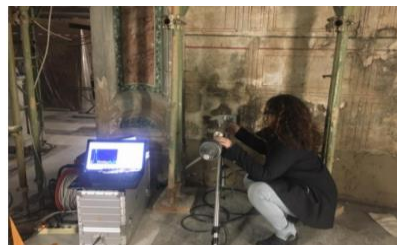
Analises by means of portable NMR spectrometer

- 1) Humidity distribution
- 2) Quantitative data on water content

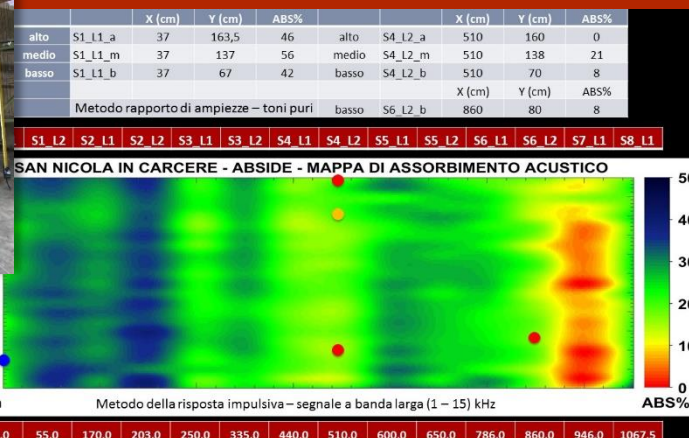
Il sistema di controllo e acquisizione rileva il segnale dell'onda sonora diretta e dell'onda riflessa dalla superficie e lo elabora per estrarre l'informazione sull'assorbimento acustico

- muratura umida valori di assorbimento acustico ABS% elevato;
- zone asciutte valori di assorbimento acustico ABS% bassi;

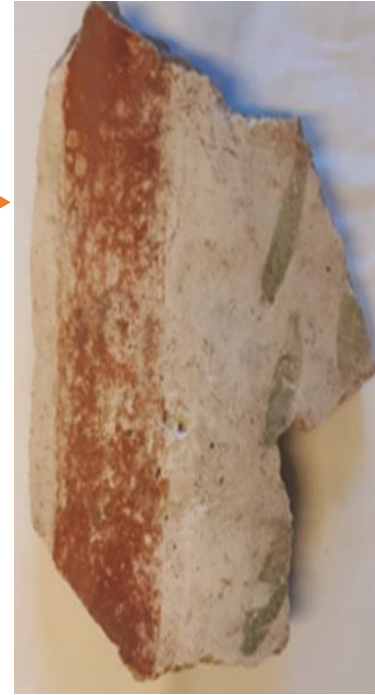
Samples from the hypogeal site

Fresco fragments were examined in order to identify agents responsible for biodegradation and to test biocide effectiveness.

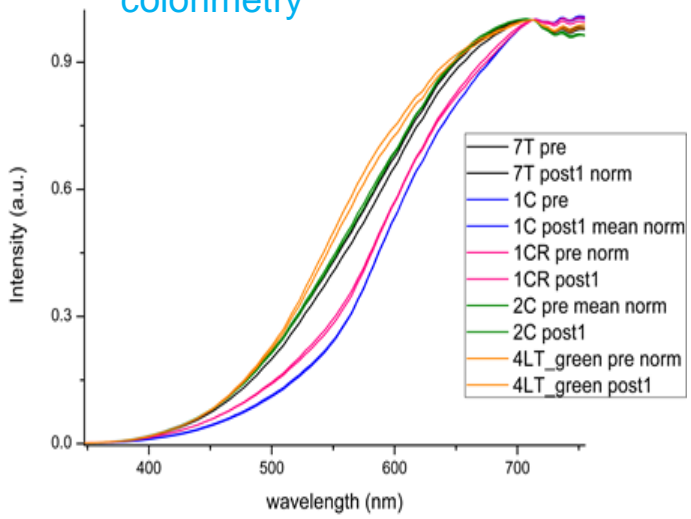
2 Reflectance and colorimetry

Standard contact colorimetry

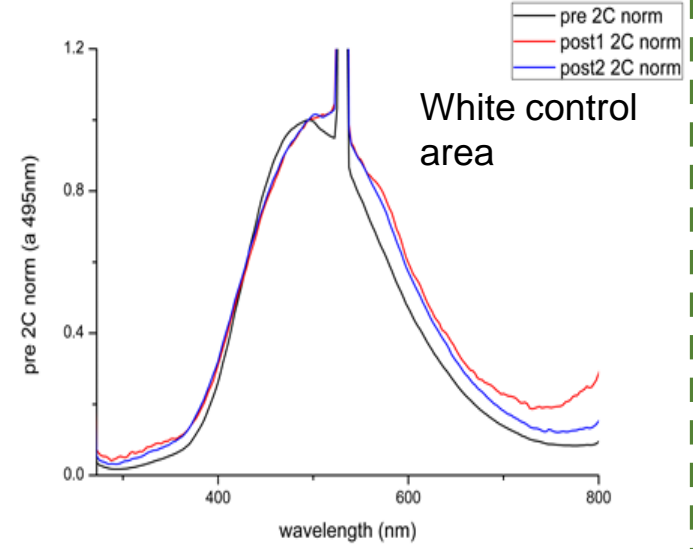
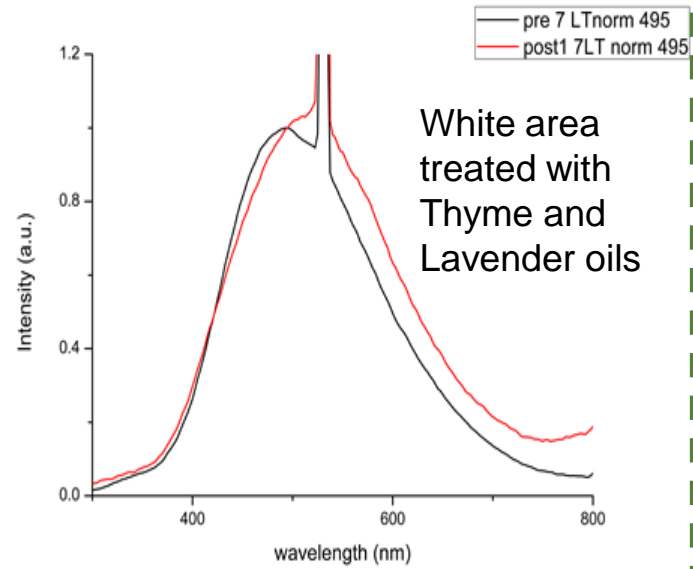
1 Laser Induced Fluorescence

Remote Imaging

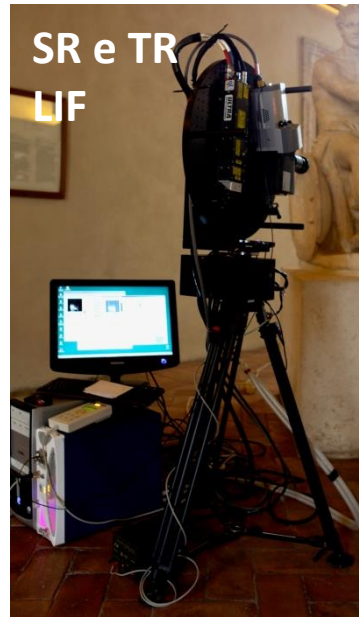
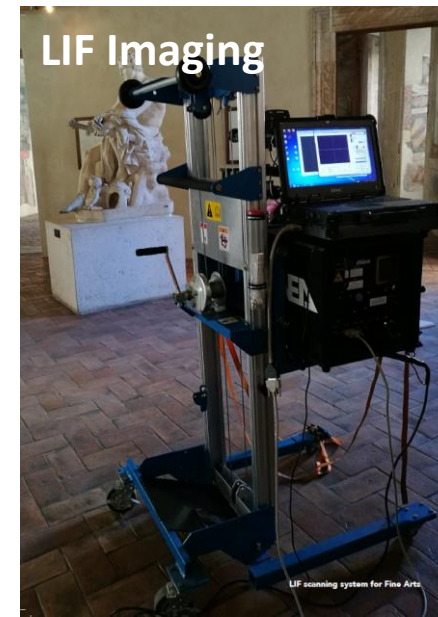
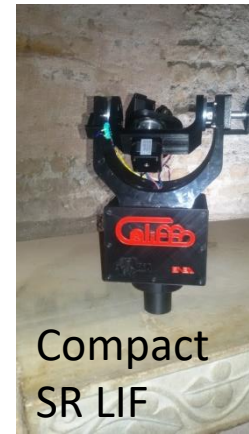
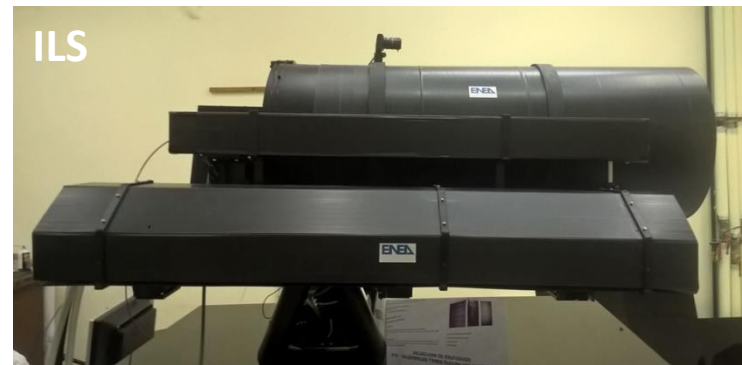
ENEA laser scanner prototypes in situ utilized for remote imaging

IR-ITR Laser scanner at 1.55 μm

LIBS – Raman
combined systems

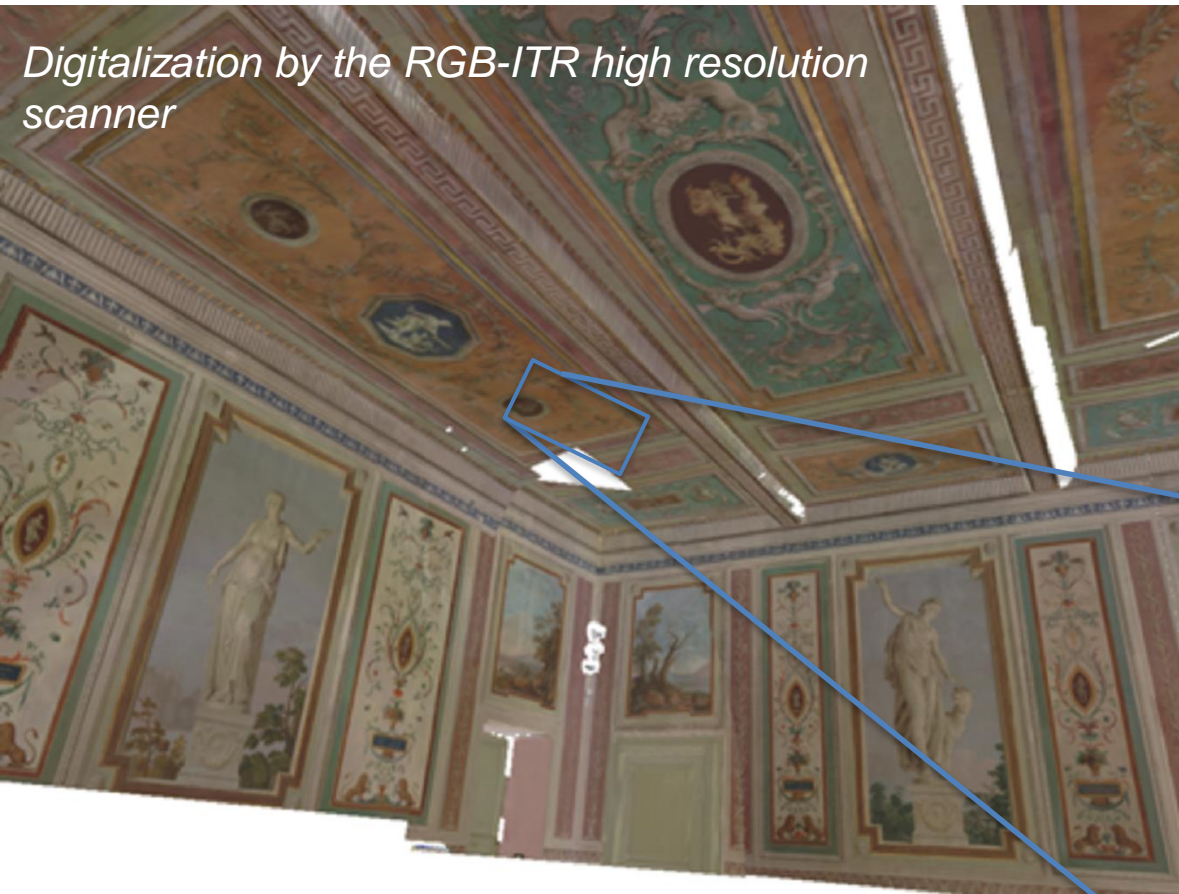
The Bishop's Palace in Frascati – The «Landscape» room

Digitalization by the RGB-ITR high resolution scanner

Wall tissue painted with water colors, covers the room.

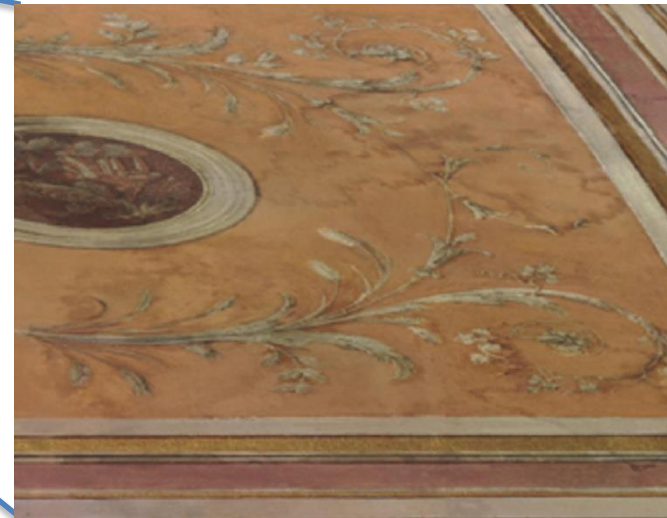
Details of the roof ceiling showing area repainted in the former restauration to compensate for discoloration

- Discoloration associated to former water infiltration were detected on the ceiling
- Morphologic irregularities due to the tissue fiber degradation were observed at high resolution
- The occurrence of former restoration on painted wood and frescoes surface was obtained, with consolidants assignment and distribution.
- Early damage from residual water infiltration was detected on the frescoes by TG LIF imaging.

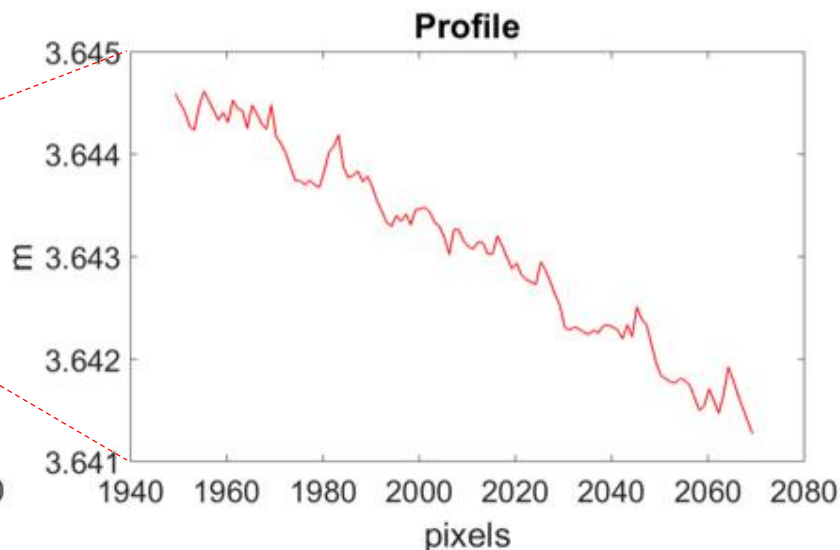
Morphologic analysis on RGB-ITR data

Detection of irregularities in the tissue fibers

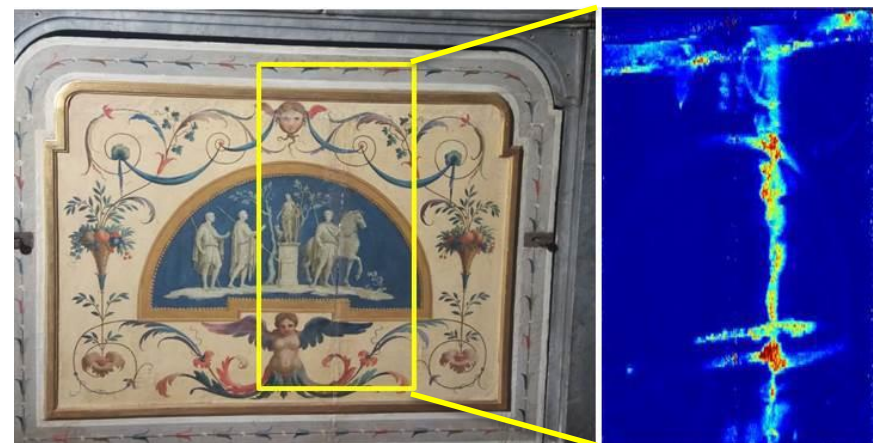
LIF investigation on the painted wood cover of the fireplace

The fluorescence image obtained for the ratio of 380/450 emission channels shows a crack, which was carefully restored by a consolidant and afterwards repainted

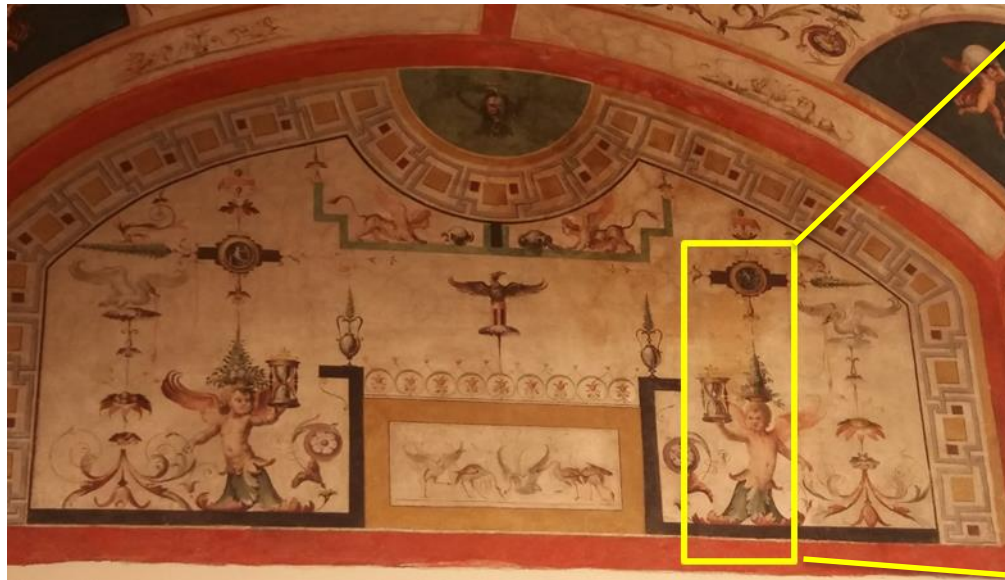
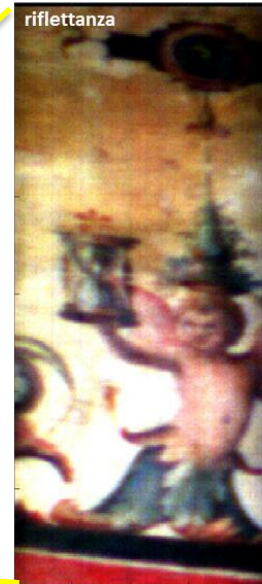
Additional evidence of former restorations and early warning of on-going damages by LIF imaging – The «Stufette» room

Is it possible to have an early detection of alteration in pigmentation?

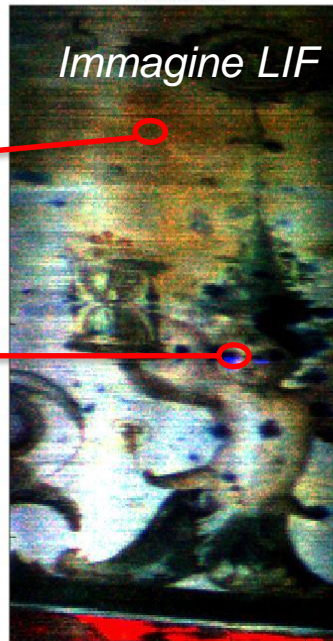
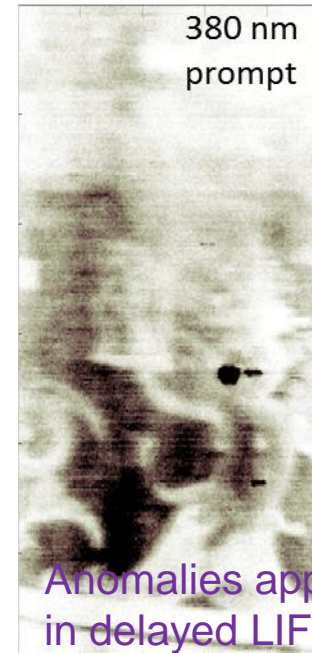
Color degradation @550 nm

ZnO retouches @380 nm

Anomalies appear well evident in delayed LIF images
