eeFACT – 2022

Status report of vacuum system of ESRF

Cristian Maccarrone

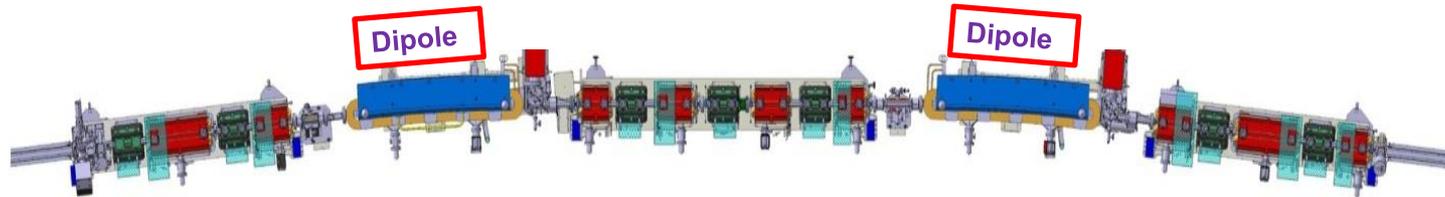
- **Old ESRF lattice**

Double Bend Achromat = (2 dipoles + 15 quad. sext.) per cell - ID length = 5 m (standard) / 6m / 7m

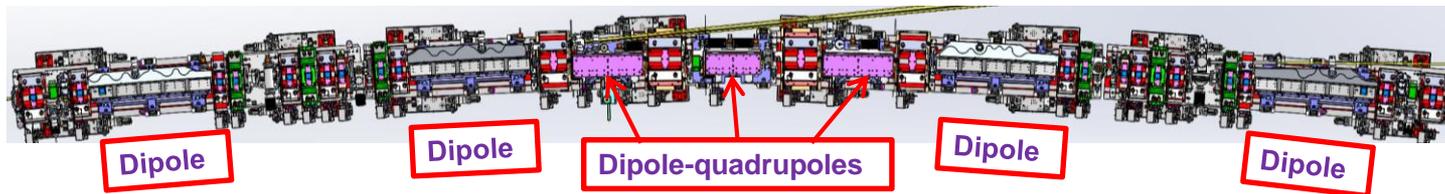
- **New EBS lattice**

Hybrid 7 Bend Achromat = (4 dipoles + 3 dipole-quad + 24 quad., sext., oct.) per cell - ID length = 5 m

31 magnets per cell instead of 17!

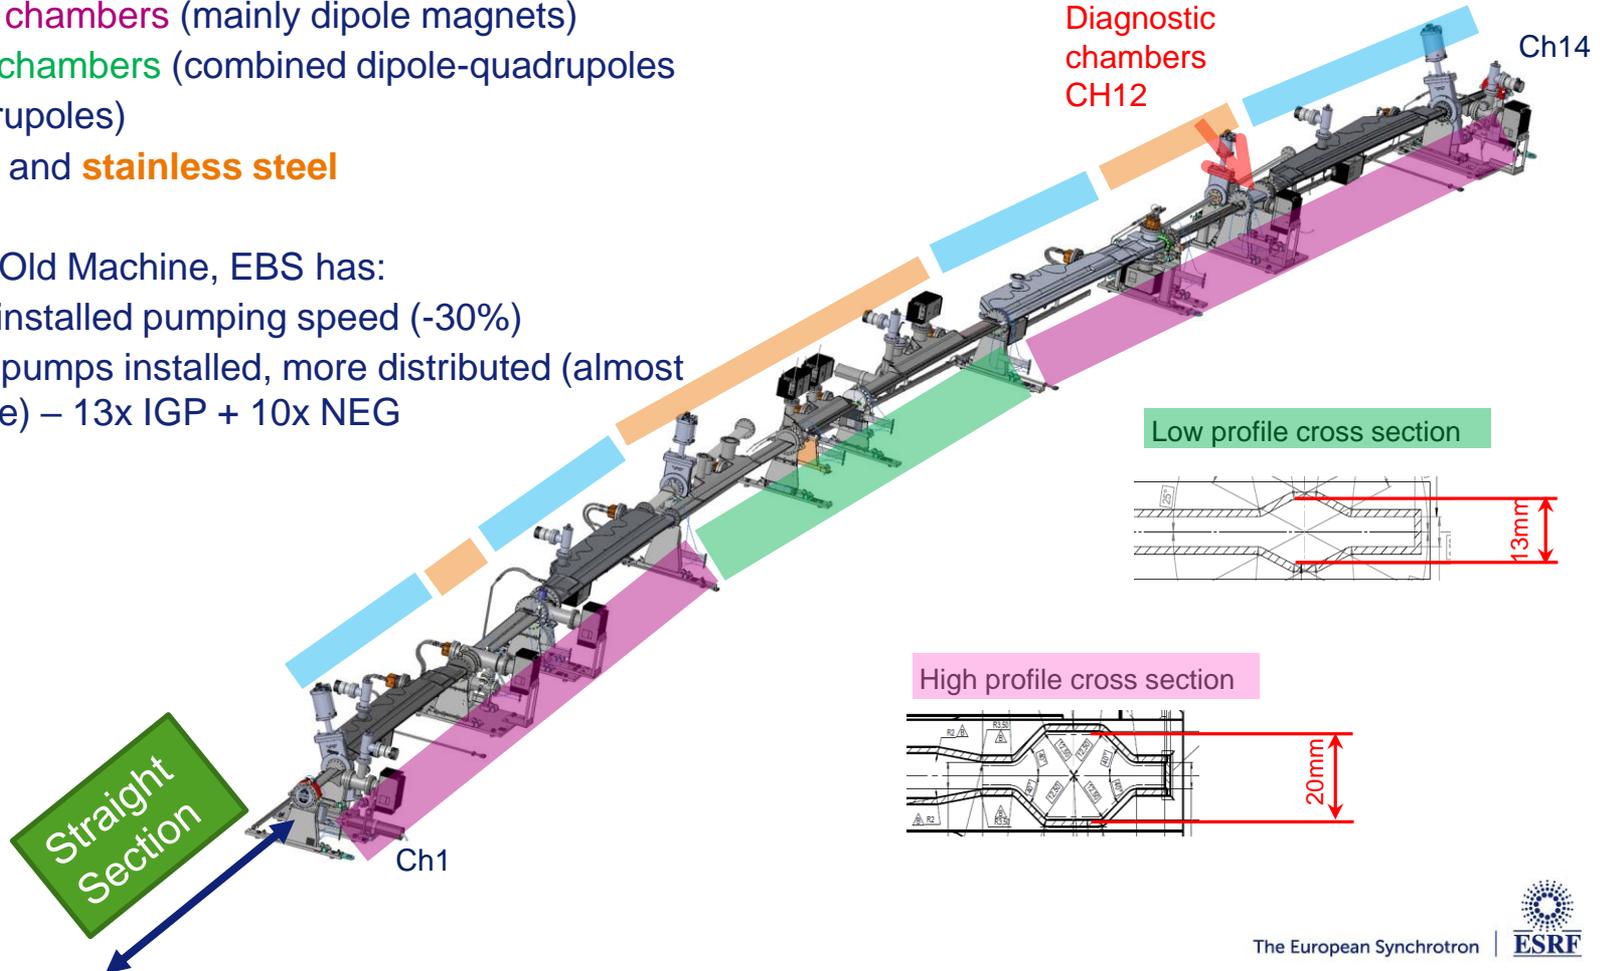
DESIGN - VACUUM CHAMBERS - ARC

- 12 Chambers per arc
- **High profile chambers** (mainly dipole magnets)
- **Low profile chambers** (combined dipole-quadrupoles & HG quadrupoles)
- **Aluminium** and **stainless steel**
- Respect to Old Machine, EBS has:
 - Less installed pumping speed (-30%)
 - More pumps installed, more distributed (almost double) – 13x IGP + 10x NEG

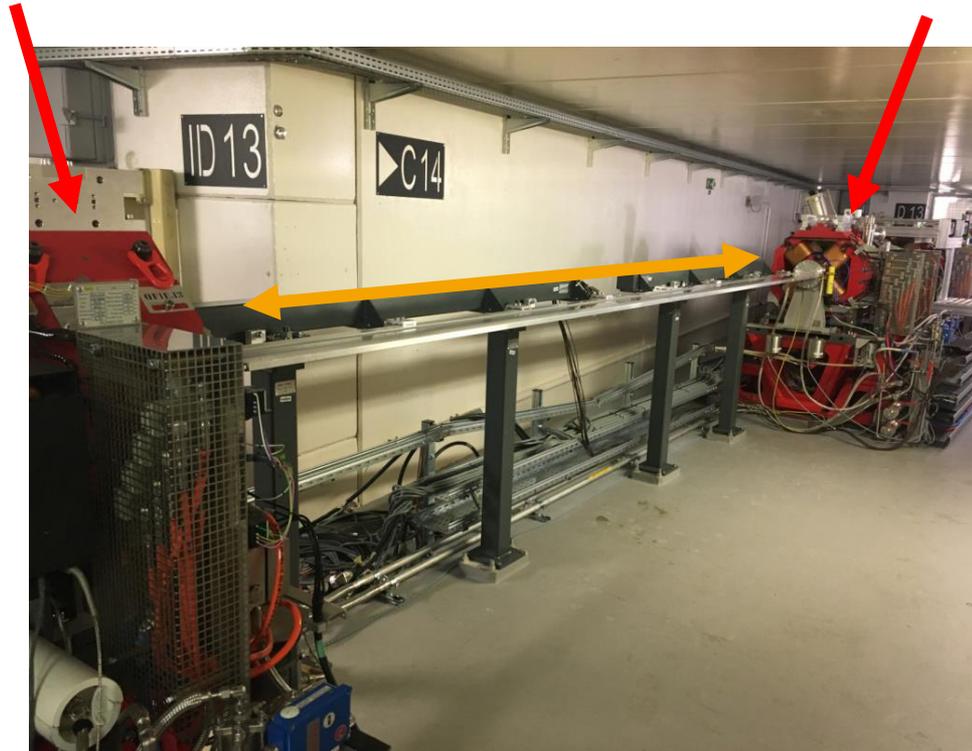
DESIGN - VACUUM CHAMBERS – STRAIGHT SECTIONS

32x STRAIGHT SECTIONS (7m long)

- **2x chamber at extremities for quadrupoles**
- **Internal “real” straight section 5m long**
- 1x Injection
- 3x RF Cavities
- 13x with IN-VACuum Undulator
- 15x with IN-AIR Undulator
 - **Aluminum chambers (ID-5000)**
 - elliptical section 8 x 56 mm 5m long
 - NEG coated
 - Highest pressures in the SR
 - Cell-14 used to pre-condition NEG coated chambers

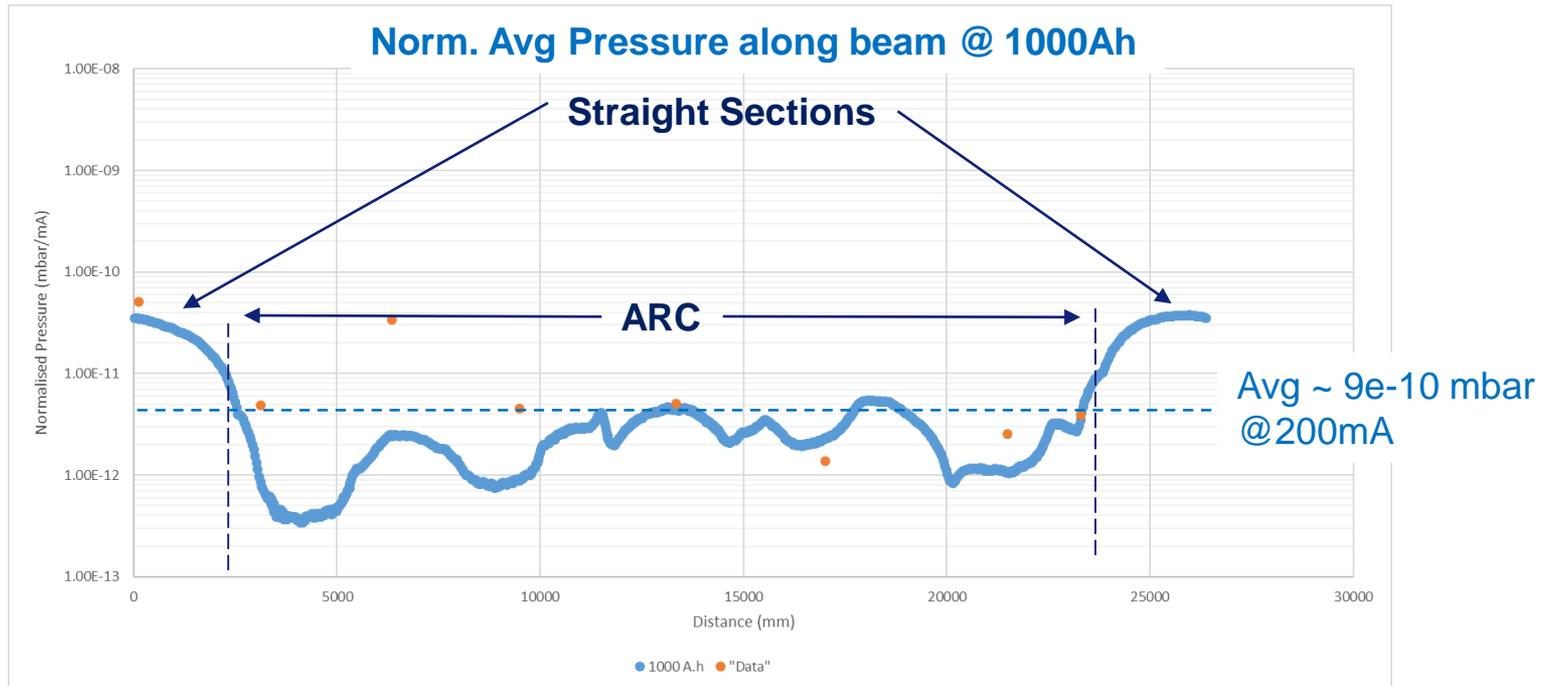
DESIGN – SIMULATED PRESSURE PROFILE @1000 A*H

- Gas: 90% H₂ and 10% CO
- Pumping speeds: all nominal
- PSD yields:
 - as measured at ESRF desorption beamline for copper (different from real one used CuZrVd)
 - as measured at ESRF desorption beamline for NEG coated IDs

CONDITIONING – READINGS VS SIMULATION @1000 Ah

Norm. Avg Pressure along beam @ 1000Ah

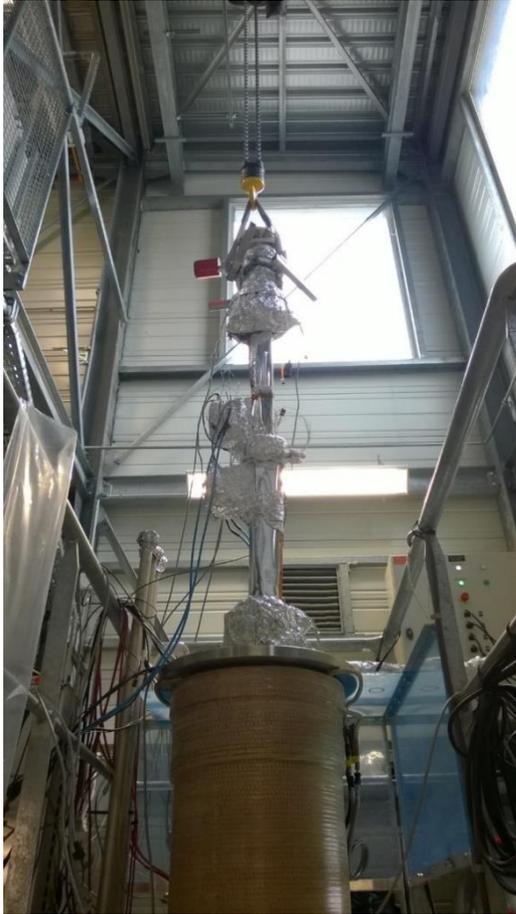
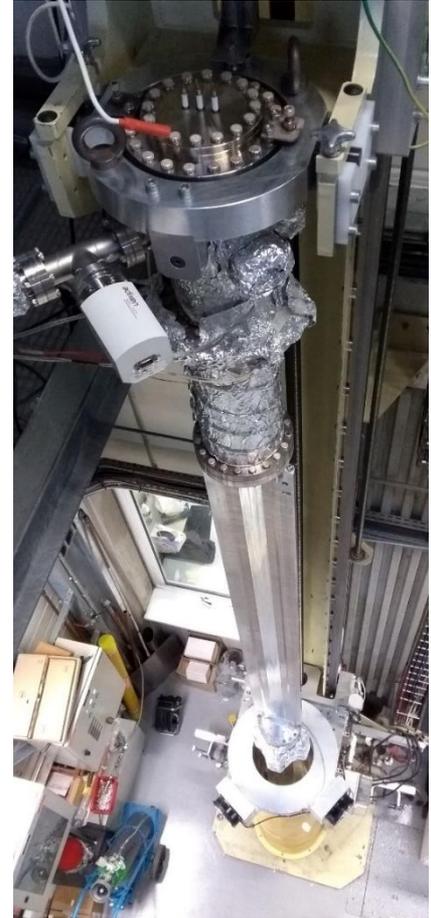
ASSEMBLY – COATING CH1 & CH14 (AND ID CHAMBERS)

CH-1 and CH-14

- All chambers (34+34) NEG coated at ESRF
- 2x chambers per run
- One week each run roughly

ID

- All IDs chambers (22) - All 5m long

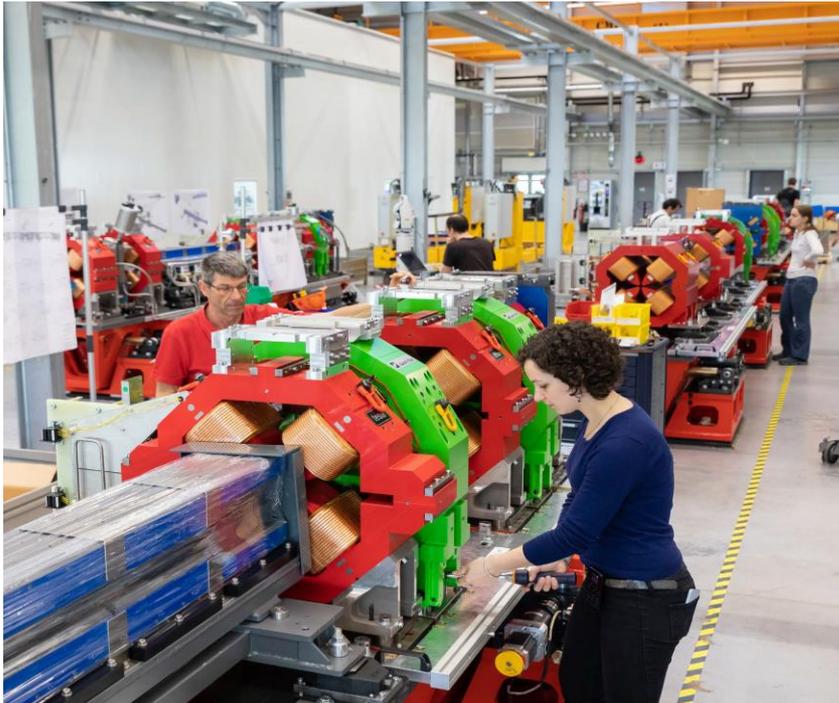
Assembly

- By girder in dedicated area
- Bake-out, alignment
- Stored under N2

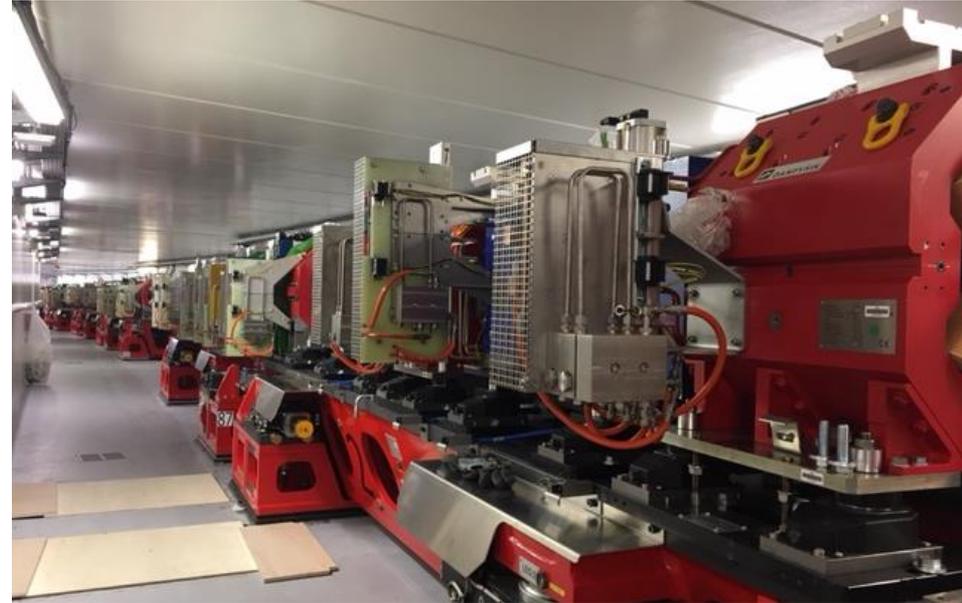
Installation

- 32 ARCS + 32 Straight Section installed and baked in 8 months

- No big issue unless burst-disks (over-pressure protection) opening during bake-out...!!!

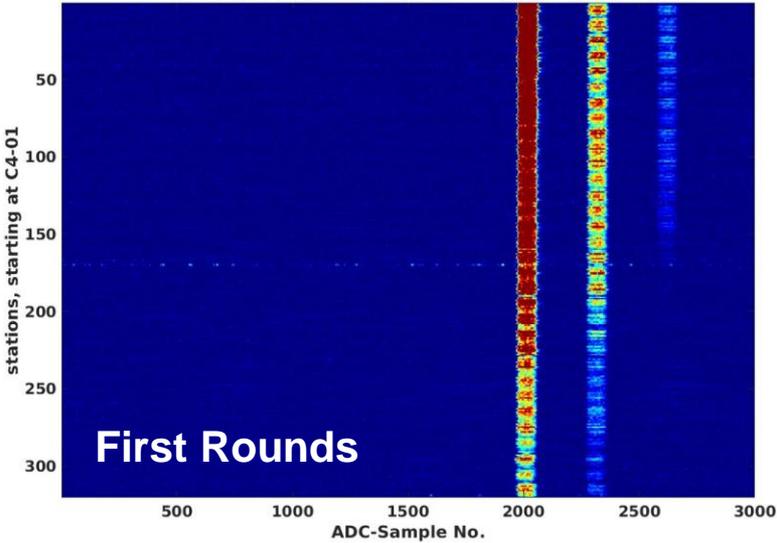
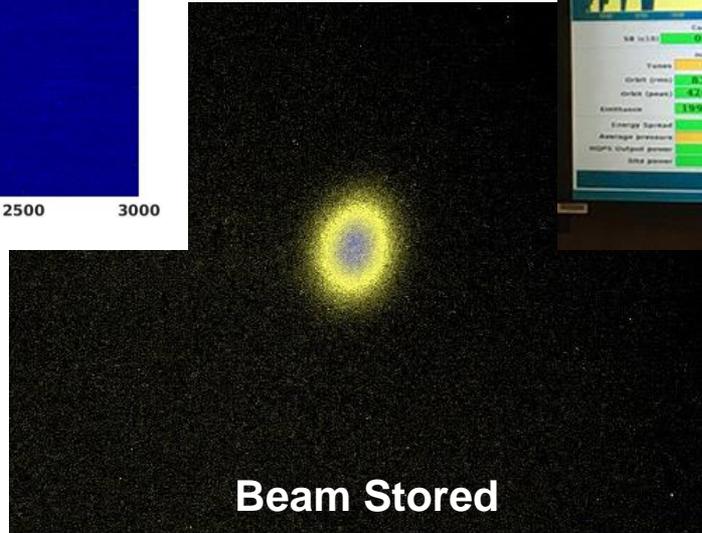
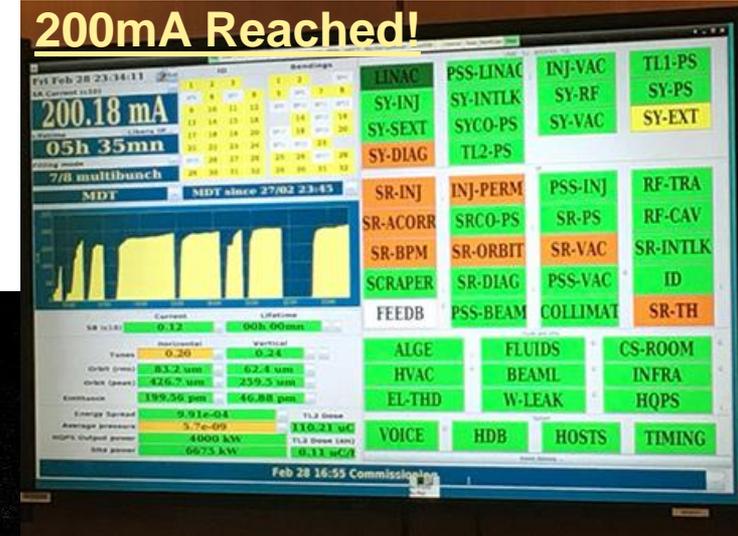
CURRENT RUMP-UP

SUM of the 4 (absolute of) ADCs Turn1 Turn2 Turn3

Static: Pavg 8e-10 mbar

200mA Reached!

Dynamic: Pavg 6e-9 mbar

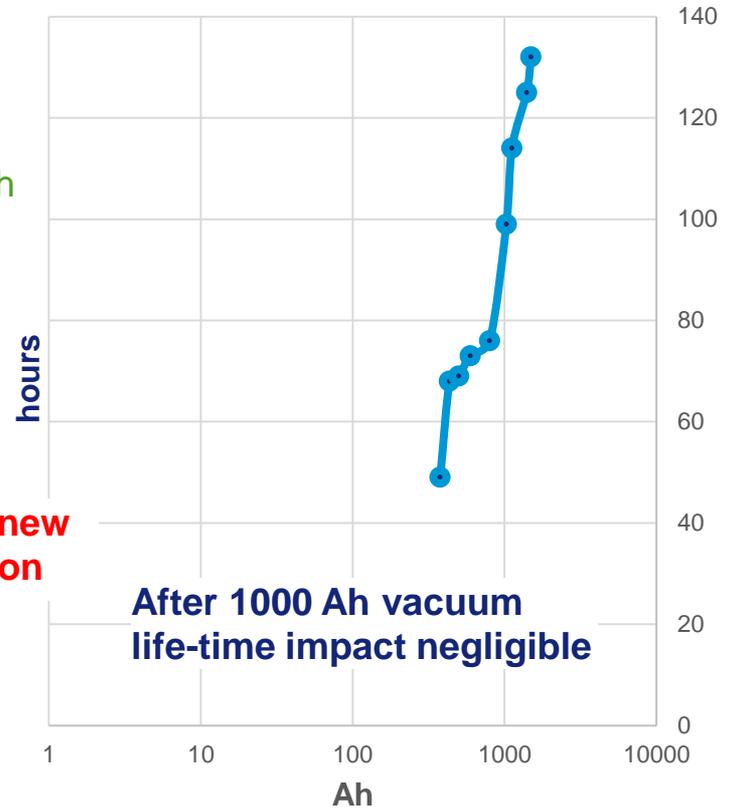
Vacuum Life Time vs Dose

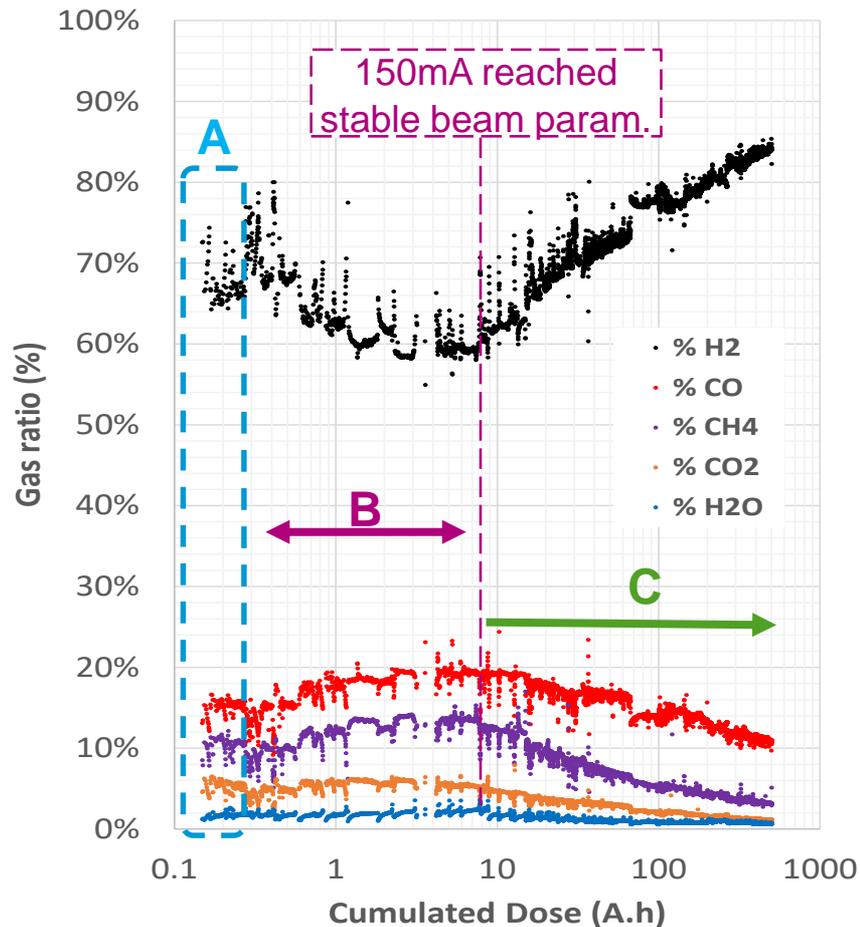
CONDITIONING – VACUUM QUALITY - RGA

- Many RGAs permanently installed: 3x cell
- Static: 90% is H₂
- **A** - With beam, at the beginning, contribution of “other gases” increases, due to PSD
- **B** - The increasing trend for “other gases” before 10Ah, is due to the gradual current ramp-up and beam “waving”
- **C** - After stabilisation of operation parameters, the conditioning effect clearly becomes visible and H₂ becomes increasingly dominant

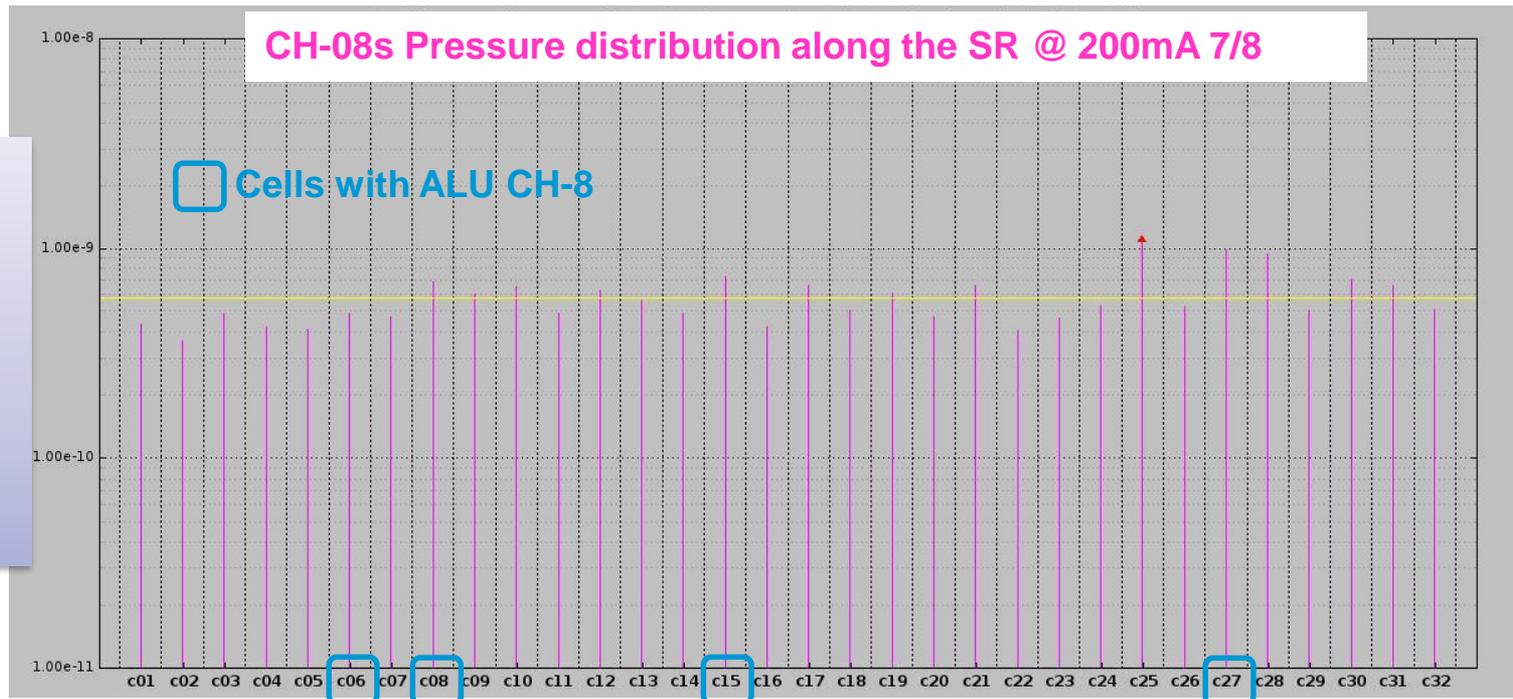
CH8 example: 32 chambers, 4 of them made in ALU, the rest in SST
Same absorbers, pumps, RF fingers and positions

No significant deviation is visible !!!
Adsorbers' design matters !

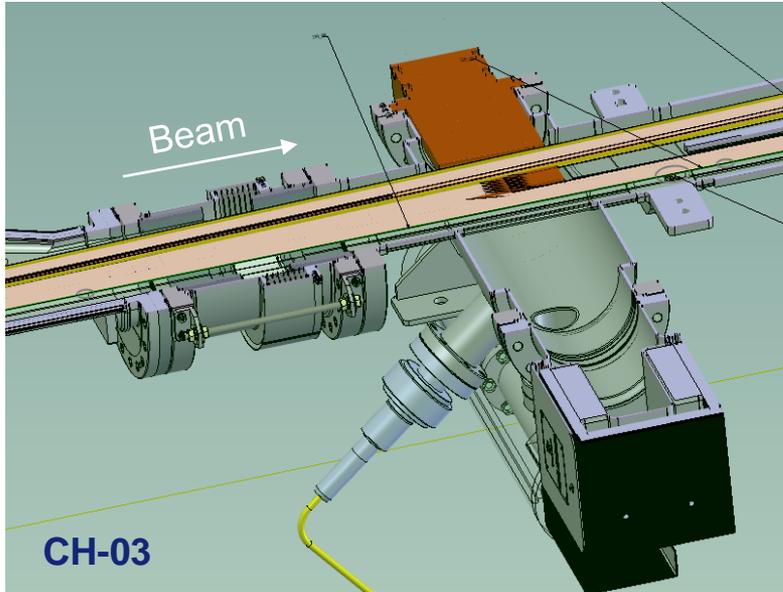
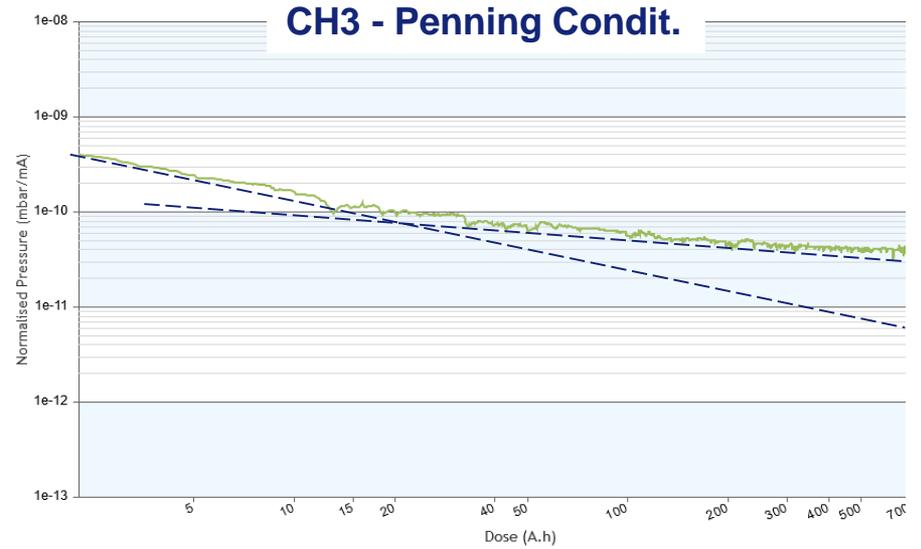
Chamb-3 gauge “slowing-down” conditioning Gauge reading affected

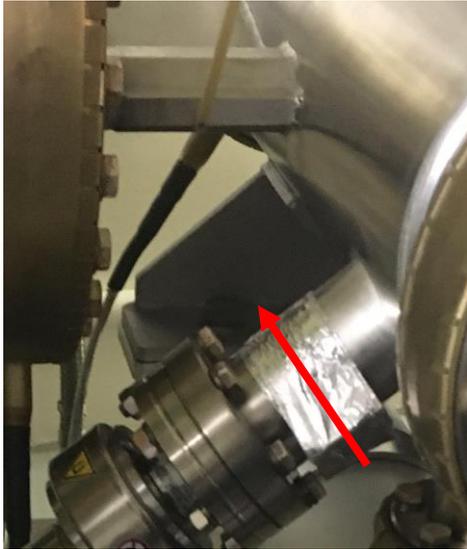
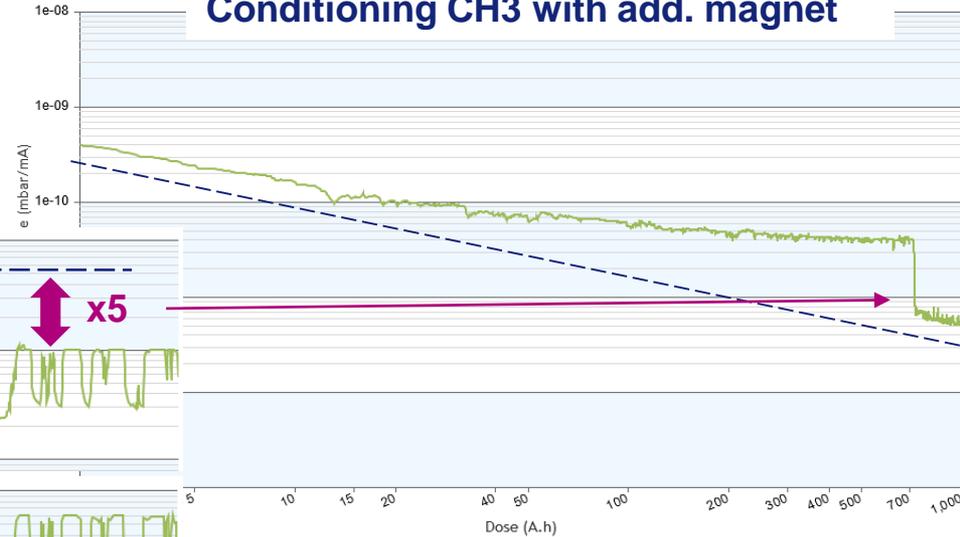
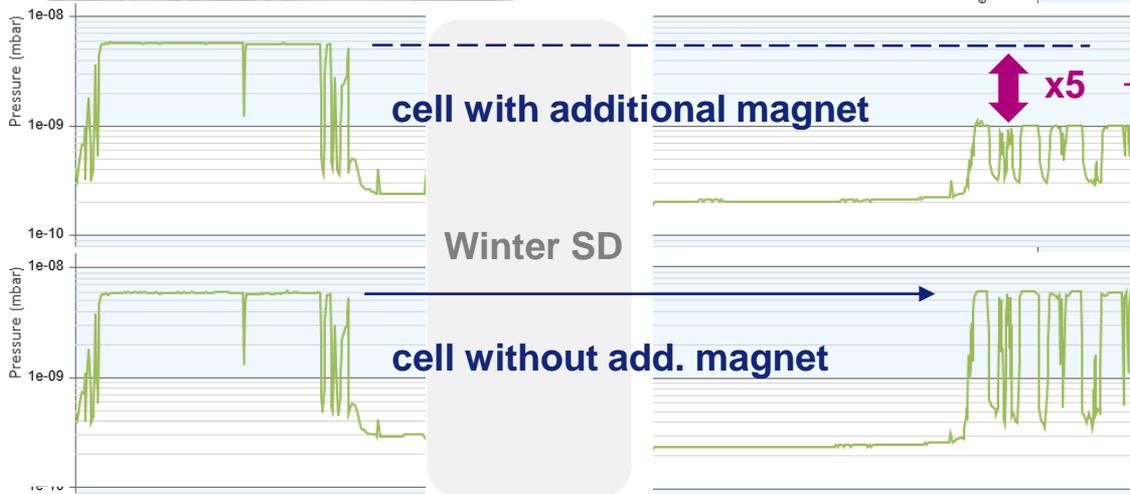
CONDITIONING – GAUGES READING

- **Secondary Electrons:**

- Installed magnets with **mag field perpendicular to the gauge axis**
- Pressure is about factor 5 lower and in line with IP

Conditioning CH3 with add. magnet

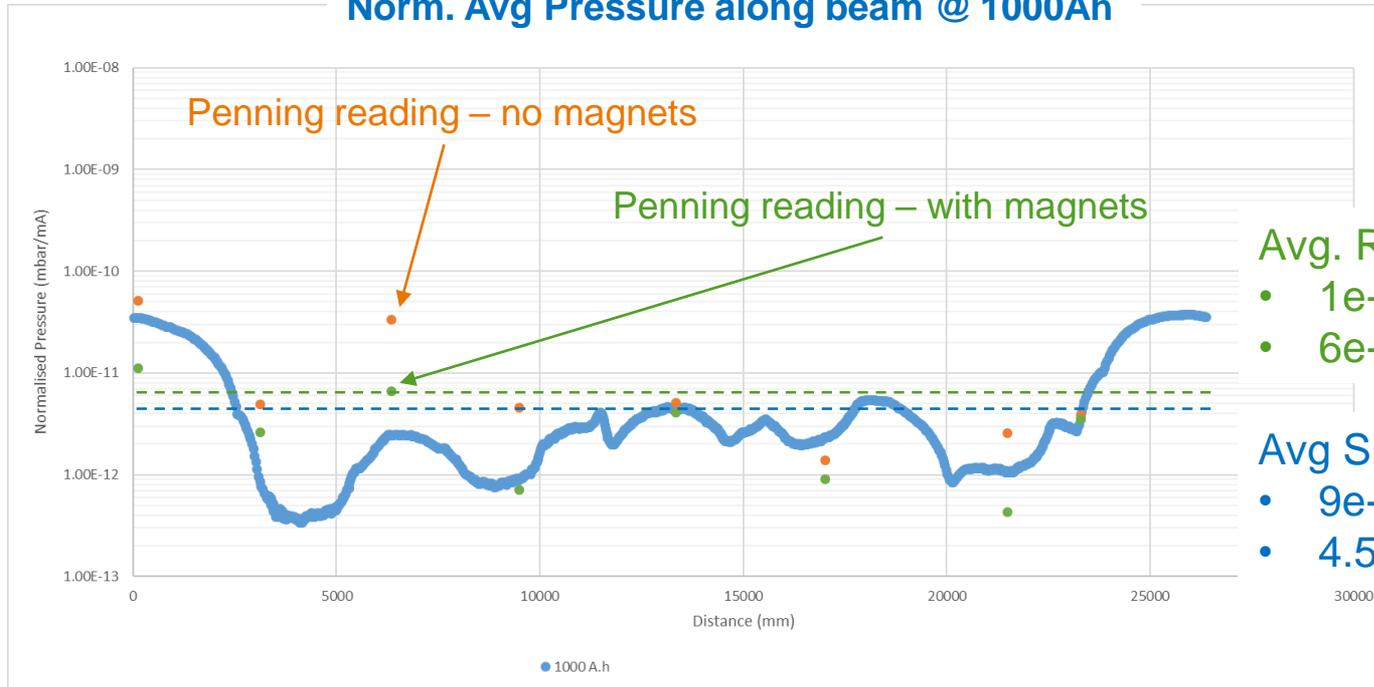
Avg. Real

- $1e-9$ mbar @ 200mA
- $6e-12$ mbar/mA

Avg Simulation

- $9e-10$ mbar @ 200mA
- $4.5e-12$ mbar/mA

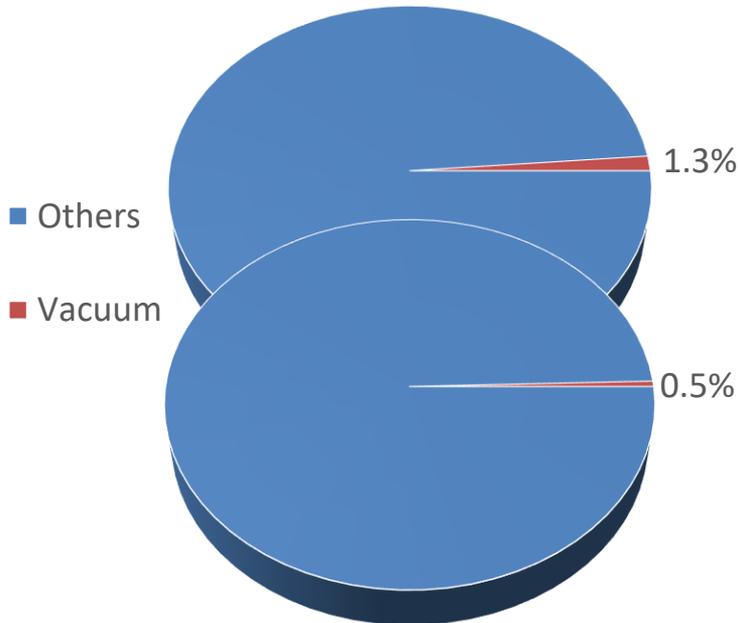
Beam Failures Events 2021

- 2021
 - stable parameters
 - machine conditioned
 - Machine availability > 96%

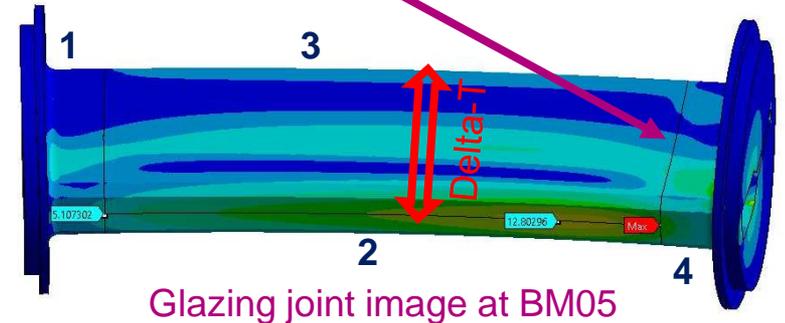
- Complex internal shape: not symmetric, antechamber + tapered
- -> internal machining -> made of 4 ceramic parts glazed together

- Up to March-22 - limit at 32 mA in 16 bunch (nom. 96mA)
 - Mechanical stress due to thermal gradient
 - Cause cracks – leaks

Glazing joints - Weak point
Cracks/leaks due to mech/thermal stress

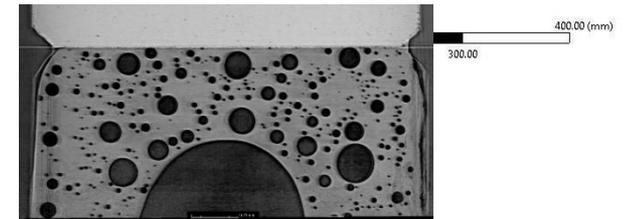
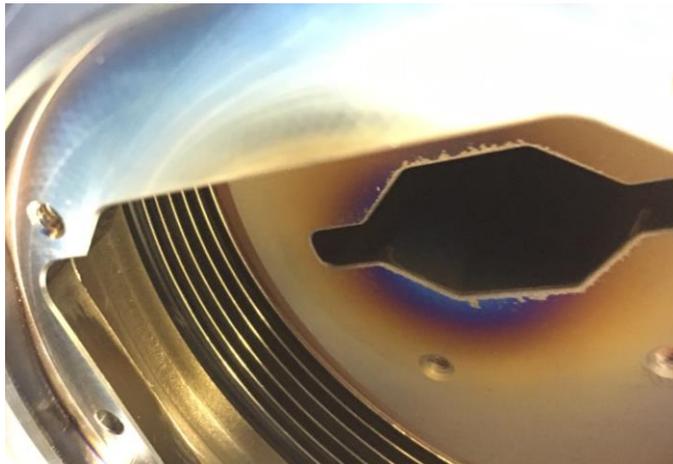
Glazing joint image at BM05

Titanium **coating erosion** on corners

- not good contact between RF finger and ceramic
- Cause injection perturbation

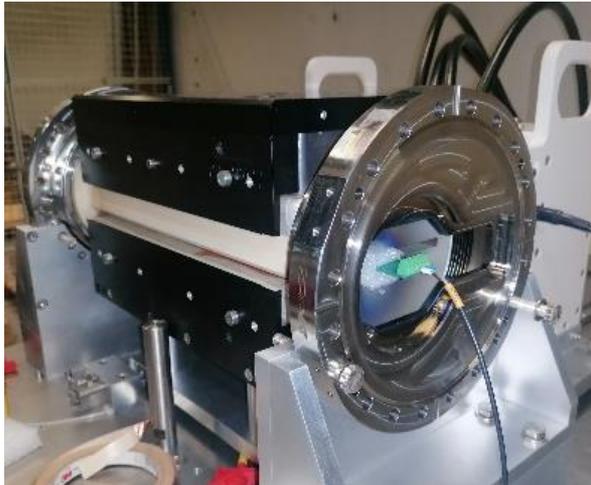
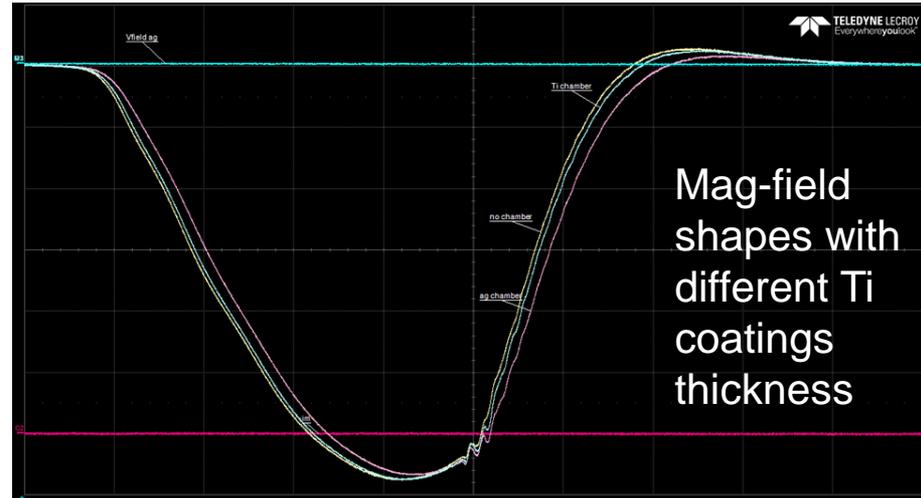
Additional coating -> Reduce total resistance by factor 10 (20 -> 2 ohm)
Same power (hence stress) with x3 current (x9 power) -> 32 to 96 mA

Many tests, with different coatings (resistance) to be sure to not affect the mag field

Installed in Winter and March ShutDown

75mA in 16-bunch validated

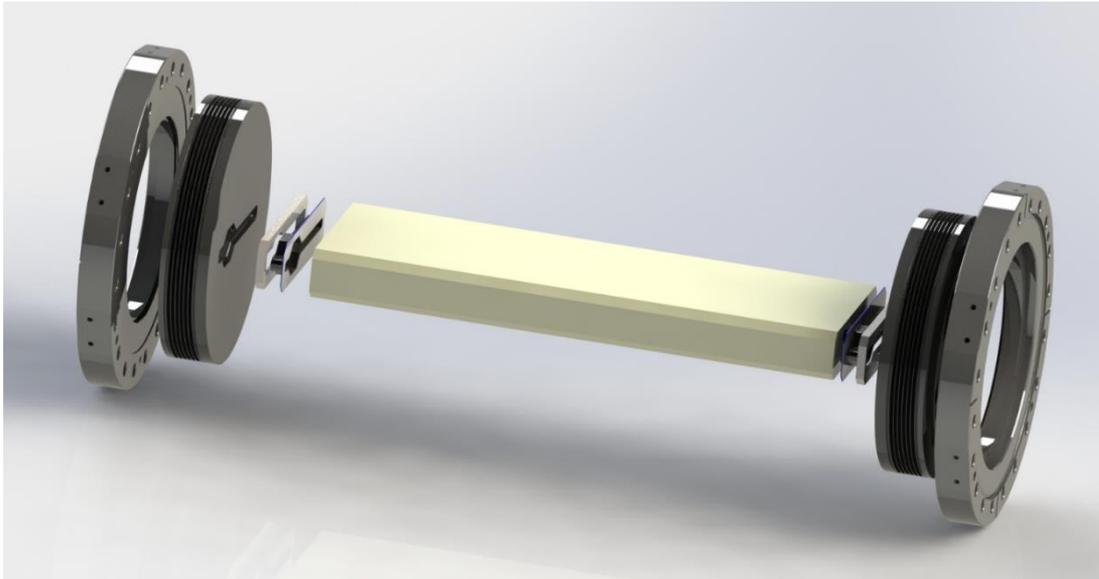
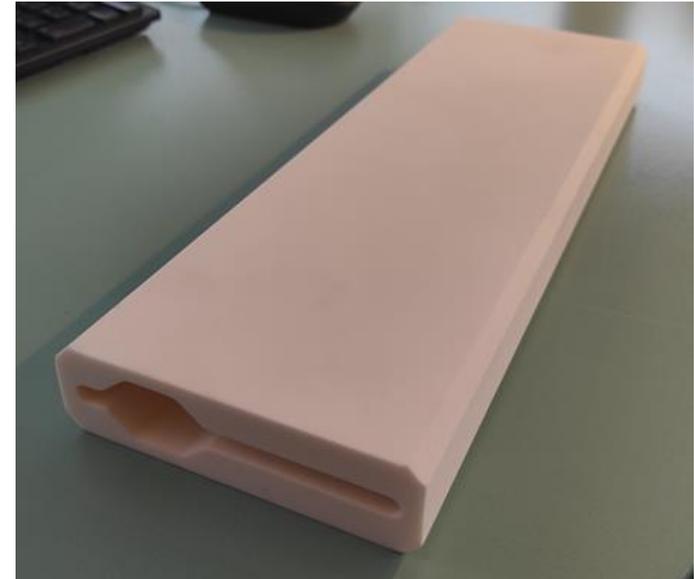
OPERATION – KICKERS' NEW-DESIGN

- No glazing joints (single body)
- Common design for all 4x kickers (today we have one design for K1K4 and one K2K3)
- Production challenging due to internal shape
- **Installation foreseen by summer 2023**
