Status of L6D6 detectors

Recap L6D6 n_TOF Ph-3: EAR1

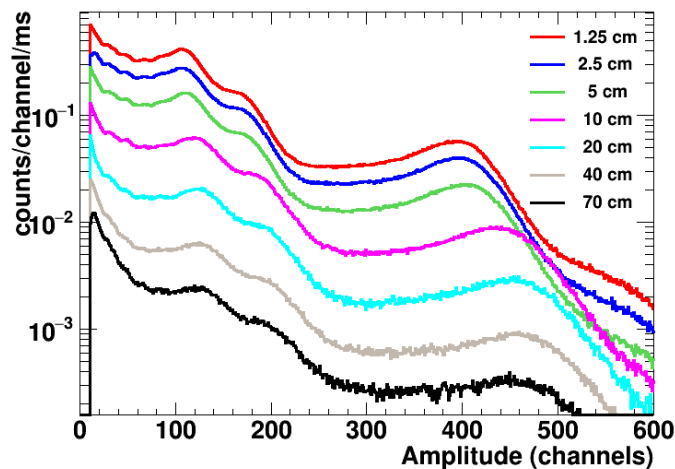
- In steady conditions, source test: gain shifts towards lower amplitudes when counting-rate increases
- In beam conditions: gain shifts toward higher amplitudes passing over high counting-rate regions

Cs137+Y88 sources, 400 KBq each, **Rate 0.7-50 kHz**

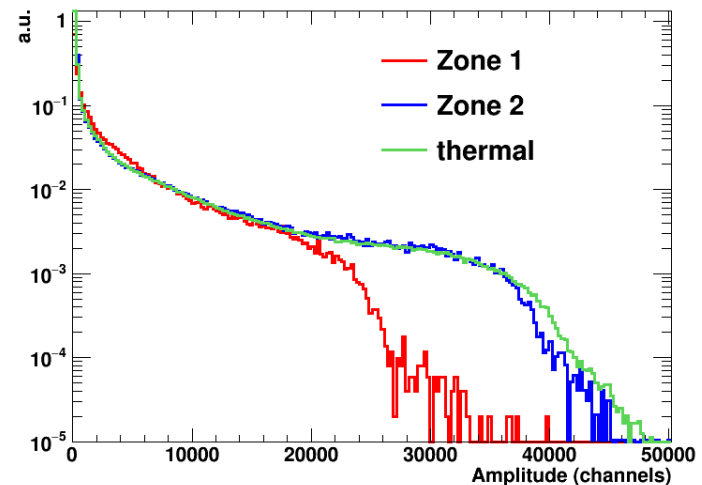
Au197 in beam, **Rate 14 MHz**

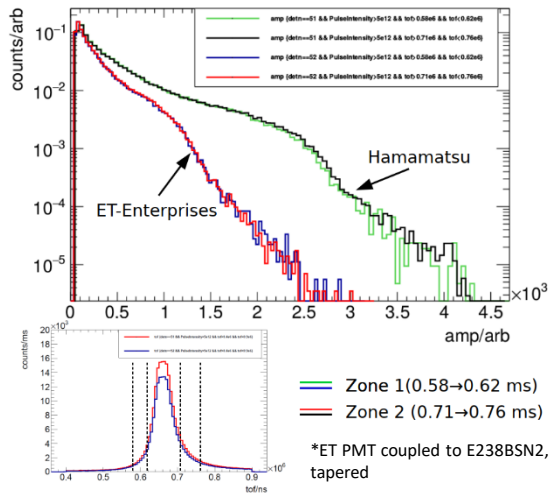
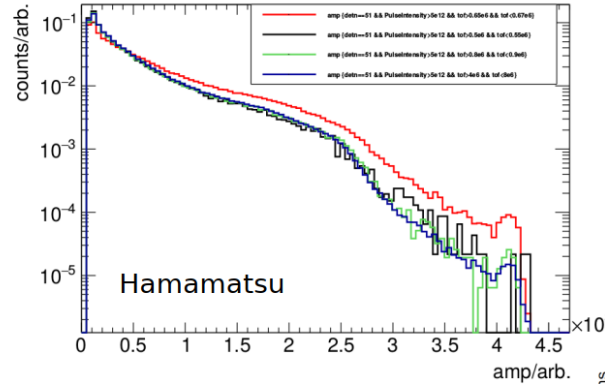
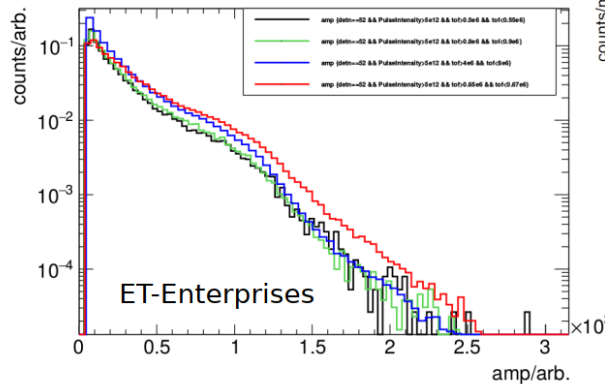
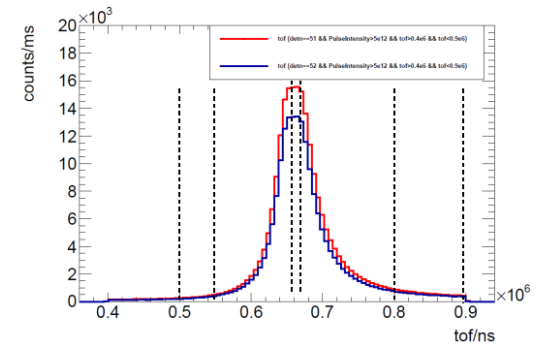
Repeat the test in EAR2 in similar conditions to the previous test but with the new assemblies.

- Plateau (0.65→0.67 ms)
- Zone 1 (0.5→0.55 ms)
- Zone 2 (0.8→0.9 ms)
- Thermal (4→8 ms)

Clear indication that there is an improvement with both PMT/VD assemblies

Probably due to pile-up, the shape at the top of the resonance looks different with respect to the other regions.

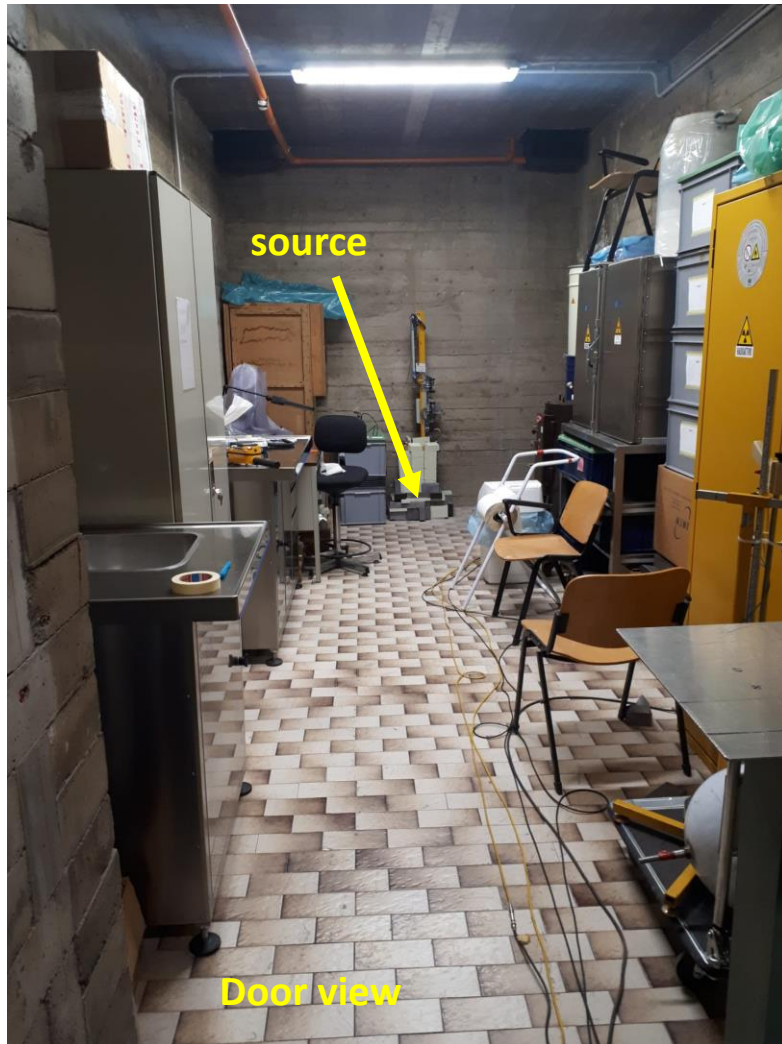
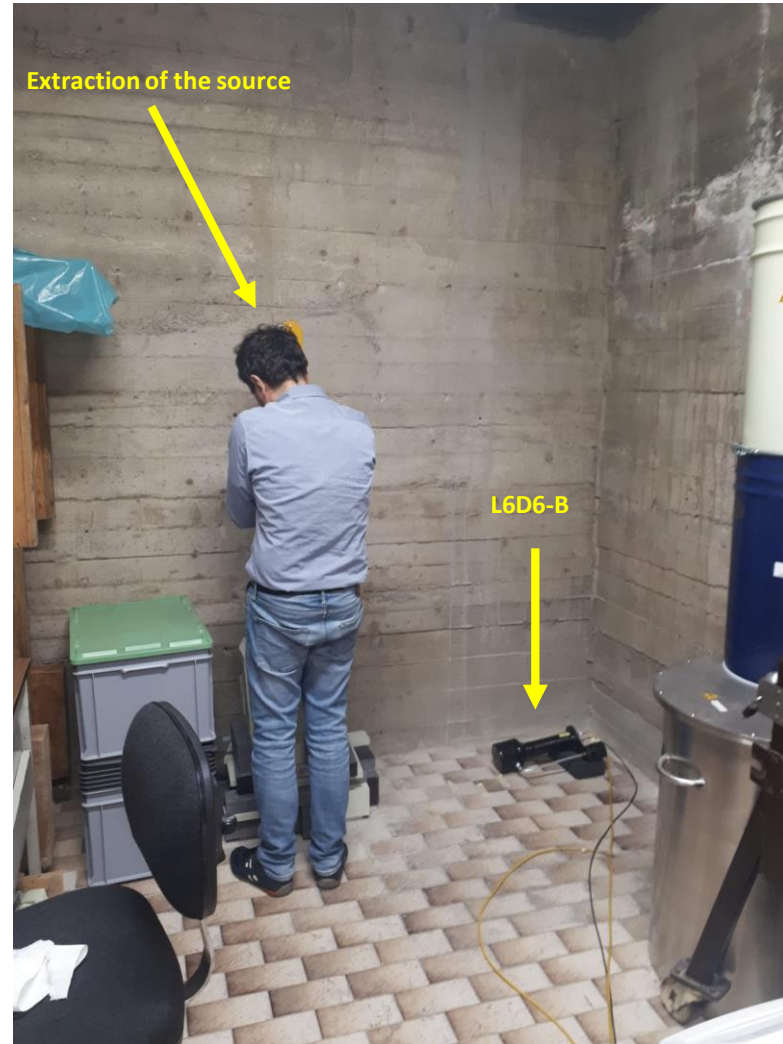
Test in "hot-room" with a 35.4 GBq ^{137}Cs source at LNS

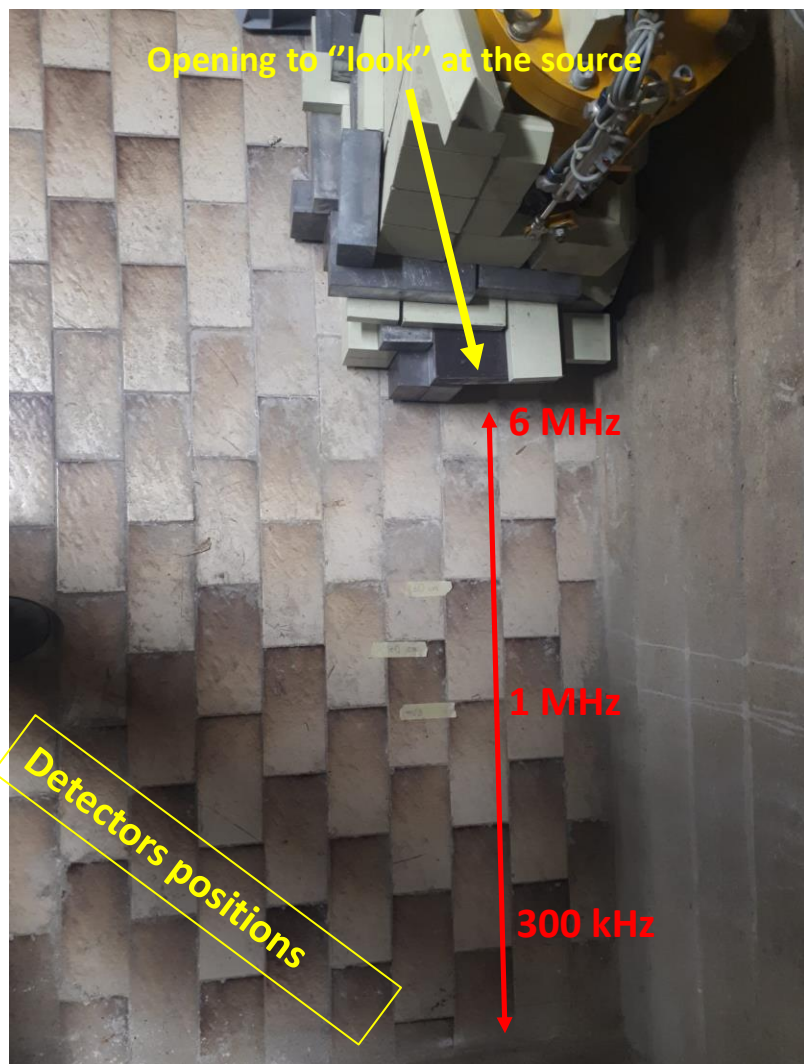
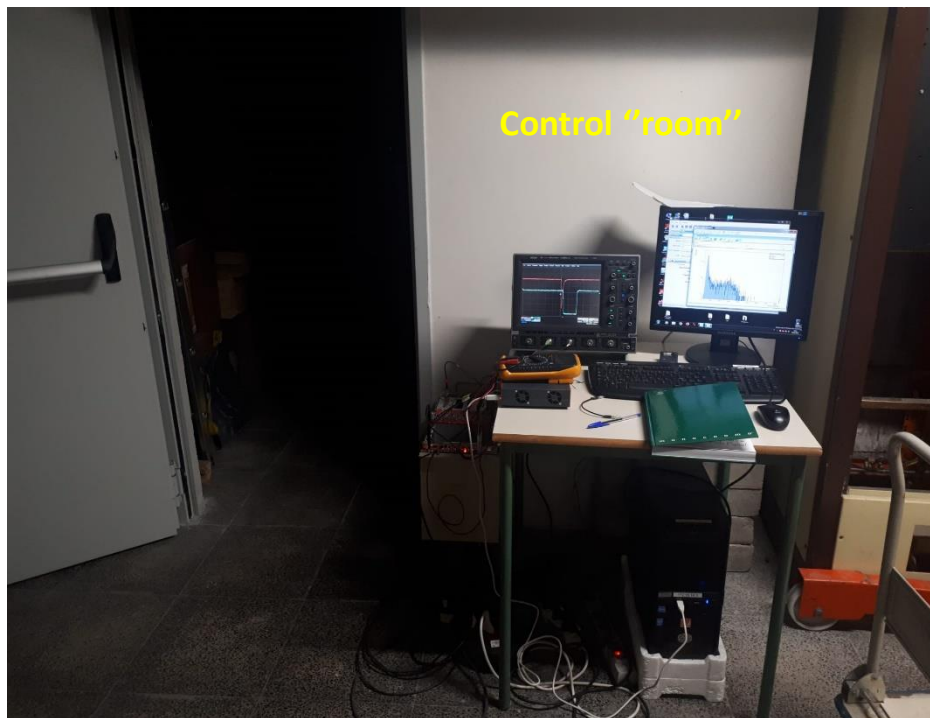
Test in “hot-room” with a 35.4 GBq ^{137}Cs source at LNS

Signals acquired with portable CAEN-DT5751 module

Limitation in the rate the daq system can stand to (<350 KHz)

(distances not smaller than 1.2 m therefore)

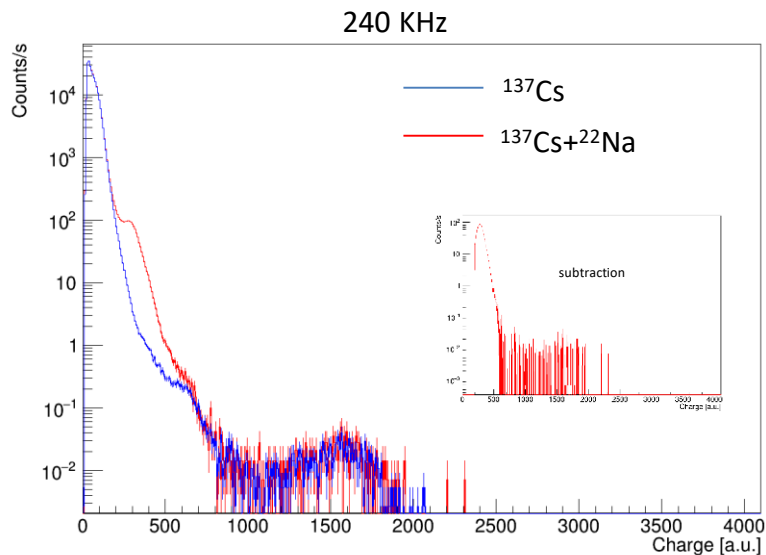
To check the stability of the gain we exposed the detector to the intense ^{137}Cs source and a standard ^{22}Na source, at several positions, at one fixed voltage value (-1120 V).

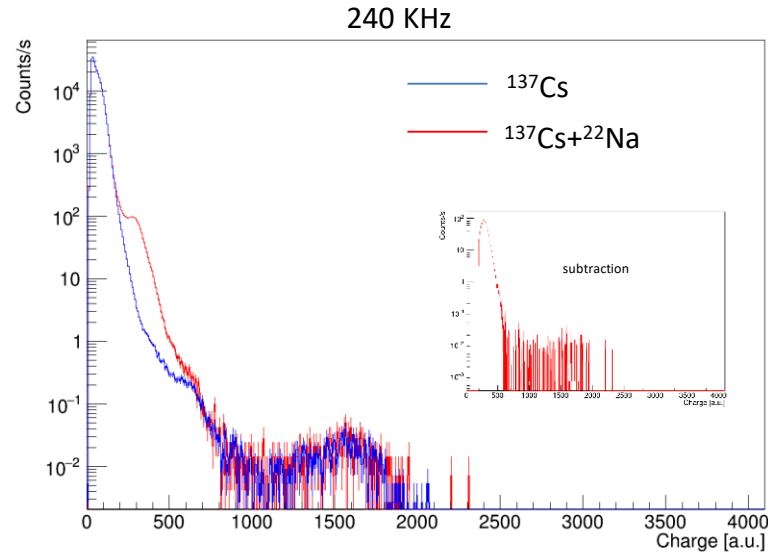
To check the stability of the gain we exposed the detector to the intense ^{137}Cs source and a standard ^{22}Na source, at several positions, at one fixed voltage value (-1120 V).

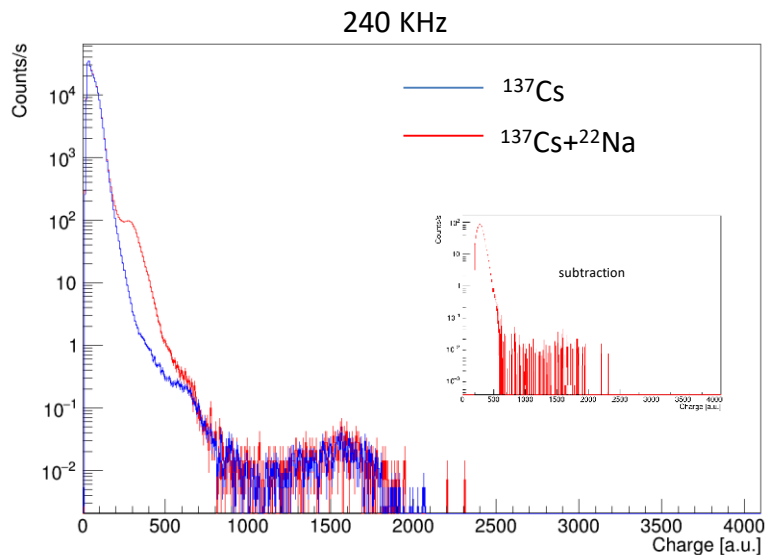
To check the stability of the gain we exposed the detector to the intense ^{137}Cs source and a standard ^{22}Na source, at several positions, at one fixed voltage value (-1120 V).

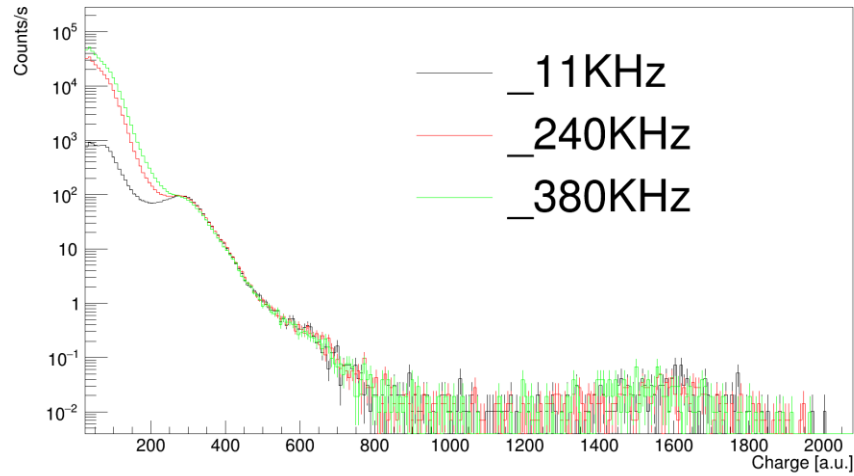
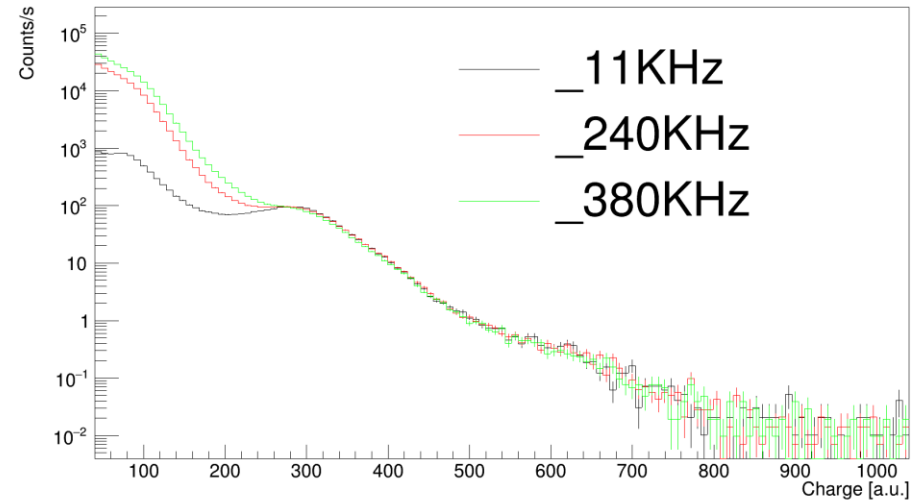
- Coupling active VD ET-E238ASN2 with SbCs photomultiplier seems to solve the problem of gain shift in steady conditions.

More systematic tests to be done for this configuration:

- Scan over different voltages and more rates
- Test in beam

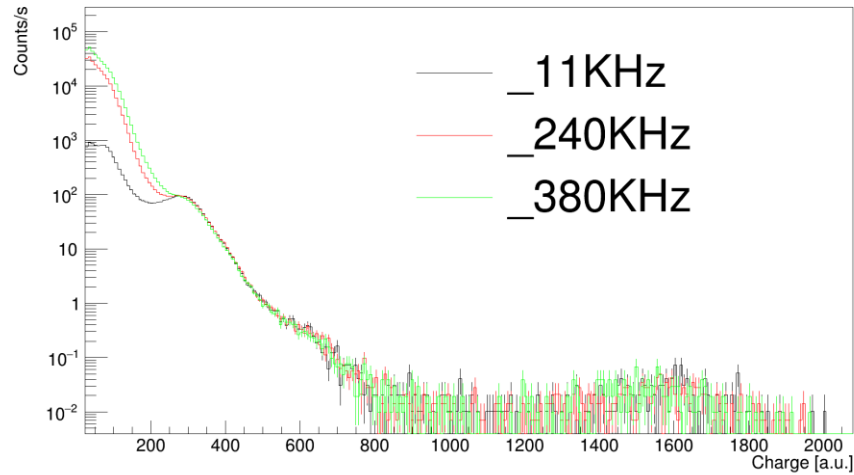
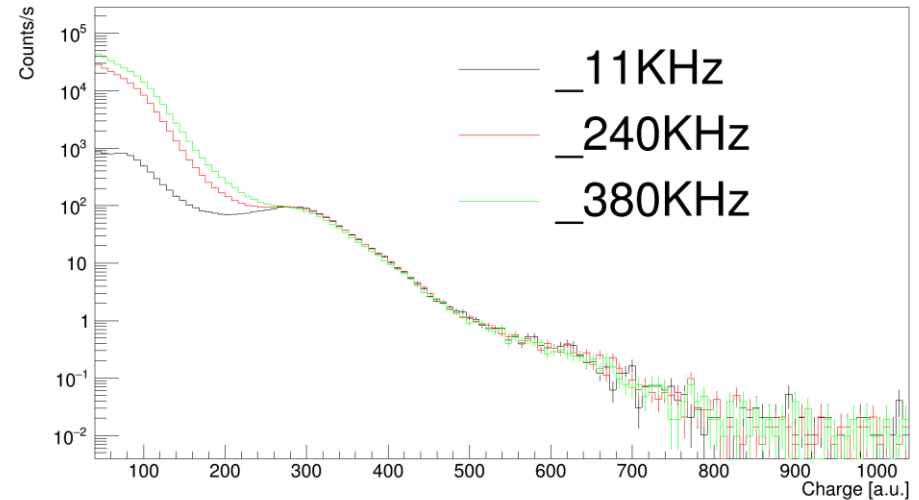
- Coupling active VD ET-E238ASN2 with SbCs photomultiplier seems to solve the problem of gain shift in steady conditions.

More systematic tests to be done for this configuration:

- Scan over different voltages and more rates
- Test in beam

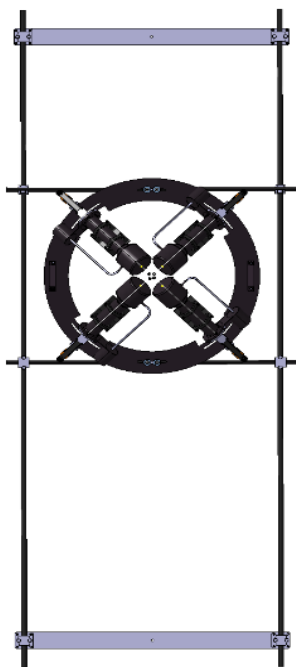
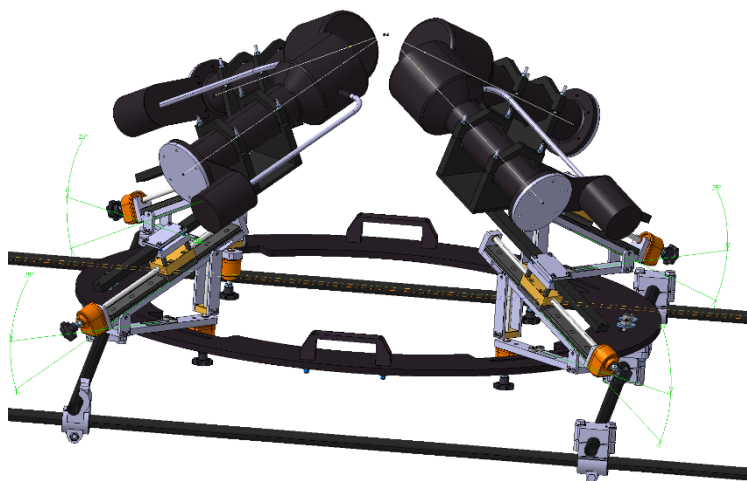
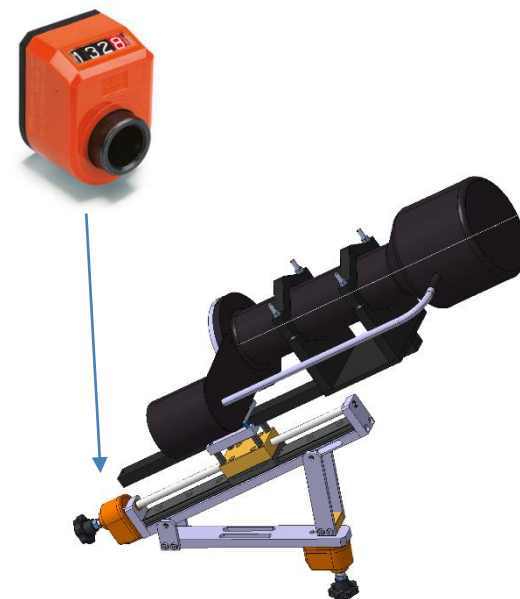
In order to improve stability of the detectors a new support system has been designed.

The new support will also offer more degree of freedom in terms of different axis of translation or rotation.

Reproducibility of the setup
