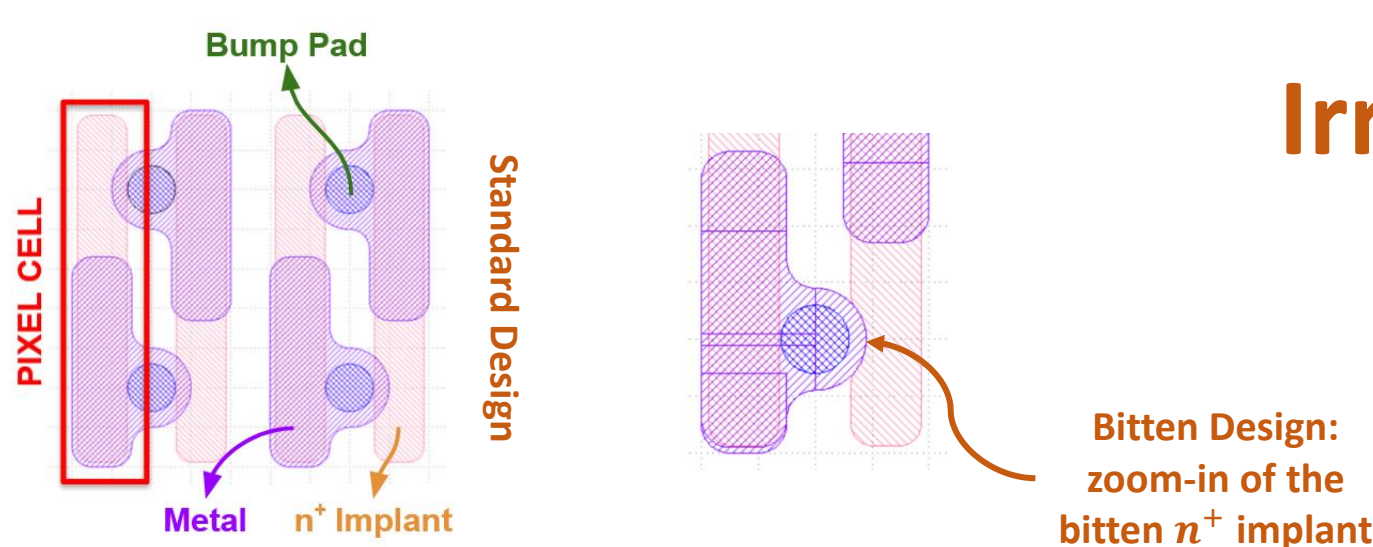
- Four irradiated planar pixel modules were tested on DESY beam
 - Two with the “standard” design and two with the “bitten” design

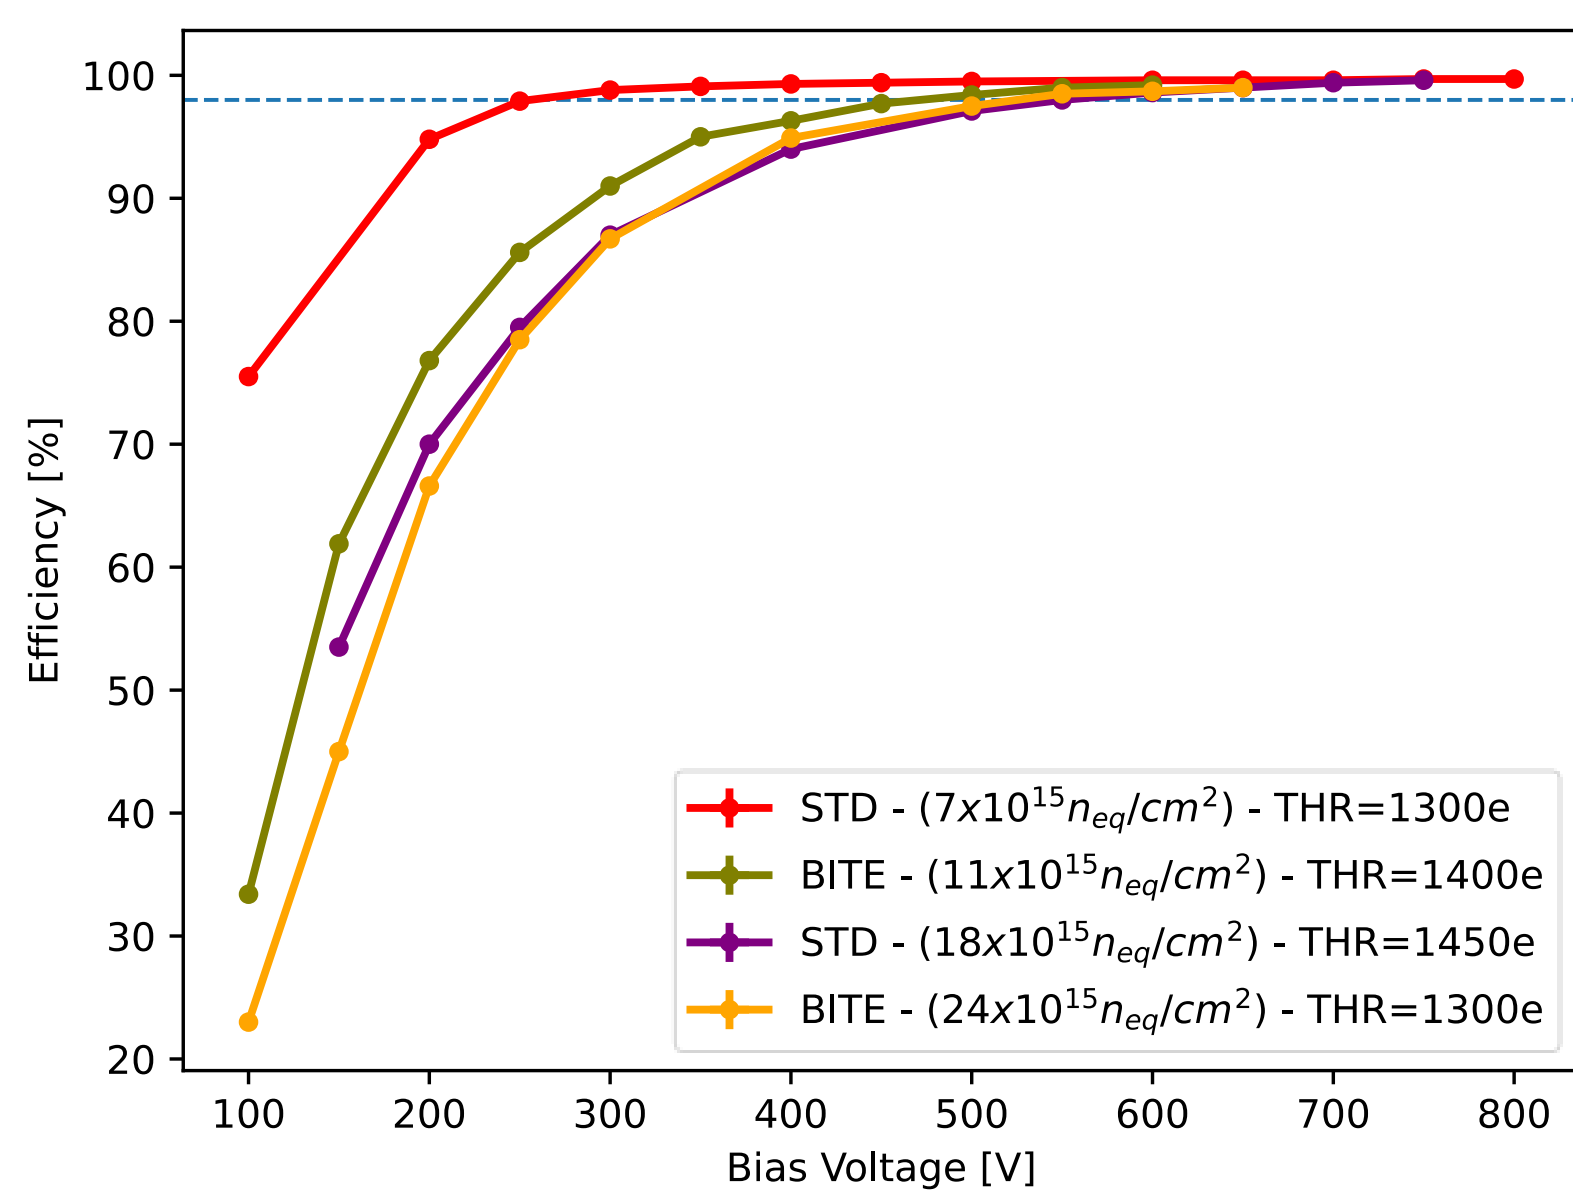
- In order to reach a hit detection efficiency $> 98\%$:
 - $V_{\text{bias}} > 200 \text{ V}$ after a fluence of $7 \times 10^{15} \text{ n}_{\text{eq}} \text{ cm}^{-2}$
 - $V_{\text{bias}} > 500 \text{ V}$ after a fluence of $24 \times 10^{15} \text{ n}_{\text{eq}} \text{ cm}^{-2}$
- Planar pixel modules can survive HL-LHC Runs 4+5 (2200 fb^{-1}) ...
 - ...in the innermost tracker layer (only 3 cm from the beam line)
 - However, very high bias voltages are required
 - Cooling** becomes challenging, especially in the innermost tracker layer

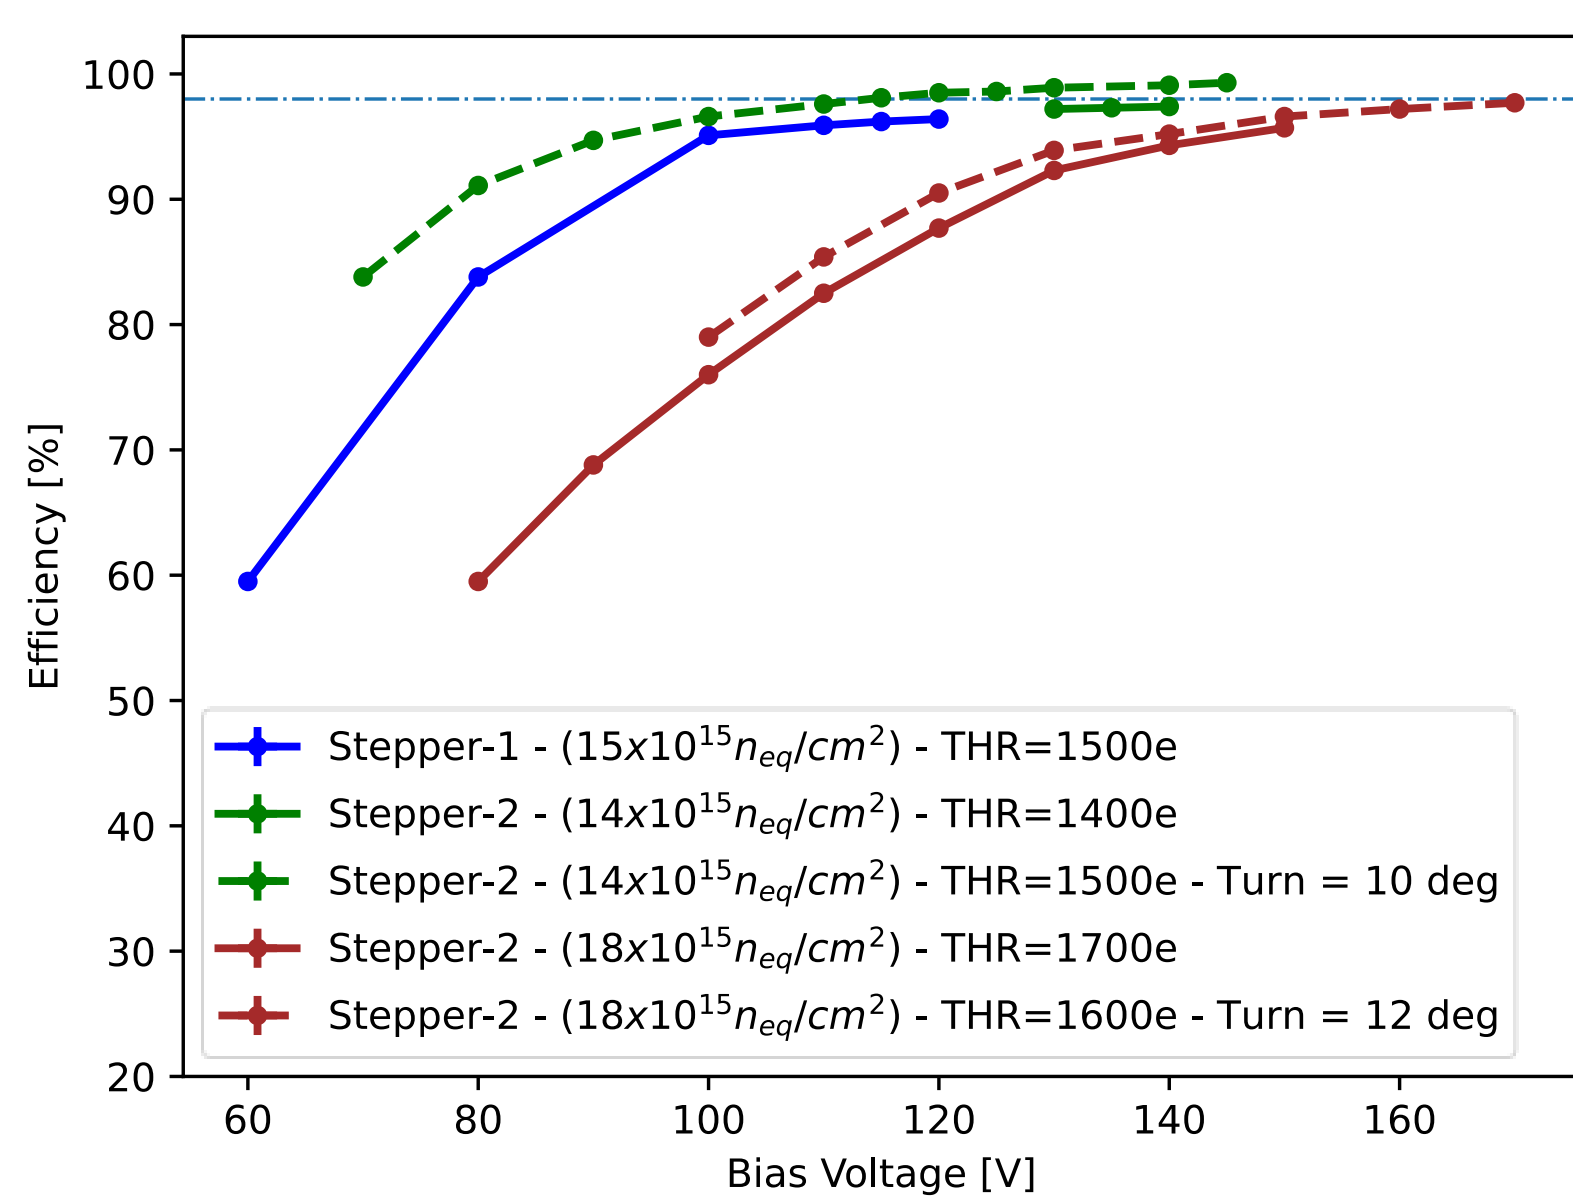
Dashed lines refer to measurements with the DUT rotated with respect to the beam

- Three irradiated 3D pixel modules were tested on DESY beam
- In order to reach a hit detection efficiency $> 98\%$:
 - $V_{\text{bias}} > 110 \text{ V}$ after a fluence of $15 \times 10^{15} \text{ n}_{\text{eq}} \text{ cm}^{-2}$
 - $V_{\text{bias}} > 160 \text{ V}$ after a fluence of $18 \times 10^{15} \text{ n}_{\text{eq}} \text{ cm}^{-2}$
- A sudden increase in the number of noisy channels was observed...
 - ...at high bias voltages (greater than 130 – 170 V, depending on the module)
 - The problem was more severe with **Stepper-1** modules ($> 10\%$ of channels)
 - The cause is still under investigation: might be related to the very high TID

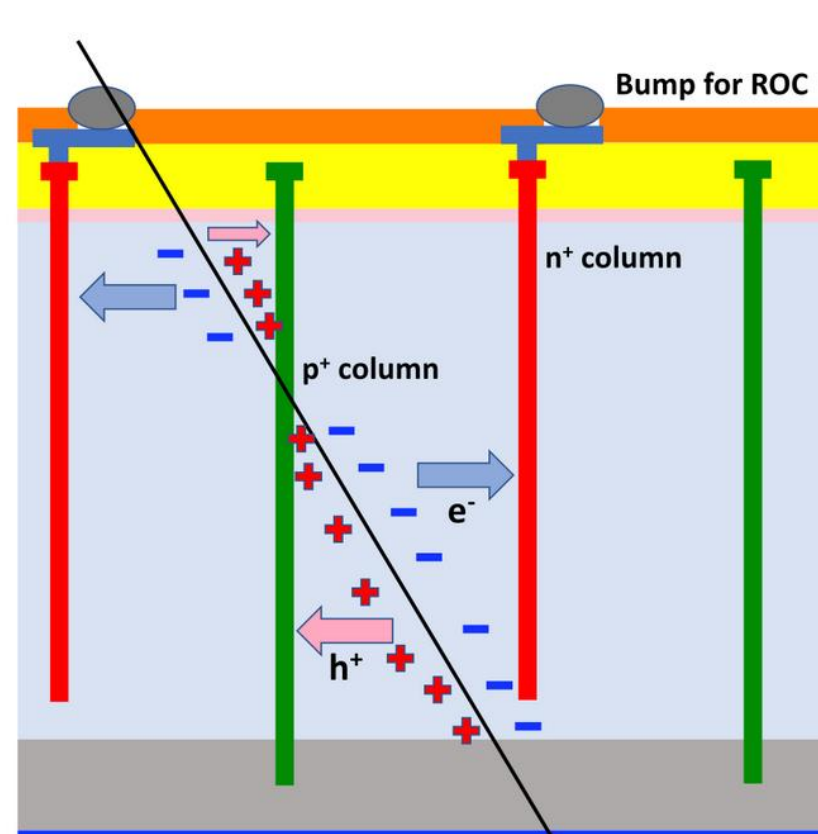
3D pixel layout

- n^+ and p^+ columns penetrate the substrate from the same silicon face
- Two FBK 3D productions: **Stepper-1** and **Stepper-2**
 - Step-And-Repeat photolithography technology
 - Same pixel design, but in Stepper-2 production the distance between n^+ columns and the backside of the sensor (low resistivity silicon) is increased
