Commissioning and operation in magnetic field of CMS

GE1/1 station

Simone Calzaferri¹

on behalf of the CMS Muon Group

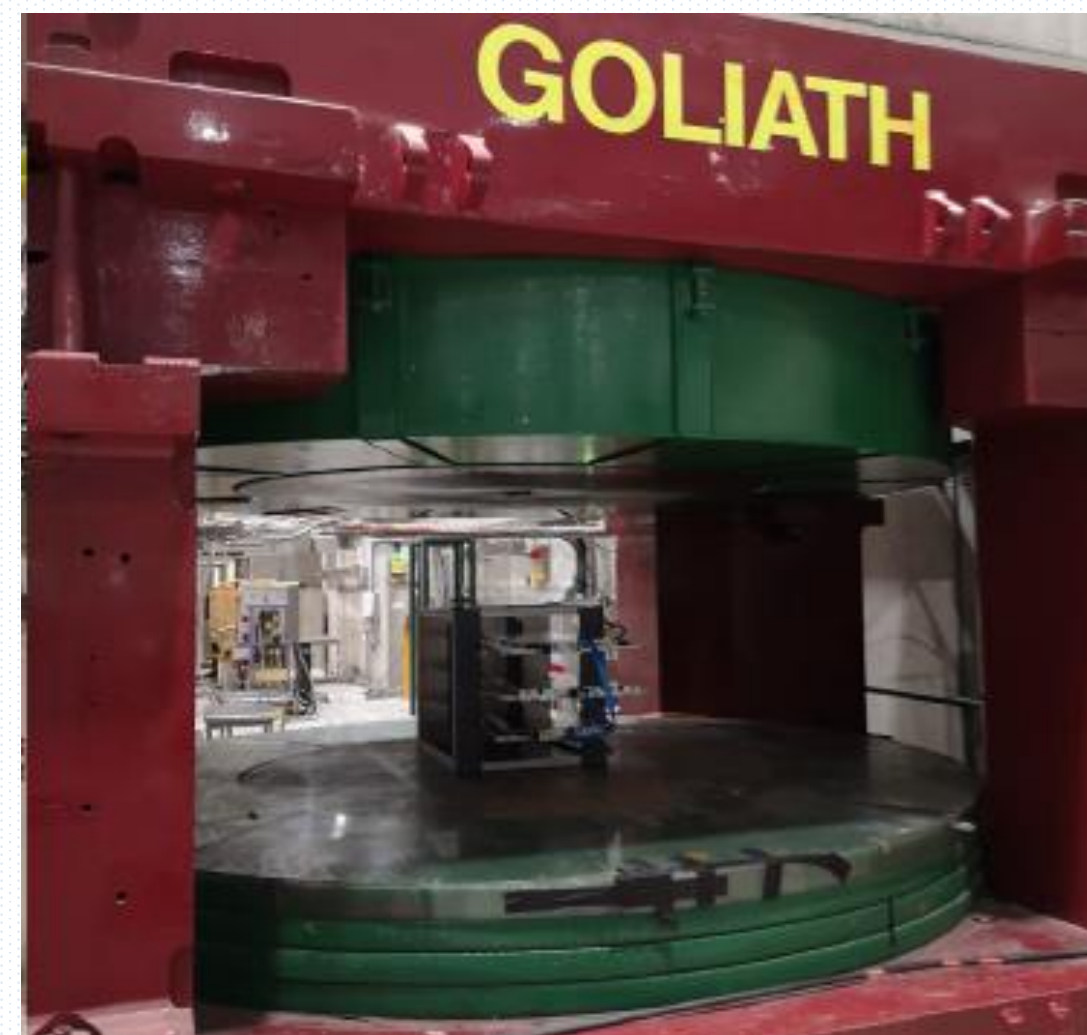
Figure 2. GE1/1 chambers inside Goliath magnet

During the first operations of CMS magnet, GE1/1 experienced the occurrence of many discharges, which triggered trips on high voltage (HV) channels. A test aimed at reproducing the unstable behaviour was set up with the Goliath magnet in the CERN North Area [3]. The final goal was to define a safe and smooth operational procedure for the detectors installed in the experiment. During the test 4 GE1/1 spare chambers were installed inside the Goliath magnet and the HV was provided with 4 independent cables from 2 A1515 boards.

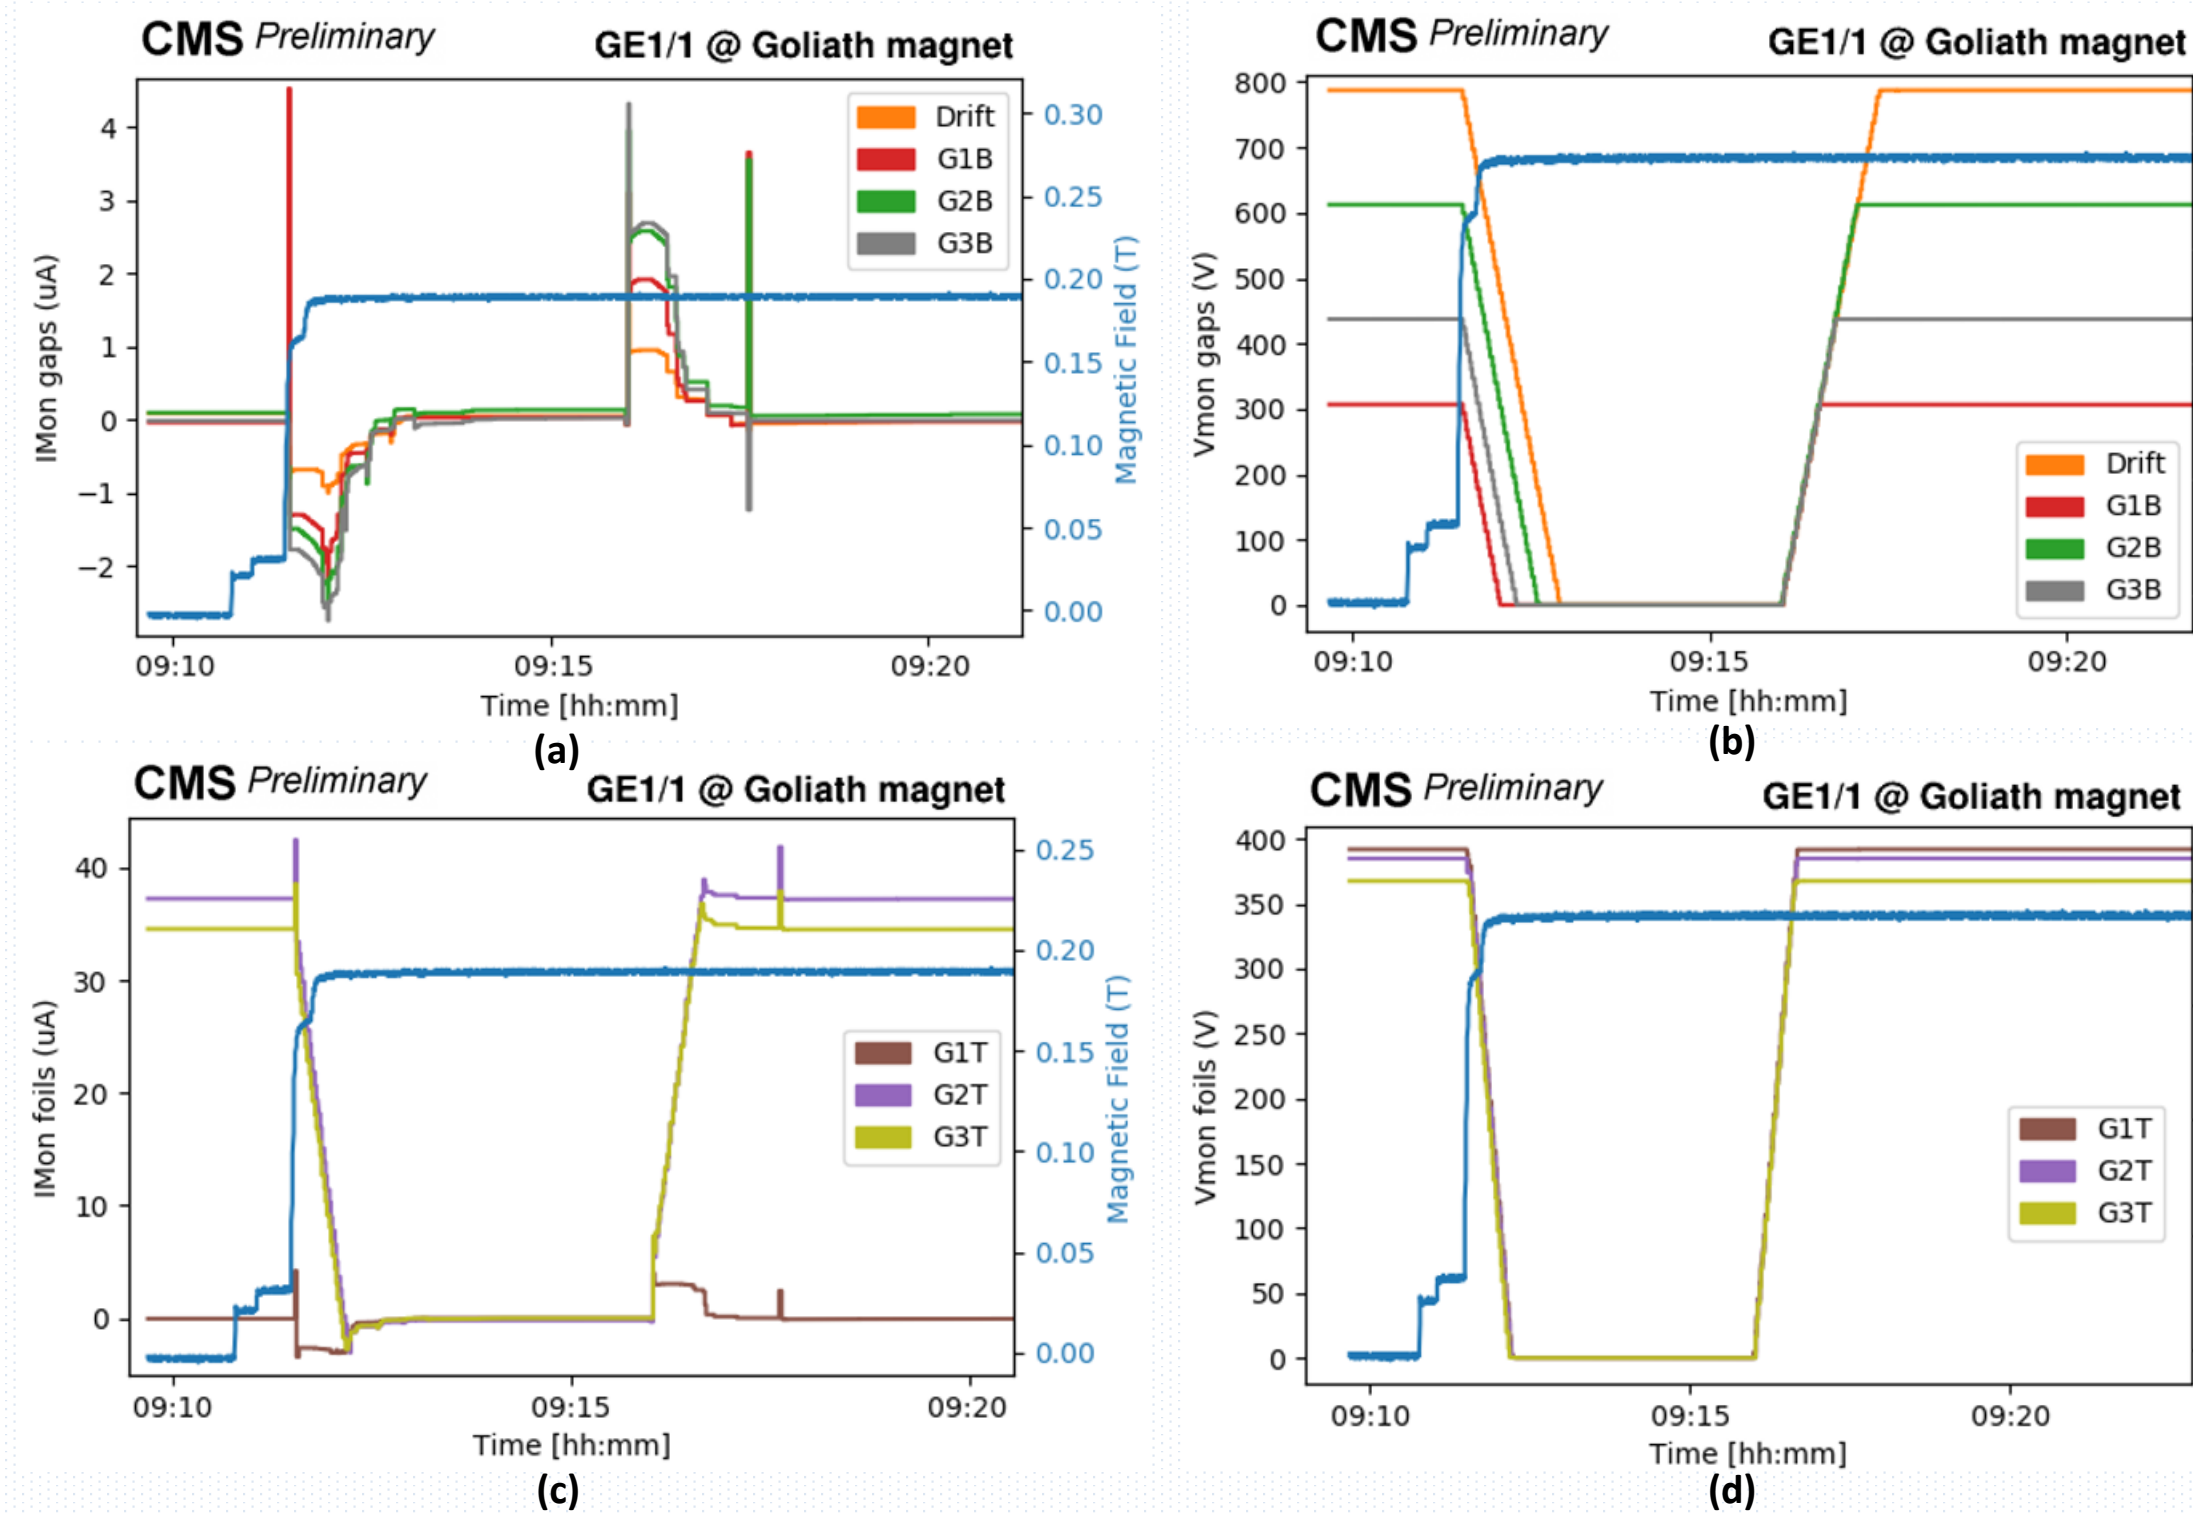
Figure 3. Current and voltage data read from A1515 board channels

During the test many magnetic field variations were performed, adopting at the same time different chambers' parameters. The current and voltage observed on the A1515 board for the 7 HV electrodes powering the chambers have been monitored. The scheme of HV electrodes for a GE1/1 detector is reported in Fig. 4.

From plots in Figure 3a and 3c, the occurrence of discharges can be identified as a current spike. HV ramp up and ramp down are instead visible in Figure 3b and 3d; they are also characterized respectively by positive and negative currents shown in Fig. 3a and 3b at the same time. A ramp down can be triggered by the occurrence of a discharge overcoming a protection threshold called I_0 in the A1515 board settings, in an event called trip, such as for the discharge illustrated in Fig. 3 at time 9:12. In addition, this chamber presents a short circuit in the second and third GEM foil, resulting in a high baseline current for G2T and G3T HV channels when HV is applied (Figure 3c).

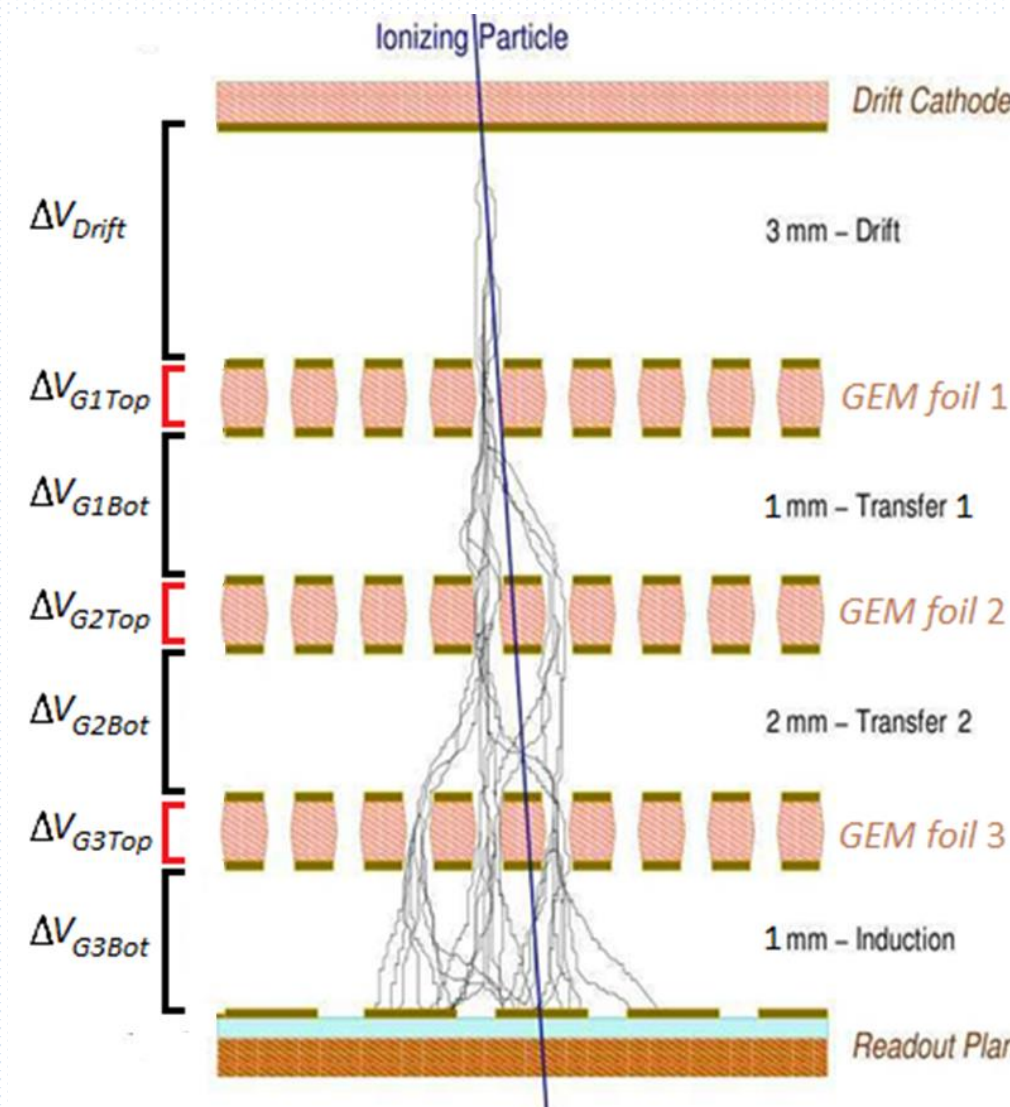
Figure 4. Scheme of HV electrodes in a GE1/1 detector

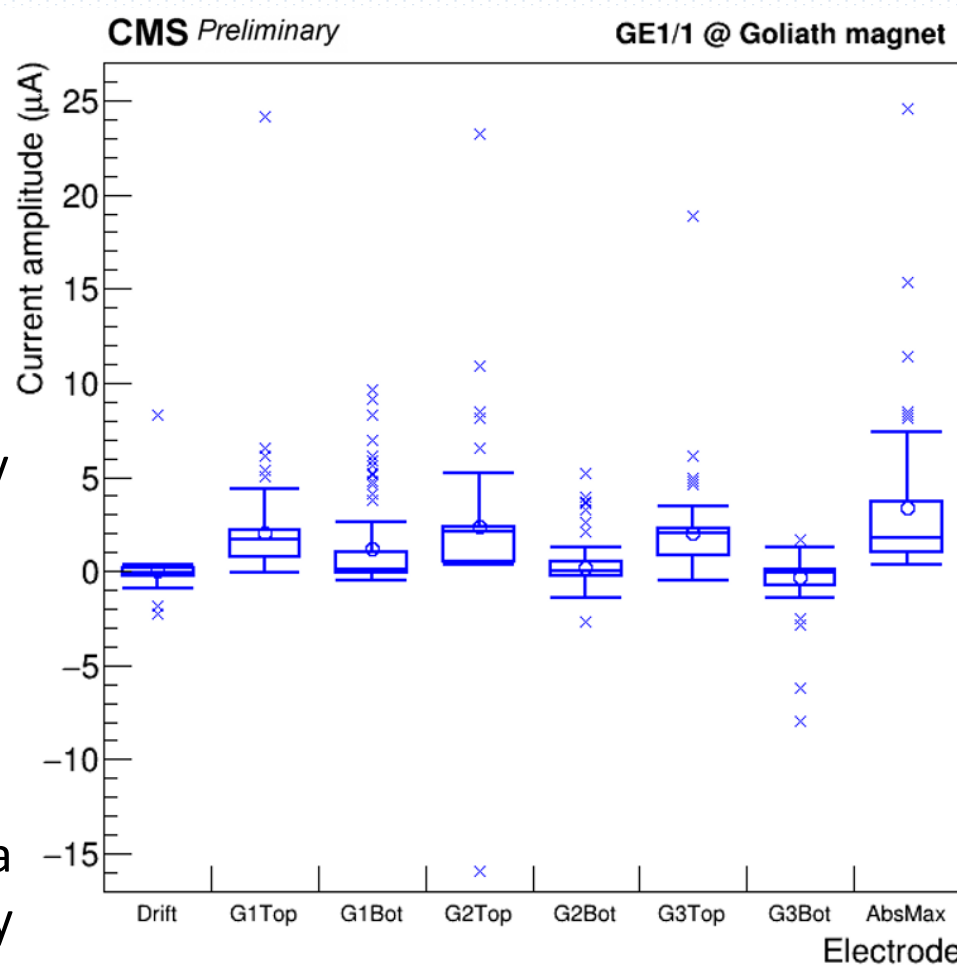
Figure 5. Current values observed at discharge instant, for each electrode and the maximum for discharge event (AbsMax)

In Figure 5, the distribution of currents observed at the occurrence of a discharge on each electrode and the maximum per each discharge event (AbsMax) is represented. Fig. 6 shows instead the fraction of discharge events overcoming a given threshold. These information are useful to tune the I_0 threshold to trigger a trip only when really needed.

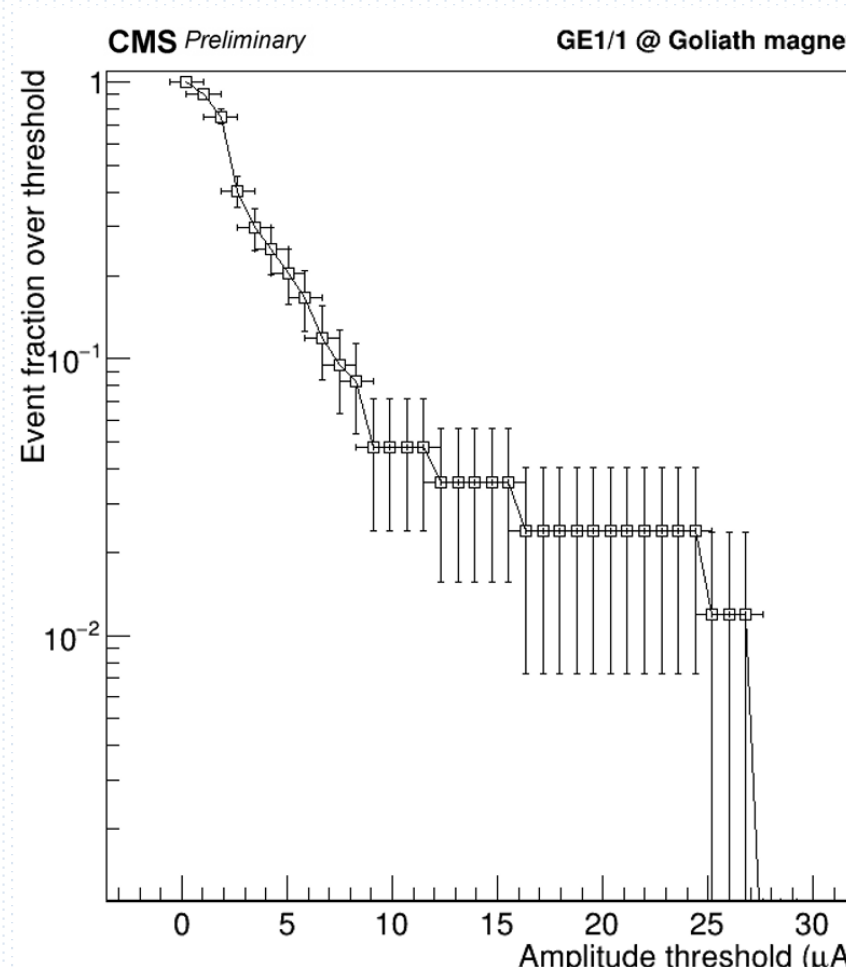
Figure 6. Fraction of discharges overcoming a given current threshold

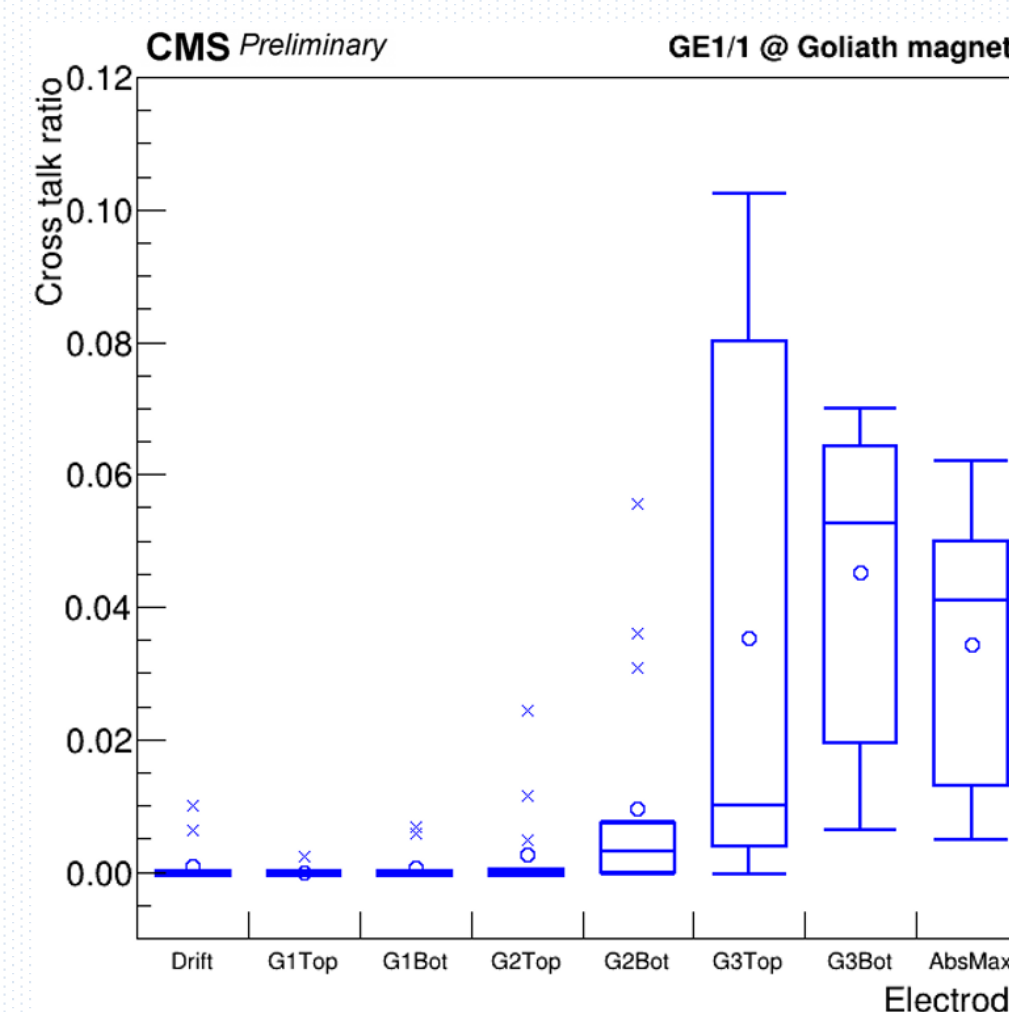
Figure 7. Cross talk ratio among chambers powered by the same A1515 board

When a discharge occurs in one chamber, a small induced current is observed on the other chamber powered with the same A1515 board. This phenomenon, known as cross talk was measured and the result is displayed in Fig. 7: it's clear that the electrodes more prone to cross talk are the closest to the ground. The collected data have shown as the cross talk phenomena will not represent anyway a problem for chambers operation, setting an adequate I_0 threshold ($> 2 \mu A$).

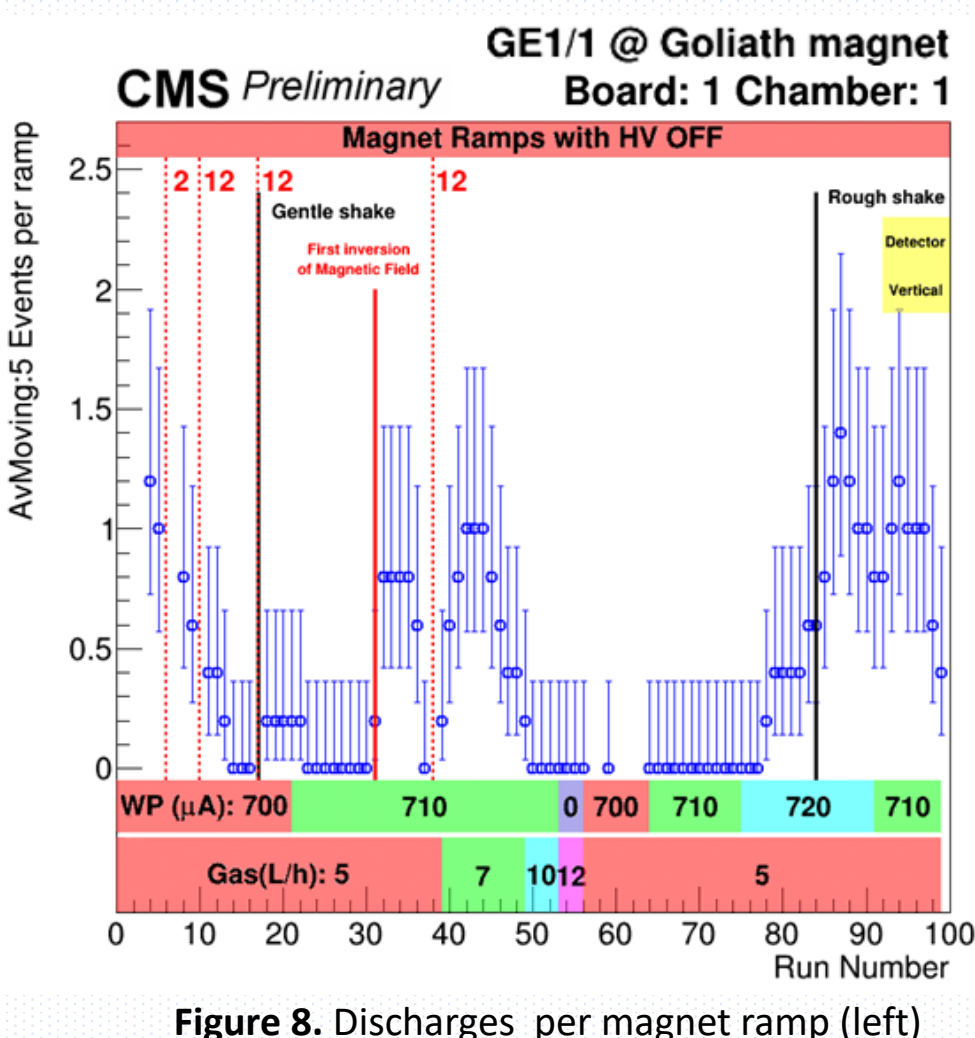
Figure 8. Discharges per magnet ramp (left)

Figure 8 shows the evolution of the discharge rate during the test, using a moving average of 5 magnet ramps. The rate of discharge decreases with the increase of the number of magnet ramps performed, while it increases when a mechanical stress is applied (as in CMS during disk movements) or when magnetic field sign is inverted for the first time in the test. These observations are compatible with the hypothesis of dust hidden inside the detectors and moved by the magnetic field variation. When the dust reaches a GEM hole, it can trigger a discharge and it is consequently burned. In addition, discharge occurrence seems to be not affected by gas flux or HV working point.

Magnetic field ramps were also performed while the HV was off and are indicated by the red vertical dashed lines: this operation induced a short circuit in one sector of one GEM foil in one of the chambers. We calculate then a short production probability of $p_{\text{short}} = 2.6^{+6.0}_{-2.2}\%$ (CL = 68%). This short circuit was then burned applying 1000 V with a MEGGER.
