investigation, mechanical design and construction

LAYER 3 DAMAGE

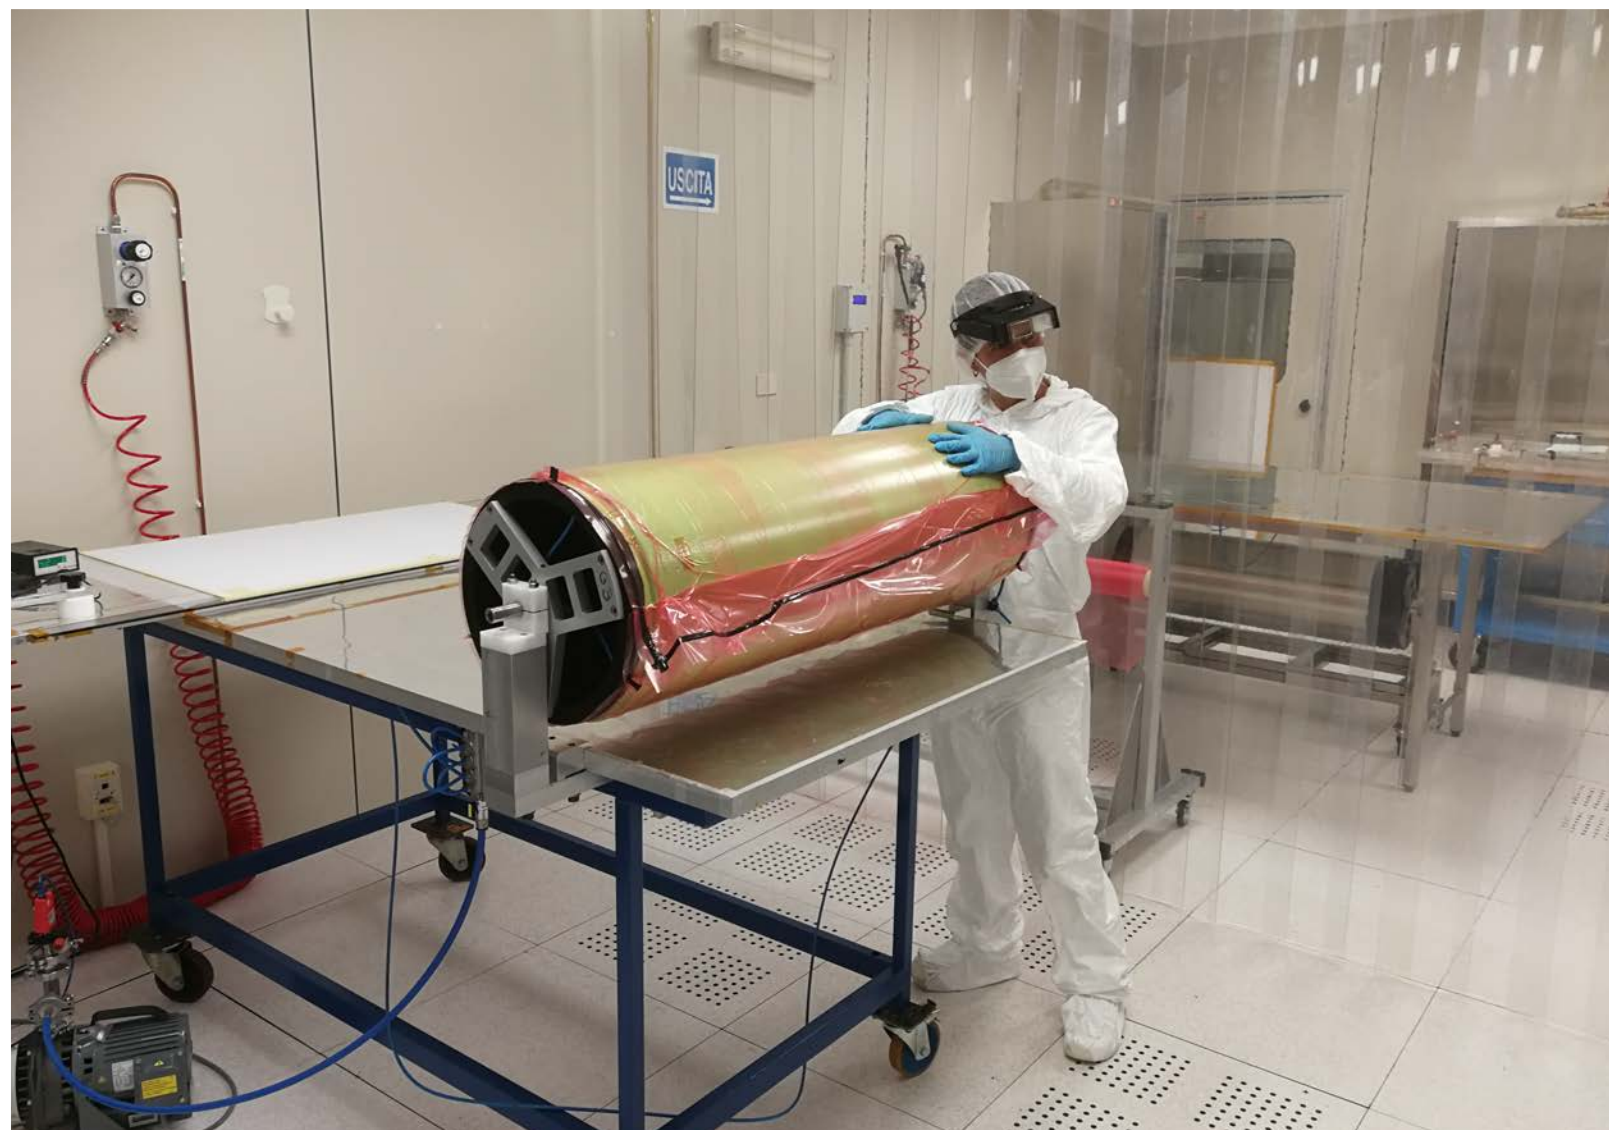
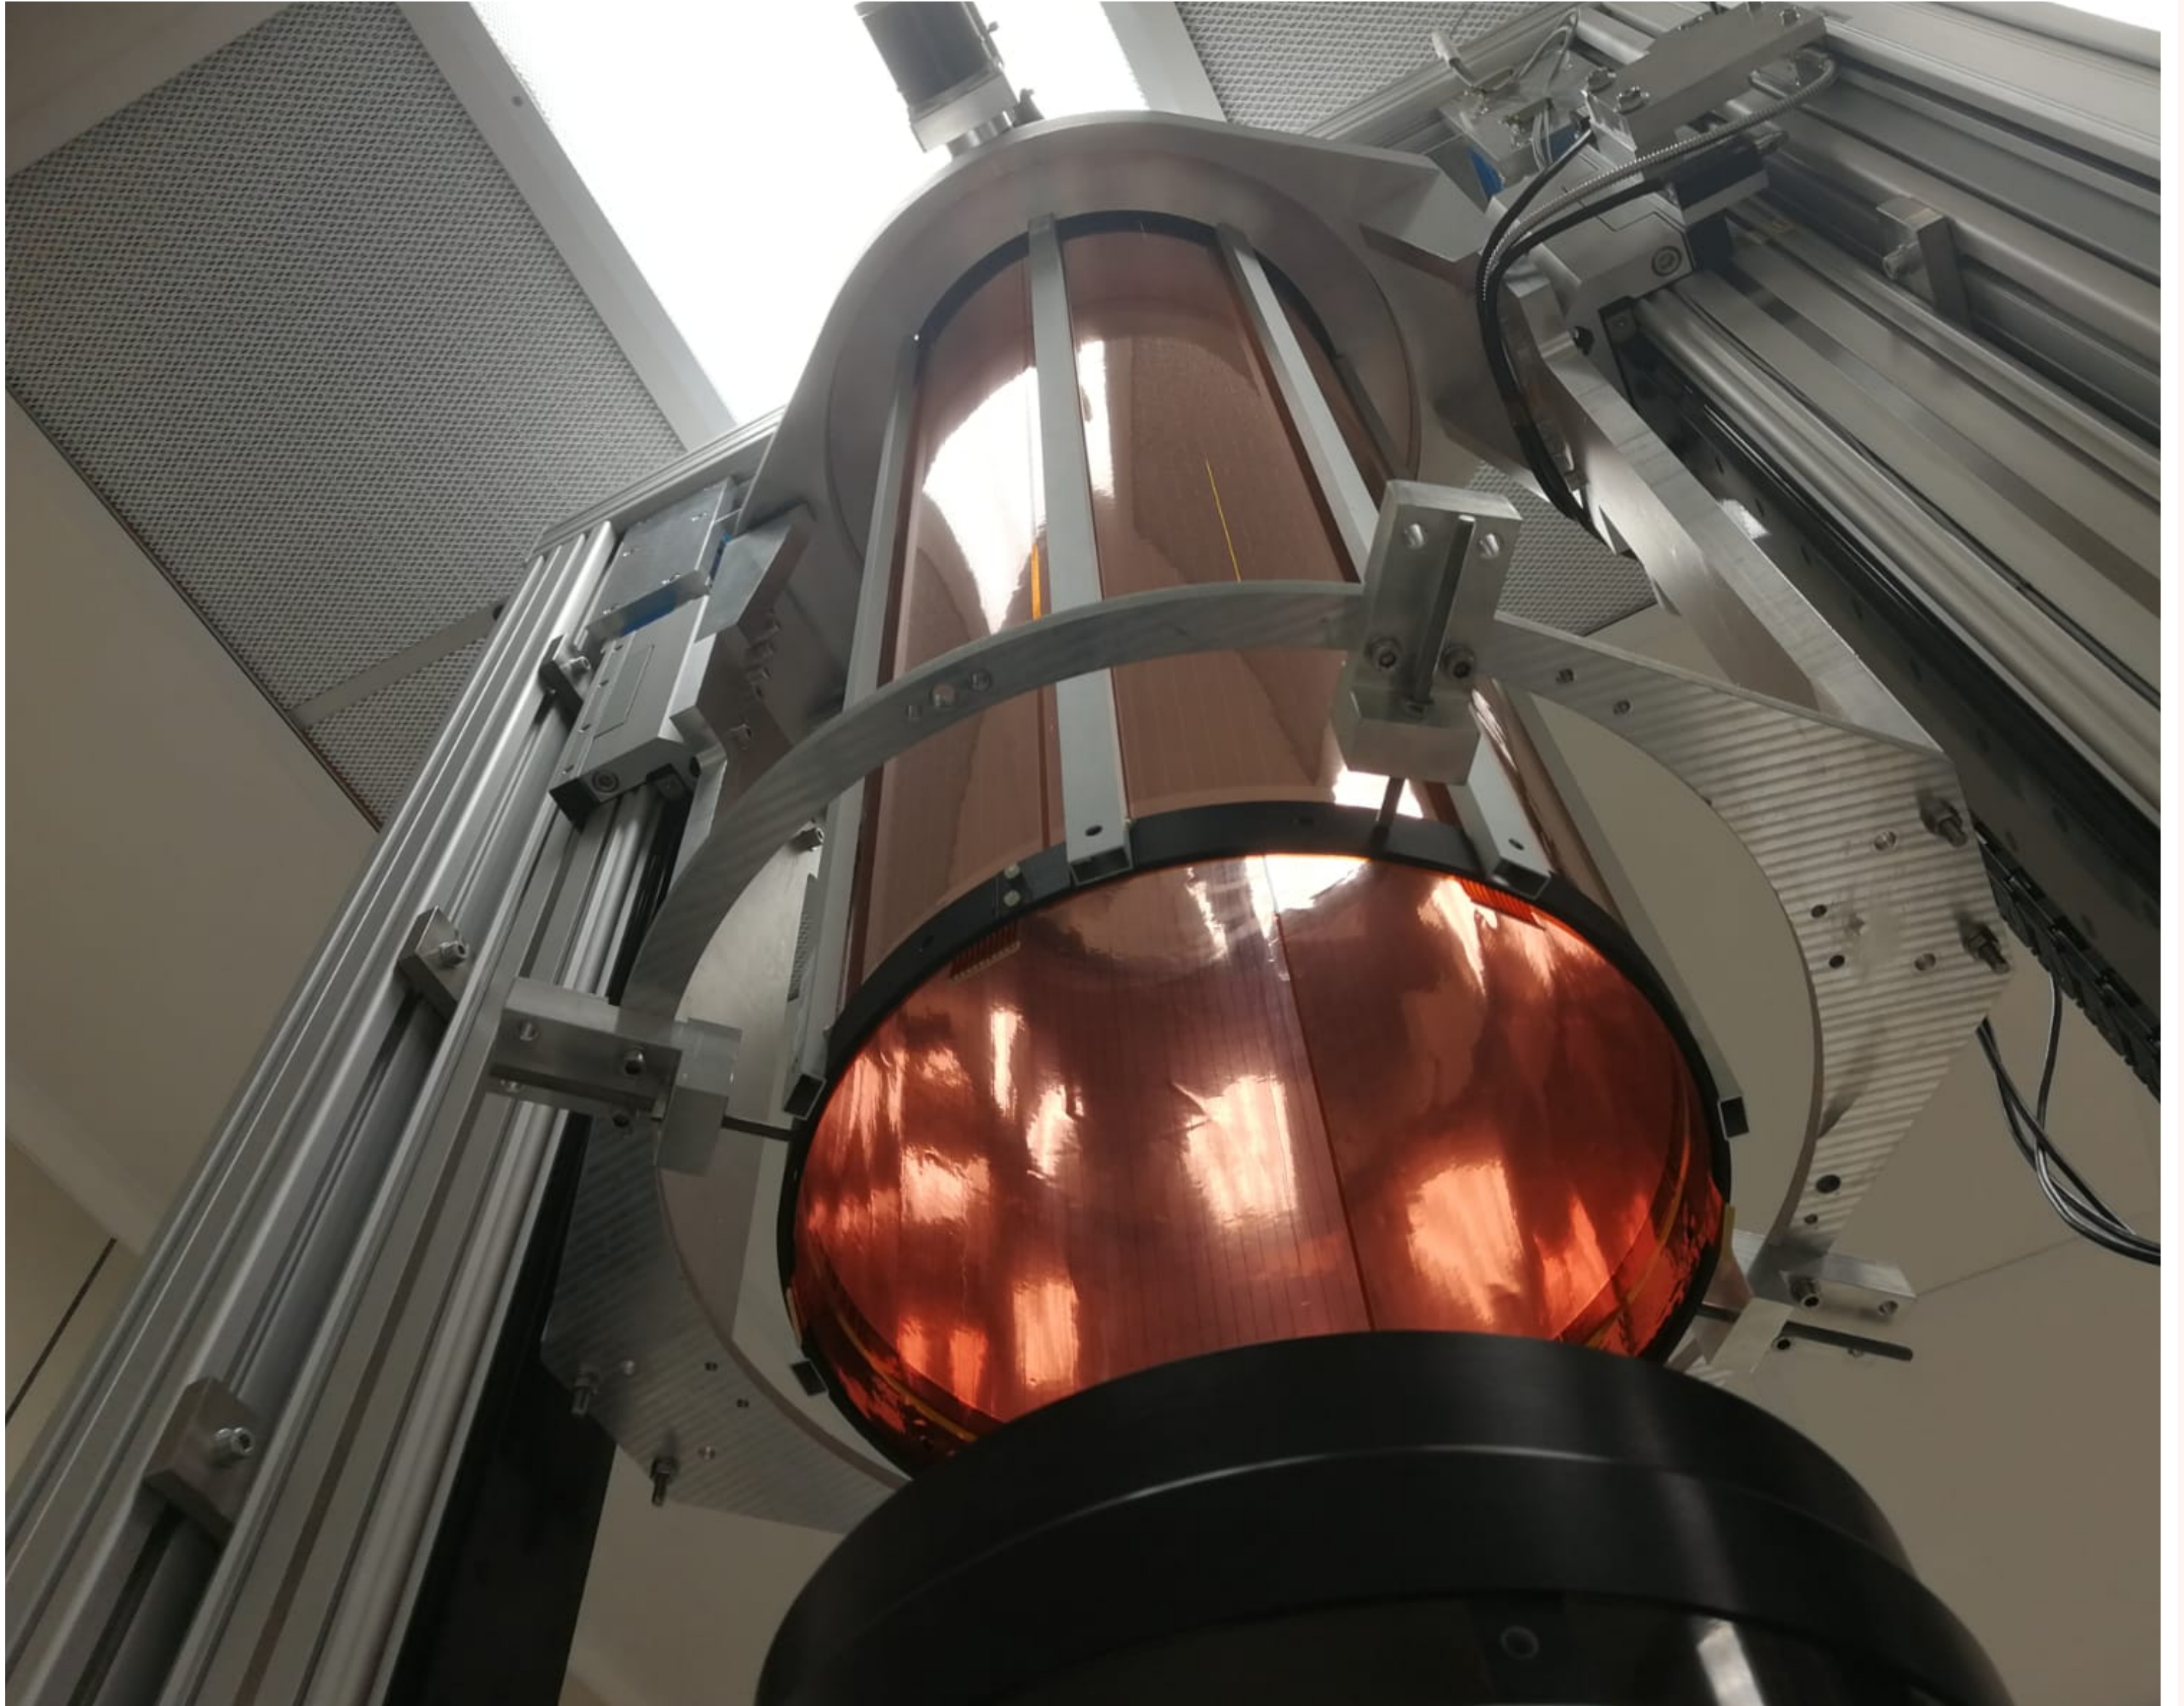
DROP TEST

- FEM buckling analysis showed a limit point of $\sim 2.4g$ for the layer 3 GEM geometry
- Depending on the surface, such an acceleration can be reached even with small impacts
- Simulation needs to be validated against data
- A “drop test” will be conducted later this week at LNF with a mockup of a layer 3 GEM cylinder
- The mockup has been assembled from spare GEMs and 3D-printed flanges (see next slide)
- One side of the mockup will be constrained onto a table; while the other side will be dropped from different heights
- Up to five accelerometers will be attached to the supporting structure and to the GEM foil to measure the deceleration due to the impact

Support Grid
10x10cm²
T2
T1
Drift

GEM Foils
GEM3
GEM2
GEM1

Carbon Fiber
Mechanical Structure
External [Anode]
Internal [Cathode]

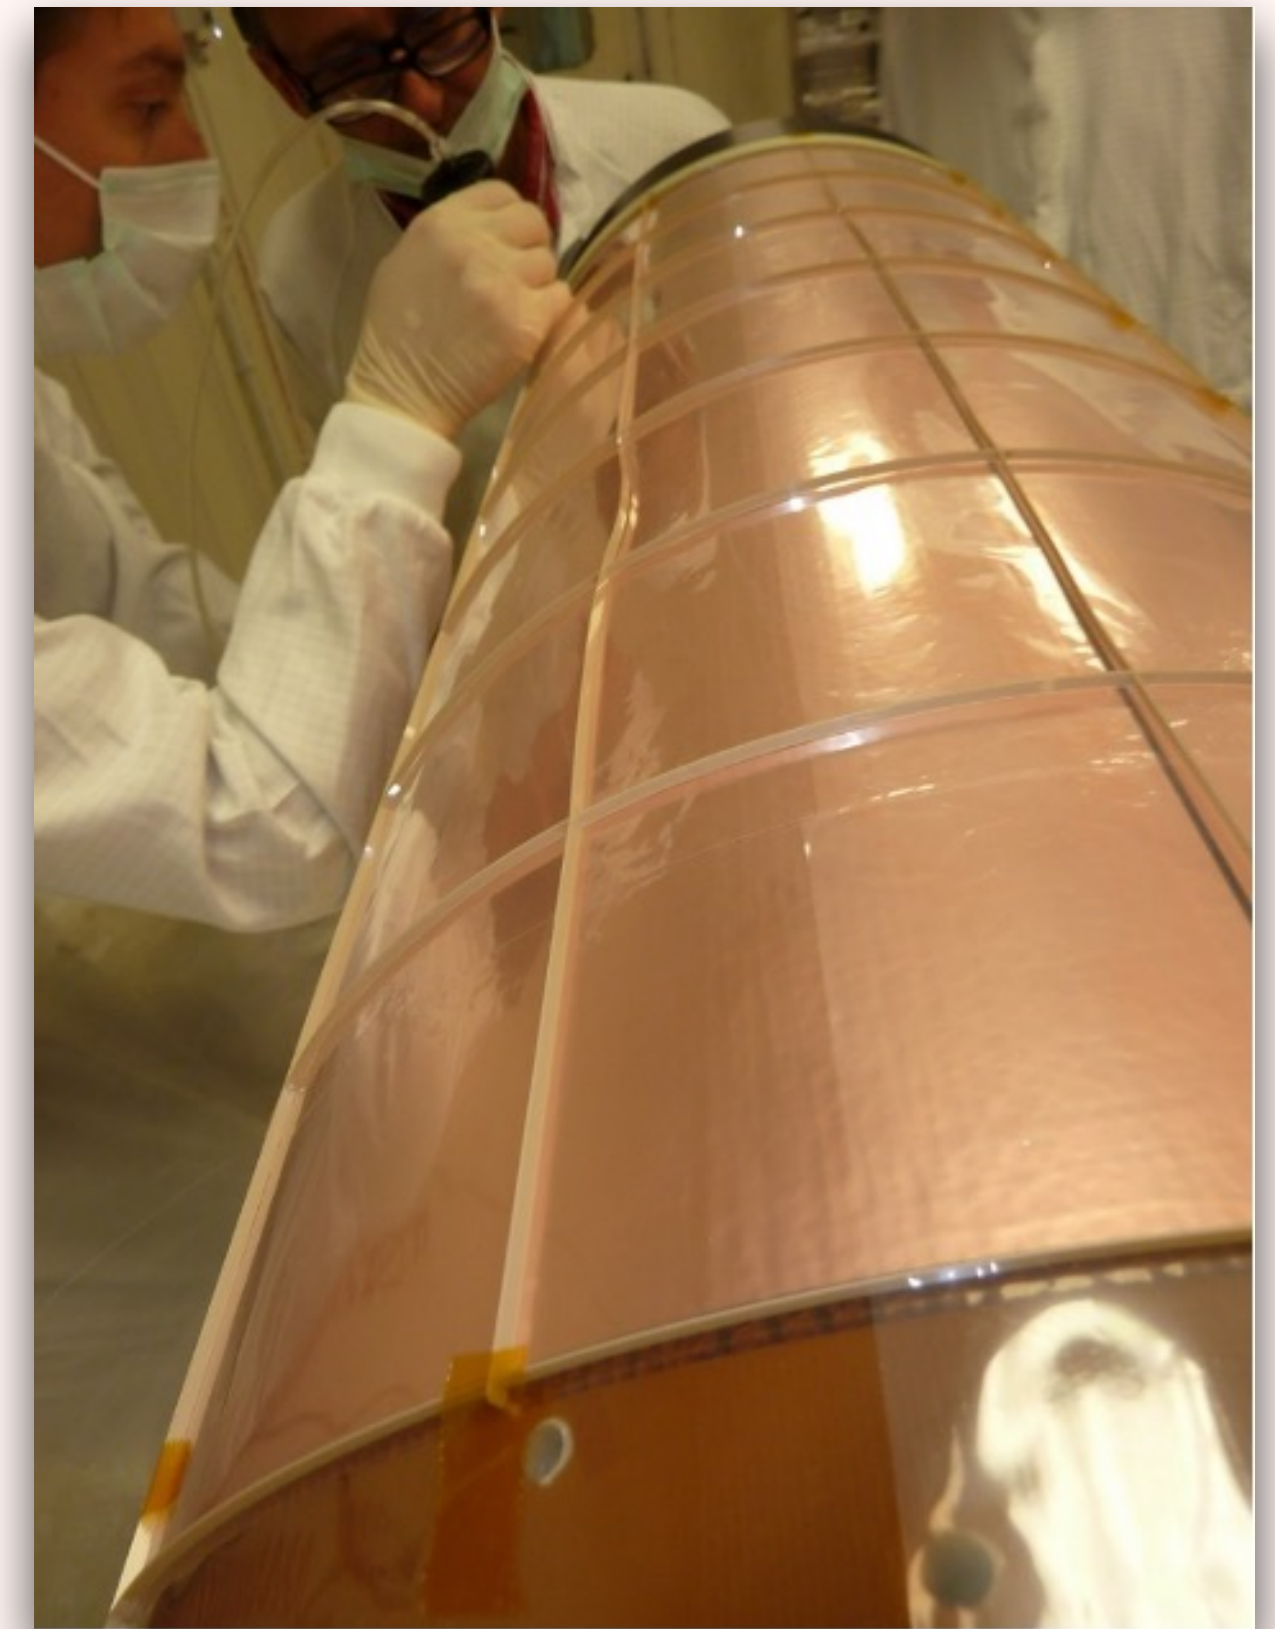
SPACING GRID

- KLOE-2 used a peek grid to keep the distance between the GEM foils on the outermost layers (L3 and L4)
- The grid have been shown to be effective in containing a large defects due to assembly accidents on KLOE-2 layer 3
- No buckling effects on KLOE-2 layer 4

- Dynamic simulation too complicated and would require some validation with data
- A mechanical test could be the best way to assess the its efficacy
 - Discussion in progress
