Pixel detector commissioning

Claudia Gemme

Pixel Detector installation was completed June 28 2007:

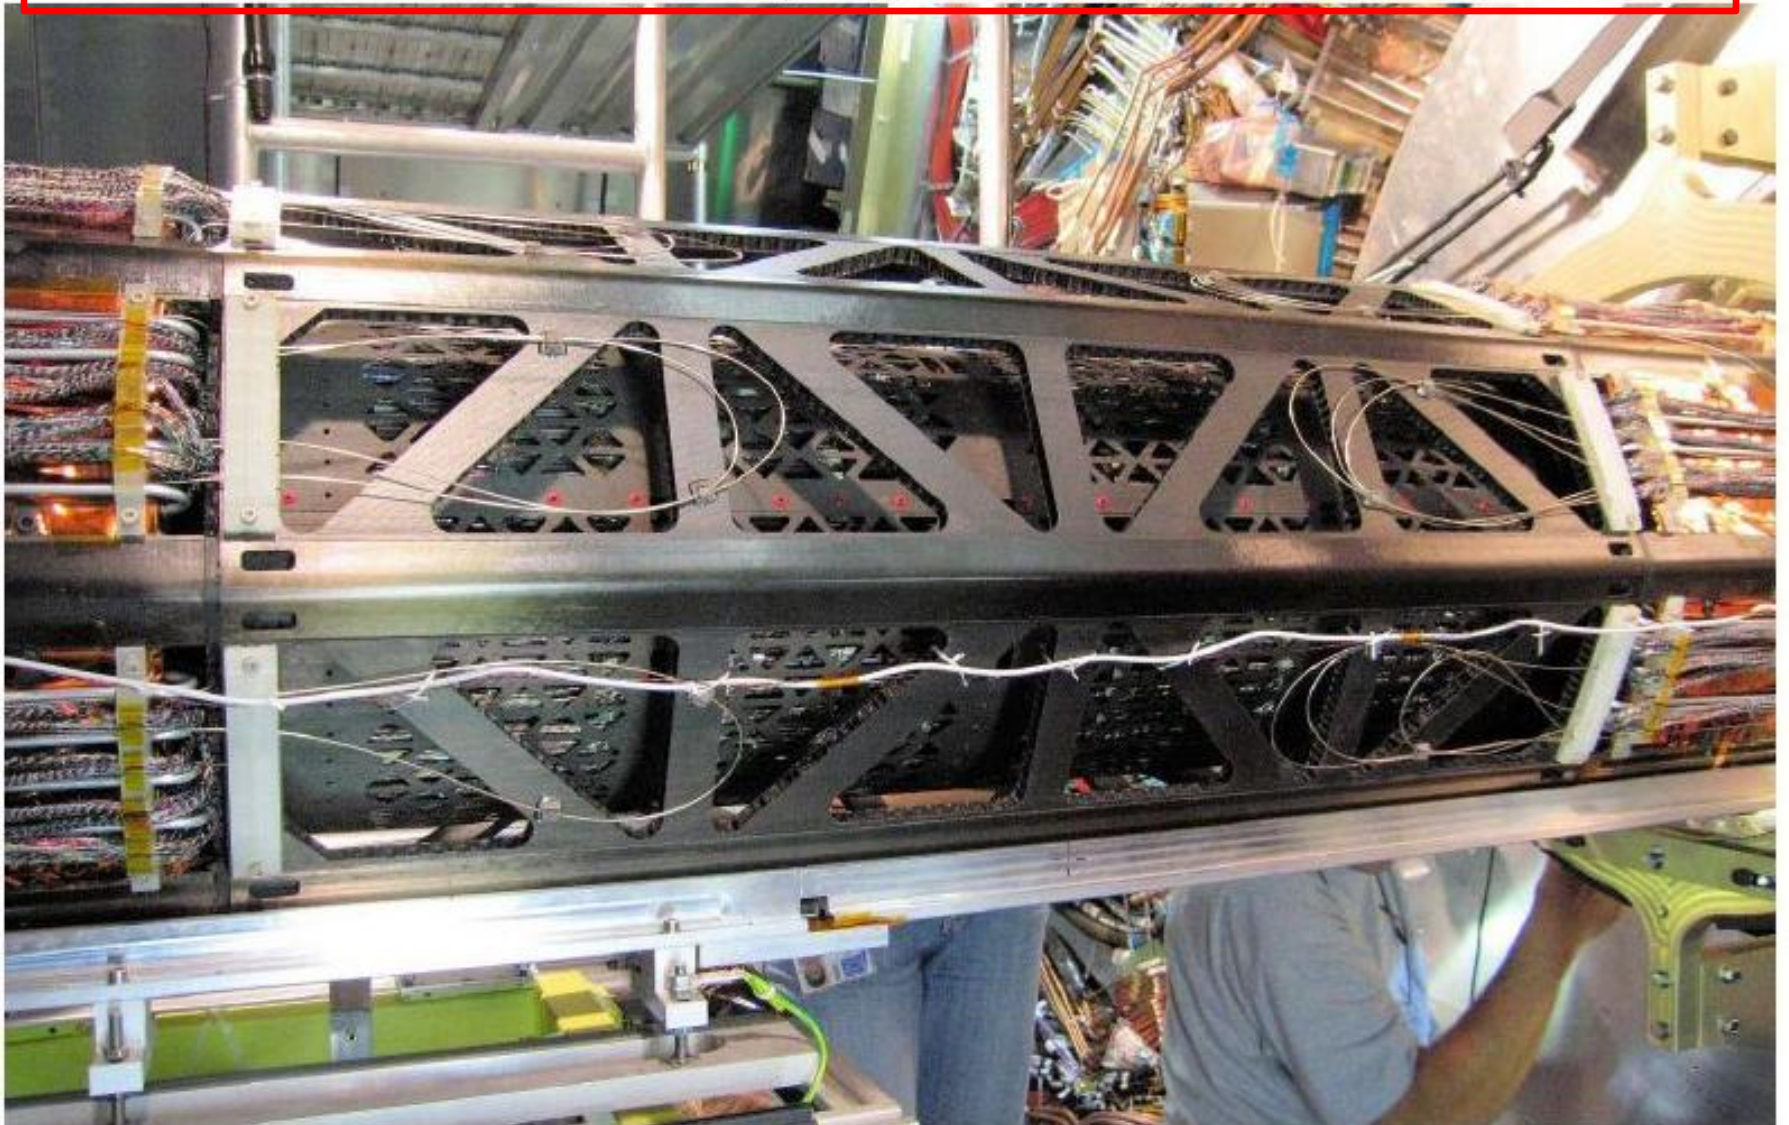
- Last view of the Detector for a very long time as it entered the C-side of ATLAS:

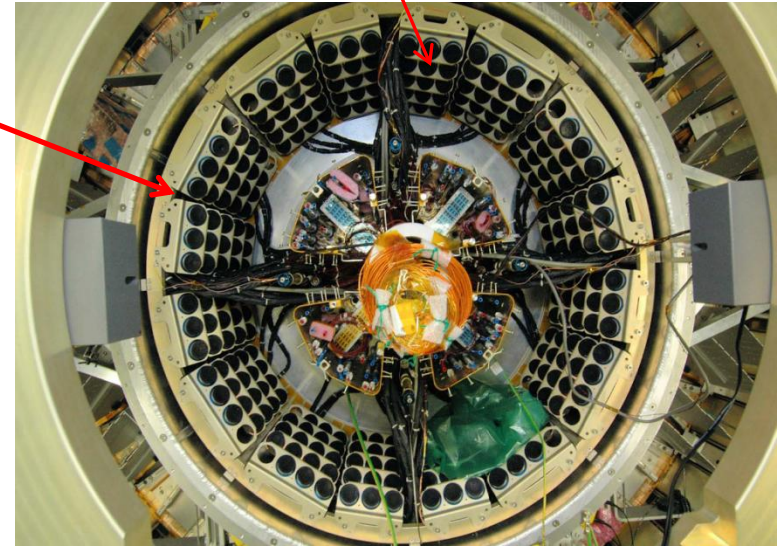
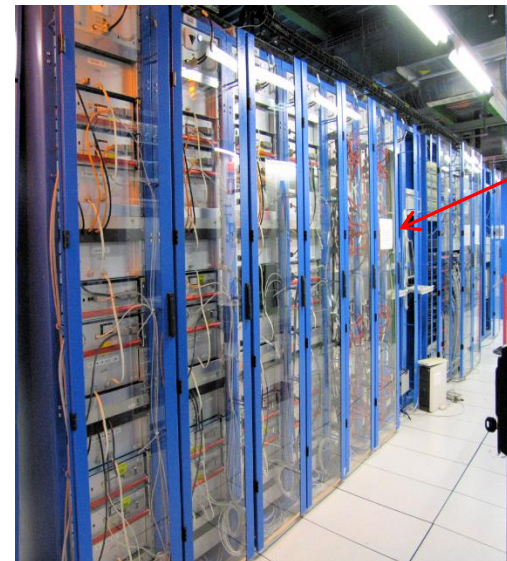
PP1: Pixel interface to external services (before beginning of external service connection)

- ✓ Partial test of the continuity from PP1 to the detector after unfolding.
- ✓ ***Services Test*** which exercised the system down to the PP1 connection point using a "dummy detector" consisting of programmable loads, simulated temperatures, and voltage and current measurements.
- ✓ All installed optical services have been qualified with an optical TDR (reflectometer) to validate their attenuation and optical length.
- ✓ ***Cooling: "Loopback Tests"*** with real capillaries and heaters outside the detector to begin flushing and operating all Pixel cooling circuits (and clean the system).

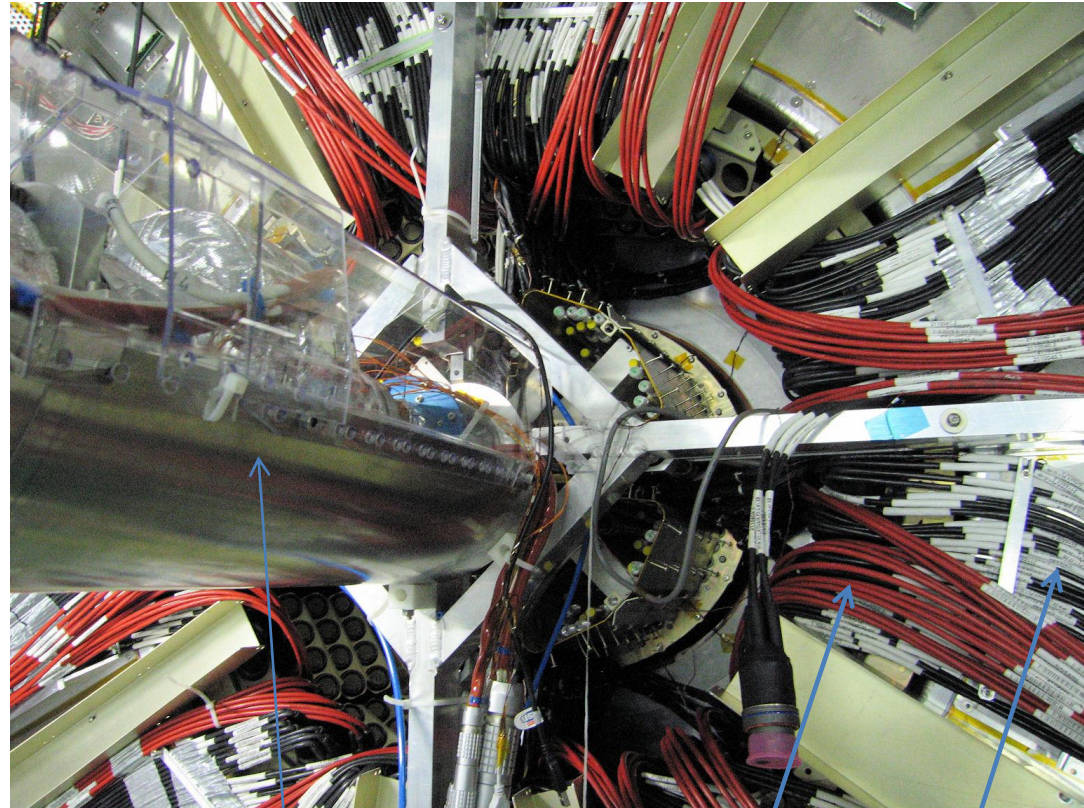
- ✓ La connessione dei servizi e' iniziata il 5 Febbraio sul lato C e una settimana dopo sul lato A. Una decina di persone impegnate sui due lati.
- ✓ Necessario connettere ~ 300 cavi per lato. Per ottante un bundle di cavi NTC, HV e due di LV.
- ✓ Test online per ogni cavo connesso per verificare la connessione sia stata fatta correttamente e che ci sia continuita'.
- ✓ Lavoro maggiore e' il dressing dei cavi per non violare l'ID envelope.

Beam pipe (support)

HV

NTC

Ultimi cavi cablati oggi sul lato C. Una ventina di cavi mancano sul lato A.

- alcune carte negli Scolink (alimentatori delle optoboard) non piu' funzionanti,
- alcuni problemi minori nelle PP2 (diodo rotto, un cavo sconnesso, un corto a massa),
- un cavo troppo corto-> necessario aggiungere uno spare,
- Un cavo con shielding danneggiato,
- due sensori ambientali in corto sul detector,
- **Molti retracted pin nei connettori Lemo (dell'ordine di alcuni per decina di cavi). Necessario rincollarli e curing overnight.**

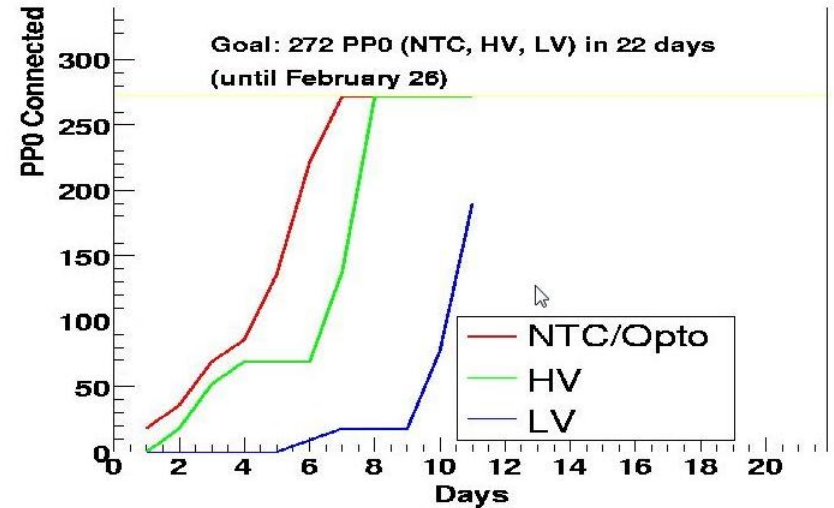
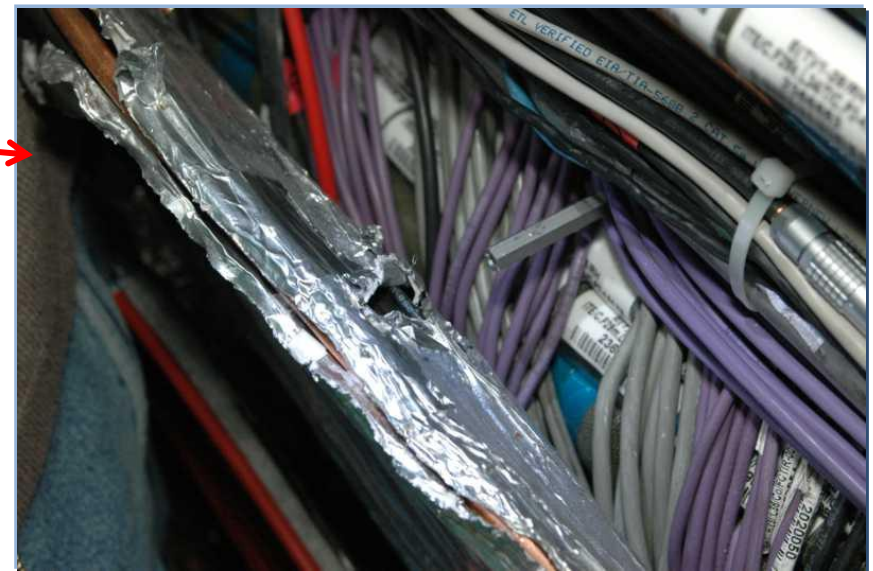
Pixel Electrical Connection (Feb. 18)

Connected cables

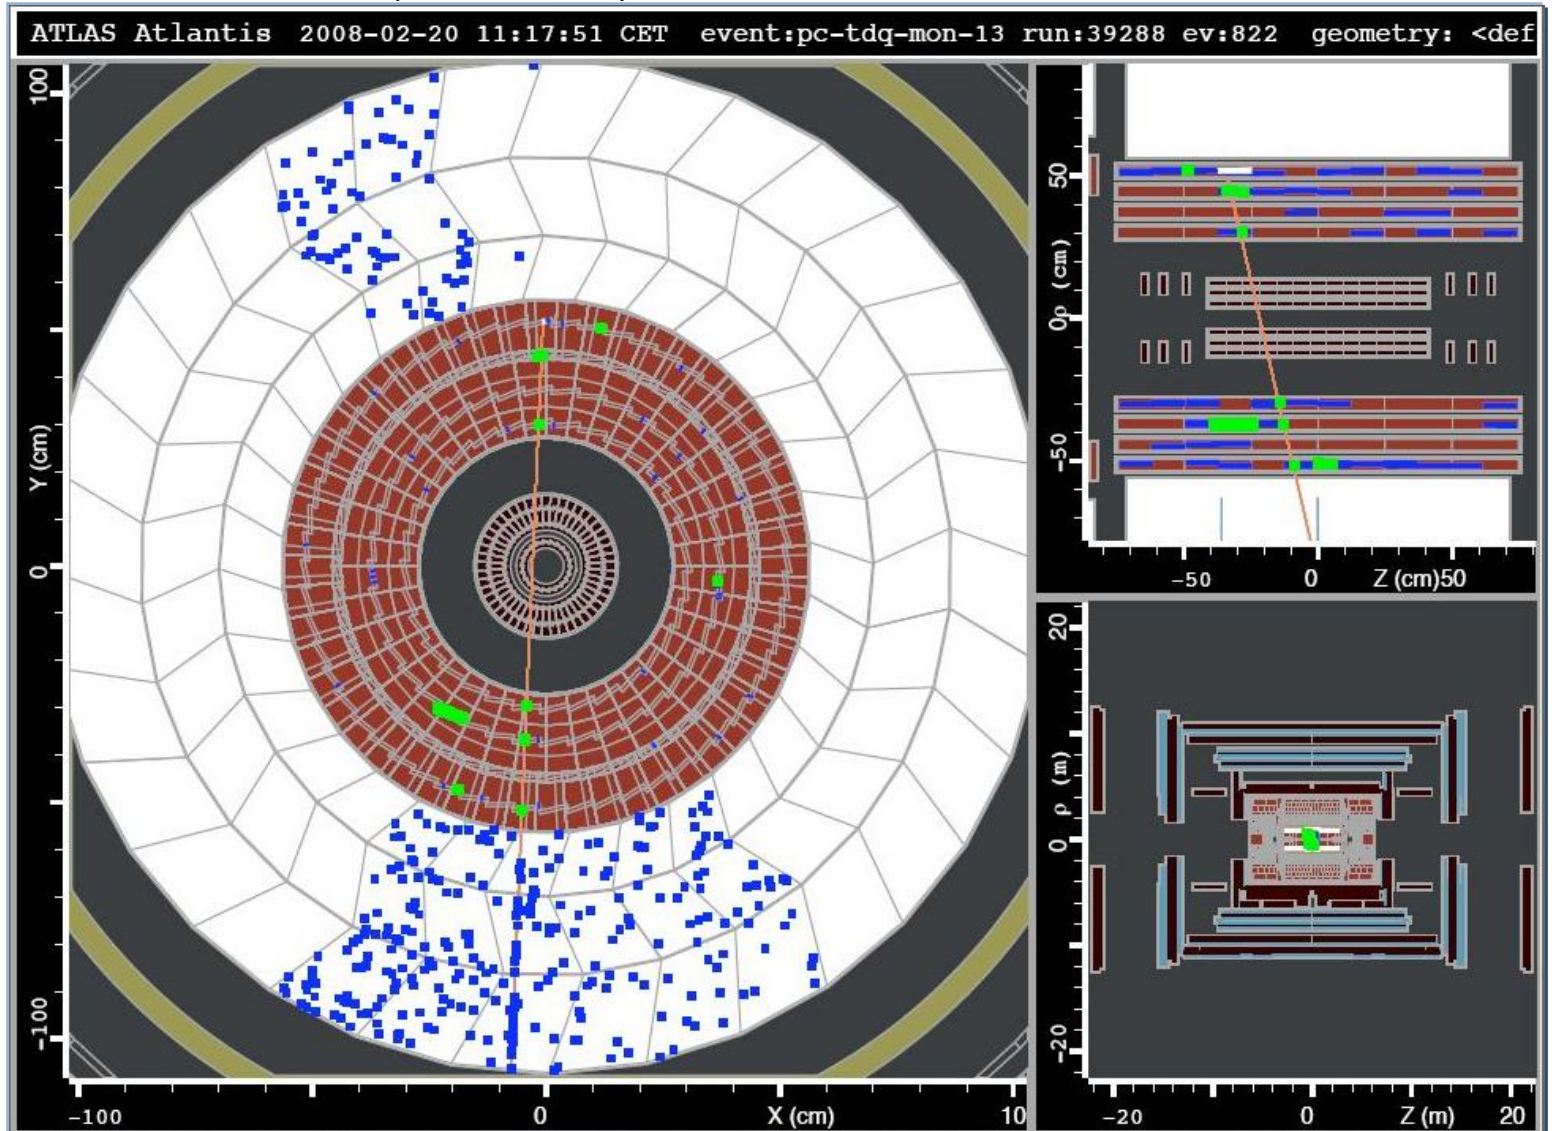
First combined cosmics run (SCT+TRT)!
