Lessons learned with Virgo

Romain Gouaty, on behalf of the Virgo Collaboration

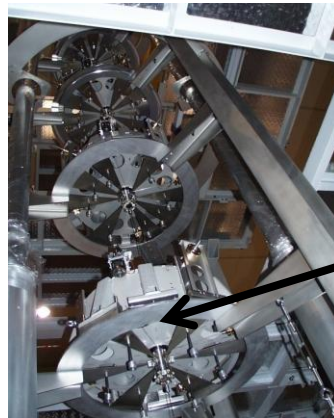
Virgo Super Attenuators

On site measurements of seismic isolation give upper limits below Advanced Virgo requirements

Blade Springs

- SA helped Virgo to reach good sensitivity at low frequency (< 60 Hz)

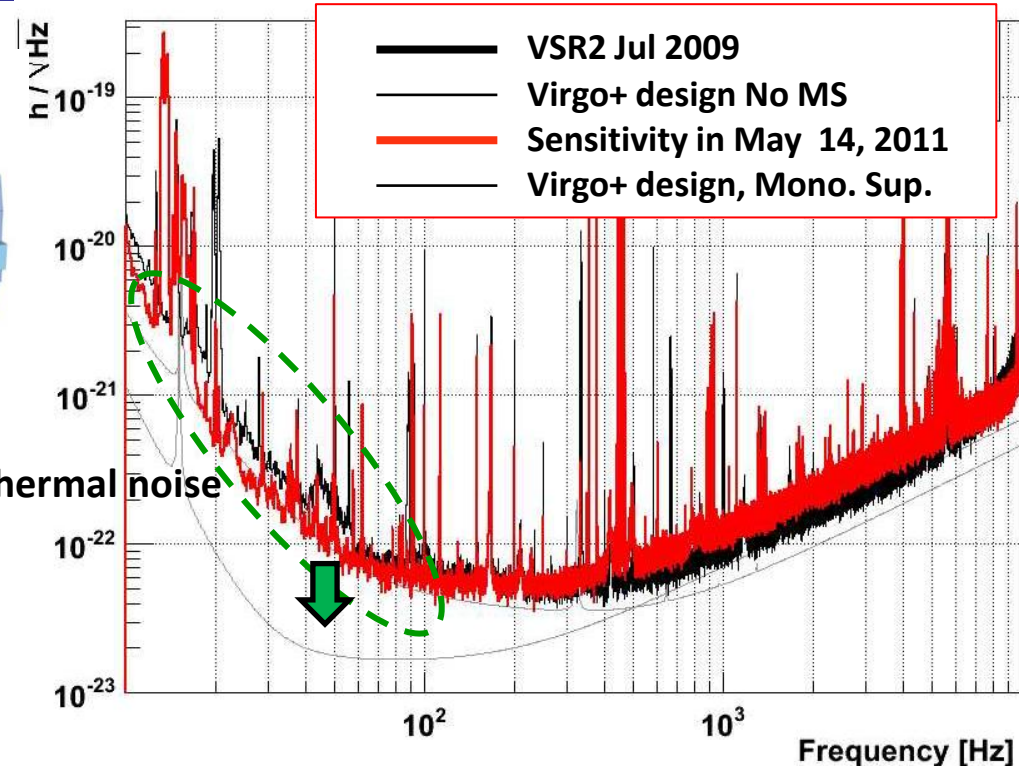
Reducing thermal noise

- Installation of monolithic fused silica susp. for the 4 arm mirrors (spring 2010)

- Sensitivity at 20-80 Hz sometimes beating design without Mono. Sup.
- Still far from expected thermal noise limit (instrumental + unknown noises)

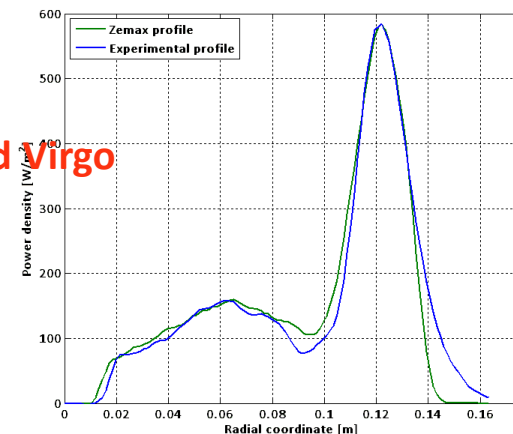
Encouraging results obtained in laboratory
with “double axicon “

⇒ Obtain an optimal heating pattern

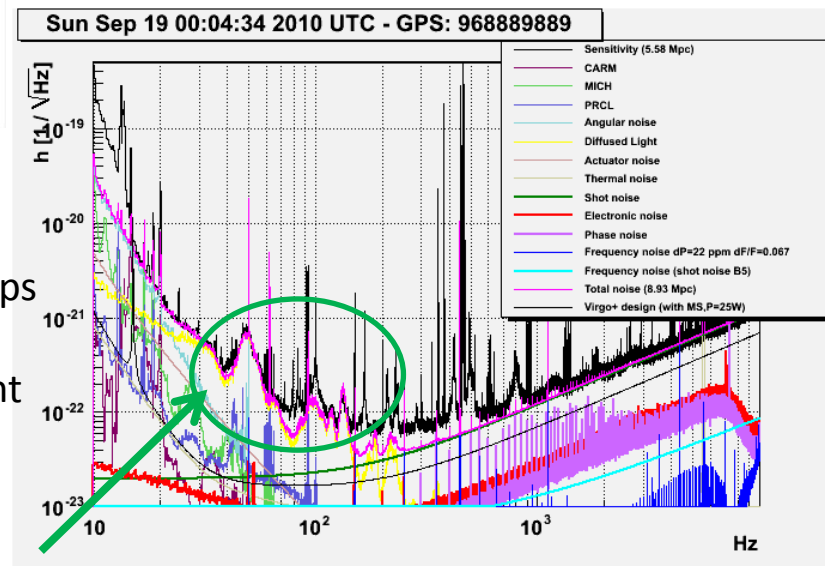
30-200 Hz: sensitivity limited by diffused light noise coupling inside detection tower

⇒ Partly fixed by adding a beam dump at the OMC reflection

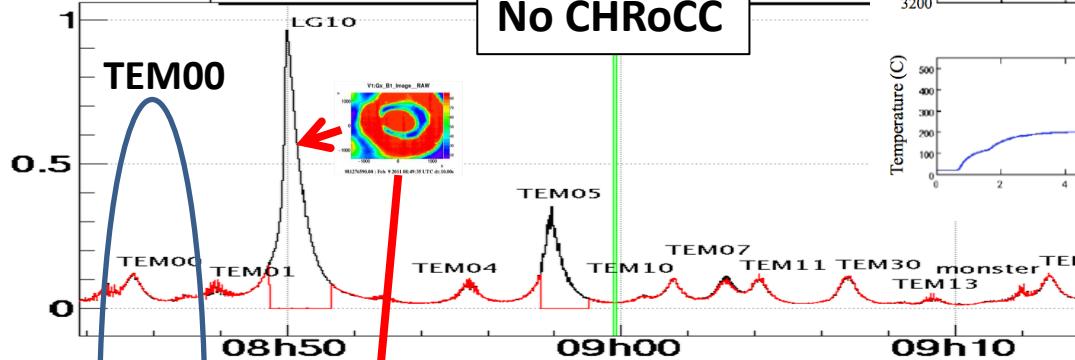
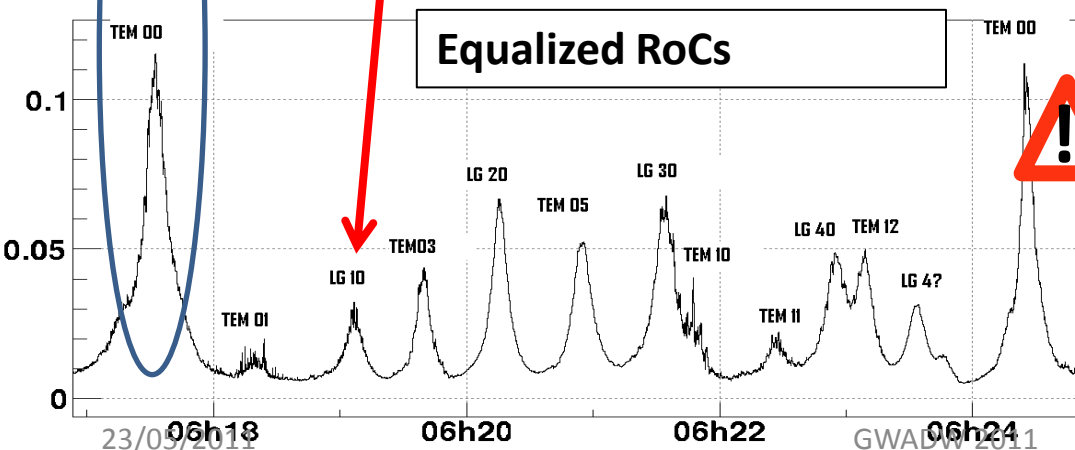
Central Heating Radius of Curvature Correction (CHRoCC)

- Increase End Mirror RoC by projecting heat pattern onto center of mirror's HR surface.
- In-vacuum heat projector with ellipsoidal reflector
- Installed at NE(WE) in Dec 2010 (March 2011)

Scan of the Output Mode Cleaner:

Probe mode content of dark fringe beam

⇒ Dark fringe power (High Order Modes) reduce by a factor ~ 5

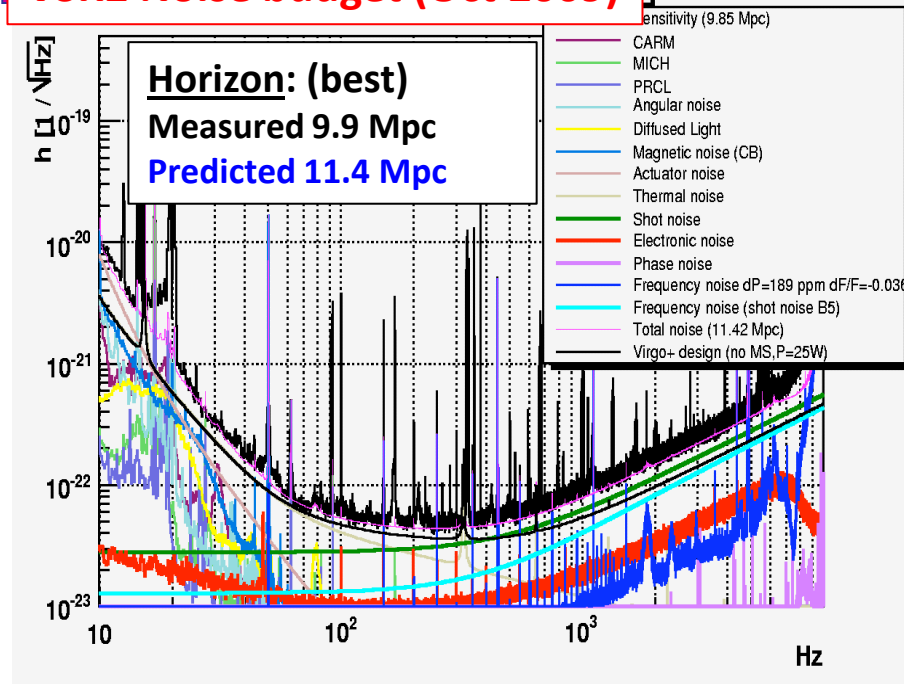
VSR2 Noise budget (Oct 2009)

• VSR2 sensitivity was very near design, and noise seemed to be well understood
