Material Damages and Burn-Through Detection for FEL Beams at LCLS

Shanjie Xiao, Alyssa Prinz, Phil Heimann, Andrew Rosenstrom,
Michael Rowen and Sayed Rokni

SLAC National Accelerator Laboratory

May 31, 2024, SATIF-16

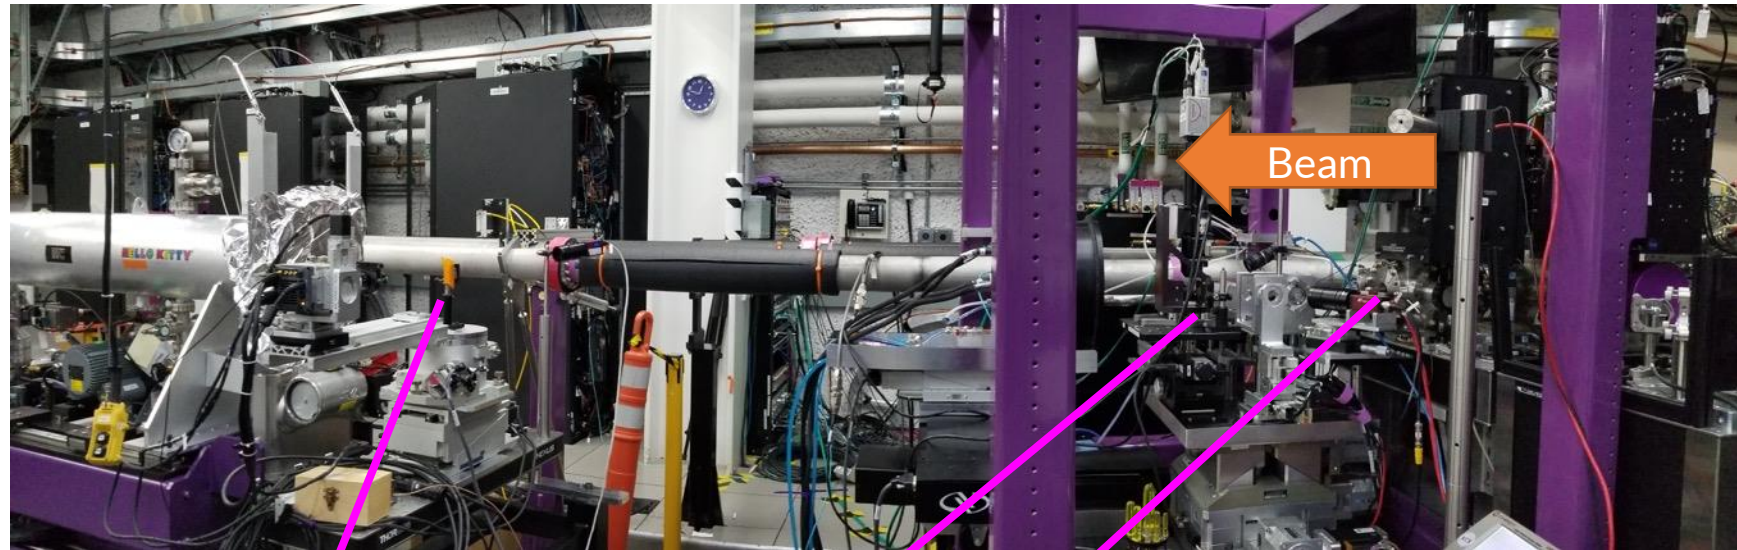
Test Setting for Material Damage

Adjust beam sizes at the sample location to get different beam intensity

120 Hz, 9.1-9.3 keV beam

Test Purposes:

- Damage threshold
- Damage speed
- Hole size

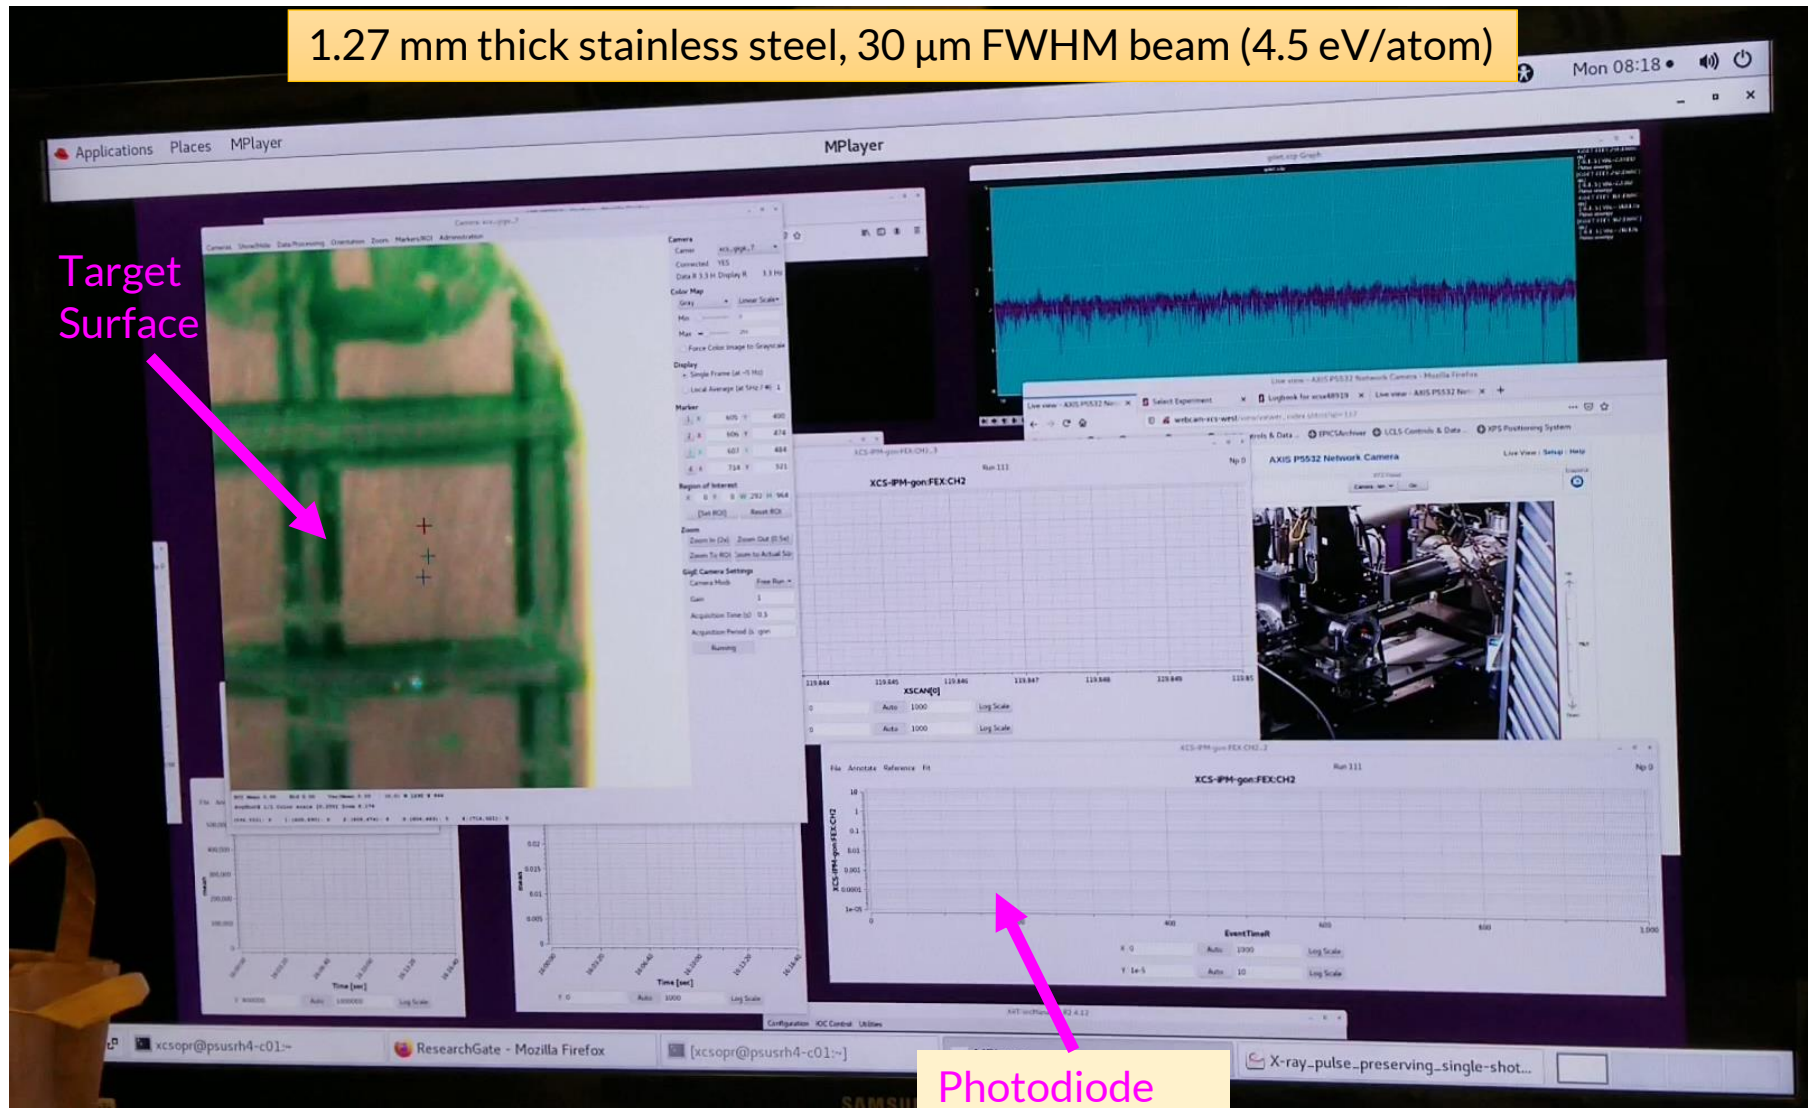
Material Damage Test: Drill Time

1.27 mm thick stainless steel, 30 μm FWHM beam (4.5 eV/atom)

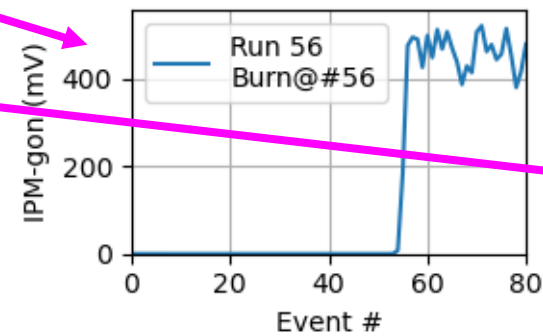
Material Damage Test: Drill Time

Spot Size (FWHM μm)	eV/atom	Burn In	
			Pulses*	Second
1.27 mm Stainless Steel	2.25	800	57 \pm 2.2	0.5
	5	160	58 \pm 1.2	0.5
	10	40	60 \pm 0.4	0.5
	20	10	76 \pm 1.3	0.6
	30	4.5	117 \pm 2.4	1
	40	2.5	Not in \sim 1,000 pulses	
12.5 mm Stainless Steel	2.25	800	Not in \sim 65,000 pulses (9 min)	
	10	40		
	5	160	622	5
14 mm Al	2.25	60	83 \pm 1.0	0.7
7 mm SiC	5	10	150	1.2
50% trans.	5	5	600	5
25% trans.	5	2.5	Not for 1 hour

9.09 keV, 0.36 mJ (on target), 120 Hz, 0.043 W

* Repeat 10 times for each beam size on steel (raster the sample), but only twice on aluminum

- 12.5 mm thick steel was burned by 5 μm beams in 5 s, but not drilled through by 2.25 or 10 μm beams
- 7 mm thick SiC was burned quickly at ≥ 5 eV/atom, but not drilled through at 2.5 eV/atom for 1 hour

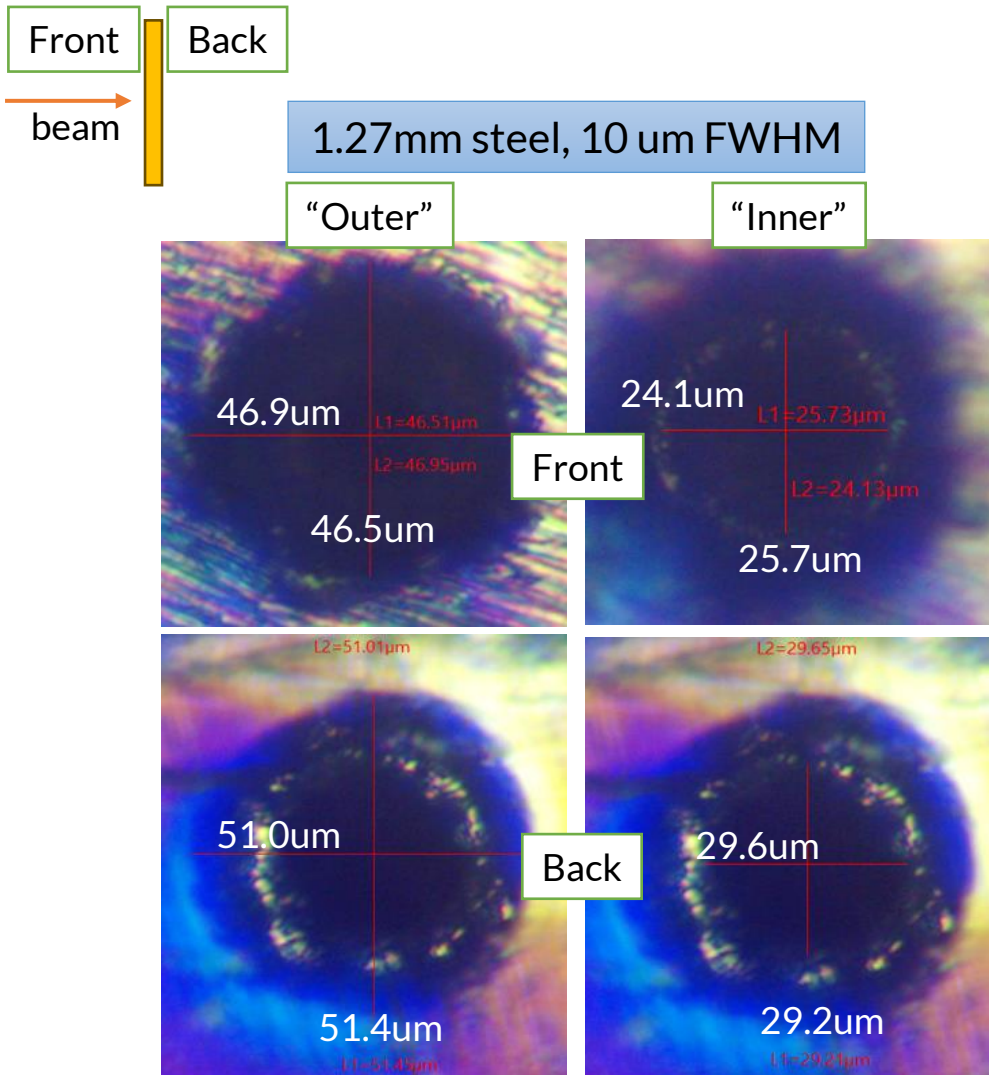
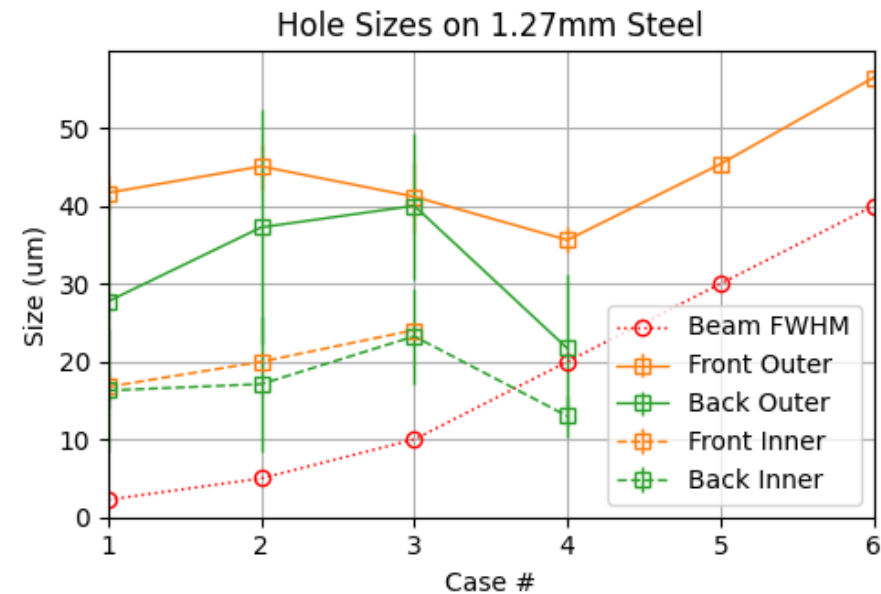
Material Damage Test: Hole Size

Assume hole diameter = beam FWHM in radiation safety analyses

- Assumption is **conservative in most cases** but not conclusive
- No “Inners” and no Back holes for 30 and 40 μm beams
- More tests with SC beam are planned

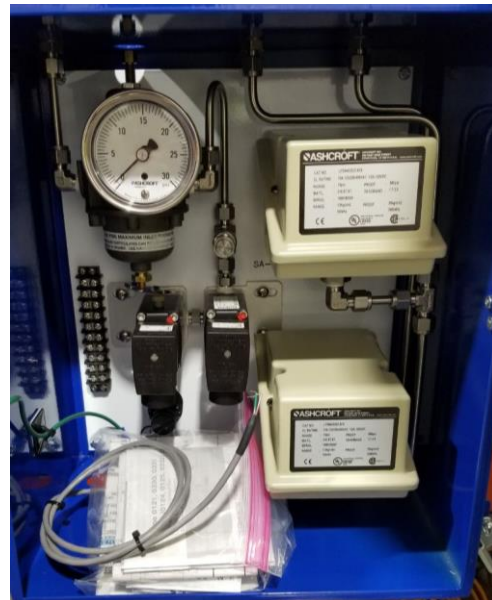
BTM Control Box (as built)

BTM Control Box

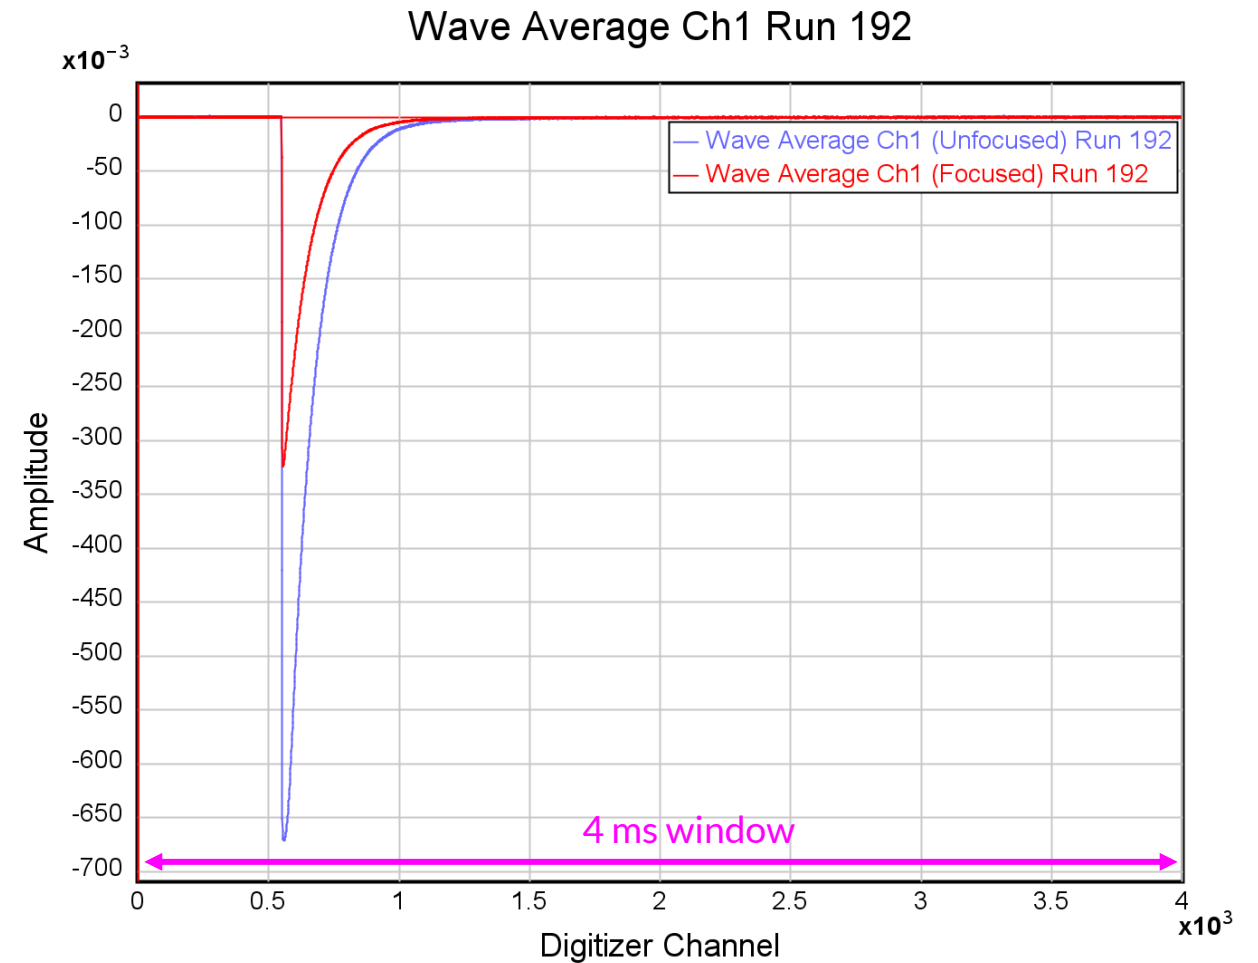
Waveforms from Photodiode

Averaged waveforms were plotted

- Fast response
- The amplitude from focused beam is smaller, because of the absorption of lenses

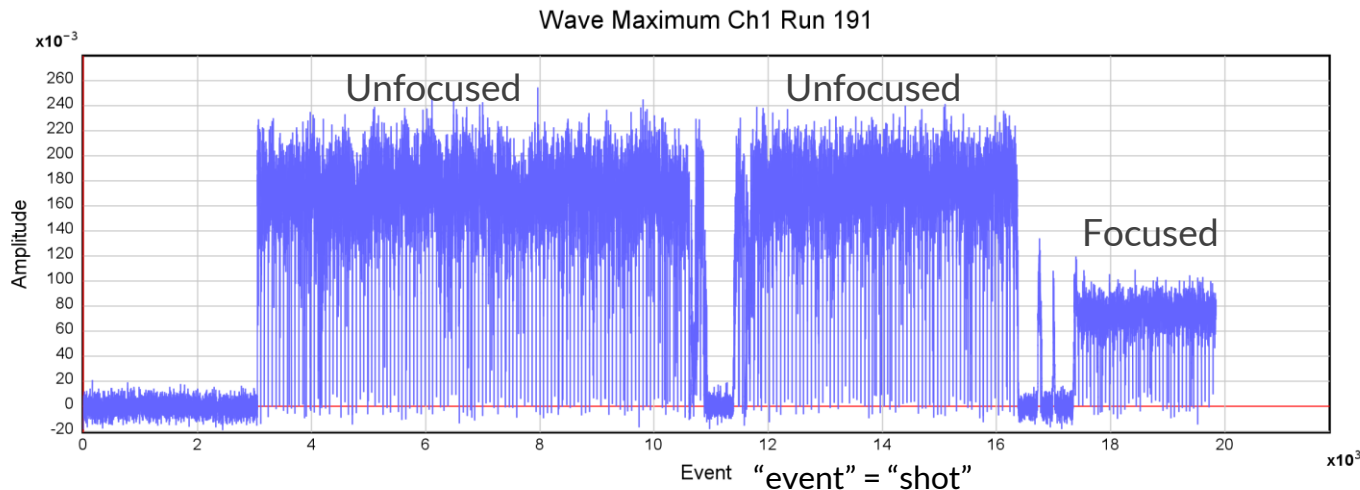
Test for Photodiode BTM

Tested 3 cases at different intensities (9.8 keV):

- Unfocused beam
- Focused beam to damage YAG → ~half signal after damaging
- No YAG (air only) → noticeable signal
