Pixel Commissioning

Pixel connection and sign-off: Overview

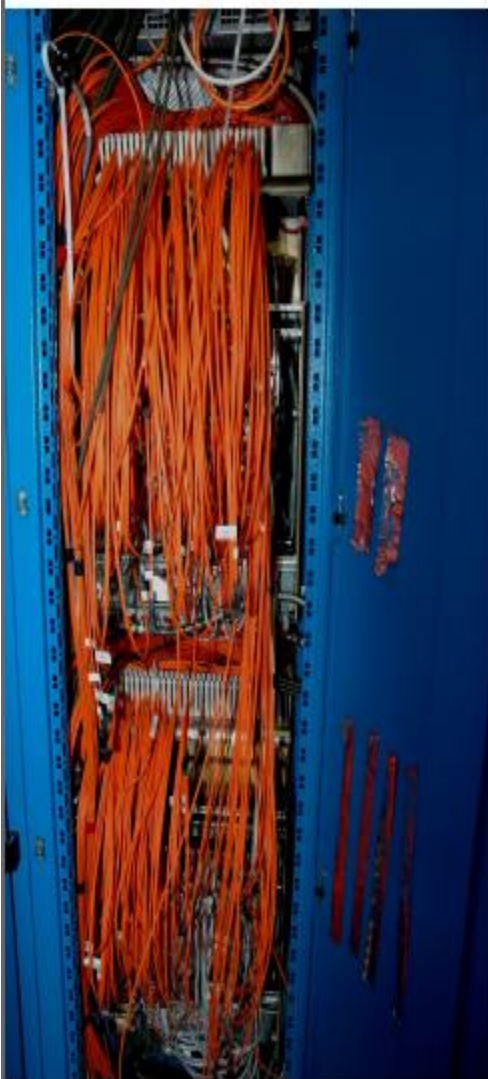
Fibers wrong mapping

- Wrong mapping of MT16 to 2xMT8 inside the connectivity
- Found during first tests on Monday 17th
- Corrected in 4 days from Wednesday 19th to Saturday 22nd
- Only those Fibres reconnected which had to be moved, some via database (eg. L0 data)

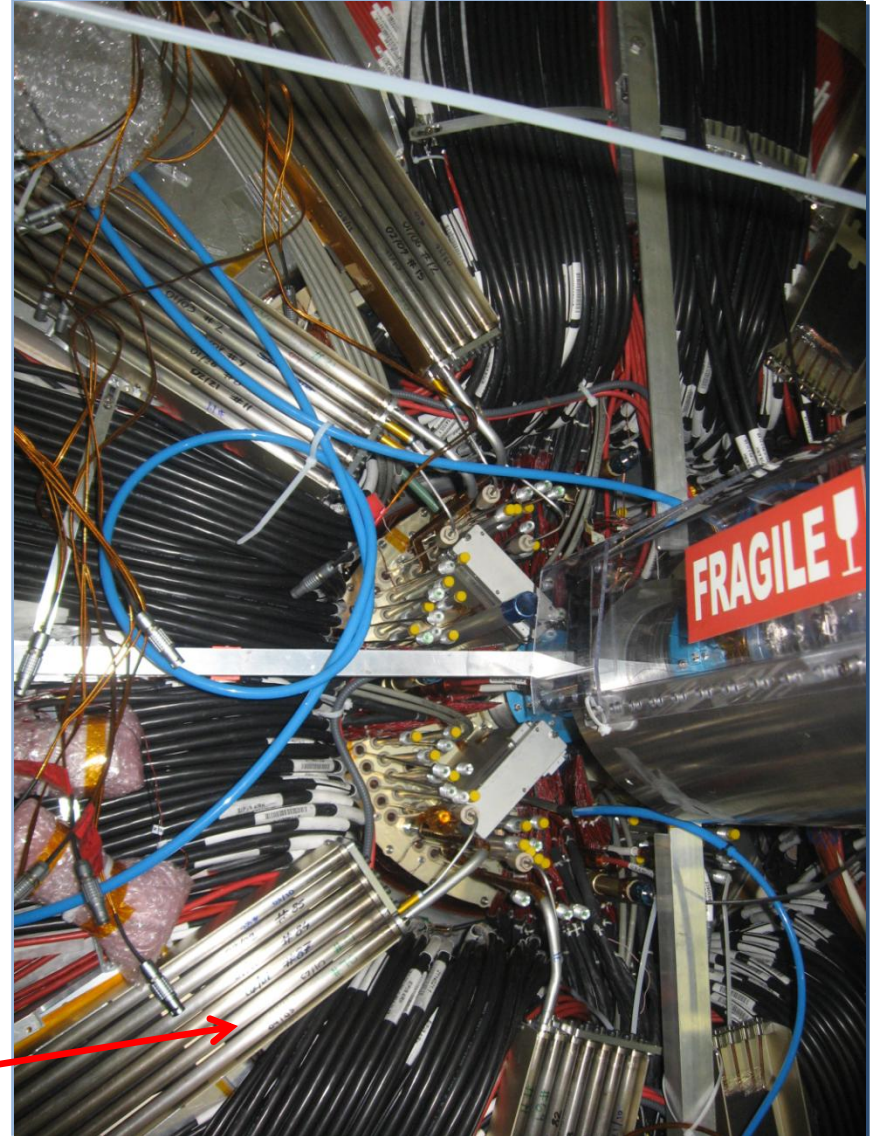
C side US: trays heaters installed

8 cooling circuits connected to the detector.

Cooling outer services are installed but not connected to the detector.

Fiber installation is on-going and we plan to finish during the weekend.

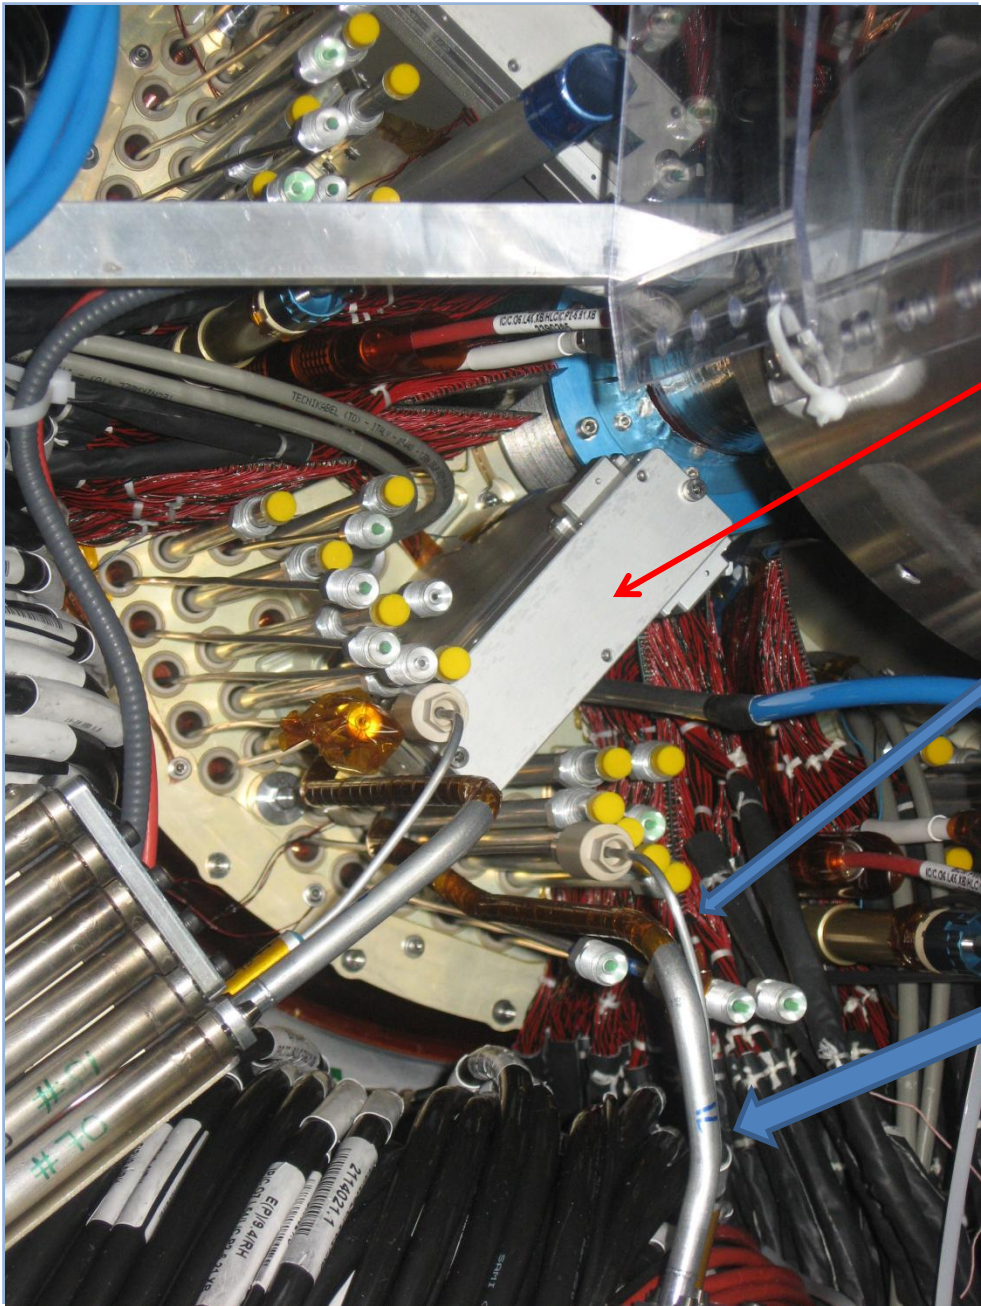
Heaters trays

Zoom in of the pp1 connection location for fibers and cooling pipes.

Faceplate hides a 10x4 matrix where 40 fiber ribbons has to be connected

Inlet pipe

Exhaust pipe
