Evaluation of a new muon monitor sensor for the T2K experiment using the J-PARC neutrino beam

Yukine Sato for the T2K collaboration

15th International Neutrino Summer School 2024
Monday, 3 June 2024 – Friday, 14 June 2024
Bologna, Italy

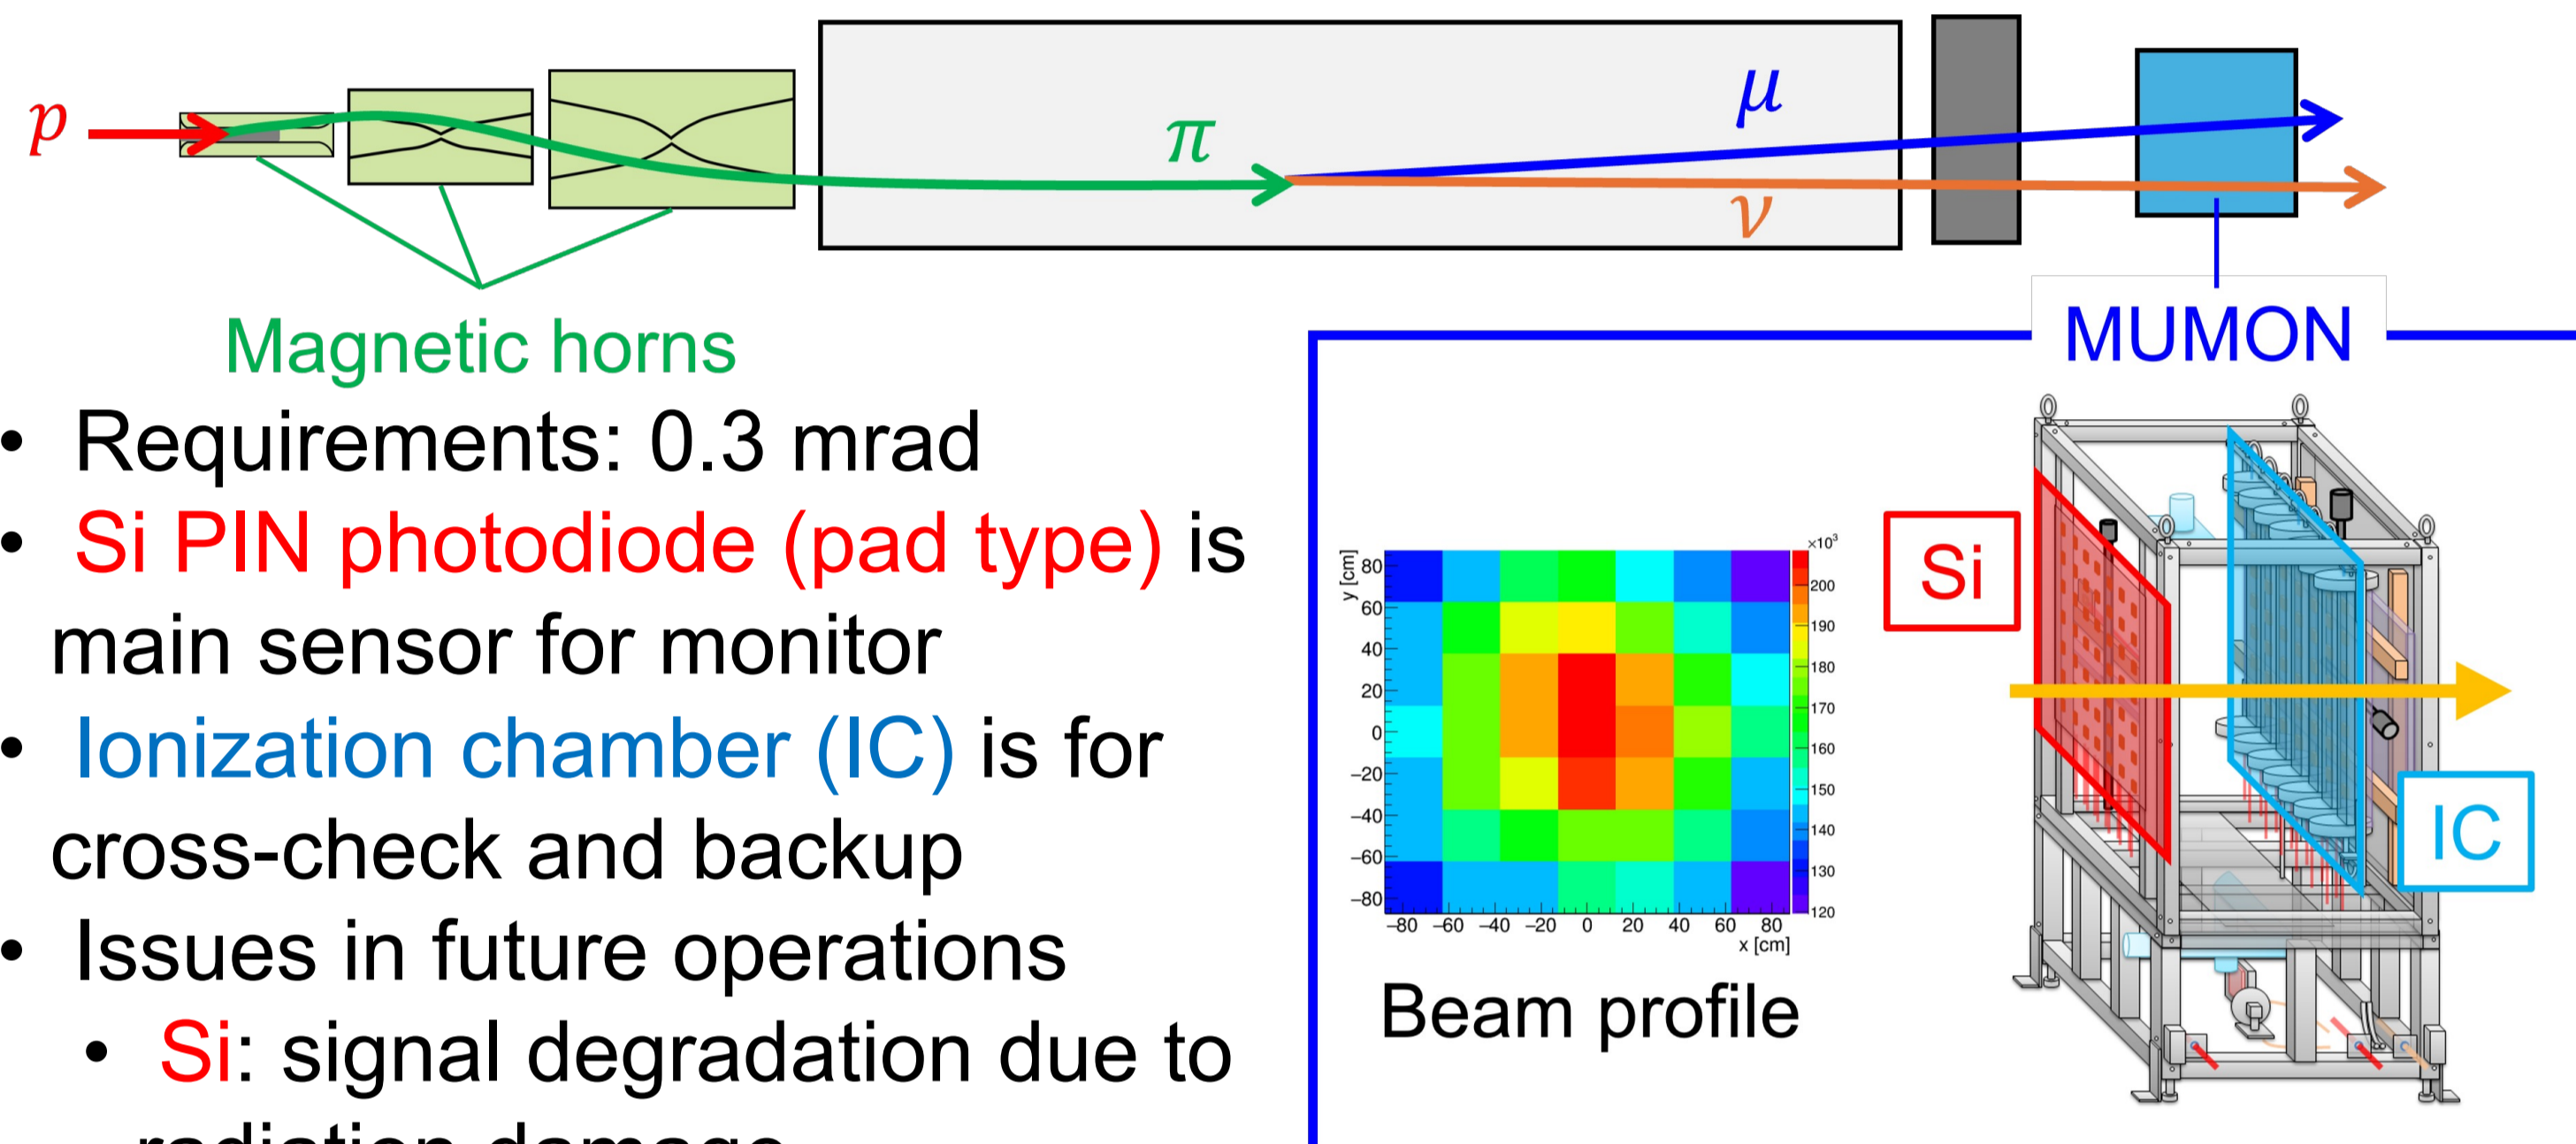
- Indirectly monitors neutrino beam intensity and directions in real time

- Requirements: 0.3 mrad
- Si PIN photodiode (pad type) is main sensor for monitor
- Ionization chamber (IC) is for cross-check and backup
- Issues in future operations
 - Si: signal degradation due to radiation damage
 - IC: non-linearity due to the space charge effect

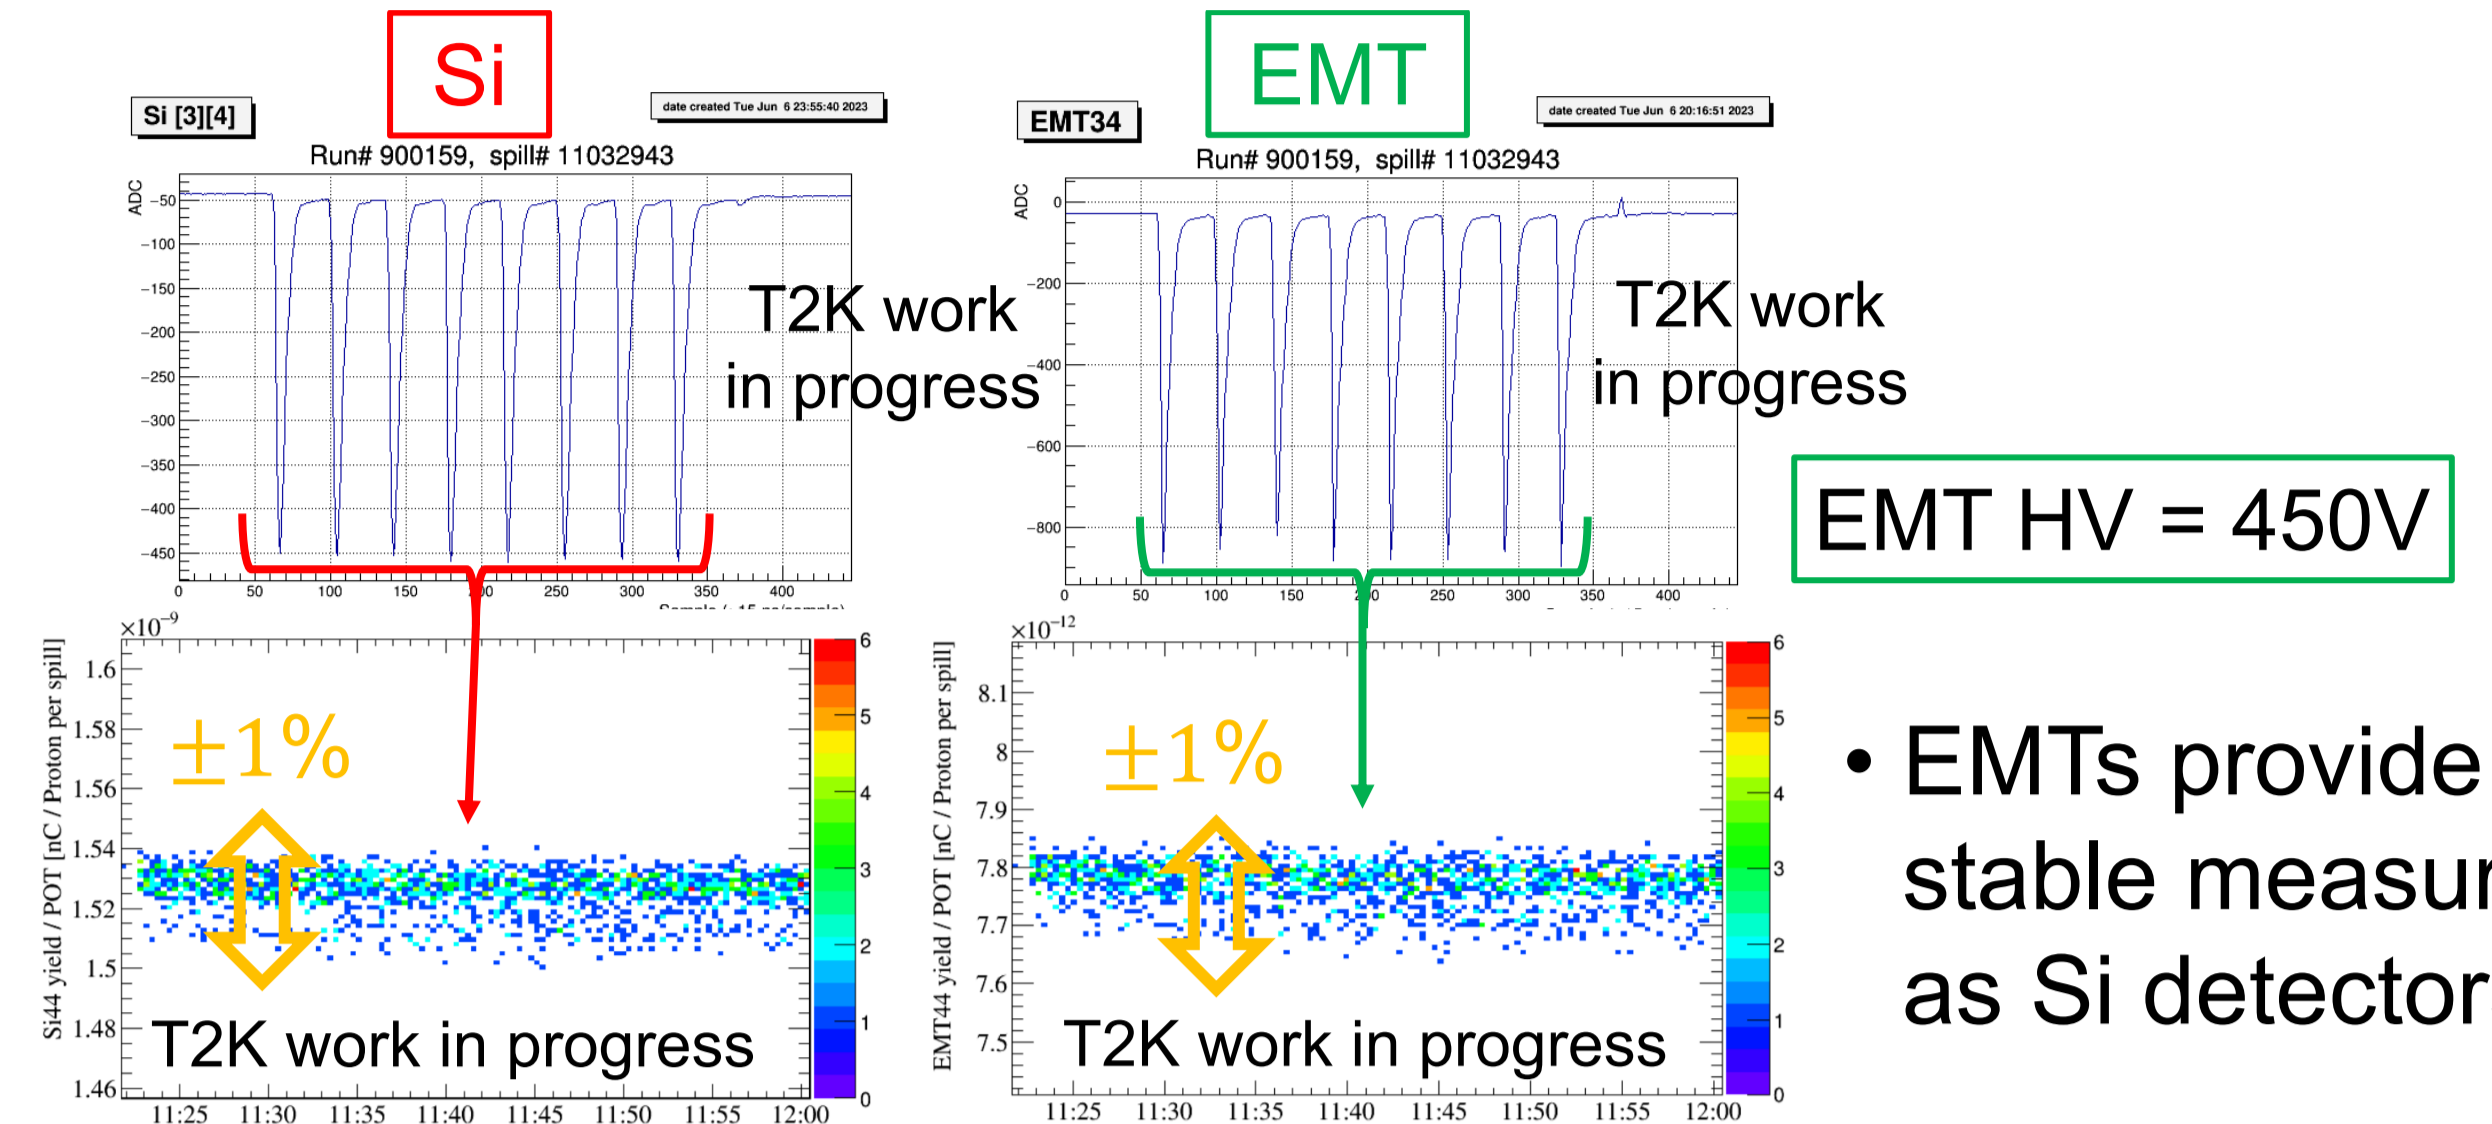
3.1.1 Time dependence of the integrated charge

- EMTs provide as stable measurements as Si detectors

- T2K beam direction and intensity are indirectly monitored by muons (MUMON)
- EMTs (new candidate sensors) were installed at MUMON in J-PARC
 - EMT response has been stable within $\pm 1\%$ during beam operation
 - Muon profile was measured by 7 EMTs at high and low intensity beam
 - Beam center measured by EMTs was misaligned by 1.7cm w.r.t. Si measurement → Cause of the shift is currently under investigation
- EMTs will be fully implemented and used as the primary monitors after the validation with neutrino beam data

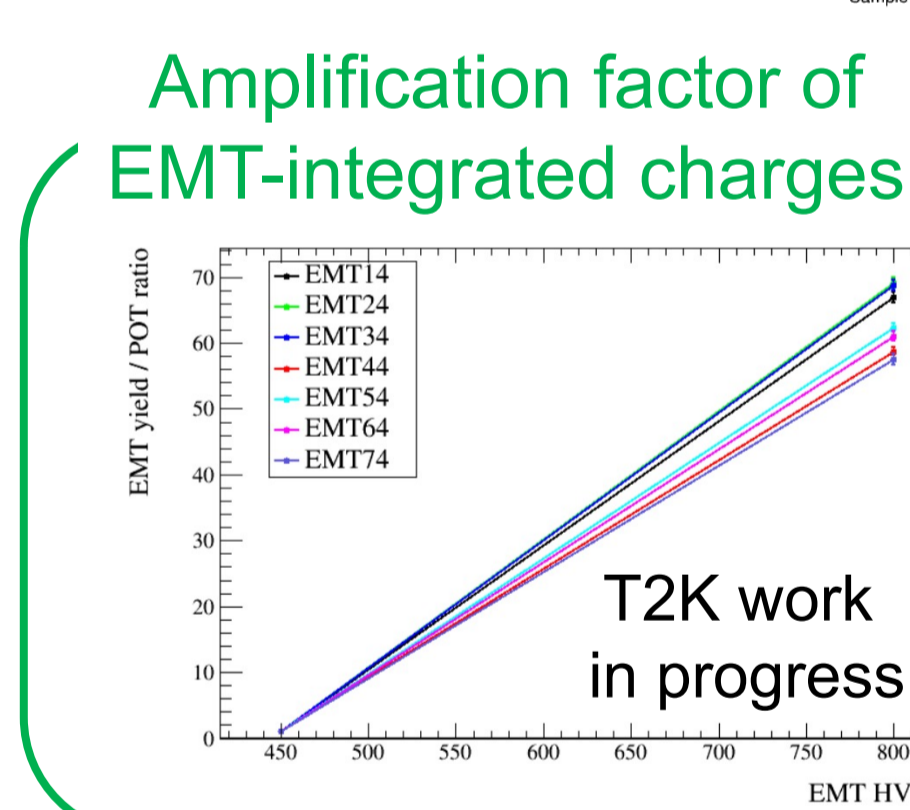
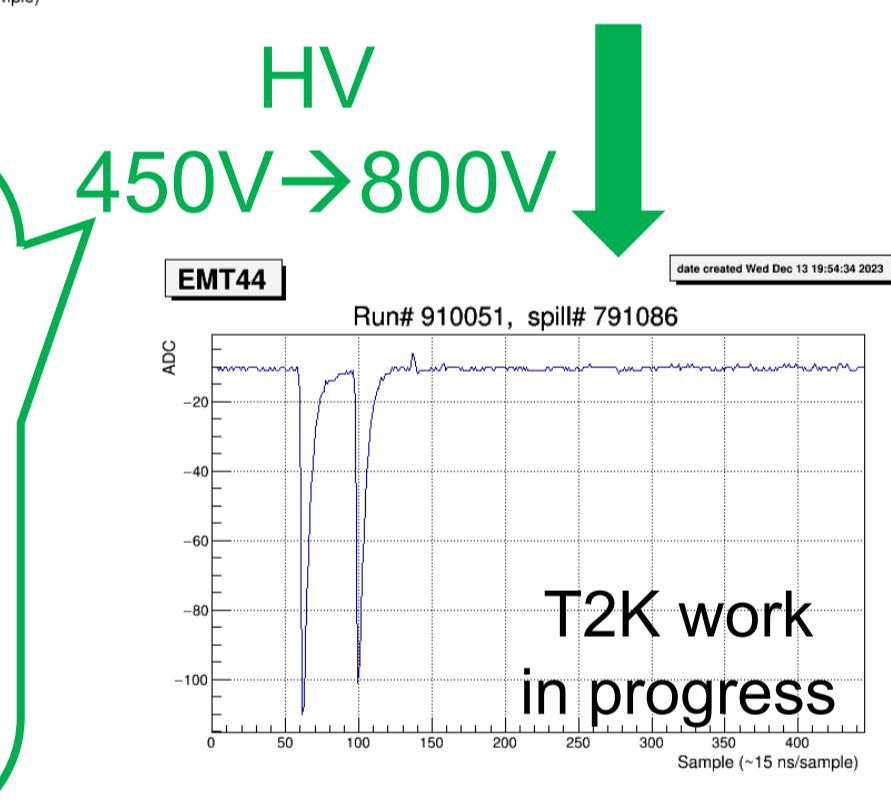
3.2.1 Waveforms and applied voltage

- Gain variations are different for 7 EMTs
- EMTs need to be recalibrated to operate at different voltages

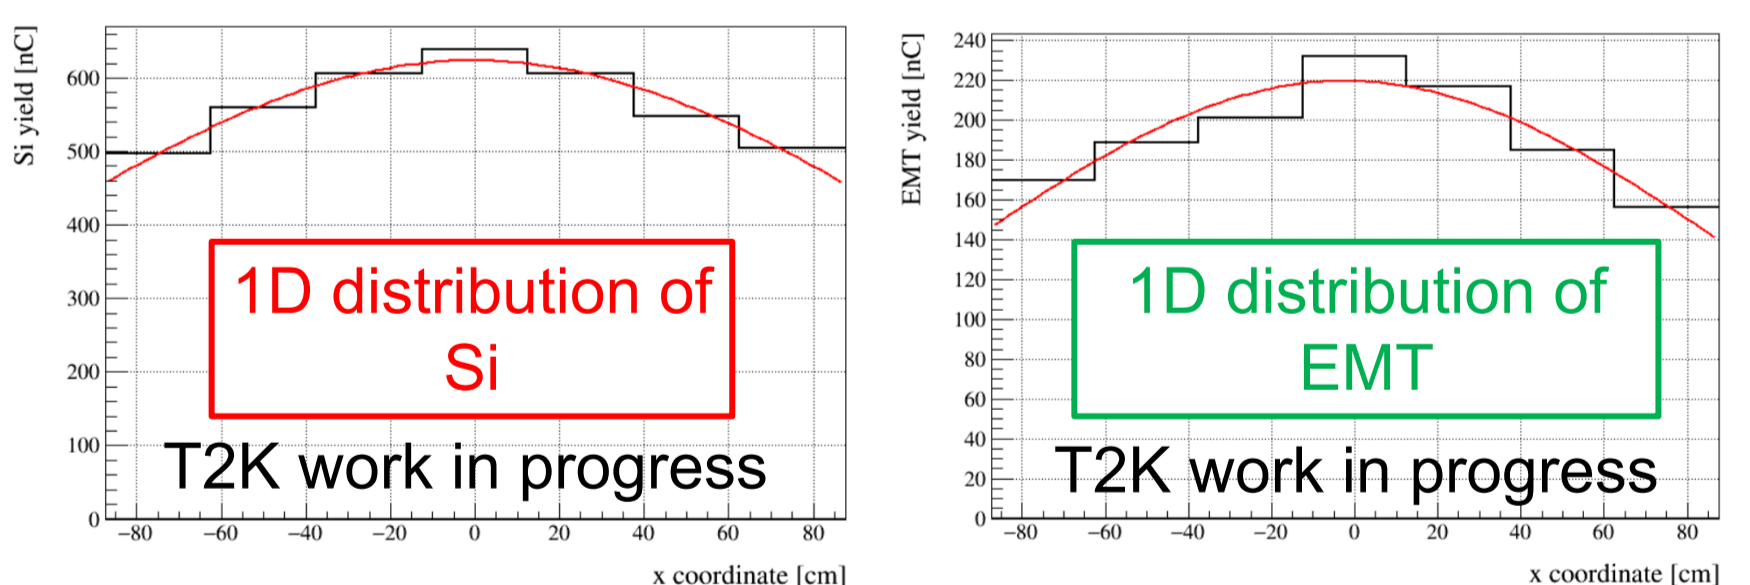
3.2.2 1D beam direction measurements

- 1D profiles of the integrated charge at low intensity were obtained in the same way as for Si
